**Fifth International Conference on CANDU Fuel
1997, September 21-25
Toronto, CANADA**

**NUCLEAR FUEL PERFORMANCE IN EMBALSE NPP,
DESIGN OPTIMIZATIOS AND MANUFACTURING IMPROVEMENTS**

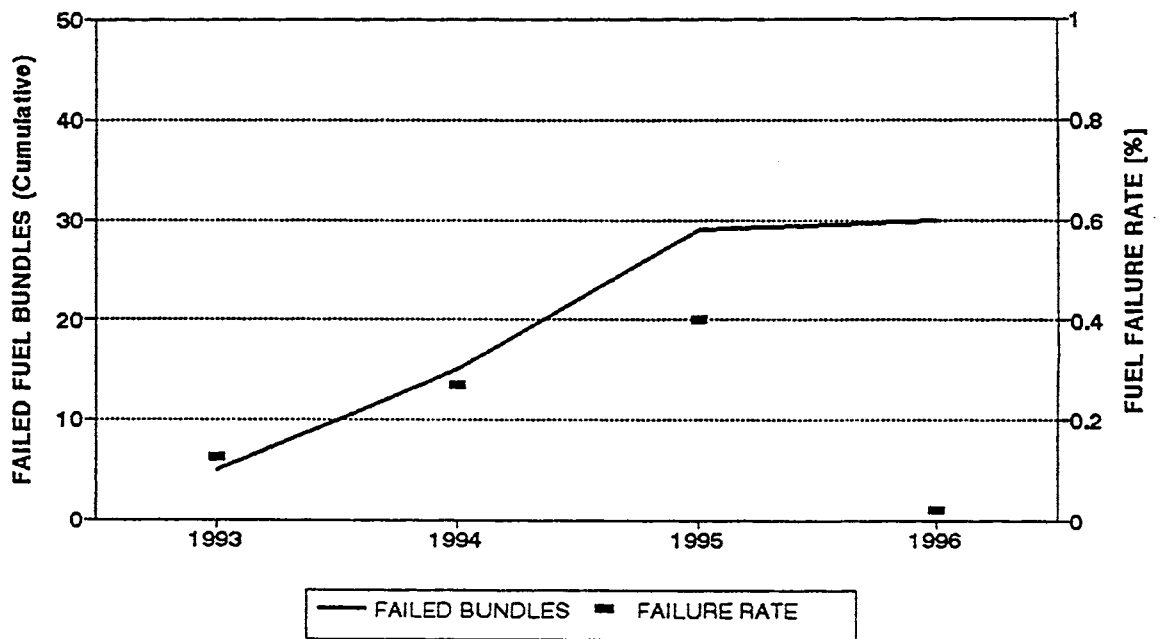
Figure 2: Domestic failed fuel bundles and fuel failure rate during the last four years.

Relevant data regarding the domestic supply of fuels to Embalse NPP during the last four years is presented in Figures 1 and 2. More than 3000 fuel bundles were delivered by the fuel manufacturer to the power station each year. Figure 2 shows the cumulative number of failed fuel bundles in this period and the failure rate for each year. This rate was less than 0.2 % in 1993 and then jumped to 0.4 % in 1995. In 1996 the failure rate was again very low. Although some fuels manufactured during 1996 are still into the reactor, the activity level of the primary coolant is very low so we expect that the good performance of these fuels will remain at that level until the end of their irradiation.

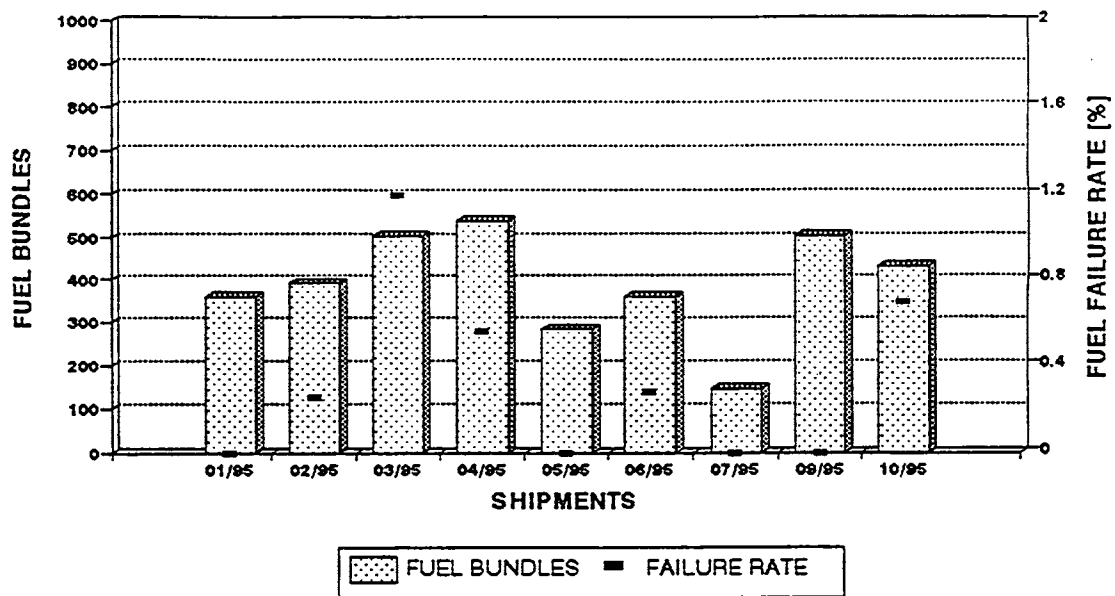
Figure 3: Evolution of the fuel failure rate for each shipment of fuels manufactured during 1995.

The evolution of the failure rate for each shipment of fuels manufactured during 1995 was analyzed in Figure 3. Shipment 03/95 had the maximum failure rate (1.2 %) and shipments 04/95 and 10/95 were also rather high, around 0.6 %. Some correlations with fuel manufacturing and control records suggest that there may be a relation between the failures and some batches of the graphite coating process. Although further investigations are necessary to confirm these findings, it is clear that failures are part of a "failure excursion". The same might be demonstrated for shipment 10/95 but related with the endcap welding process. The failure rate corresponding to the "failure excursions" modifies the overall fuel failure rate for the whole year. Table 2 shows relevant information for the last four years, including the failure rate without considering the "failure excursions". This rate is 0.10 - 0.15 %, depending on how many fuels are considered as part of the failure excursion.

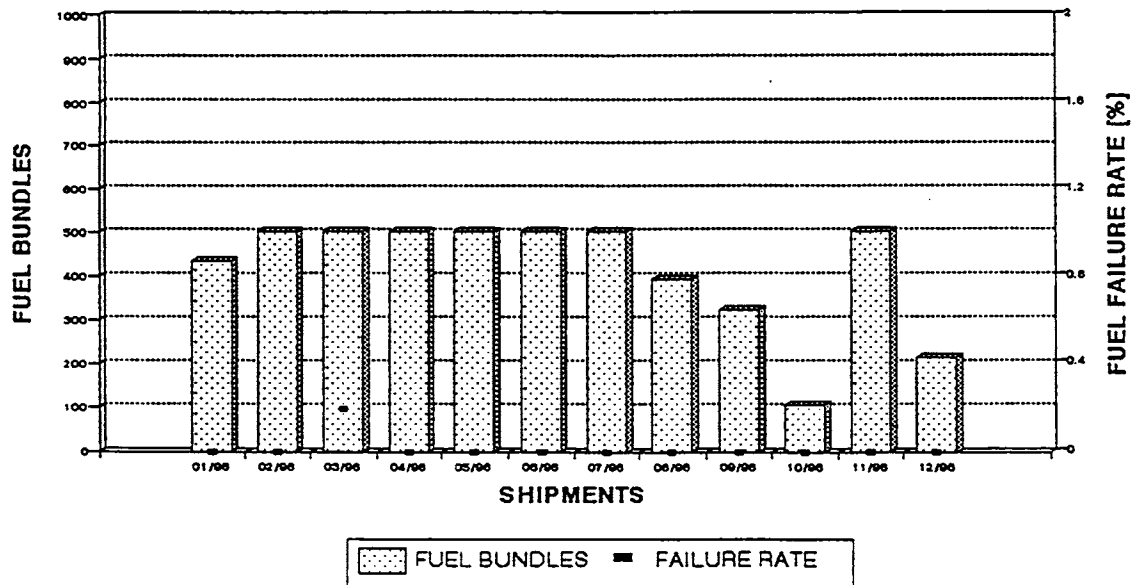
Figure 4: Evolution of the relevant data for each shipment of fuels manufactured during 1996.

Figure 4 shows relevant information for fuels manufactured during 1996. In this case there is only one failed fuel and therefore the failure rate is very low.
