## FUEL DEFECT ROOT CAUSE INVESTIGATION AT WOLSONG-1

## ABSTRACT

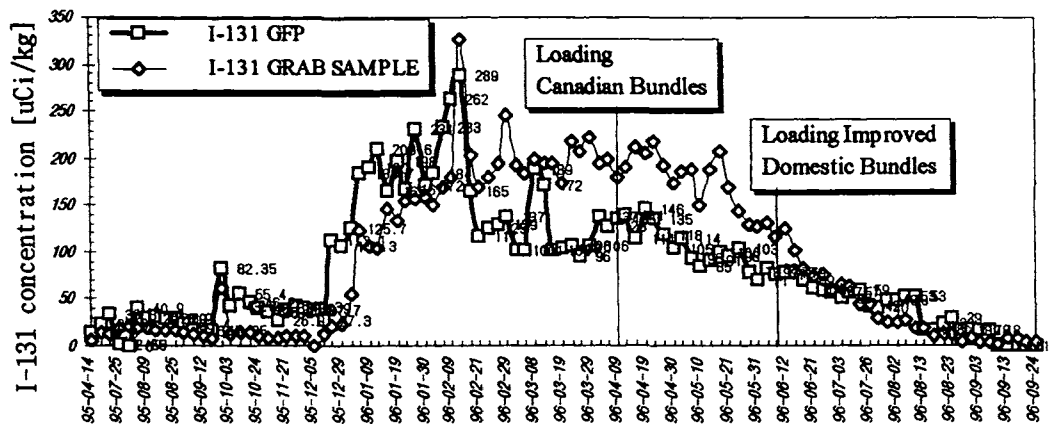
FIGURE 1. I-131 ACTIVITY CONCENTRATION TREND IN THE PHTS

After the annual maintenance outage in September 1995, the fission product activities in the PHTS began to increase slightly, and in December 1995 the activities continued to increase substantially indicating the presence of many defective fuel elements in the core. Figure 1 and 2 show the I-131 and Xe-133 activity concentration trend in the PHTS, respectively, from April 1995 to September 1996. This paper summarizes the investigation and actions taken by KEPCO, KAERI and AECL to reduce the activity level at the station and to determine the root cause of the fuel failures.

- The coolant purification flow rate was increased from 10 kg/sec to 12 kg/sec initially, and later to 24 kg/sec to lower the radioiodine levels.
- The frequency of calibration and scanning of the Delayed Neutron (DN) system (or the failed fuel location system) was increased from once per month to once per week to improve the search for defective fuel.
- To reduce the rate of fuel failures, refueling operations were switched from fuel bundles from the 1994 batch to ones from the 1995 batch only. At the time, the defect rate of the 1994 production bundles was observed to be higher than normal. As a follow-up, two 1994 bundles stored in the new fuel room were sent to KAERI for destructive examination to identify the root cause of failure.

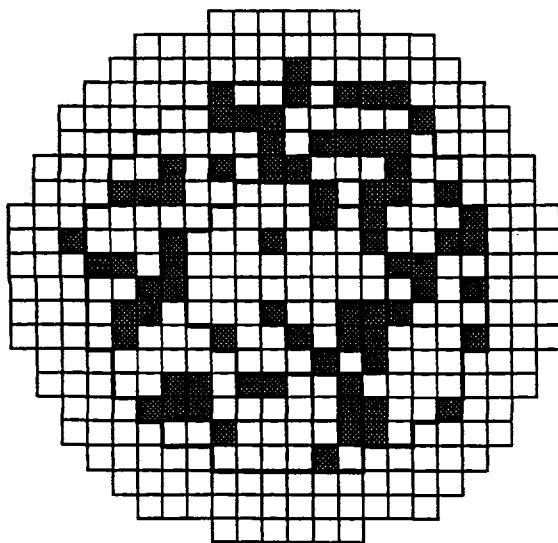
FIGURE 3. CHANNEL LOCATIONS OF DEFECTIVE FUEL DISCHARGED FROM WOLSONG UNIT 1 (1995/96)

- Almost 80% of all channels having fuel failures or suspected to have fuel failures belonged to the region of the core called "high power annulus"(See Figure 3). This is the region where the channel powers are the highest.

- With the exception of a small number of channels, all fuel failures seemed to have occurred in one of the center four bundles in the channel. As a result, it was recommended that four bundle shifts be avoided and all refueling operation for suspect channels be performed with eight bundle shifts to ensure that the center four bundle were discharged.

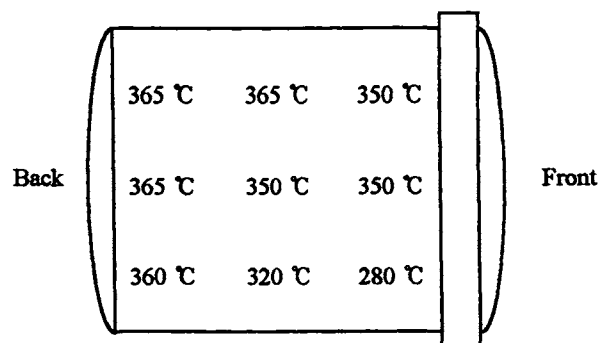
FIGURE 4. TEMPERATURE DISTRIBUTION IN BAKING OVEN

In order to quantitatively evaluate the correlation between coating thickness and hydrogen content, hydrogen contents in several test samples having various coating layer thicknesses were analyzed. As a result of the analyses, it was shown that hydrogen content increased from 1.3  $\mu\text{g/g}$  in a 3  $\mu\text{m}$  thick layer to 10.0  $\mu\text{g/g}$  in a 12  $\mu\text{m}$  thick layer. The analyses results are shown in Table 3. The general increase in hydrogen gas content with coating thickness is an indication of underbaking. Hydrogen gas content for fully baked coatings should not have a strong dependence on coating thickness. Another significant finding from the review of manufacturing system was that non-uniform temperature distribution exists in the baking oven. The time-temperature cycle of the facility's baking oven is controlled by thermocouple readings from the back center of the oven. A characteristic of this baking oven is that the baking times and temperature may vary in different regions inside the oven. According to the manufacturing instructions, temperature in the baking oven should be greater than 320  $^{\circ}\text{C}$  for more than two hours. However, time-temperature profile measurements have shown that complete baking conditions are not being met close to the bottom of the oven, particularly in the region close to the door. Figure 4 shows the results from 9 separate measurements at various locations in the oven.

Moreover, it was revealed that the sheaths are preferentially loaded into the baking oven, that is, the bottoms of the sheaths are always oriented to the front of the oven, at least since mid 1994. This presents a worst case scenario where the thickest coating receives the lowest temperature and shortest times in the baking cycle for sheaths located in the bottom of oven. Relative measurements have shown that hydrogen content is about three times higher for sheaths baked in oven bottom locations compared to sheaths baked in other areas in the oven chamber (See Table 4). This method of loading was done by operator preference. Previously, the loading had been random.

- This localized elevated hydrogen content was caused by the combination of an increase in the CANLUB graphite coating thickness and localized underbaking in the lower section of some fuel sheaths.

In order to reduce the temperature difference in baking chamber, the thickness of thermal barrier in the entrance of the baking chamber was increased. Also, the operation program of the baking oven was modified and local heating rates were adjusted.
