# RTD PROBLEMS AT DARLINGTON

### Abstract

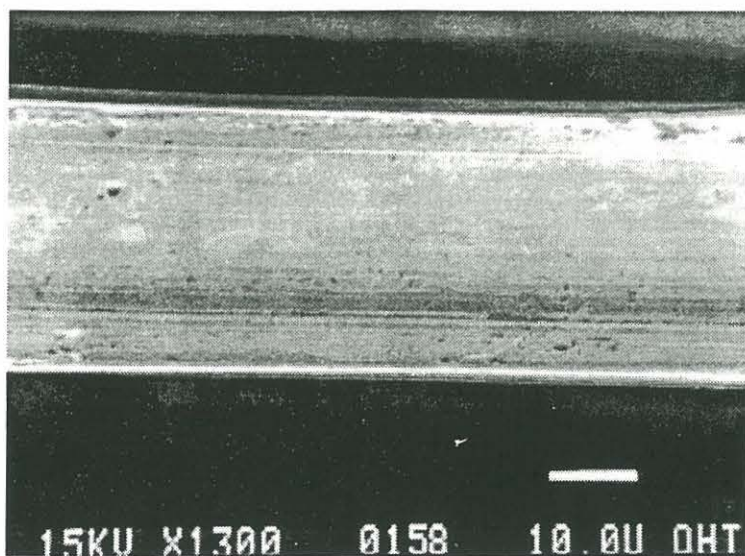
Figure 3. Scanning Electron Microscope Picture of Platinum Wire Surface from Unshifted RTD

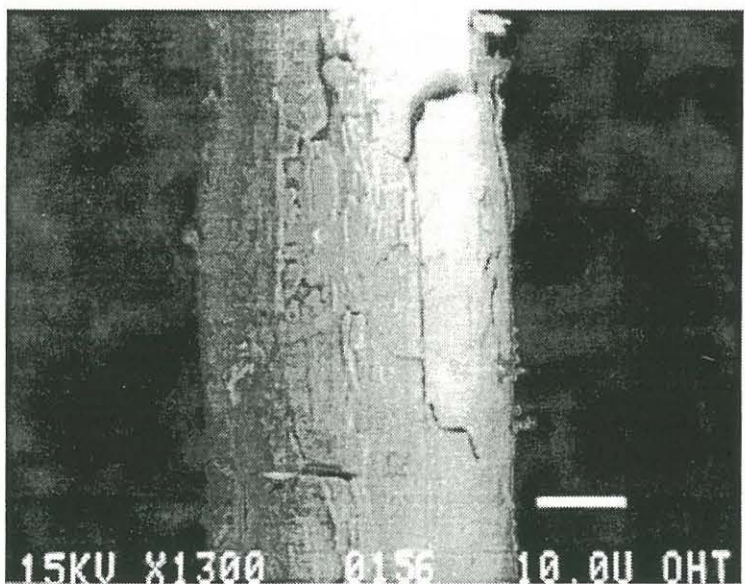
OHT took some scanning electron microscope pictures of the platinum wire of the RTD elements. (Refer to Figures 3 and 4 - pictures of unfailed and failed RTDs) The normal, unfailed RTDs have platinum wire with a smooth surface (Figure 3). The failed RTDs have platinum wires with a damaged surface that shows flakes peeling off the surface (Figure 4). The increased resistance of these damaged wires is thought to come from the loss of cross-section caused by the flaking.

What would cause this kind of damage to the RTD surface? Initially, oxidation was suspected, but a literature search revealed no evidence for oxidation at the conditions to which the RTDs are exposed. The current theory is that chlorine present on the surface of the platinum wire during manufacturing could have caused damage to the platinum surface. During operation, thermal stresses cause flakes to peel off the surface and reduce the effective current-carrying diameter of the wire. Only a 1% reduction in diameter is required to cause the resistance to increase to the extent observed. The process may take years of operation before an RTD resistance increase is noticed. (Note: we don't really know whether the problems show up suddenly or only gradually. Bias measurements of RTDs during low power hot conditions are the only way to really tell and they are not done very often.)

RTD calibration shifts are real and traceable to a physical effect on the RTDs. The root cause of the shifts is contamination of the platinum wire or other sensor components during manufacture with chlorine, carbon and oxygen-containing compounds.

Figure 4. Scanning Electron Microscope Picture of Platinum Wire Surface from Shifted RTD.

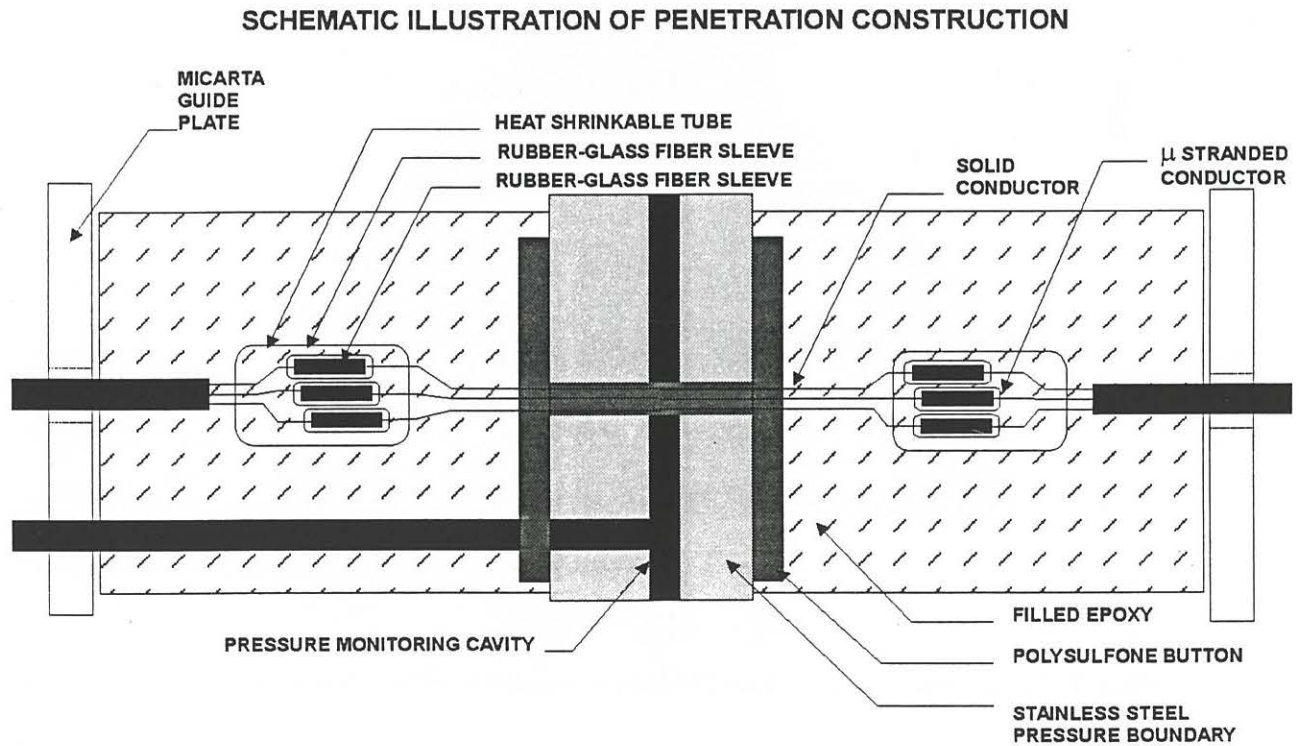
A module consists of a bundle of wires that are crimped onto a single-strand conductor to pass through the containment barrier. There are two crimps on each cable internal to the module - one on each end of the single-strand conductor (see Figure 6).

Darlington has found that some crimps have degraded and a series resistance has built up (even as small a resistance as 0.1 ohms can affect the RTD measurement). The particular mechanism that causes the series resistance is thought to be incomplete crimping [1].

Figure 6. Schematic Illustration of Penetration Construction

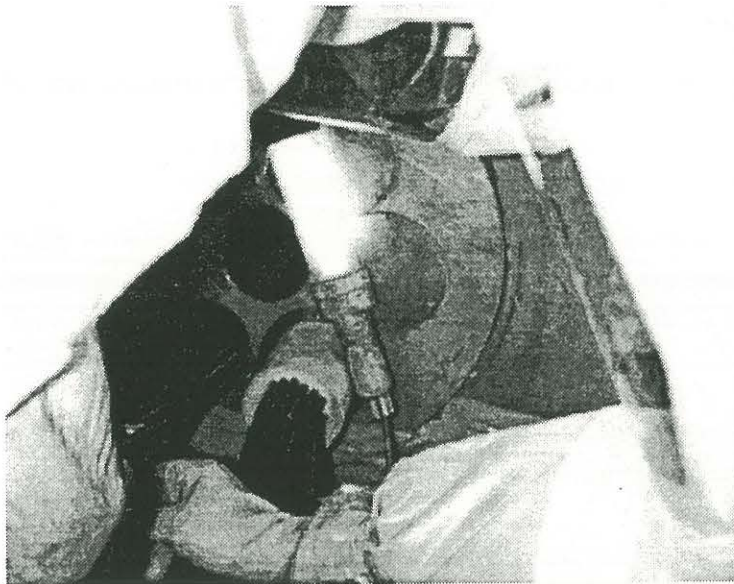
Figure 8. Module Being Pulled Through Electrical Penetration 2260 From Inside the Vault

Originally, the plan was to use a custom flask to maintain the containment boundary; however, the flask could not be used because cable trays blocked its access to the penetrations. Since the flask could not be used, opening the required hole in containment forced us to declare the Negative Pressure Containment System (NPCS) out-of-service, which was allowed partly because all four units were in Guaranteed Shutdown State (GSS) during the installation. Modules were inserted from outside the vault end and pulled through the penetration from inside the vault. See Figure 8 showing a module being pulled through. There was a lot of pre-planning and prerequisites prior to declaring NPCS out-of-service and backout plans were put in place to handle all possible scenarios. In the future, if a module has to be installed, a special, flexible flask that takes advantage of the cabling that makes up most of the length of the modules would be required. Then the penetration can be opened inside the vault and the module pulled through without compromising containment.

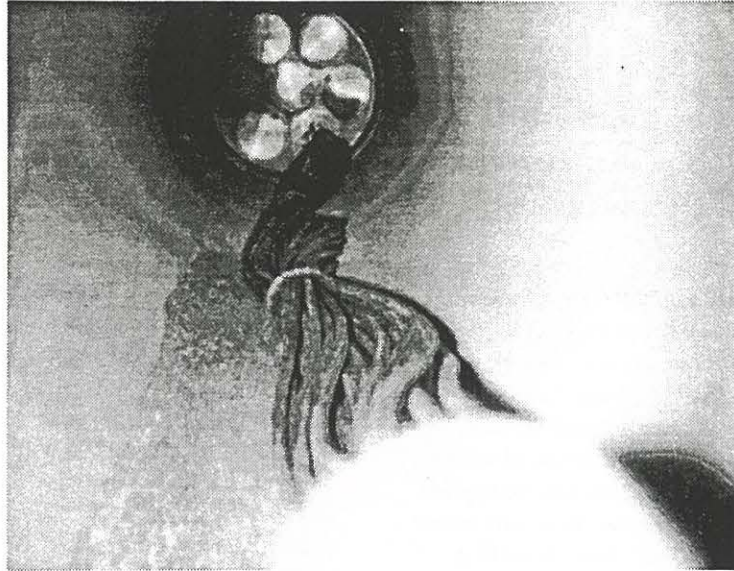
Figure 9. Inside of Electrical Penetration 2262 Showing One Module and Supporting Sand

EP 2260 (above 2263). The modules would be installed at the bottom of the electrical penetration and sand would be used to support the cables. See Figure 9 showing the inside of EP 2262 with one module installed and cables supported by sand.
