**CANDU MAINTENANCE CONFERENCE  
S08: INVESTIGATION AND REPAIR OF A  
CRACKED FEEDER AT POINT LEPREAU GS**

**ABSTRACT**

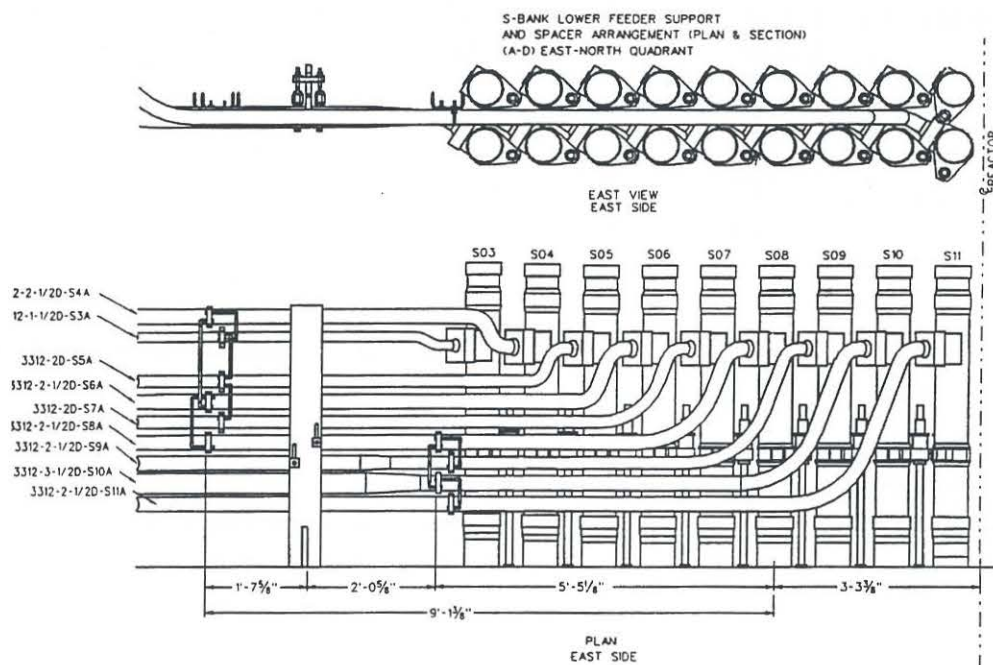
FIGURE 1:  
S08 FEEDER ARRANGEMENT

- Atypical S08 feeder spacers resulting from the 2 ½ inch diameter feeder being adjacent to a larger diameter feeder (see Figure 1).
- The normal design configuration of a single end of the fuel channel locked in position.
- The abnormal situation where the S08 fuel channel was left unlocked after the 1995 Spacer Location and Re-positioning (SLAR) program.

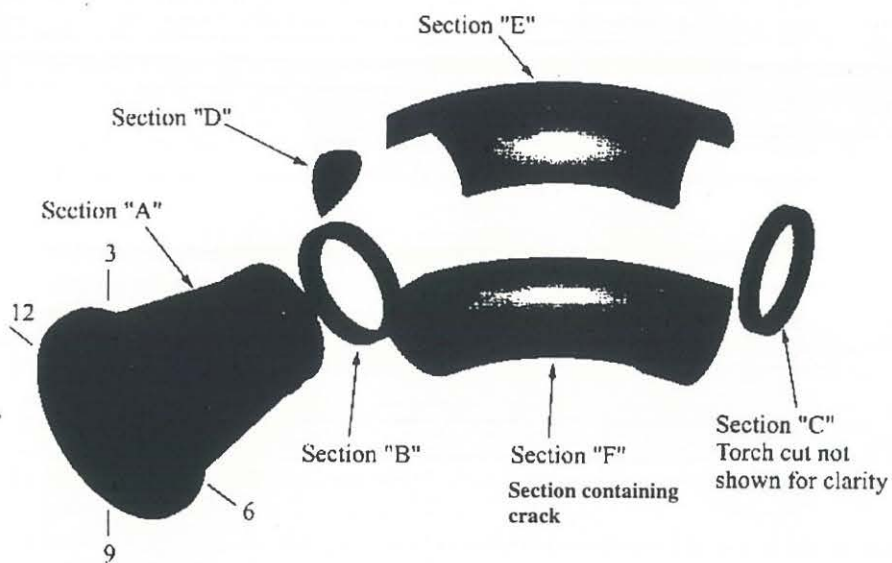
The pipe was sectioned as indicated in Figure 2, and further sectioned in and around the crack. Upon splitting the pipe into the E & F sections in Figure 2, it was noted that the pipe sprung open. This indicated high remaining residual stresses within the pipe. Increased hardness, within the bend section of pipe was also measured. Both the springing open of the pipe and the increased hardness was attributed to the cold bending process used during fabrication.

A section of the pipe to Grayloc hub weld region was prepared for examination of the heat-affected zones (HAZ) of the weld (Section A in Figure 2). No cracking, intergranular attack, or crack initiation was observed in the one plane of the HAZ examined.

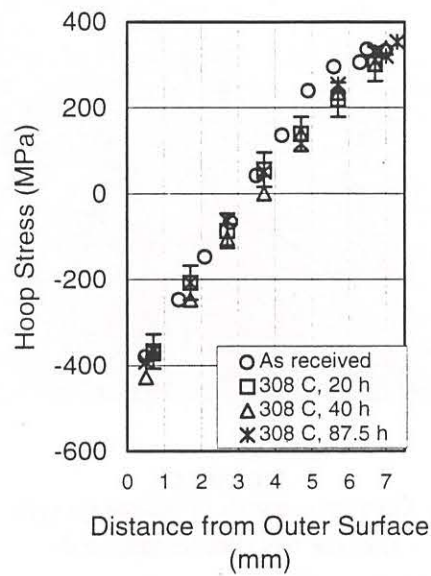
Measurements of residual stress were made at positions through the wall thickness of the material on the spare elbow using a non-destructive neutron spectrometer. The residual stresses were measured on the spare elbow at a location equivalent to the crack on the failed component [1] (See Figure 3). The residual stress measurements showed that the hoop stress varied from compressive at the OD surface to tensile at the ID surface. The maximum tensile stress was 330 MPa, which approximates the yield point of the material of 350 MPa. Additional residual stress measurements were conducted after 20, 40, and 87.5 hour heat treatments at 308°C, the nominal temperature of the primary coolant. As expected, there was no apparent relaxation of the residual stresses at the nominal coolant operating temperature [2] (see Figure 3). Residual stresses were measured to be a maximum at the location equivalent to the crack defect [1].

From these measurements, it was concluded that the high residual stresses were present in the failed component during its in-service period. This is consistent with the observation that the pipe section sprung open during sectioning and the increased hardness in the bend region.

FIGURE 3:  
RESIDUAL STRESS SCANS OF ARCHIVED  
ELBOW

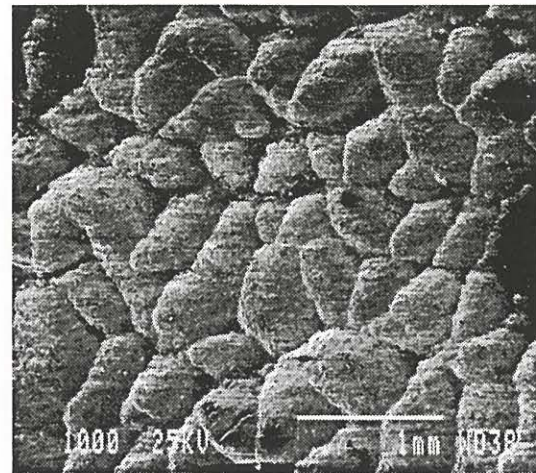
Specimens were cut remote from the crack to determine the general morphology of the inside and outside surfaces as well as the deposit/oxide thickness. The inside surface of the pipe was scalloped around the entire circumference (Figures 4 and 5), with an oxide thickness of less than about 1  $\mu\text{m}$ . In cross-section, the oxide was found to be  $\sim 1 \mu\text{m}$  thick, and exhibited a single-phase, compact structure typical of that expected for high flow outlet feeder conditions which can limit the oxide film thickness.

FIGURE 4:  
SEM, SECONDARY ELECTRON IMAGE, OF  
AREA REMOTE FROM THE CRACK  
SHOWING SCOLLOPS

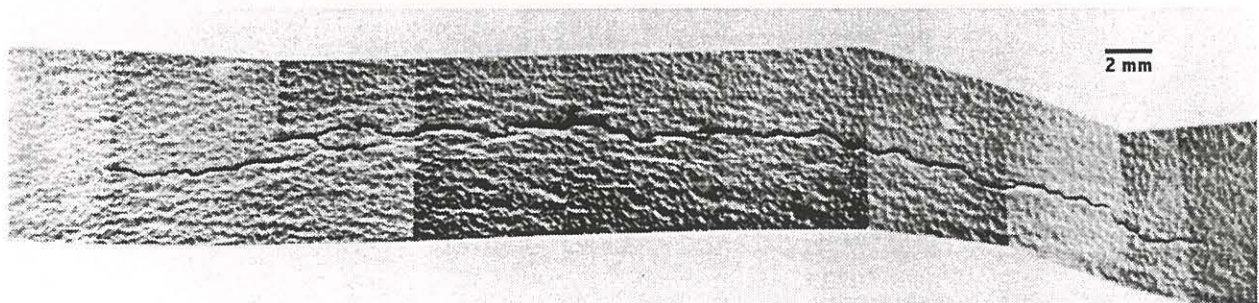
The upstream end of the crack, see Figure 5, was cut to enable metallographic cross-sections to be taken through the crack. Three cross-sections through the crack were examined. These cross-

FIGURE 5: PHOTOGRAPH OF THE MONTAGE ASSEMBLED FROM SEM, SECONDARY ELECTRON IMAGES, OF THE ENTIRE CRACK LENGTH (ID SURFACE)

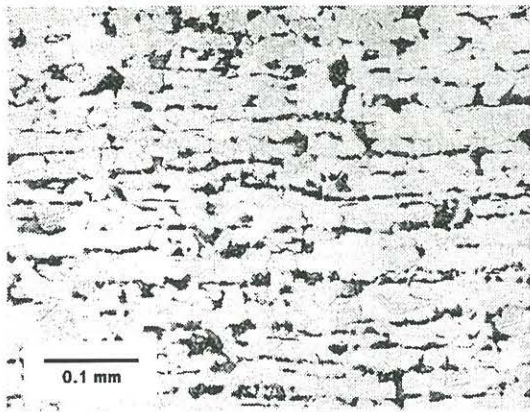
The outside surface was generally smoother than the inside, but with thick deposits. Inclusions in the feeder pipe material appeared to be consistent with the sulphur content (0.016 wt. %) and fabrication route of the pipe. When etched (Figure 6) the grain structure consisted of ferrite and pearlite grains, typical for SA 106B, with a decarburized zone of  $\sim 100 \mu\text{m}$  depth on the outside surface only. Vickers hardness measurements made remote from the crack gave an average value of 183 HV (20 kg). Immediately adjacent to the crack, the Vickers hardness values ranged from 203 to 223 HV (20 kg). Microstructure and hardness are consistent with a cold-bending process.

FIGURE 6:  
MICROSTRUCTURE OF FEEDER PIPE  
CIRCUMFERENTIALLY ADJACENT TO  
THE CRACK SHOWING BANDED  
FERRITE/PEARLITE GRAINS

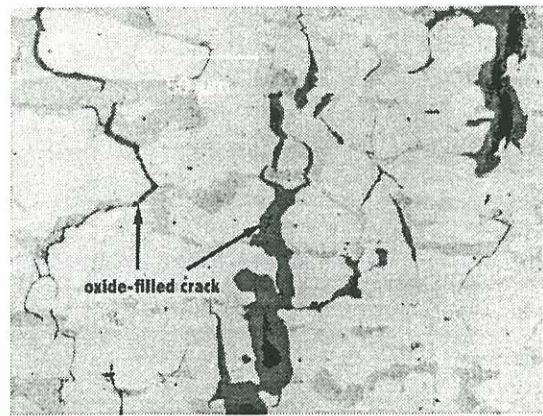
sections showed not only the main crack and the branches observed on the inside surface of the pipe, but also numerous adjacent finer secondary cracks (Figure 7). All of the cracks showed micro-branching and followed an irregular path. Upon etching, the crack path was observed to be intergranular. There were very few transgranular fracture features. At high magnification, all the cracks were observed to be oxide-filled (Figure 8).

FIGURE 8:  
OXIDE FILLED INTRAGRANULAR CRACK  
IN FEEDER PIPE (RADIAL-  
CIRCUMFERENTIAL PLANE)

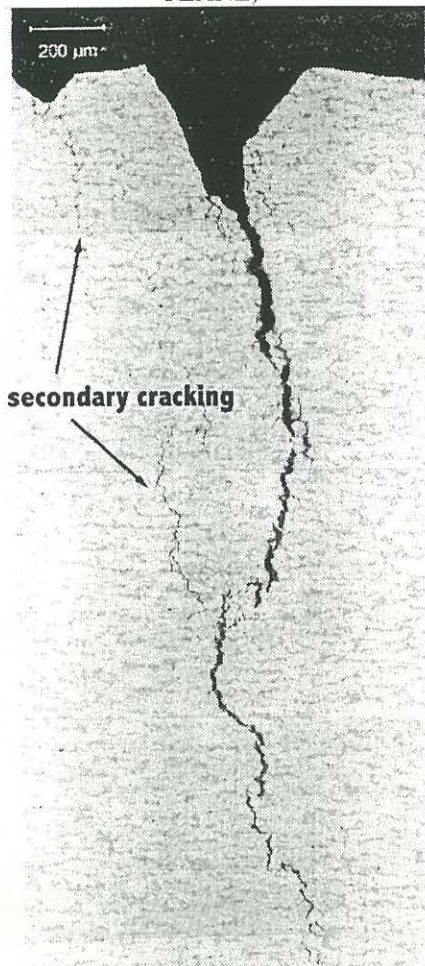
FIGURE 7:  
INTRAGRANULAR CRACK IN FEEDER PIPE  
(ETCHED, RADIAL-CIRCUMFERENTIAL  
PLANE)

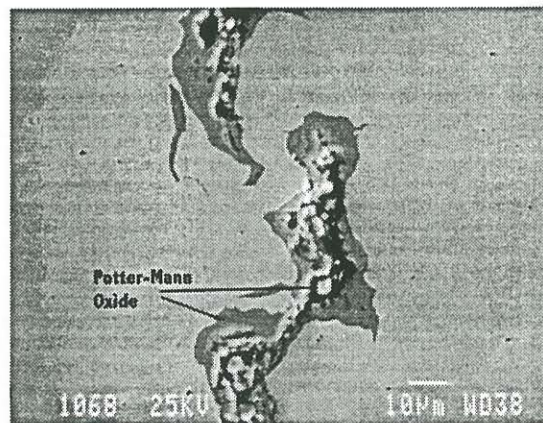
Two of the cross-sections were examined by electron microscopy, each showing identical features (Figure 9). Oxide was present in all cracks. The oxides in the wider cracks had the thickest oxide films (up to 10  $\mu\text{m}$ ) and exhibited a duplex structure, characteristic of a Potter-Mann type film [3] usually formed in low flow conditions. The oxide thickness could not be used to date the crack because the oxide growth is by both direct oxide formation and dissolution/re-precipitation. The rate of oxide growth by both mechanisms are affected to different degrees by different parameters and are not linear with time [4].

FIGURE 9:  
SEM, SECONDARY ELECTRON IMAGE, OF  
CRACK ON CROSS SECTION

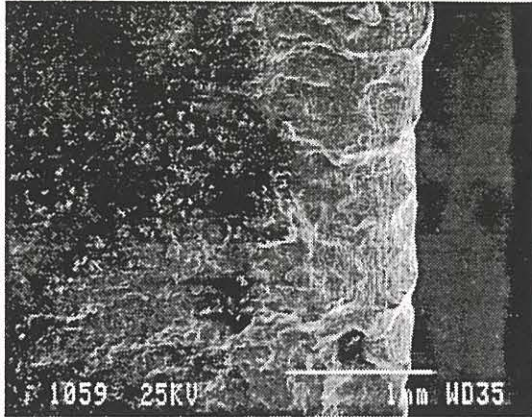
Close to the ID surface, the fracture was eroded and the features reflected the banding of the underlying microstructure (Figure 10). The remainder of the fracture was generally covered with magnetite crystals; however, visible regions of the fracture appeared to be intergranular. After removal of the magnetite crystals, no additional features were detected, such as fatigue striations or beach marks. The fracture was observed to be mostly intergranular (Figure 11). Crack initiation appeared to occur at the inside surface of the pipe as evidenced by the crack shape. No obvious initiation site(s) was observed. The radial marks on the fracture surface suggest that crack growth was predominantly in the radial direction along the entire crack length. An estimate of the crack depth (a) to length (c) ratio was made using the crack profile. The estimated a/c was 0.25.

FIGURE 10:  
SEM, SECONDARY ELECTRON IMAGE, OF  
FRACTURE SURFACE SHOWING ERODED  
REGION AT INSIDE SURFACE OF THE PIPE  
AND DEPOSITS ON FRACTURE

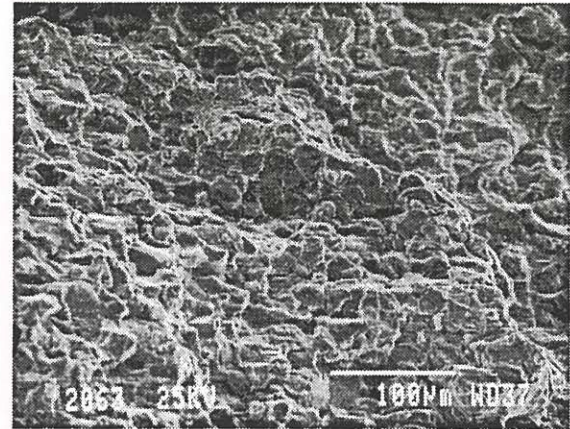
The mechanism fitting the majority of the crack features discussed above, is stress corrosion cracking (SCC). The most distinctive of these is the intergranular and branched crack path. SCC can be driven by residual stress alone and evidence suggests the high residual stress at the crack location was a very significant factor in this failure. The crack was tightly closed and relatively difficult to see on the outside surface. This indicates the operating stresses were not high enough to cause general plastic rupture resulting in opening of the crack, even though the crack tips may have been propagating under high stress intensities during the final stages of crack growth. The low aspect ratio ( $a/c = 0.25$ ) is also consistent with growth dominated by residual stresses.

FIGURE 11:  
SEM, SECONDARY ELECTRON IMAGE, OF  
FRACTURE SURFACE AFTER CLEANING  
TO REMOVE SURFACE DEPOSITS  
SHOWING PREDOMINANCE OF  
INTERGRANULAR FRACTURE

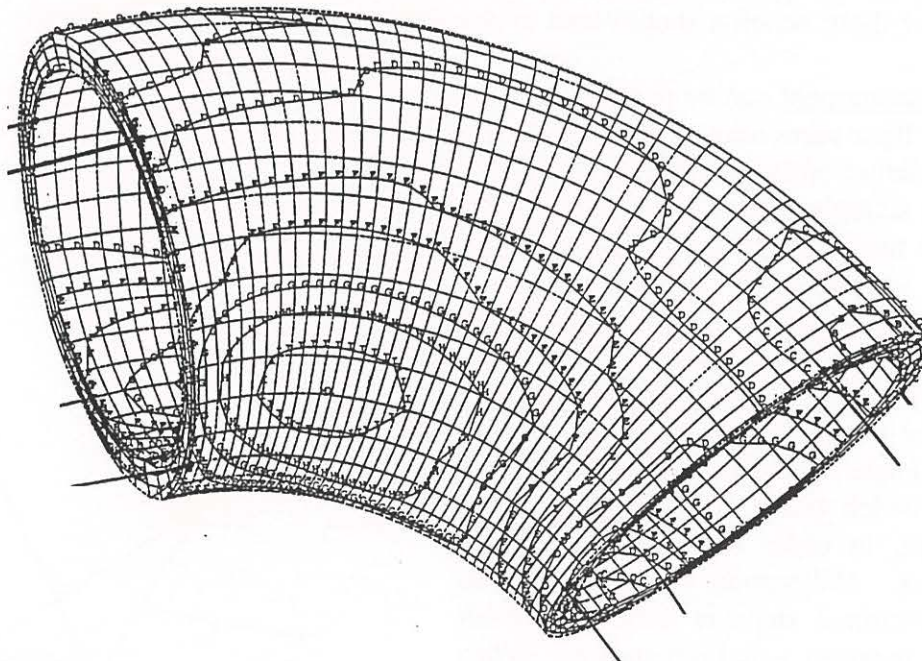
- With the atypical S08 feeder spacer in combination with the unlocked fuel channel, a 12.5 mm channel movement during re-fueling increases the maximum stresses in the outlet feeder by 79% compared to the normal design configuration.

The additional stresses due to the combination of the unlocked channel, atypical feeder spacer, and normal fueling machine loads could result in a local dynamic strain in the crack region exceeding 0.3%. This level of strain is sufficient to initiate SCC, when the applied load produces strain rates in a critical range, and when appropriate environmental conditions exist.

FIGURE 12:  
FINITE ELEMENT MODEL OF S08 ELBOW  
INCREASING STRESS LEVELS FROM A THROUGH I
