Steam Generator Leak Detection at Bruce A Unit 1

Kevin J. Maynard Senior Research Scientist Ontario Hydro Technologies 800 Kipling Ave. Toronto, ON M8Z 5S4 Don E. McInnes Senior Technical Engineer Bruce NGS-A Eng. Services Box 3000 Tiverton, ON NOG 2T0 Vic P. Singh Principal Research Engineer Ontario Hydro Technologies 800 Kipling Ave. Toronto, ON M8Z 5S4

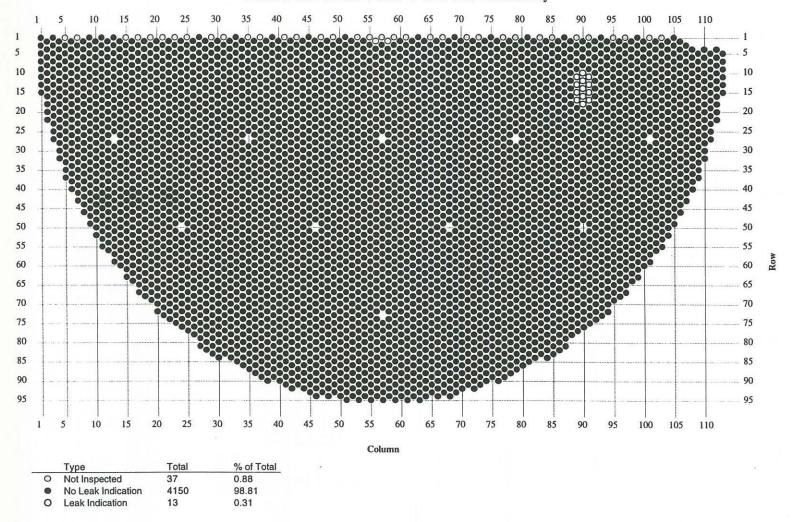
Figure 2 Dew Point tubesheet map for survey phase of leak search

In this phase, 99% of the tubesheet was inspected (a total of 4163 tubes) over a period of approximately 24 hours. The 37 tubes not inspected were all located in Rows 1 and 2. Obstructions near the boiler divider plate prevented the funnel sniffer probe from reaching these tubes. The dew point data for the survey is shown in Figure 2 as a tubesheet map. The ambient dew point in the boiler primary head was around -21°C, which indicates that the boiler was well dried by the air purge prior to the leak search period. The tubes marked as leak indications correspond to elevated dew point readings. The threshold utilized for a leak indication on this map was -19°C, approximately 3σ above the mean value of -21°C. When an elevated reading was obtained using the 7 tube funnel, all 7 tubes being inspected were logged with the same elevated dew point reading. The localization of the actual tube leak indication was performed with the single tube probe (described below).

Approximately 120 tubes were flagged for individual inspections. The tubes in the vicinity of rows 10-20 and columns 89-91 were chosen on the basis of elevated dew point readings. Most of the other tubes among the 120 were selected on the basis of suspected small variances of helium signals.
