An Overview of the Metallurgical Investigations
into the Failure of Darlington NGS Unit 2
Fuel Bundle End Plates

E.G. Price
AECL CANDU
2251 Speakman Drive
Mississauga, Ontario L5K 1B2
Canada

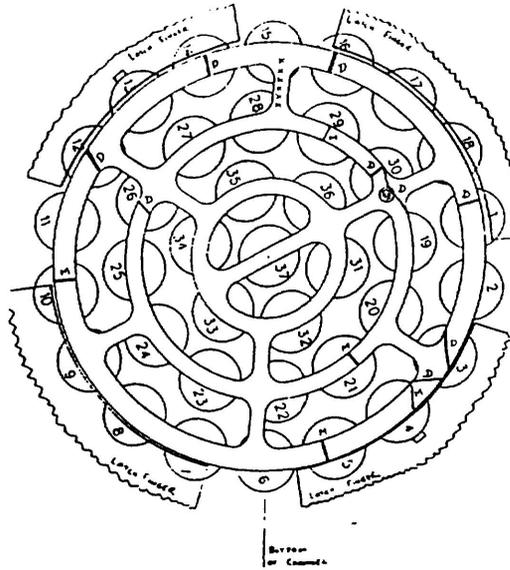
In November 1990, difficulty was experienced in refuelling channel N12 of DNGS Unit 2. The carrier tube containing replacement fuel (from another channel) could only be inserted into the outlet end fitting with difficulty but fuelling could not be performed. The carrier tube was removed from the end fitting but in turn difficulties with the fuelling machine operation indicated fuel debris was trapped in the fuelling machine. When the carrier tube was fully removed from the fuelling machine at a later date and the fuel from the carrier tube examined in the fuel bay, pieces of fuel elements were found among the intact replacement fuel. This finding led to the formation of an investigation team to determine the cause of the problem. The team which subsequently recommended an examination by television of the downstream end plates on outlet bundles of a number of channels. This inspection revealed other channels in columns 12 and 13 (either side of the midline of the reactor) in which the outlet bundle had cracked end plates. A typical diagram of cracking sketched from the video of the inspection is shown in Figure 1.

Figure 1: Diagram of a Cracked Outlet Bundle End Plate (Channel K12) Obtained from an In-Situ Television Inspection

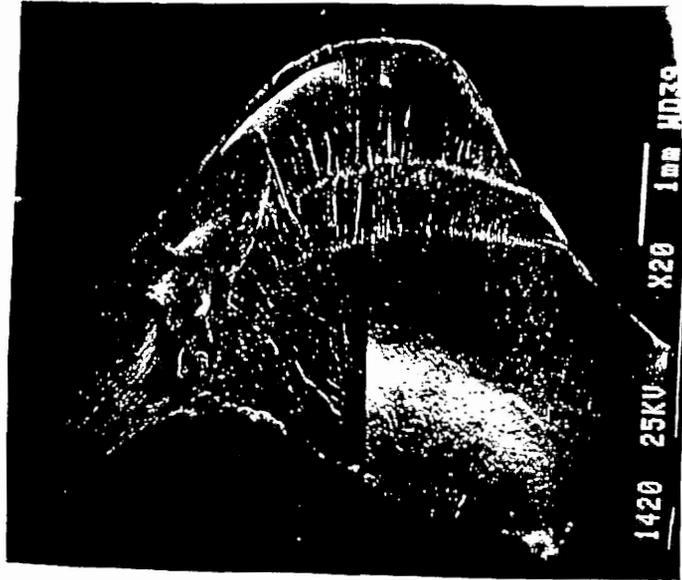
Examinations of outlet end bundles at CRL, starting with pieces of the end plate of the N12 channel and continuing with failed bundles from the Q12 and K12 channels, showed that failure had occurred by fatigue. The fracture surfaces were generally characterized by a region of relatively featureless crack propagation (called a "black eye" from the SEM photographic image) followed by a region which contained "beachmarks" where the texture of the surface differed but the main

crack propagation features were continuous through to adjacent bands (Figure 4). Over this region of surface, fatigue striations 0.5 - 2.0 microns were present. On some surfaces, particularly those of Q12, up to three crack arrest marks were seen indicating the driving force decreased below the fatigue threshold for a period at that stage of cracking.

The cracks mostly originated in the crevice formed between the end cap and the end plate by the welding. Crack initiation occurred slightly away from the trip of the crevice at the edge of the altered metal structure and progressed through the heat affected and weld region to the parent metal and through the plate.

The crack surfaces were relatively undamaged by post fracture rubbing and were covered with a thin oxide (< 2 microns).

Figure 5: Typical Fracture Surface Formed in the End Plate
