## DARLINGTON UNIT #2 RETURN TO SERVICE PROGRAM

W. Robbins  
Ontario Hydro  
Darlington Nuclear Generating Station  
Box 4000 Bowmanville, Ontario  
L1C 3Z8

D.J. Benton  
AECL Candu  
2251 Speakman Drive  
Mississauga, Ontario  
L5K 1B2

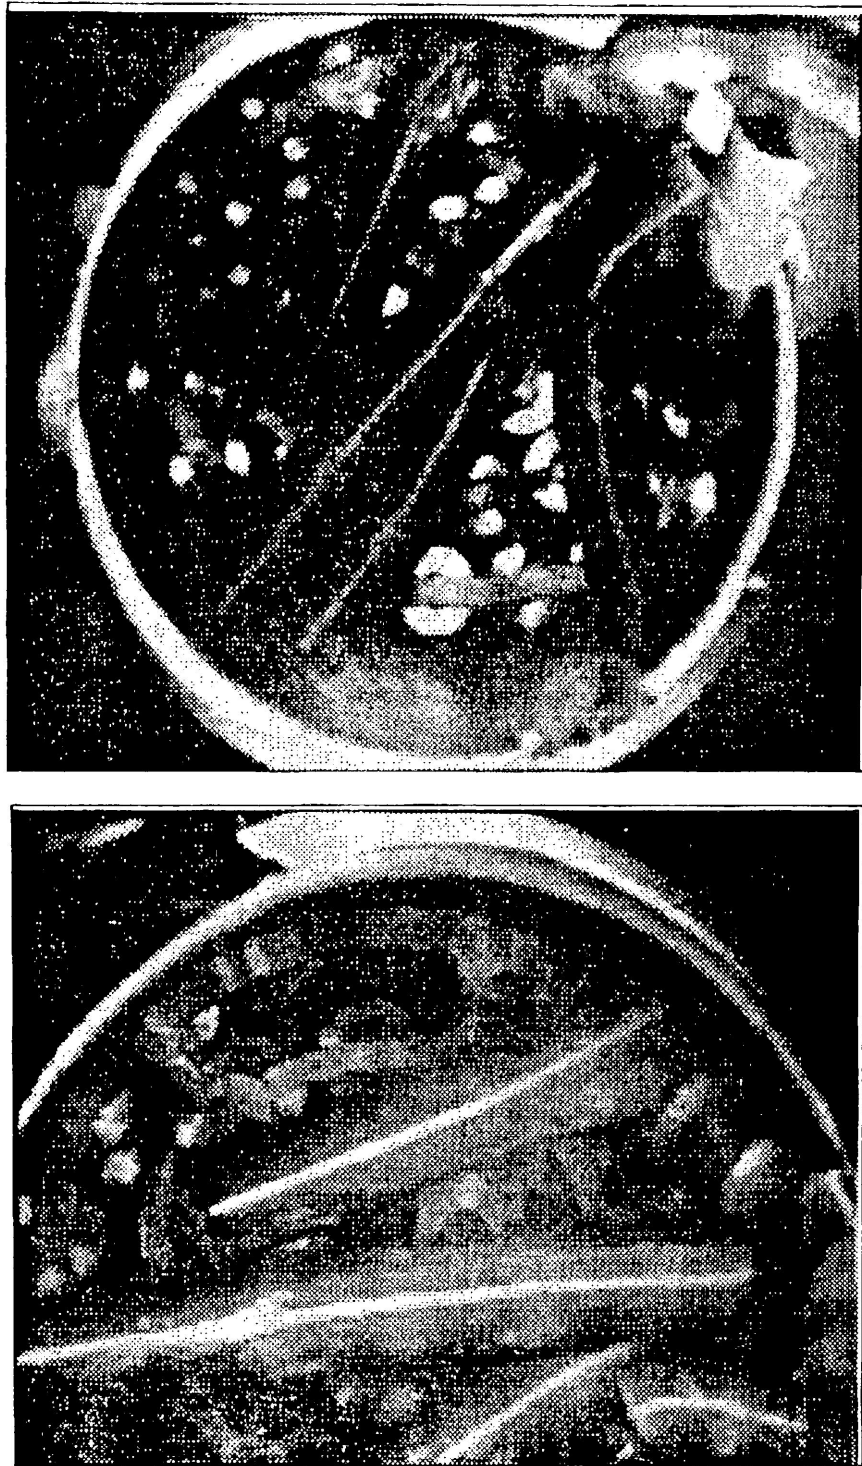
Figure 2  
Fuel Carrier with Fragments

On January 8, 1991 the reactor was returned to a derated power level of 65% F.P. due to lack of reactivity. It was not possible to fuel as there was only one FM trolley commissioned and available for service (T3/4). The FM trolley (T3/4) used on N12 was taken to the west service area (WFFAA) to discharge the fuel from Y08. The fuel inspection in the reception bay showed pieces of fuel elements jammed into the end of the fuel bundles from channel Y08. The elements were later identified as elements from N12 bundle # 1. This was the first view of the fuel damage in channel N12.

See Figure 2. Picture of Fuel Carrier with fuel fragments.

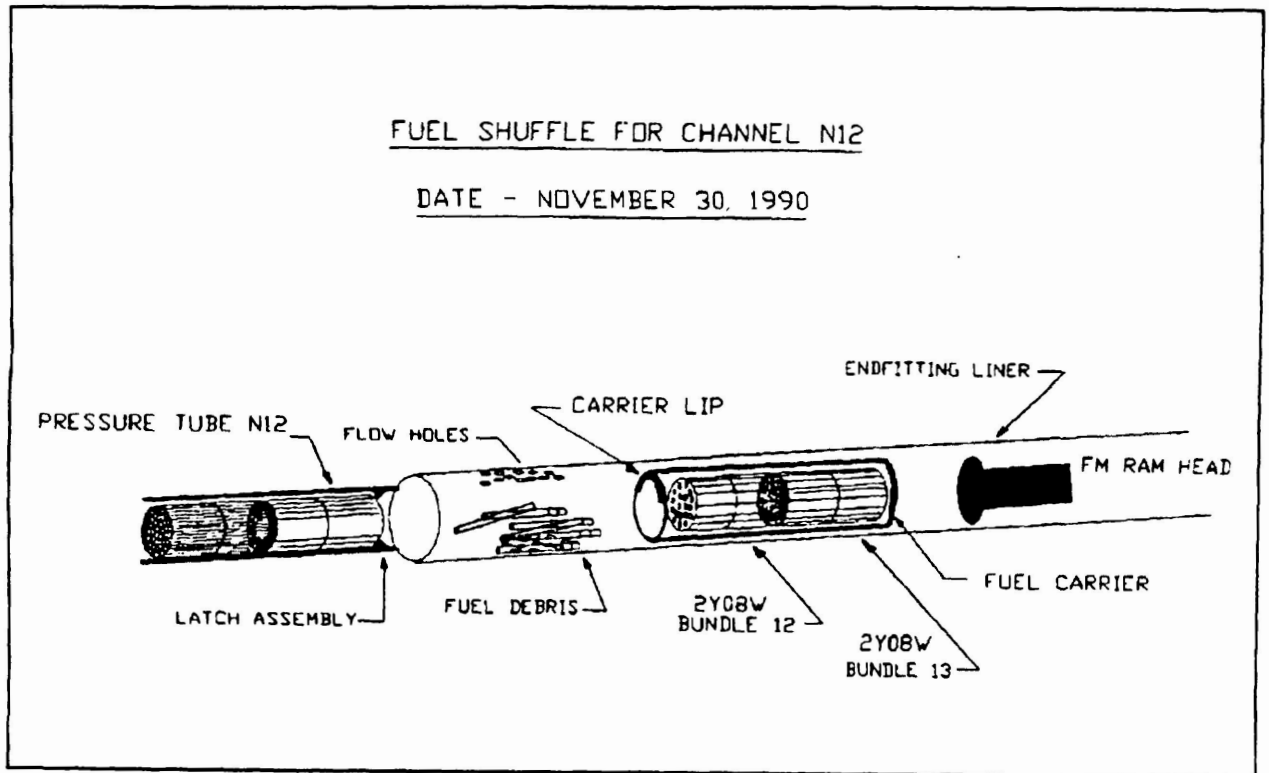
Figure 3  
Suspected Debris in 2N12E

See Figure 3. Sketch of suspected fuel debris in 2N12E.

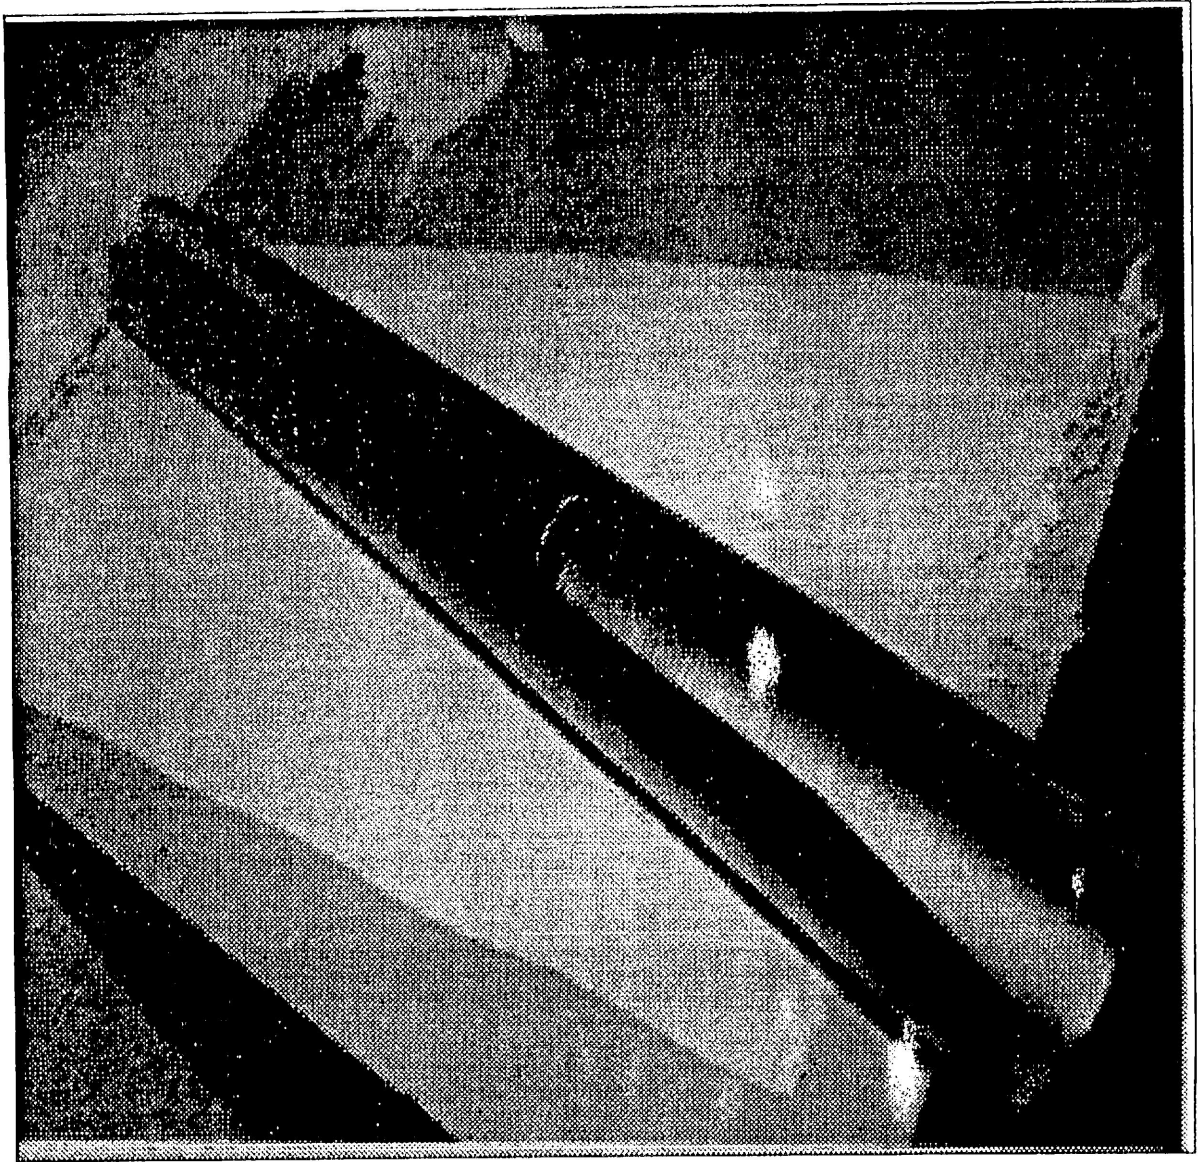
Figure 6  
Debris Scoop

See Figure 6. Picture of Debris Scoop

This scoop was advanced down the endfitting until it stalled. This stall location was determined to be the start of the flowholes in the liner.

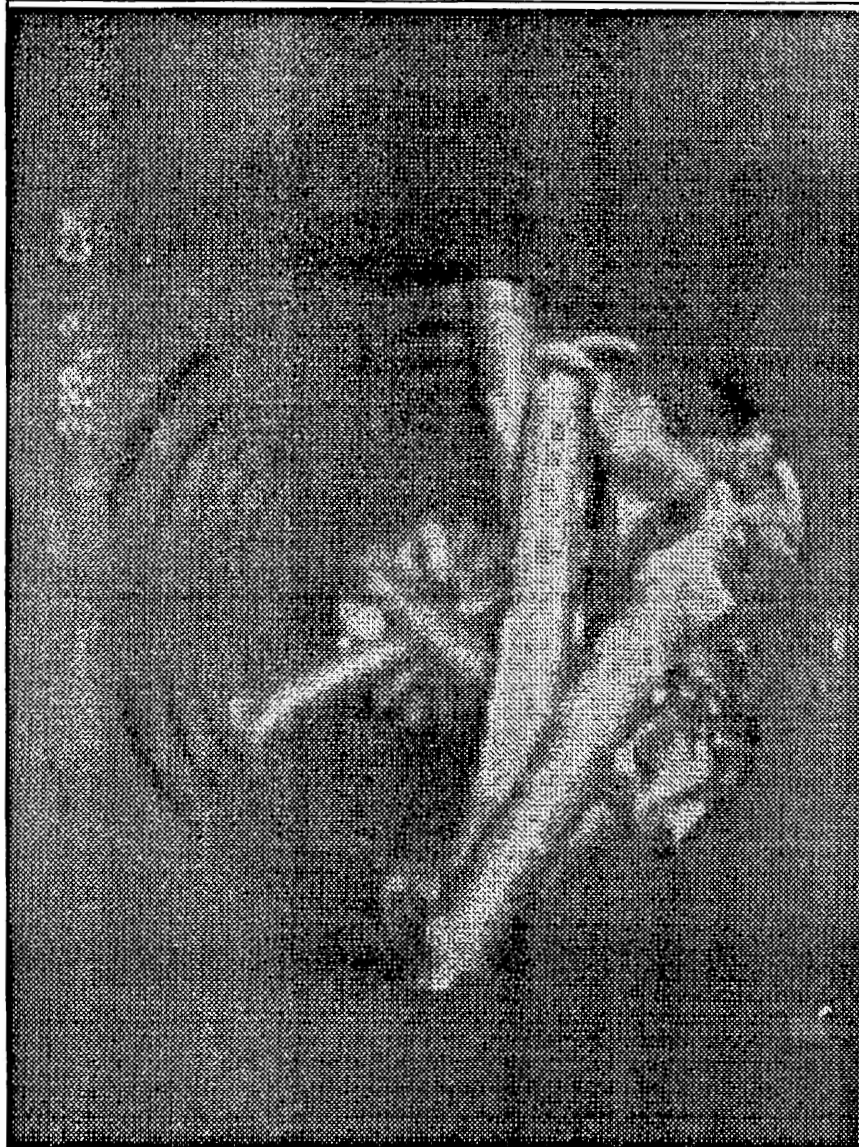
Figure 7

The CIGAR picture showed that there were fuel elements from bundle # 1 in the channel stuck crossways in the flowholes of the liner. Part of bundle # 1 was visible behind the debris.

N12E Before Shear Scooping

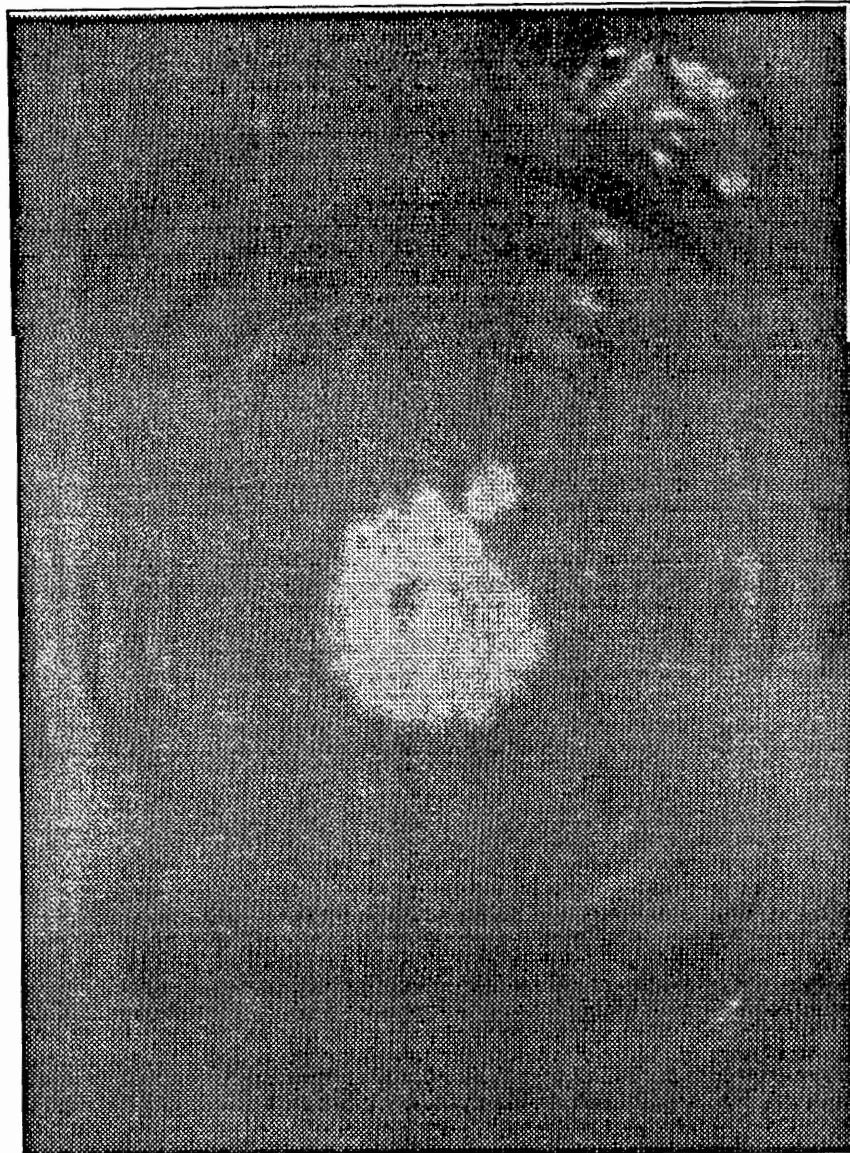
Figure 8  
CIGAR video after shear scoop advanced

The shear scoop was then advanced through the endfitting in an attempt to shear off the fuel fragments that were stuck in the flowholes. After several attempts, this shear scoop was eventually advanced to the latch.

The channel was again CIGAR videoed to assess the state of bundle # 1 and the fuel debris remaining in the flowhole area. The CIGAR picture showed that the fuel debris was removed from the flowhole area but debris still remained in the holes. Bundle # 1 appeared to be intact but the centre seven elements were missing and there appeared to be a small pile of debris still at the front of the bundle. It was decided to try to advance a defuelling scoop to push bundle # 1 away from the latch and attempt to open the latch. After three attempts, the latch was successfully opened (i.e. the defuelling scoop had advanced the full distance).

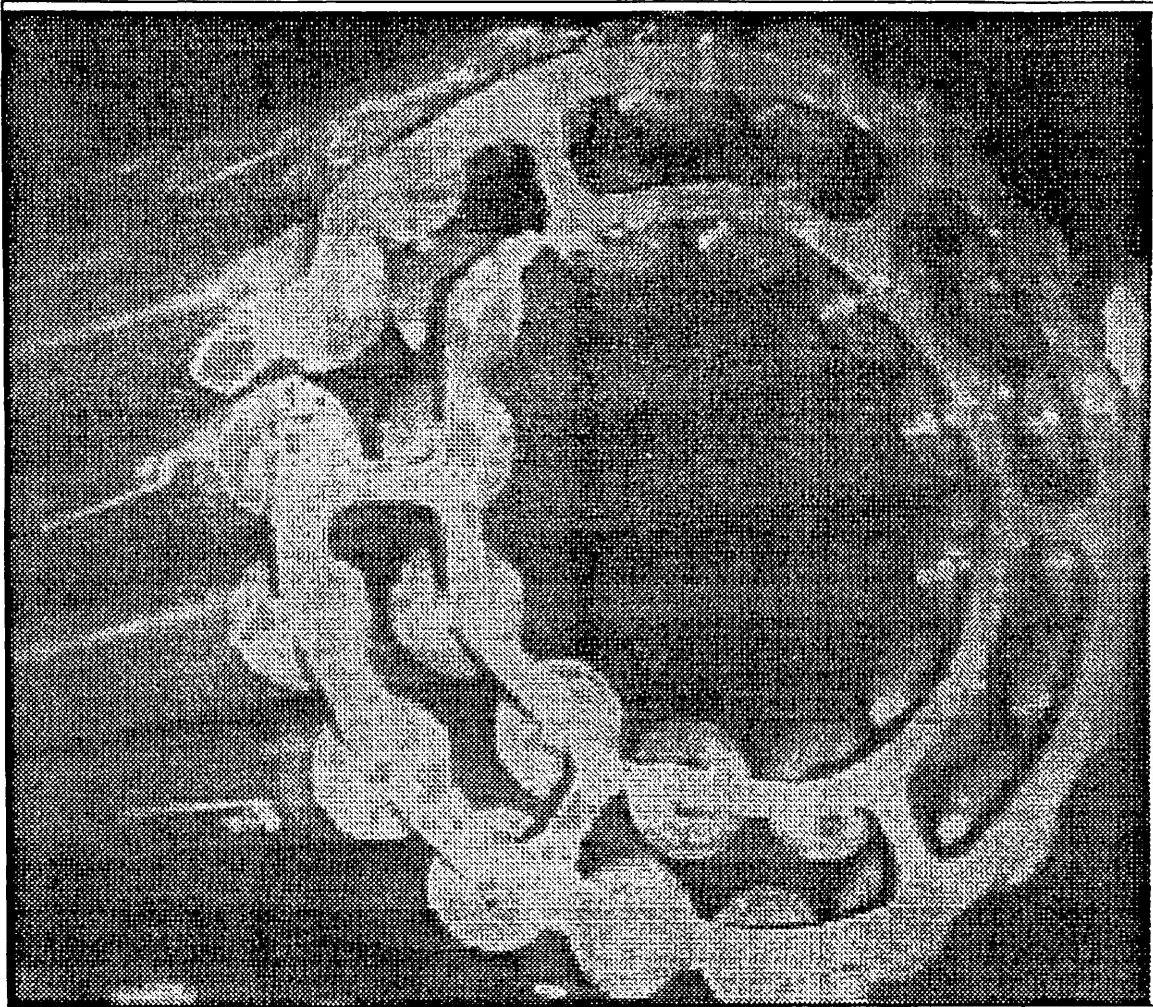
Figure 10-A

The push defuelling operation was started on March 3, 1992. The defuelling of channel N12 was completed in approximately 8 hours. The damaged fuel was then pushed into the reception bay where the fuel was subsequently examined for damage.

Bundle #1 from 2N12 (Downstream end)

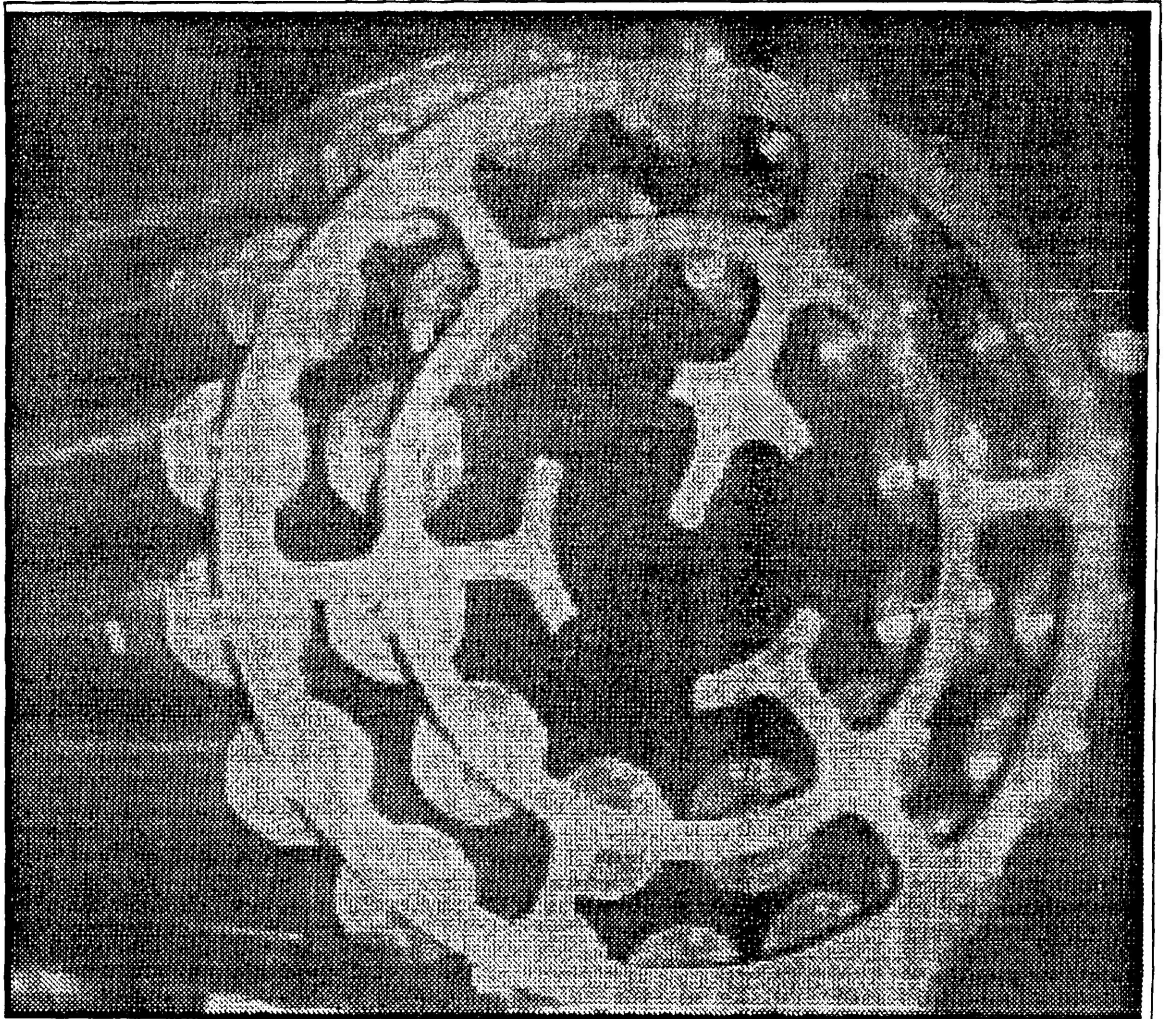
Figure 10-B

Bundle #1 from 2N12 (Upstream end)
