# MECHANICAL FATIGUE SIMULATION TESTING OF FUEL BUNDLES AND SPECIMENS FOR END PLATE FAILURE

Michael Gabbani, Tim Richards, A.M. Babayan, E.G. Price

AECL CANDU  
2251 Speakman Drive  
Mississauga, Ontario  
Canada L5K 1B2

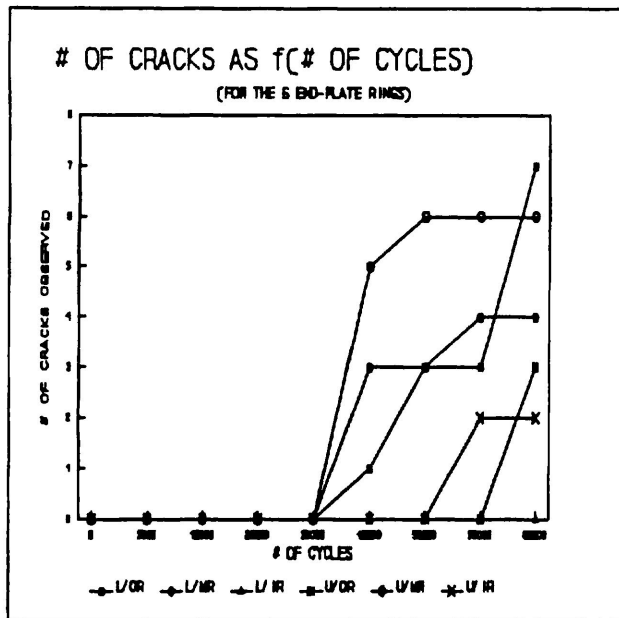
FIGURE 6:  
Distribution of cracks in the  
end plate during TEST 2.

The first two tests produced a significant proportion of cracks on the outer ring of the downstream end plate which is inconsistent with in-reactor failures. This skew in crack distribution is likely a result of the load distribution produced by the pad configuration used in these first two tests. The middle ring of the end plate (both ends) is the preferred crack location in reactor and this was also seen in the three axial bundle tests despite the relatively high number of cracks on the outer ring in the first two tests (see Figure 6 for Test 2).

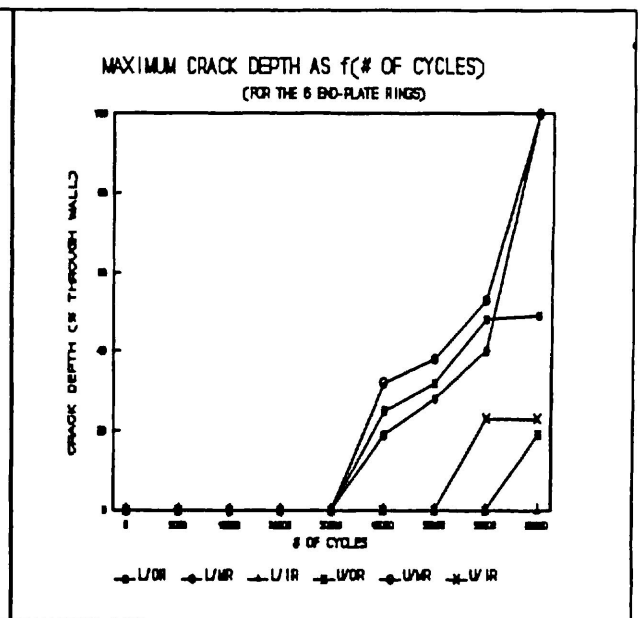
FIGURE 7:  
Approximate crack growth rates  
measured in TEST 2

A crack growth curve (Figure 7) was developed from the periodic

U.T. scans. The propagation rates for all cracks were quite similar and indicative of the rapid progression phase of fatigue.

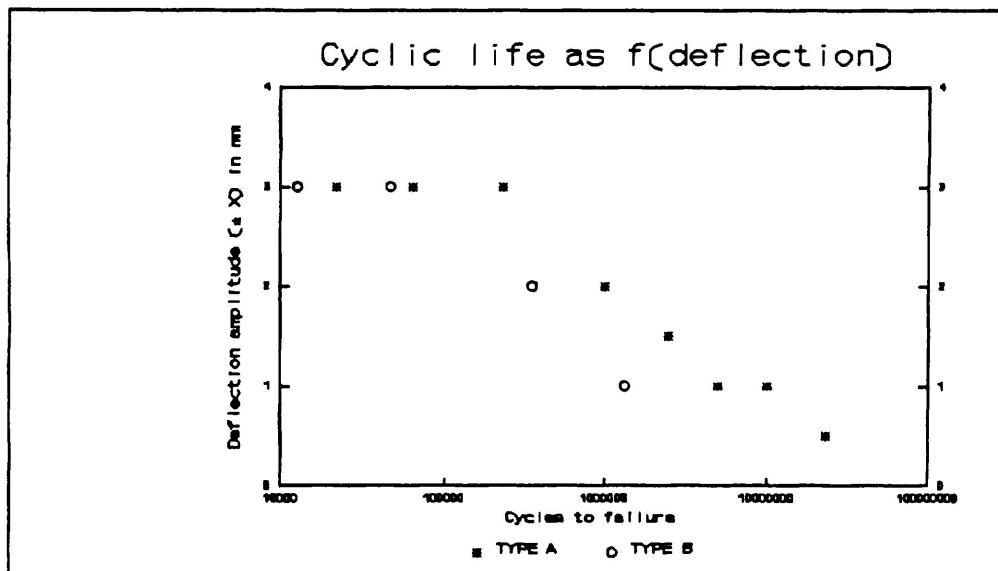
FIGURE 8:

As shown in Figure 8, the effective S-N (displacement amplitude-fatigue life) curve for the two lateral tests are similar, despite having different  $R$  ( $\sigma_{\max}/\sigma_{\min}$ ) ratios (there is an imposed static stress on the end plate in the Type A tests as a result of the simulated hydraulic drag.) A stress analysis for the conditions used in the TYPE B tests suggested that these specimens were somewhat more resistant to failure than similar specimens cycled axially at OHRD<sup>1</sup> and that the test results fit well on to the established S-N curve<sup>2</sup> for Zircaloy material. However it should be noted that conversions from deflection to stress are difficult for both test geometries.

The number of cycles to failure as a function of the half amplitude in the lateral deflection tests.
