DARLINGTON N12 EVENT INVESTIGATION:
UNIT 1 & 2 FUEL AND FUEL CHANNEL INSPECTIONS

P. T. TRUANT
Fuel Section
FPD/NOCD, Ontario Hydro

G. J. Field
Fuel Channel Department
AECL-CANDU

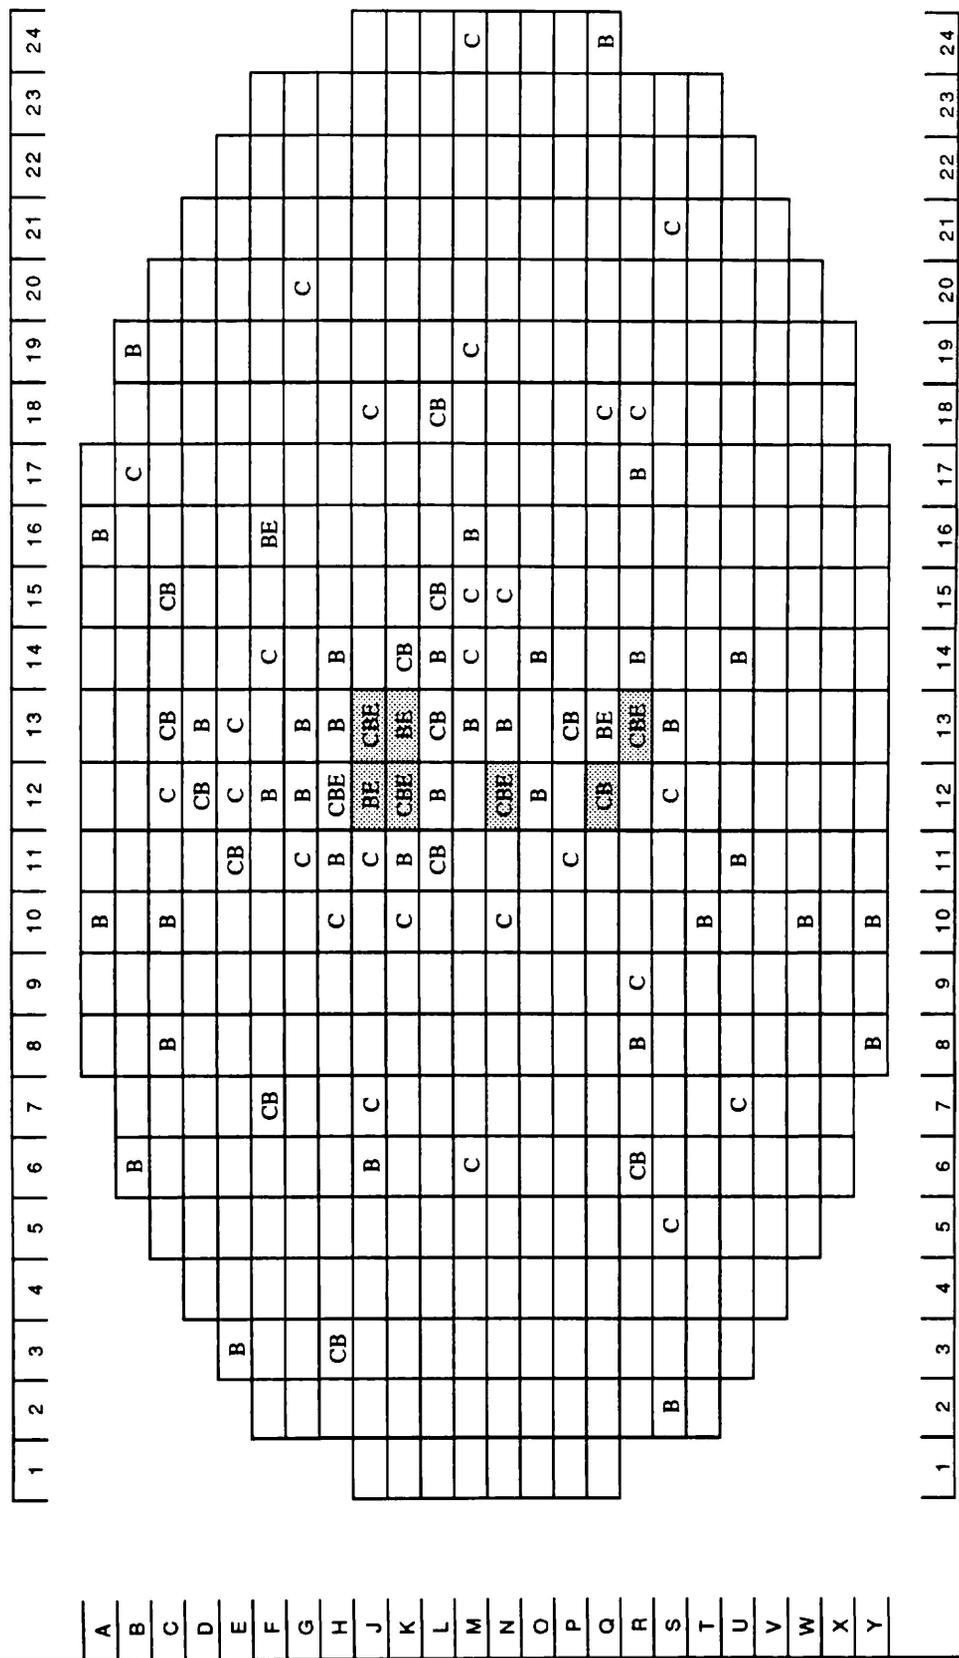
FIGURE 1 DARLINGTON NGS UNIT 2 - CHANNELS CONTAINING BUNDLES WITH CRACKED ENDPLATES (CONFIRMED IN FUEL BAY AND / OR HOT-CELLS)
 (UPDATED TO 1 MARCH 1992)
 REACTOR EAST FACE

Figure 1 for DNGS-2 and Figure 2 for DNGS-1 show core maps of: channels given in-situ video inspections, channels from which fuel has been inspected in-bay, and channels from which fuel has been examined in the hot-cells.

Some DNGS fuel bundles have developed low amplitude high cycle fatigue cracks in and through the endplates at high stress locations. Cracked endplates have been confirmed in position #1, #2, #3, #4, #5, #8 and #9 fuel bundles, with the extent of cracking decreasing in the upstream direction from bundle #1. Cracked endplates have been detected in eight Unit 2 channels and two Unit 1 channels.

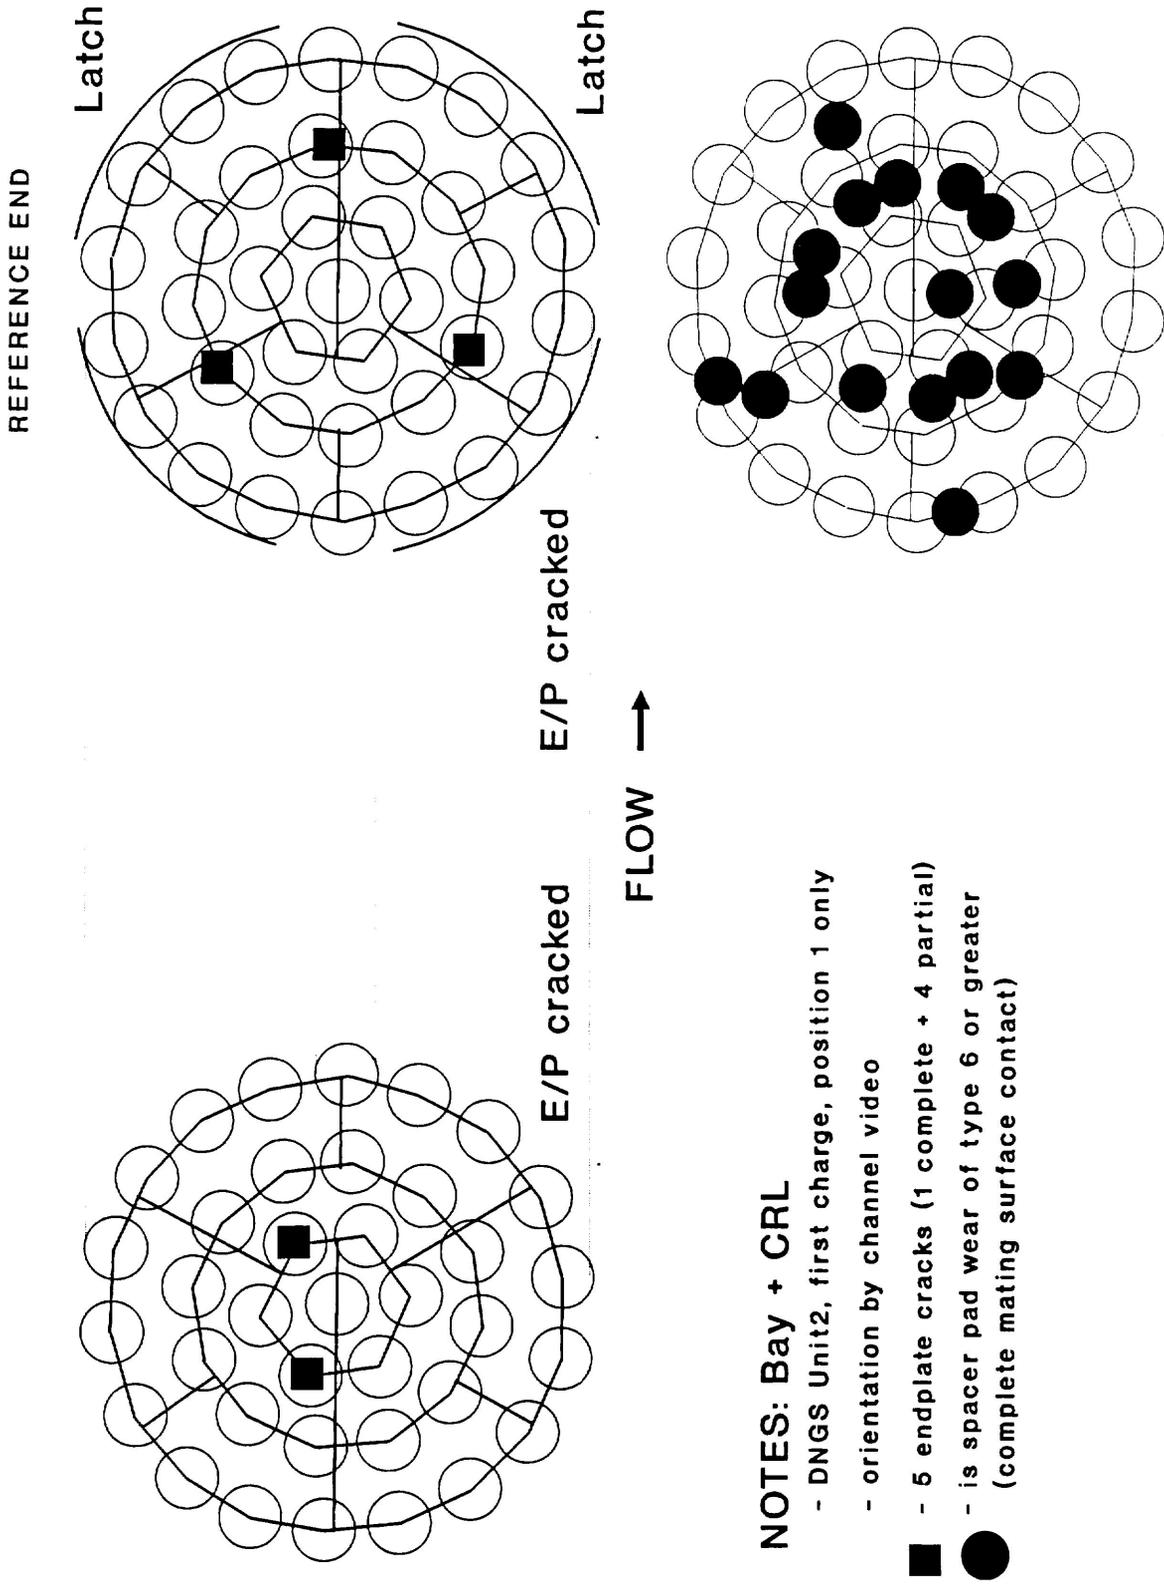
FIGURE 3: D2Q12/01 (L23406)

The spacer wear distribution is shown in Figures 3 and 4 for D2Q12/01 and D2Q12/13. The "black dots" are each spacer pair where at least one pad had sufficient wear to give full surface contact with the adjacent pad. In bundle position #1, the wear is predominantly between the inner and intermediate element rings. In position #13 the wear is still primarily between rings of elements (inner to intermediate and intermediate to outer); but the wear is more widespread throughout the bundle.

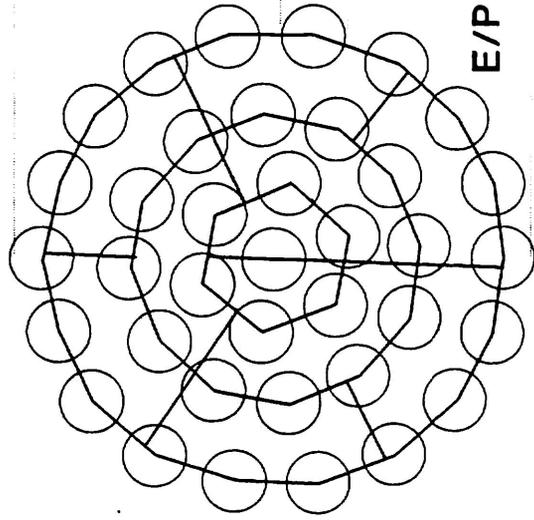
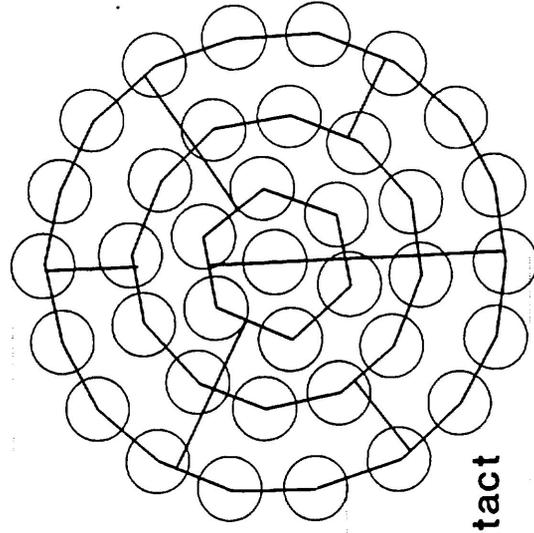
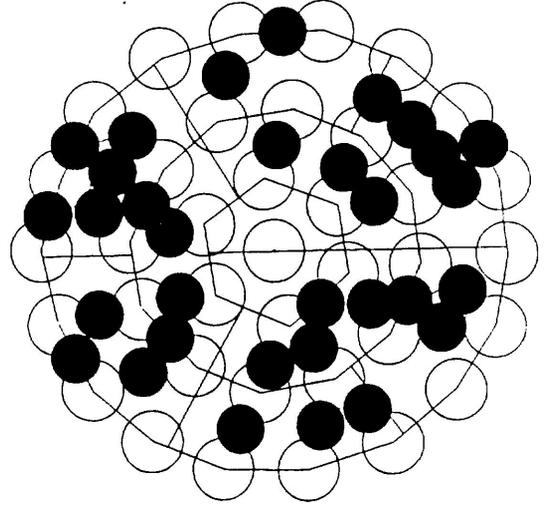
FIGURE 4: D2Q12/13 (L23251)

- DNGS Unit2, first charge, position 13 only
- orientation by bearing pad wear (bottom)
- no endplate cracks
- is spacer pad wear of type 6 or greater (complete mating surface contact)
