THE POST IRRADIATION EXAMINATION OF FUEL IN SUPPORT OF BRUCE A NUCLEAR DIVISION FUELING WITH FLOW PROGRAM

J. MONTIN*, S. SAGAT*, R. DAY†, J. NOVAK†, H. BROMFIELD†

* Atomic Energy of Canada Limited, † Ontario Hydro

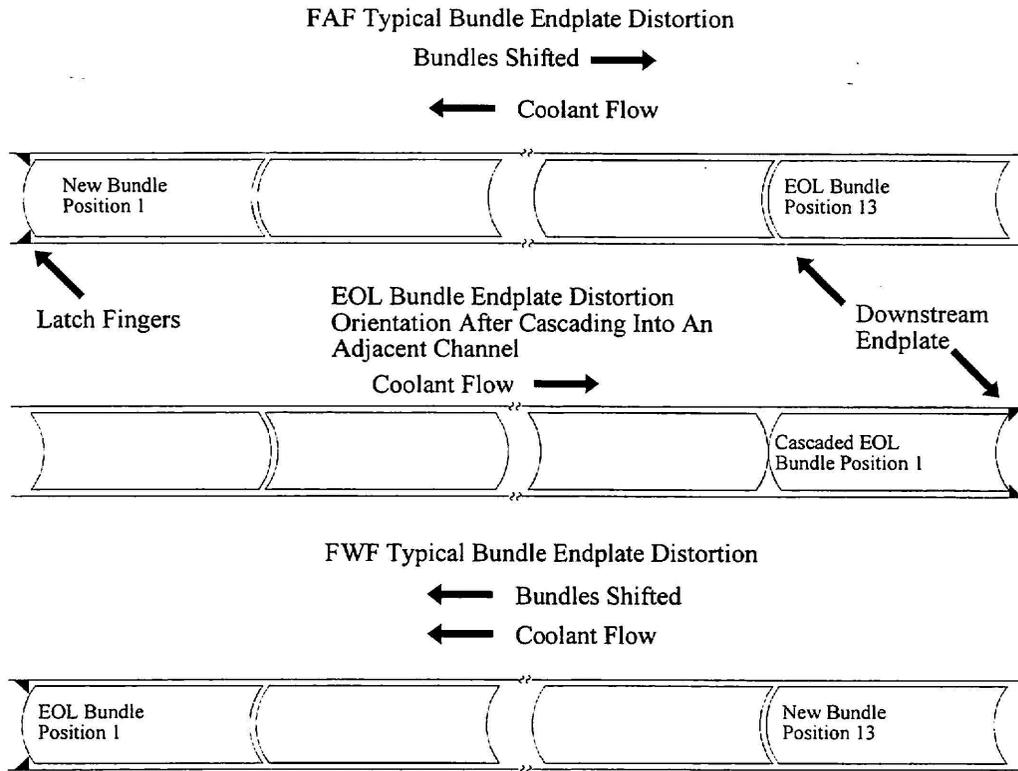
into an adjacent channel in position 1. In this position, they were placed against the channel end latch fingers, and the bundle endplate orientation was reversed to the normal situation (Figure 1).

FIGURE 1: Endplate Distortion For FAF and FWF

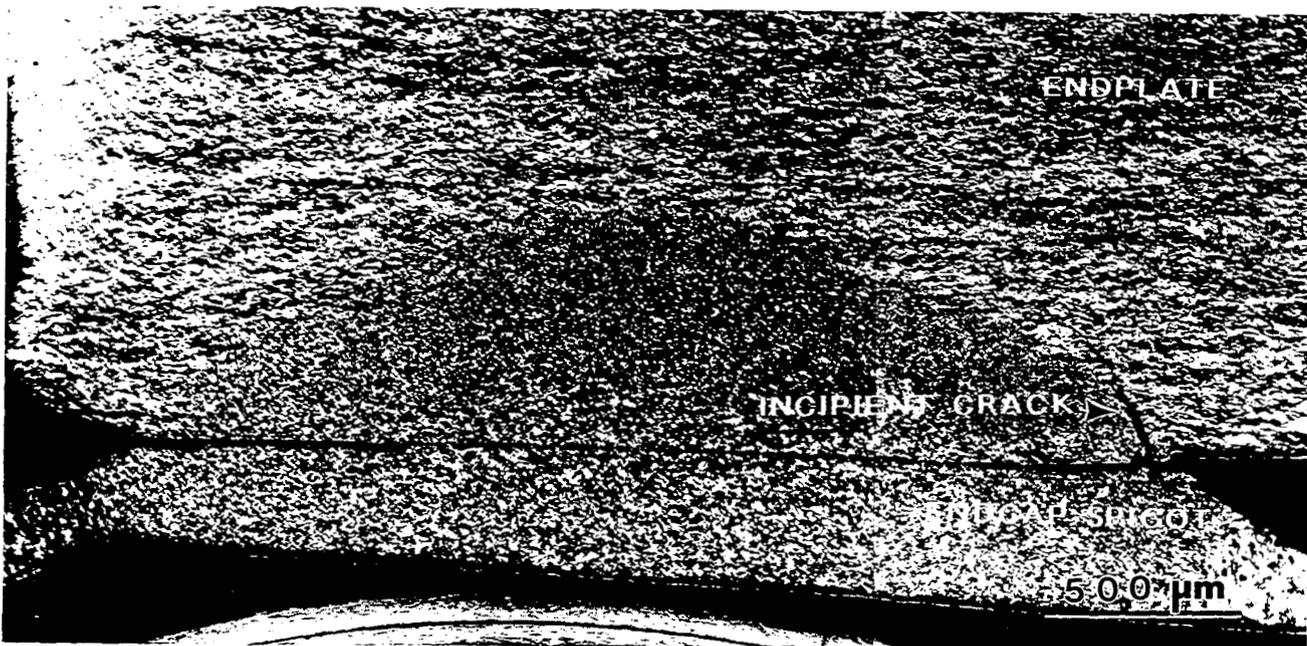
Incipient cracks propagating into or along the heat-affected zone (HAZ) were observed. The microstructures for all the cascaded and benchmark EOL bundles were comparable and no anomalies were detected. Figures 4 and 5 show typical micrographs of the microstructure and the hydride distribution of an assembly weld with an incipient crack. Less-than-ideal welds (Figure 6) were also found in the cascaded bundles from both manufacturers. Less-than-ideal weld micrographs show weld expulsion at the notches, and incomplete bonding along the weld line.

FIGURE 4: L32803C-18 Non-Monogrammed Endplate Weld Microstructure with an Incipient Crack (50X, GG30G8-G9)

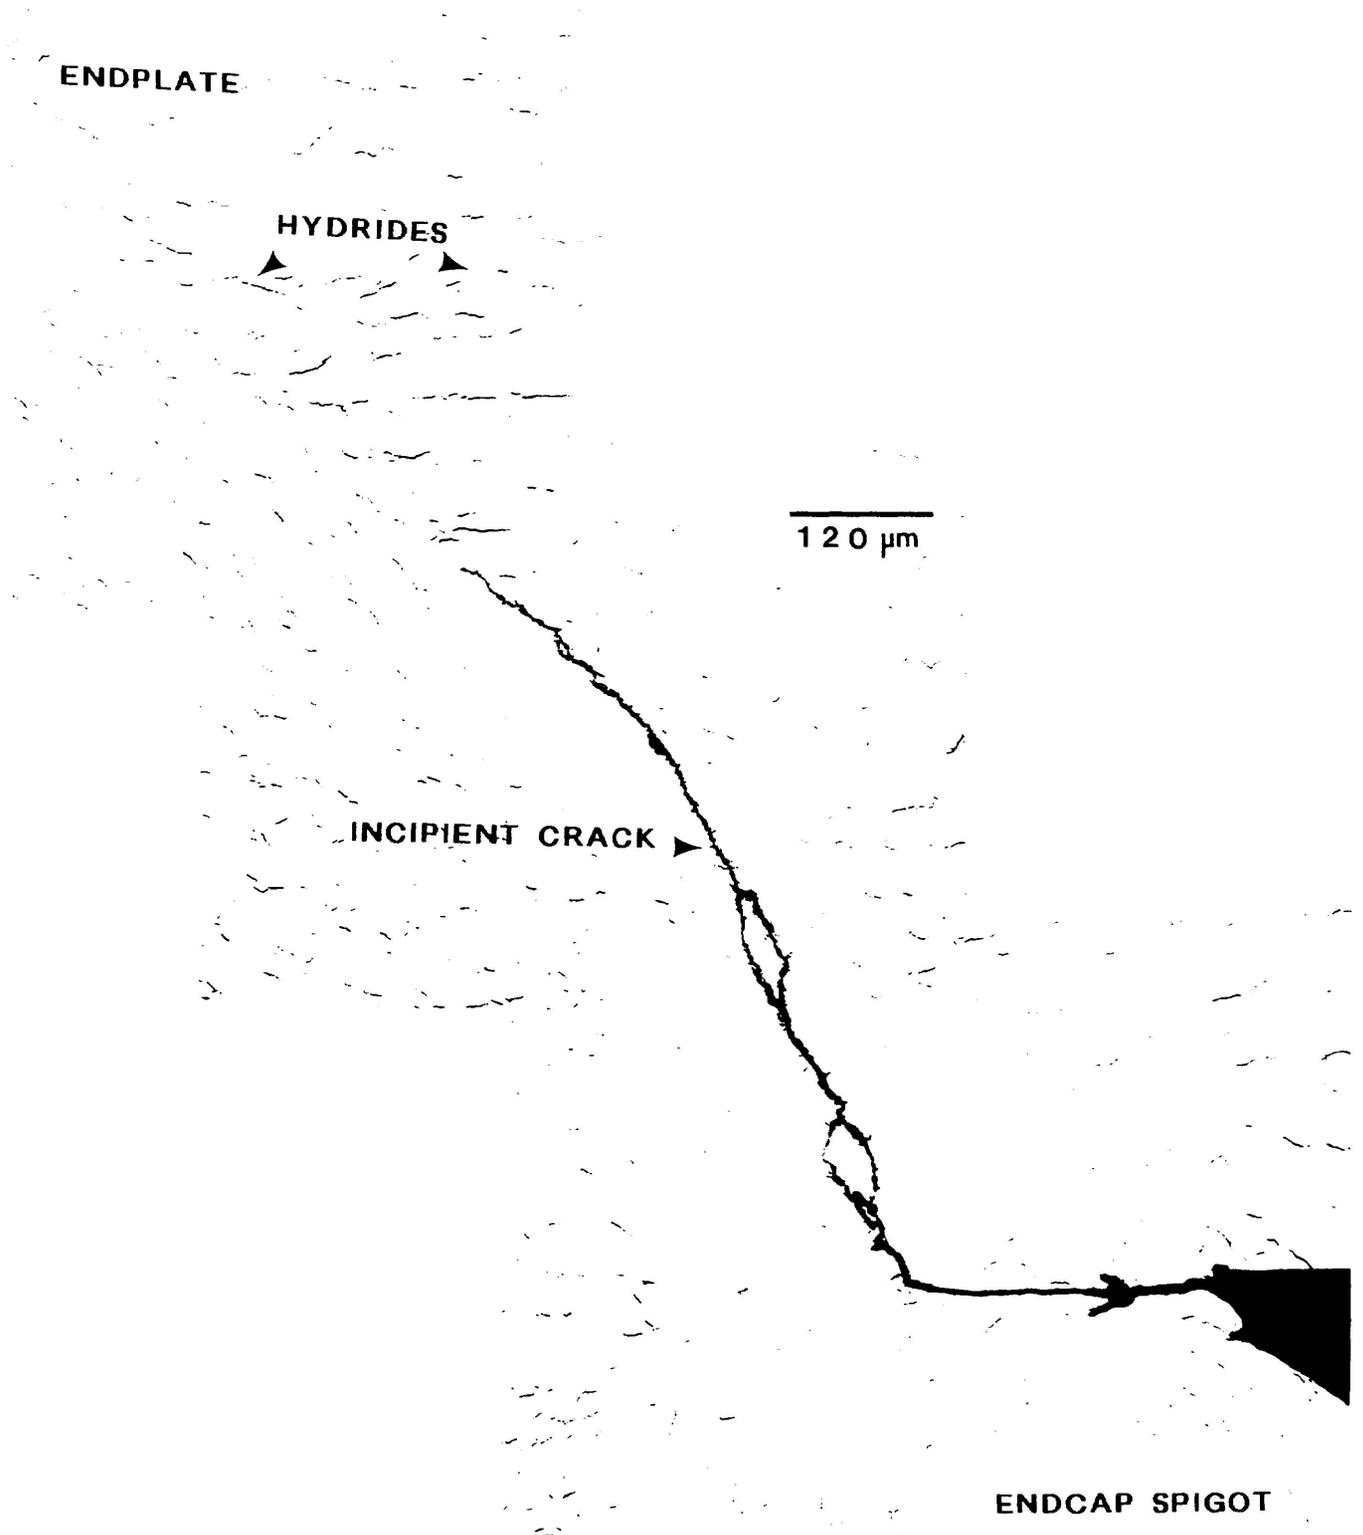
FIGURE 5: L32803C-18 Non-Monogrammed Endplate Hydride Distribution Around the Incipient Crack and in the Bulk of the Weld (150X, GG30G13-G14, G20)
