GENTILLY-2 AND POINT LEPREAU DIVIDER PLATE REPLACEMENT

W. SCHNEIDER, G. McCLELLAN, S. WESTON, E. KIISEL, C. HOLMES Babcock & Wilcox

> J. FOREST Hydro Quebec

New Brunswick Power

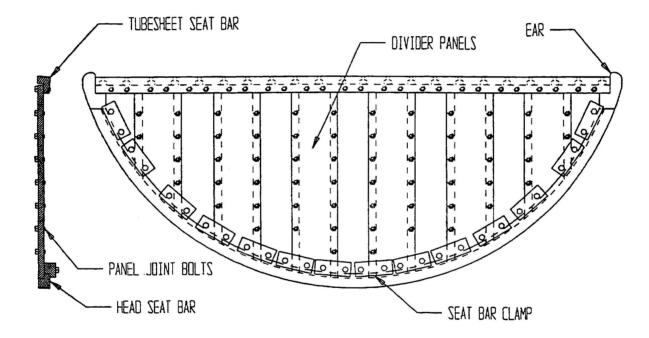
FIGURE 1: SEGMENTED DIVIDER PLATE

The original divider plate construction for the Gentilly-2 and Point Lepreau steam generators incorporated a number of $1\frac{1}{2}$ inch thick vertical panels supported by peripheral seat bars, as shown in Figure 1. The divider plate assembly was of a floating configuration in which the segmented panels rested on the seat bars at their periphery in such a way that the dilation of the pressure vessel during changes in operating temperature and pressure were accommodated by sliding of the floating divider plate relative to the seat bars. The divider panels were attached to each other by a lap joint secured by a number of bolts. The lower edge of the floating divider plate was supported by a seat bar which was partial penetration welded to the primary head. The lap joint between the divider panels and the primary head seat bar was clamped by clamping blocks. The upper edges of the divider panels were bolted to a seat bar which was bolted to the tubesheet. At the outer corners of the divider plate a space exists bounded by the end of the tubesheet seat bar, the head seat bar, and the divider panels. This area is filled with an "ear" shaped filler block, affixed to the outer- most divider panels to help reduce cross flow leakage. The divider plates were designed as segmented panels in order to meet the specified requirement that they be removable. Their design function was to partition the steam generator primary head so that the primary flow was directed from the inlet side of the head, through the tubes to the outlet side. This process involves a pressure drop across the divider plate of approximately 35 psi.

During a routine inspection in September 1993 at Gentilly-2, it was discovered that two of the divider panel joint bolts were missing. One was discovered lying in the head and the second some distance down the primary piping. It appeared that the bolts which tend to be held in place by the flow had simply popped out at some time during the shutdown or during the subsequent waterjet decontamination process. Further examination showed that a number of the divider panel joint bolts had experienced erosion to the underside of the bolt head, to the shank of the bolt and even to engaged threads. The divider plate components of all four steam generators experienced this type of damage to some degree. The divider panel to tubesheet seat bar bolts experienced a similar type of damage. The clamping block and tubesheet seat bar bolts were relatively unaffected. After further inspection, it was noted that surprisingly the performance of the steam generators improved by a small but significant amount, and that the amount of improvement happened to be consistent with the number of bolts which had been replaced in the respective steam generators. This reinforced the perception that divider plate cross flow leakage may have been more significant than previously assumed.

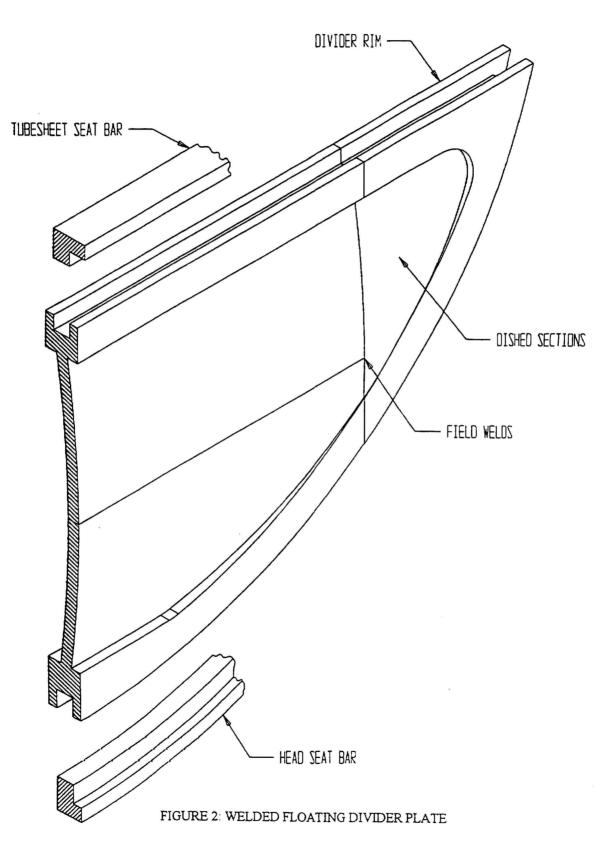
In summary, the features of the replacement divider plate shown in Figure 2 include:

- strong, light weight, welded one-piece construction designed to minimize both field welding and associated distortion
- fabricated in four segments that are manipulated into position in the primary head via the manway openings
- floating tongue and groove support
- tight fit up tolerances at sealing surfaces to minimize leakage

- erosion resistant material at all sealing surfaces to preclude erosion
- new, higher strength tubesheet seat bar welded to tubesheet overlay
- ears integral with the new tubesheet seat bar which fill the corners and create an essentially continuous seat bar around the entire periphery of the divider plate

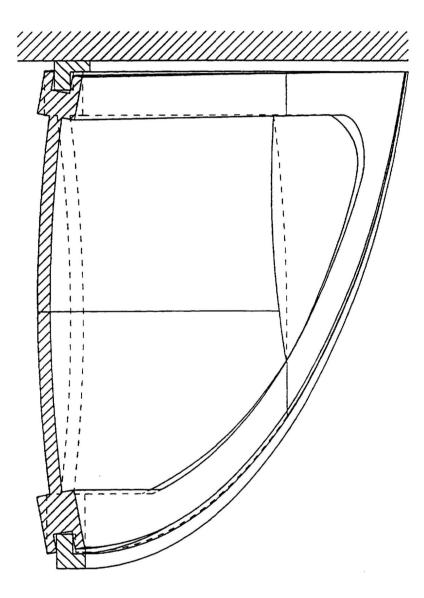
FIGURE 3: DIVIDER PLATE UNDER SMALL BREAK LOCA LOADS

to sustain small breaks (5% and 7-1/2% break sizes) with significant distortion but without any disengagement of the divider plate from the seat bar. For the purpose of modelling LOCA flow conditions, this allows the divider plate to be considered totally intact. The response of the divider plate to a small break LOCA is shown in Figure 3.

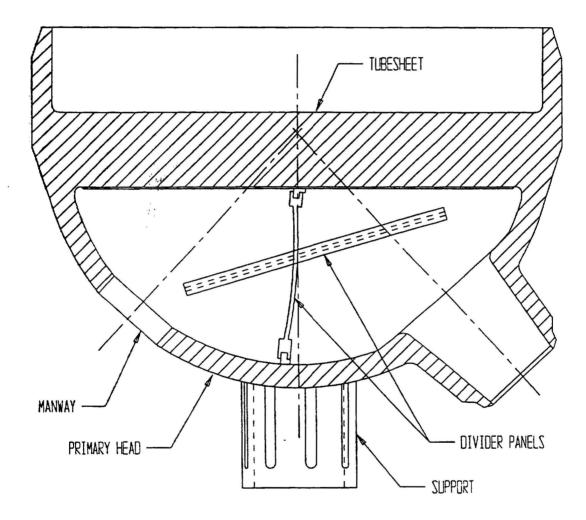
FIGURE 4: DIVIDER PLATE REPLACEMENT

Replacement one piece floating divider plates were installed at Gentilly-2 beginning in April 1995, and at Point Lepreau beginning in June 1995. Significant management and technical challenges were encountered at each site. Figure 4 shows the access constraints for the field installation.
