## **GENTILLY-2 AND POINT LEPREAU DIVIDER PLATE REPLACEMENT**

W. SCHNEIDER, G. McCLELLAN, S. WESTON, E. KIISEL, C. HOLMES  
Babcock & Wilcox

### **ABSTRACT**

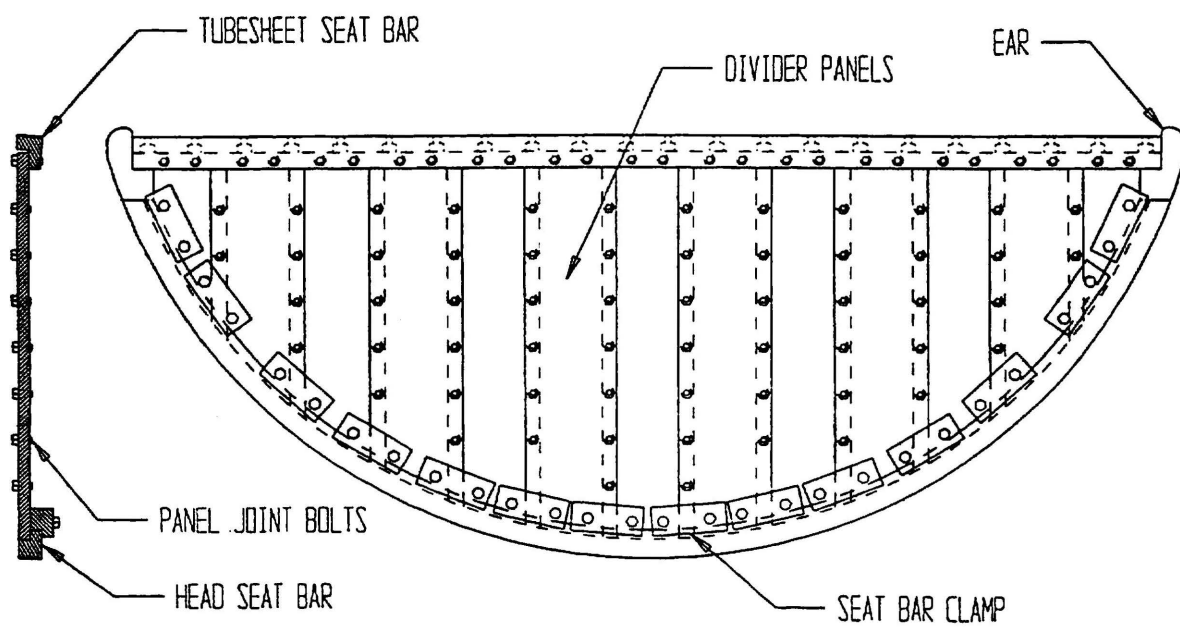
FIGURE 1: SEGMENTED DIVIDER PLATE

The original divider plate construction for the Gentilly-2 and Point Lepreau steam generators incorporated a number of 1½ inch thick vertical panels supported by peripheral seat bars, as shown in Figure 1. The divider plate assembly was of a floating configuration in which the segmented panels rested on the seat bars at their periphery in such a way that the dilation of the pressure vessel during changes in operating temperature and pressure were accommodated by sliding of the floating divider plate relative to the seat bars. The divider panels were attached to each other by a lap joint secured by a number of bolts. The lower edge of the floating divider plate was supported by a seat bar which was partially penetration welded to the primary head. The lap joint between the divider panels and the primary head seat bar was clamped by clamping blocks. The upper edges of the divider panels were bolted to a seat bar which was bolted to the tubesheet. At the outer corners of the divider plate a space exists bounded by the end of the tubesheet seat bar, the head seat bar, and the divider panels. This area is filled with an "ear" shaped filler block, affixed to the outer-most divider panels to help reduce cross flow leakage. The divider plates were designed as segmented panels in order to meet the specified requirement that they be removable. Their design function was to partition the steam generator primary head so that the primary flow was directed from the inlet side of the head, through the tubes to the outlet side. This process involves a pressure drop across the divider plate of approximately 35 psi.

During a routine inspection in September 1993 at Gentilly-2, it was discovered that two of the divider panel joint bolts were missing. One was discovered lying in the head and the second some distance down the primary piping. It appeared that the bolts which tend to be held in place by the flow had simply popped out at some time during the shutdown or during the subsequent waterjet decontamination process. Further examination showed that a number of the divider panel joint bolts had experienced erosion to the underside of the bolt head, to the shank of the bolt and even to engaged threads. The divider plate components of all four steam generators experienced this type of damage to some degree. The divider panel to tubesheet seat bar bolts experienced a similar type of damage. The clamping block and tubesheet seat bar bolts were relatively unaffected. After further inspection, it was determined that 9, 12, 20, and 7 bolts had to be replaced on SG's #1, 2, 3 and 4, respectively. On return to operation, it was noted that surprisingly the performance of the steam generators improved by a small but significant amount, and that the amount of improvement happened to be consistent with the number of bolts which had been replaced in the respective steam generators. This reinforced the perception that divider plate cross flow leakage may have been more significant than previously assumed.

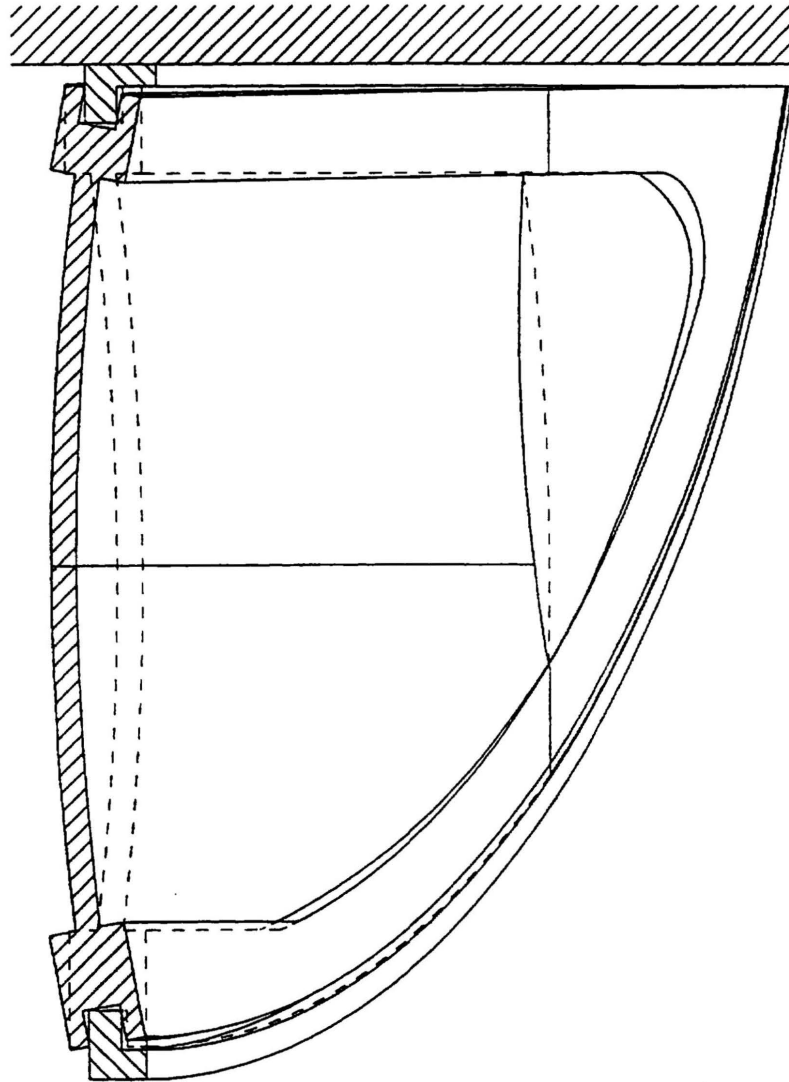
FIGURE 3: DIVIDER PLATE UNDER SMALL BREAK LOCA LOADS

to sustain small breaks (5% and 7-1/2% break sizes) with significant distortion but without any disengagement of the divider plate from the seat bar. For the purpose of modelling LOCA flow conditions, this allows the divider plate to be considered totally intact. The response of the divider plate to a small break LOCA is shown in Figure 3.

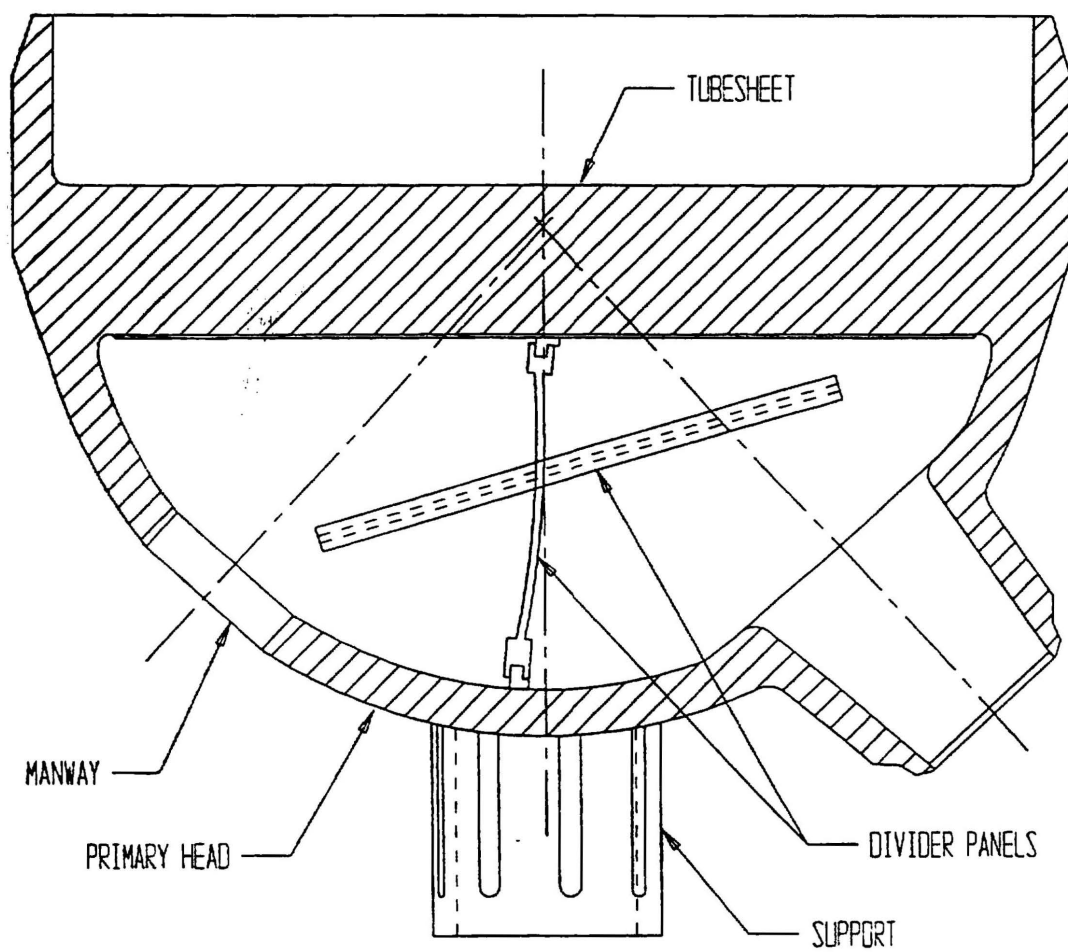
FIGURE 4: DIVIDER PLATE REPLACEMENT

Replacement one piece floating divider plates were installed at Gentilly-2 beginning in April 1995, and at Point Lepreau beginning in June 1995. Significant management and technical challenges were encountered at each site. Figure 4 shows the access constraints for the field installation.
