## ASSESSMENT OF THE INTEGRITY OF KANUPP FUEL CHANNELS

B.A. Cheadle\*, A. Celovsky\*, M. Ghafoor\* and W. Butt\*

Presented at the '96 CNA/CNS Conference, Fredericton, New Brunswick  
1996 June 9 to 12

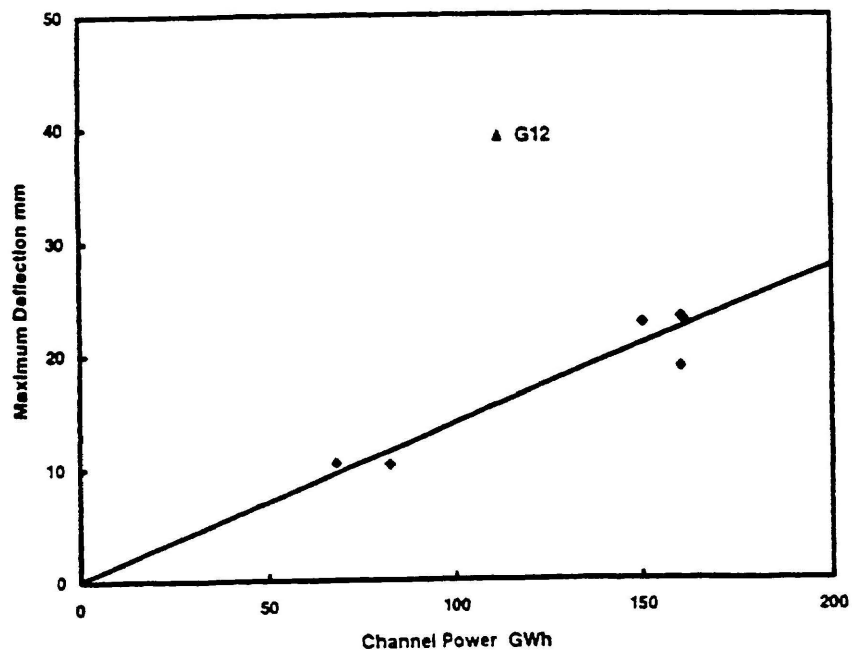
The sag, maximum transverse strain and length change of the eight channels are shown in Figures 1, 2 and 3. Since the channels were not measured after they were installed, there is no zero point and it is difficult to estimate the exact change with service or the exact deformation rates. The maximum estimated increases excluding channel G12 are: diameter 0.8%, elongation 5 mm and sag 23 mm. The elongation is much less and the increase in diameter is greater than would have occurred in cold worked Zr-2.5Nb pressure tubes operating under the same conditions. This is due to the effect of the much more random crystallographic texture of the heat treated tubes.

In CANDU fuel channels, the pressure tube is supported by the calandria tube. Since the calandria tube operates at a lower temperature than the pressure tube, the increase in sag during service is mostly a function of the sag resistance of the calandria tube. The maximum sag of 23 mm does not cause any concerns and since this reactor does not have any horizontal reactivity mechanism tubes, the estimated sag of 54 mm after a further 10 calendar years service will not cause any problems. Curvature of the channel can eventually cause problems with fuel bundles sliding through the pressure tubes but a sag of 54 mm is not expected to cause any problems.

FIGURE 1: MAXIMUM VERTICAL DEFLECTIONS VERSUS TOTAL CHANNEL POWER. LEAST SQUARES LINE DOES NOT INCLUDE G12.

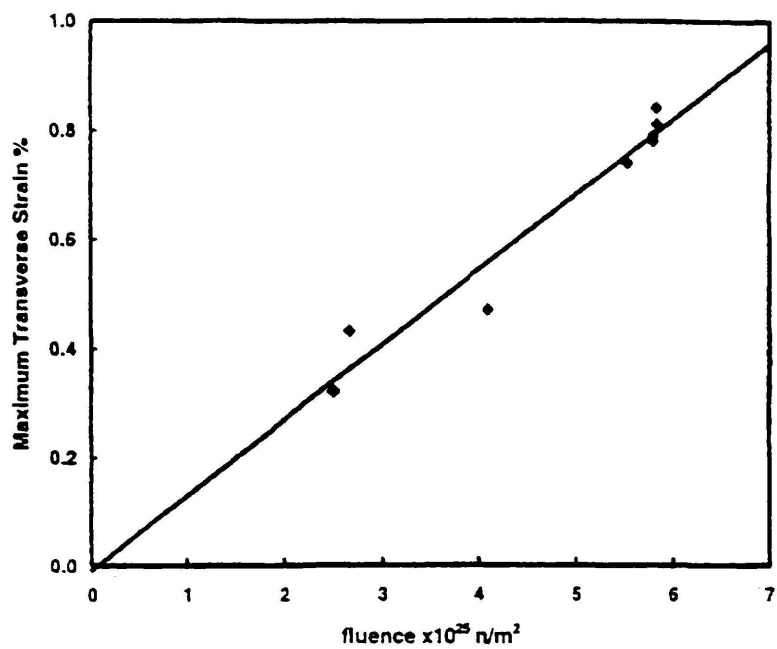
An increase in pressure tube diameter results in a larger proportion of the coolant flowing around the fuel bundles rather than through them. When the increase in inside diameter is above about 4% this can cause Critical Heat Flux (CHF) and Critical Channel Power (CCP) concerns. Hence an increase of 0.8% after 7 EFPY is not a concern and the projected increase to about 1.7% after a further 10 calendar years service is also not a concern.

FIGURE 2: MAXIMUM TRANSVERSE STRAIN VERSUS MID-BUNDLE FAST NEUTRON FLUENCE, WITH LEAST SQUARED FIT LINE.

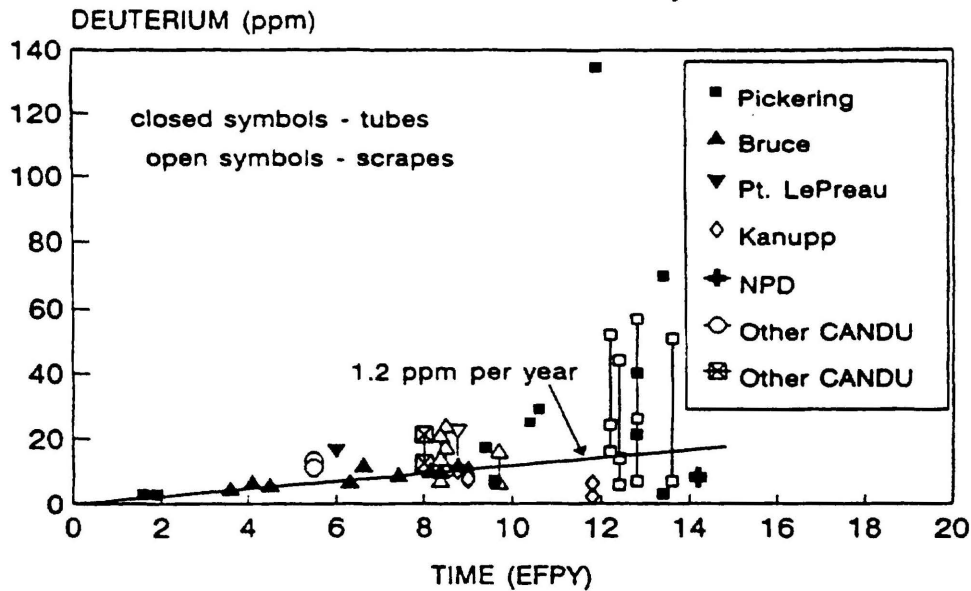
The oxide thicknesses measured are similar to those observed on other heat treated Zr-2.5Nb pressure tubes and less than has been observed on cold worked pressure tubes after the same hot service time, Figures 4 and 5. The deuterium concentrations of the KANUPP tubes, both at the ends and in the bulk of the tubes were either similar or lower than observed in cold worked Zr-2.5Nb pressure tubes after the same hot service time, Figures 6 and 7. This is due to the lower operating temperature and also possibly the behaviour of heat treated material compared with cold worked material. The deuterium ingress rates are sufficiently low, that even with some of the tubes having high hydrogen concentrations, none of them should reach TSS at operating temperature in the next 10 calendar years, even in the rolled joint regions.

FIGURE 7: COMPARISON OF DEUTERIUM INGRESS IN KANUPP TUBES WITH OTHER Zr-2.5Nb PRESSURE TUBES FROM CANDU REACTORS.

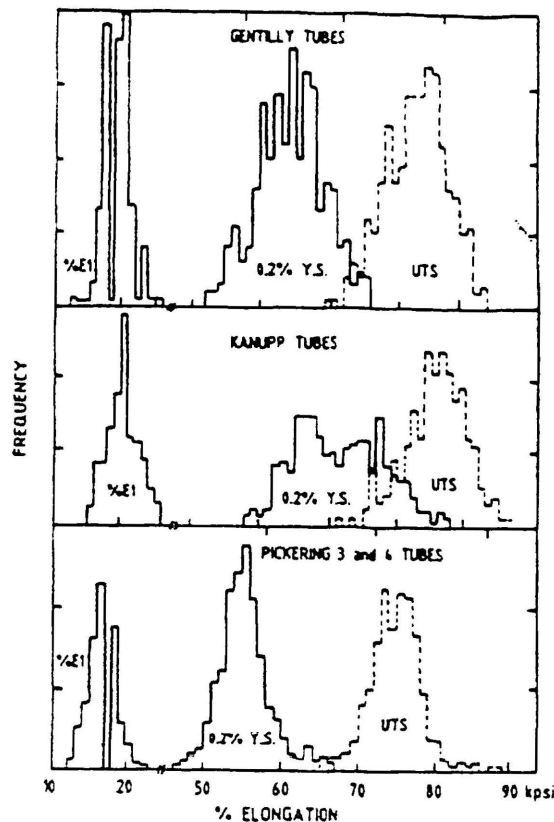
In Zr-2.5Nb, the quenching and aging heat treatment produces a higher strength than cold working. The tensile strength of the KANUPP pressure tubes were generally higher than the similar Gentilly 1 heat treated pressure tubes and also higher than cold worked pressure tubes, Figure 8. As expected, irradiation increased the strength of G12, Figure 9 and lowered its ductility, but the % elongation values were still close to the specifications for the as fabricated tubes.

FIGURE 8: THE LONGITUDINAL TENSILE PROPERTIES OF KANUPP, GENTILLY 1 AND PICKERING UNITS 3 AND 4 PRESSURE TUBES.

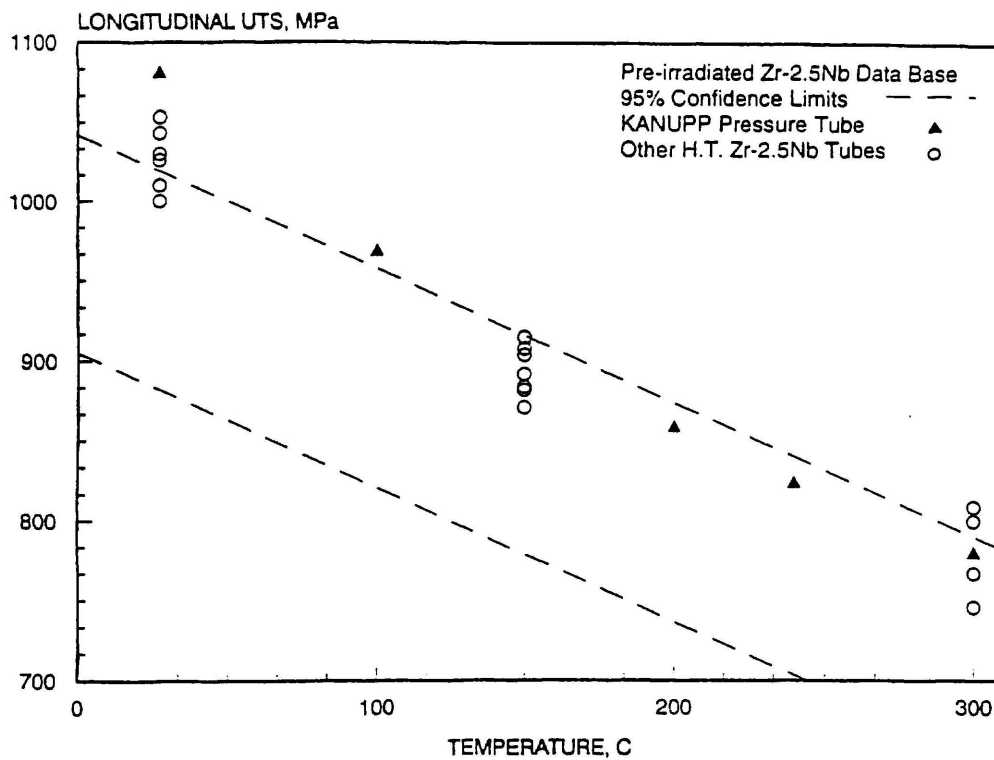
FIGURE 9: LONGITUDINAL TENSILE PROPERTIES OF KANUPP PRESSURE TUBE MATERIAL AS A FUNCTION OF TEMPERATURE COMPARED WITH IRRADIATED COLD-WORKED Zr-2.5Nb AND HEAT-TREATED Zr-2.5Nb MATERIALS.

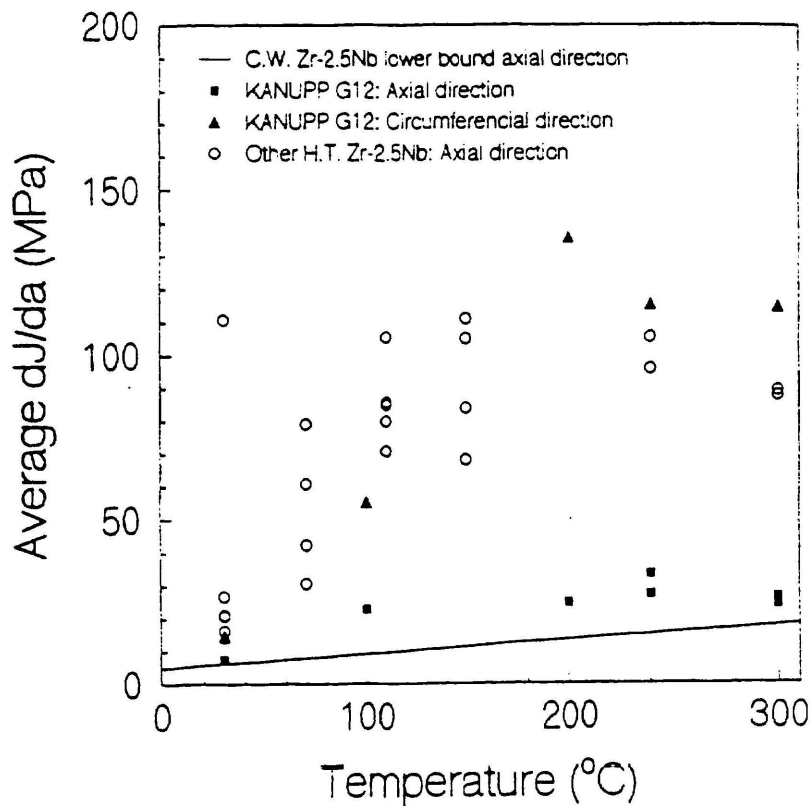
The fracture toughness of G12 was less than average cold worked Zr-2.5Nb pressure tubes but above the lower bound values, Figure 10. The toughness of the KANUPP tubes is low but probably no worse than in many of the cold worked Zr-2.5Nb pressure tubes operating in other CANDU reactors.

FIGURE 10: FRACTURE TOUGHNESS OF G12 MATERIAL AS A FUNCTION OF TEMPERATURE COMPARED WITH OTHER Zr-2.5Nb MATERIALS.

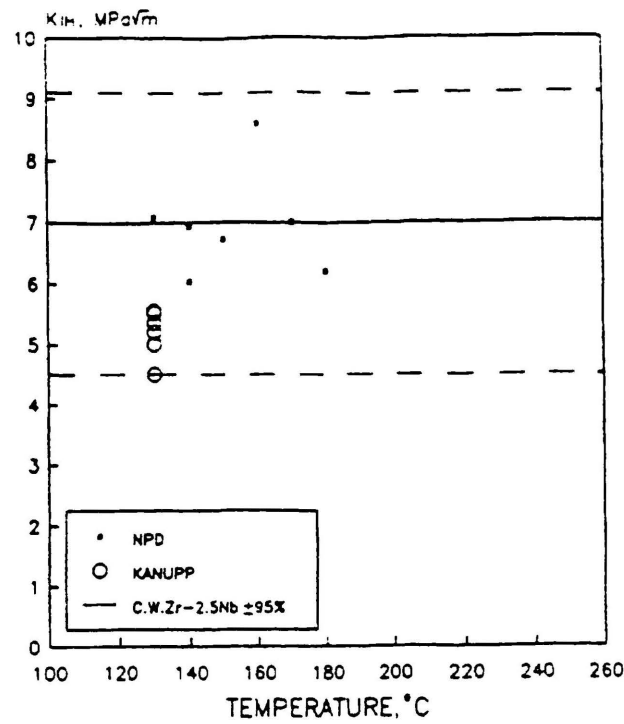
The two important properties for DHC are the susceptibility to crack initiation as measured by  $K_{IH}$  and the velocity of a growing crack, DHCV. The  $K_{IH}$  for G12 was near the lower bound of values for cold worked Zr-2.5Nb pressure tubes, Figure 11. The DHCV values were less anisotropic than those of cold worked tubes, being near the upper bound for cold worked Zr-2.5Nb in the radial direction and near the lower bound in the axial direction. Figure 12. This difference in behaviour is probably due to the difference in the microstructures of the tubes.

FIGURE 11: COMPARISON BETWEEN  $K_{IH}$  IN THE G12 TUBE AND OTHER DATA ON HEAT-TREATED PRESSURE TUBE AND COLD-WORKED Zr-2.5Nb PRESSURE TUBES.

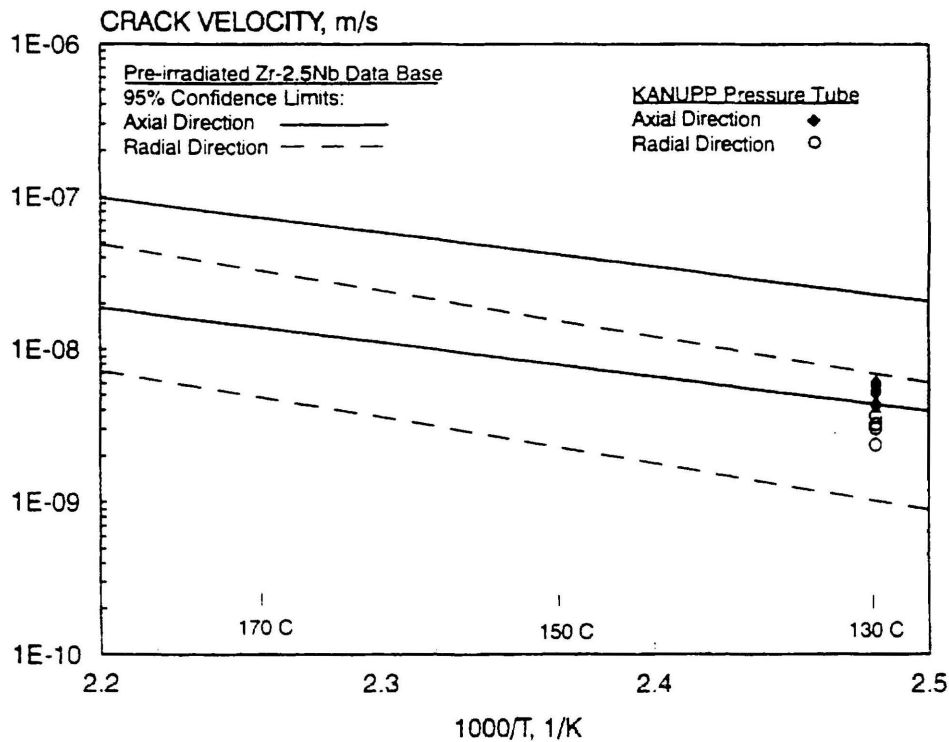
FIGURE 12: COMPARISON BETWEEN THE AXIAL CRACK VELOCITY, OBTAINED AT  $130^{\circ}\text{C}$ , IN THE KANUPP TUBE AND OTHER DATA ON HEAT-TREATED PRESSURE TUBE AND COLD-WORKED Zr-2.5Nb PRESSURE TUBES.
