New Brunswick Power Point Lepreau Generating Station

Information Report

Events Leading To Foreign Material Being Left in the Primary Heat Transport System

IR-33100-15 Rev. 0

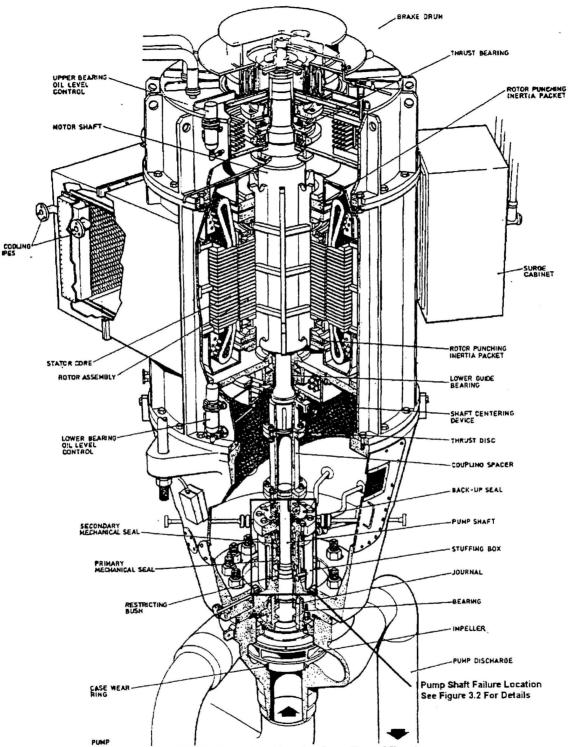
Figure 1 General Assembly of PHT Pump P1 Showing Location of Fracture

Figure 1 illustrates the general location of the shaft failure. Figure 2 shows a more detailed view of the shaft fracture location and the heat affected zones. Figure 3 shows the shaft fracture location looking down on the Auxiliary Seal Flange. Figure 4 shows an end view of the segment of the pump shaft at the fracture location.

The pump shaft fracture occurred 398 mm from the motor coupling end of the shaft, which is approximately in the middle of the breakdown bushing (pressure cell) portion of the seal flange assembly, just above the tertiary seal (refer to Figure 2). The fracture was perpendicular to the axis of the shaft and the fracture surfaces were relatively coarse and jagged, typical of torsional overload. The fracture surfaces were moderately damaged from post failure rubbing. A significant amount of deformation was evident near the fracture indicating ductile torsional overload. The total angular twist, or plastic deformation, of the material was estimated to be 120° to 160°, based on the rotation of axial scratches on the surface of the shaft at the fracture location. Fractographic analysis using the scanning electron microscope (SEM) confirmed the fracture to be ductile overload.

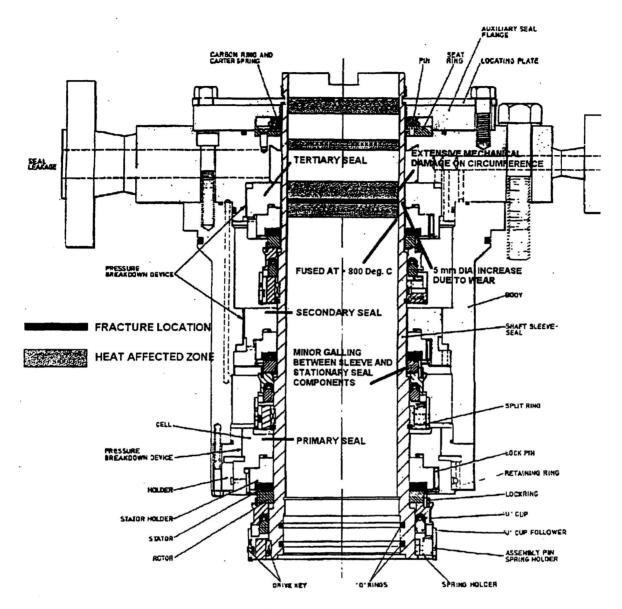
Figure 2 Details of Damage Observed on PHT Pump P1 Shaft

Discolouration of the shaft adjacent to the fracture location indicated elevated temperature. There was a distinct heat affected zone approximately 25 mm on both sides of the fracture. The shaft was fused to the seal sleeve at the location of the fracture. The melting point of the type 410 stainless steel shaft and sleeve is about 1500°C. The sealing sleeve fractured at the same location as the shaft. There was extensive mechanical damage on the outside surface of the sleeve, 25 mm on both sides of the fracture location. The mechanical damage was oriented in the circumferential direction and is typical of severe metal-to-metal wear. Minor galling was also evident on the outside surface of the sleeve at the location of the stationary part of the secondary seal. The inside of the sleeve displayed a distinct heat affected zone approximately 25 mm on both sides of the fracture. There was no evidence of rotation of the sleeve on the shaft. There were no material or manufacturing defects detected.

The inside diameter of the breakdown bushing displayed extensive mechanical damage, similar to the corresponding surface of the sleeve. Metal had flashed out the ends of the bushing leaving a lip. The inside diameter of the bushing increased by up to 5 mm as a result of the wear with the sleeve. Discolouration of the undamaged surfaces indicated the part had overheated. The fillet weld connecting the bushing to the flange had failed, most likely during disassembly based on the clean fracture surface. There was no evidence of rotation of the bushing on the flange. It was reported that the bushing separated easily from the sleeve during disassembly. This indicates that the sleeve was not welded to the bushing and the shaft had not seized. There was also evidence of wear between the outside of the sleeve and the inside of the seal flange assembly and auxiliary seal flange. The damage at those locations was significant but less severe. The mechanical and heat damage was more severe at the breakdown bushing because of the greater thickness of the seal flange and subsequent contact surface area.

Hardness testing indicated the shaft was heated to temperatures in excess of 800°C through the full thickness of the shaft. The highest hardness values (>60 HRC) were obtained at the fracture surface and decreased on both sides of the fracture. Overheating of the shaft was confirmed by evidence of microstructural changes. Metallography revealed hard martensitic microstructures indicating the shaft was transformed to austenite then quenched. The austenitic transformation temperature is about 750°C for 410 stainless steel. Based on the flow lines evident in the microstructure, the ductile fracture occurred at the elevated temperature. Quenching of the steel occurred after fracture.

Location of Damage Observed on PHT Pump P01 Shaft

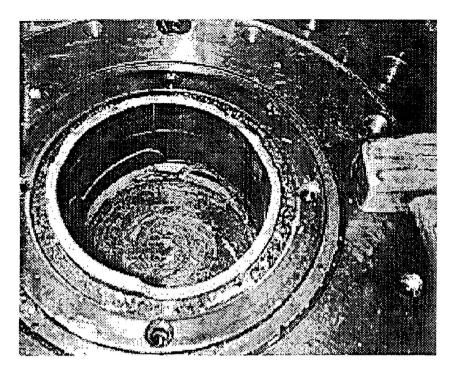
Figure 3 View of Pump Shaft Fracture looking down on Auxiliary Seal Flange
(Note: Pump Shaft dropped below normal operating position in seal housing)

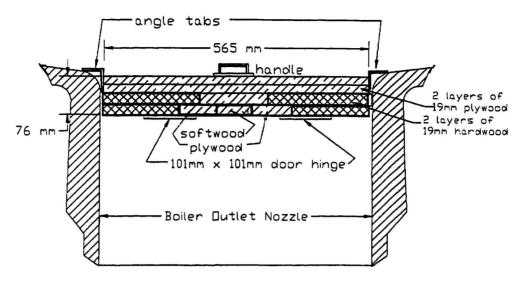
Figure 5 Modified Cover

The debris found in the impeller of PHT Pump 1 (P1), and within other areas of the PHT system, was determined to be from a modified wooden cover used in the cold leg nozzle during maintenance of Boiler B01. A sketch of the modified cover (the cover involved in this incident) is shown in Figure 5. The purpose of this cover was to provide temporary closure of the cold leg nozzle of the boilers. It had been used sequentially in all of the boilers during the performance of maintenance activities.

Design and construction of the wooden covers did not take into consideration the possibility of one inadvertently being left in the system as a source of loose parts. As such, no assessment was performed of these materials, or their associated potential impact on the heat transport system, and no exact record of the composition or amount of material used was maintained.
