LESSONS LEARNED FROM TUBES PULLED FROM FRENCH STEAM GENERATORS

Ph. BERGE, J.M. BOURSIER, D. DALLERY, F. de KEROULAS, Y. ROUILLON
Electricité de France
Generating and Transmission Division

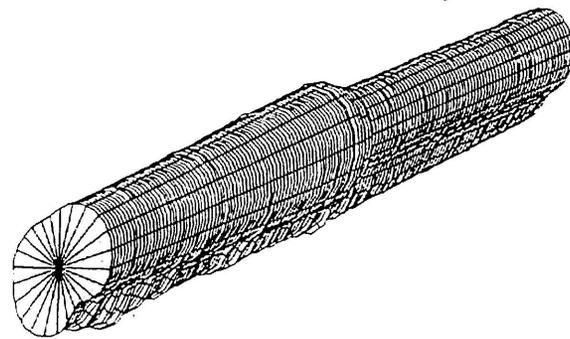
- i) lack of rolling (“skip roll”),
- ii) lack of overlap between rolling passes,
- iii) excessive bore diameter,
- iiii) tubesheet drilling defects (Figure 3).

All these conditions result in sudden changes in the internal surface profile and develop high residual stresses that cause cracks. However, these various degradations are only of limited importance in terms of safety, since the tubesheet is secured to the tubes.

Figure 3 : Cracking in the rolled area in the tubesheet. Laser profilometry of a silastic mold of a rolled tube with a drilling defect.

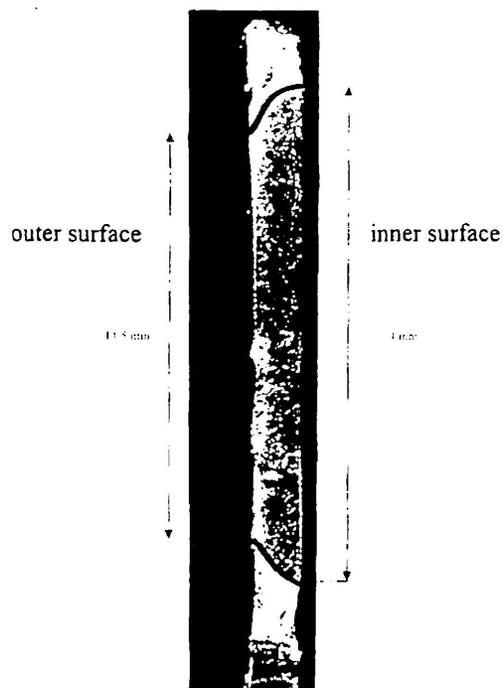
On this occasion, 50 small U-bends removed from the first and second rows were examined. The metallurgical examinations revealed some longitudinal cracks initiated in the PWR

primary water and located at the bend transition in the hot leg (Figure 4). Some longer cracks completely traverse the tube wall.

Figure 4 : PWSCC in small U-bend.
 Longitudinal cracking on MA Alloy 600.
 a) Outer surface after leak test
 b) Cross section of the main crack 13

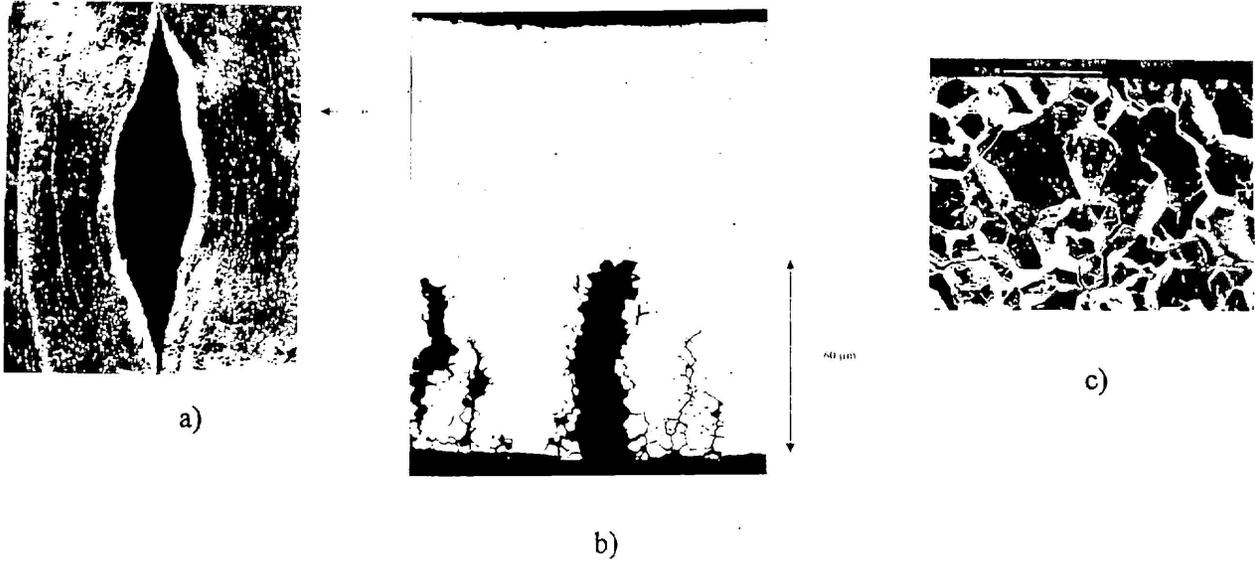
From the pulled tube investigations, free span corrosion in the tubesheet sludge pile area can be described as follows (Figure 6) :

- many short (less than 2 millimeters) longitudinal cracks,
- intergranular path,
- the cracking occurrence appears to be linked with the presence of sludge, and corrosion can therefore be found many centimeters above the top of the tubesheet.

Figure 6 : Longitudinal intergranular OD corrosion in sludge pile area on MA Alloy 600 tube
 a) outer surface after burst test
 b) transversal cut
 c) SEM observation

- Circumferential cracking : *“ Any sign detected by the rotating probe indicating the existence of a circumferential crack requires that the tube be plugged ”.*
- Secondary side corrosion in the sludge pile area : *“ bobbin coil signal ≥ 500 mV or bobbin coil signal ≥ 200 mV and presence of an internal longitudinal crack (length ≥ 10 mm) with a difference in height less than 8 mm ”*

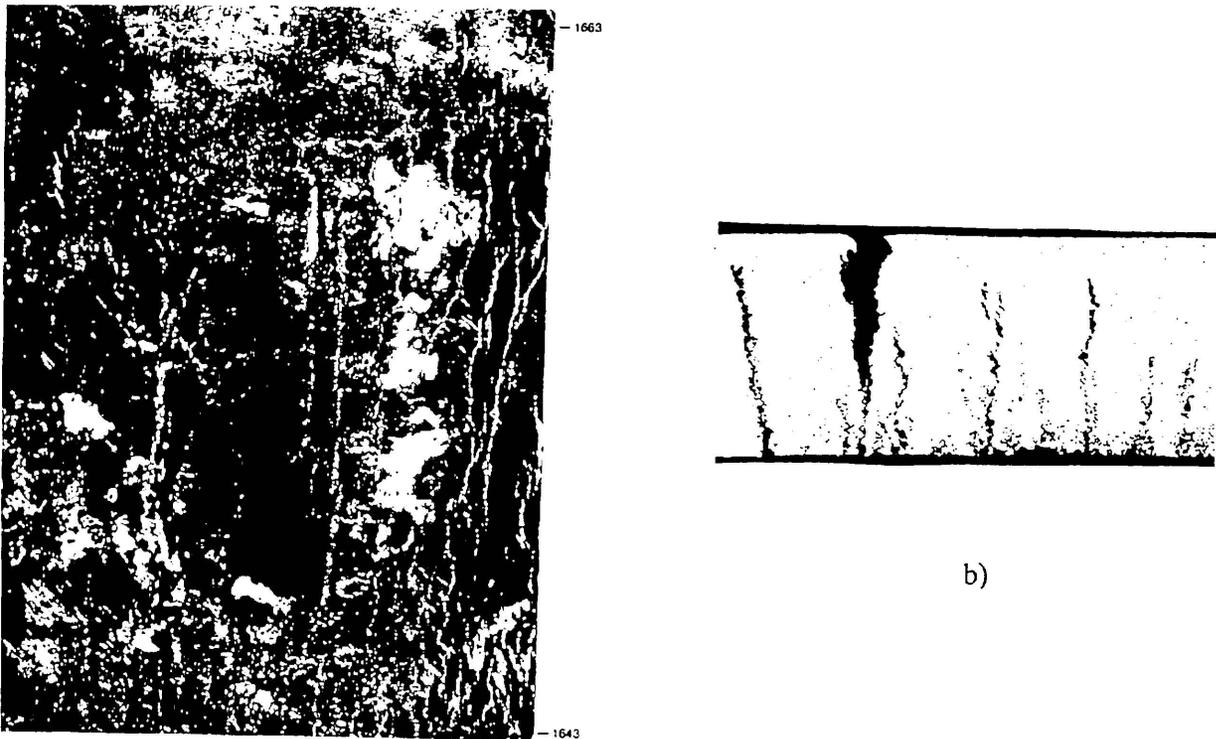
This type of cracking mainly concerns the steam generator bundles made of mill annealed Alloy 600 and equipped with drilled hole tube support plates (TSP). The metallurgical investigations carried out on 30 pulled tubes for secondary side corrosion at TSP elevations and on a replaced steam generator at Dampierre Unit 1 [26] have shown that corrosion occurs in the crevices between the tube and the TSP, which are totally filled with deposits or oxides. Two kinds of corrosion have been observed : intergranular attack (IGA) and intergranular stress corrosion cracking (IGSCC). Based on the pulled tube population, the corrosion morphology at TSP elevations is close to that observed above the tubesheet in the sludge pile area, and can be summarized as follows (Figure 8):

- numerous short longitudinal cracks with a part of IGA,
- the closer to the TSP mid-thickness, the deeper the IGSCC and the IGA,
- the corrosion does not extend beyond the TSP limits,
- on one steam generator, shallow and narrow transverse bands of IGA (300 μ m) have been found in front of the top and bottom of the TSP.
- generally, the extent of the secondary side corrosion decreases with the TSP elevation.

Figure 8 : OD corrosion at the Tube Support Plate Elevation - MA Alloy 600 tube
 a) outer surface after burst tests
 b) Transverse cut - Longitudinal IGSCC + IGA

The plugging criterion for mill annealed Alloy 600 steam generator tubes for corrosion at TSP elevations is as follows:

- Corrosion at TSP elevations : *“ Bobbin coil signal ≥ 2 V (and ≥ 1 V for TSP nos. 7 and 8) ”.*
