## **PRESSURIZER MANWAY CLOSURE RE-ENGINEERING**

R. HORVATH, J. TANG, D. JOUDREY, J. MILLMAN  
BABCOCK AND WILCOX CANADA  
D. PRITCHARD, ONTARIO POWER GENERATION, DARLINGTON

Canadian Nuclear Society  
20th Annual Conference  
Montreal, Quebec  
June, 1999

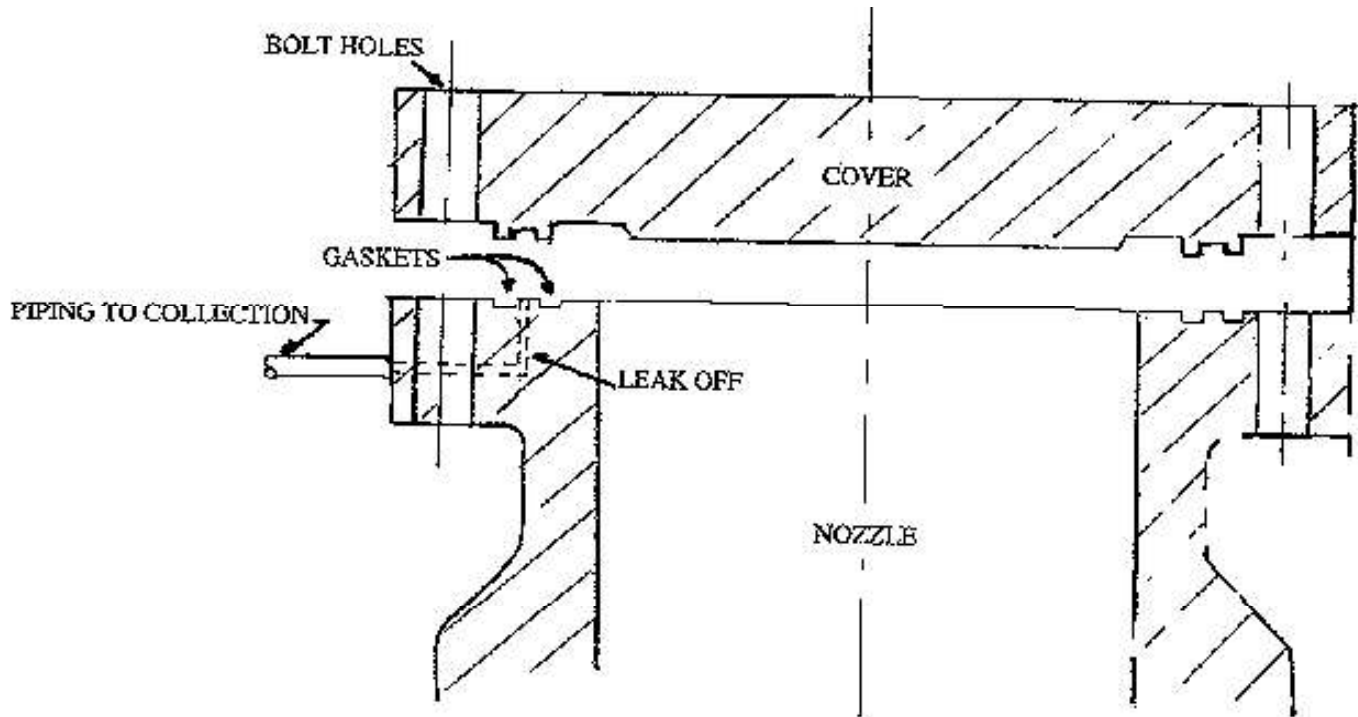
Figure 2: Darlington Pressurizer Manway  
and Inspection Port  
Original Double Gasketed Joint

The gasketed joints of the lower manway and upper inspection port have required considerable maintenance over the past several years. Leakage to the D<sub>2</sub>O Collection system from the failure of inner gasket seals results in additional cost to upgrade the D<sub>2</sub>O to return it to the system. Larger leaks have resulted in minor erosion damage to the sealing faces, and in one instance a leak through both gaskets contributed to a forced outage.

The first effort to address the leakage was to examine the existing joint geometry and the gasket material. As evident from past experience, increasing the bolt torque on the joint tended to result in greater leak rates from the inner gasket. By measuring deflection (rotation) of the flange and analyzing the bowing of the cover, it was evident that the inner

gasket was being unloaded as the torque was increased. The increased bolt force caused increased cover bowing so that the pressure on the inner gasket was relieved (see [Figure 2.](#))

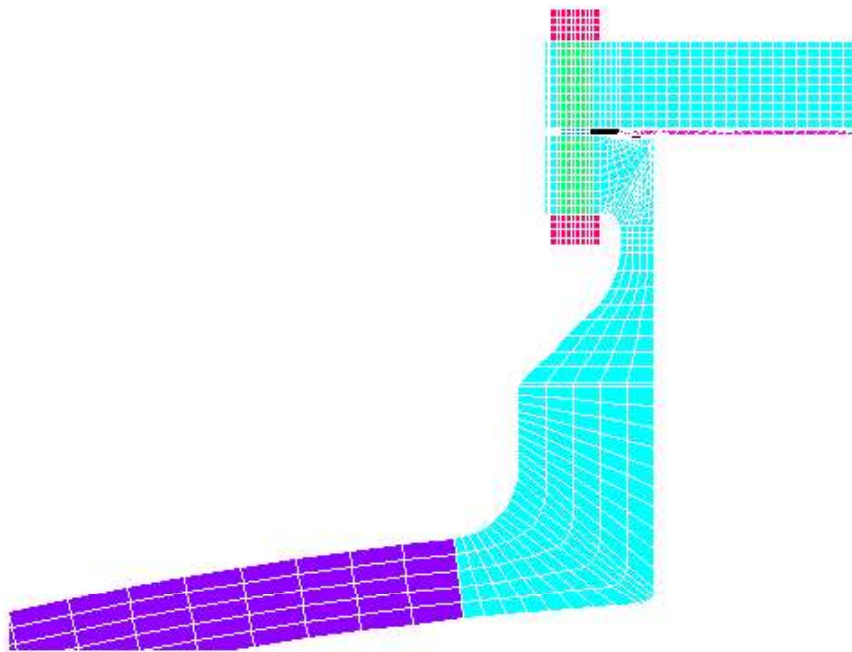
Figure 4: Finite Element Model of Manway Flange

Section III of the ASME code was invoked to govern the design, analysis, installation and inspection of the modifications. The vessel flange was re-analyzed using an ANSYS 5.0 finite element (FE) model (see [Figure 4](#)) according to the ASME code. The strength of the Inconel itself was not credited in the re-analysis of the flange. Functions of pressure and temperature versus time were applied to the FE model to conservatively envelope all transients specified for the pressurizer. These, together with original an/or recalculated inputs (material properties, heat transfer coefficients) were used to complete the level A and B analysis according to ASME code. Separate reports and registrations were performed for the modified inspection port and modified manway. Flange, cover and bolting were all included in the analysis.
