POST-IRRADIATION EXAMINATION RESULTS FROM THE BTF-105A LOCA/LOECC TEST

VALLIANT, P.J., IRISH, J.D. and CRAIG, S.T.

Fuel Safety Branch
Reactor Safety Division
AECL, Chalk River Laboratories
Chalk River, Ontario, CANADA K0J 1J0

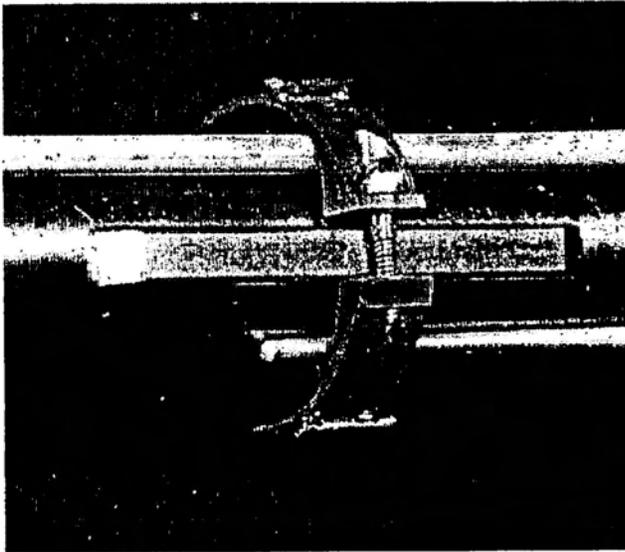
9601-22613-6 3X

Figure 3: Zircaloy Clamp at Lower Bearing Pad Securing Type-C Rhenium Clad Thermocouples to Sheath

One of the main objectives of the BTF-105A test was to investigate instrumentation improvements for the BTF-105B test. Good performance of the fuel-centreline and the high-temperature fuel-sheath thermocouples was seen in the BTF-105A test. The high-temperature rhenium-clad thermocouples attached with Zircaloy clamps remained operational and PIE showed them to be in good mechanical condition after the test. As a result, this technology was used for the BTF-105B test.

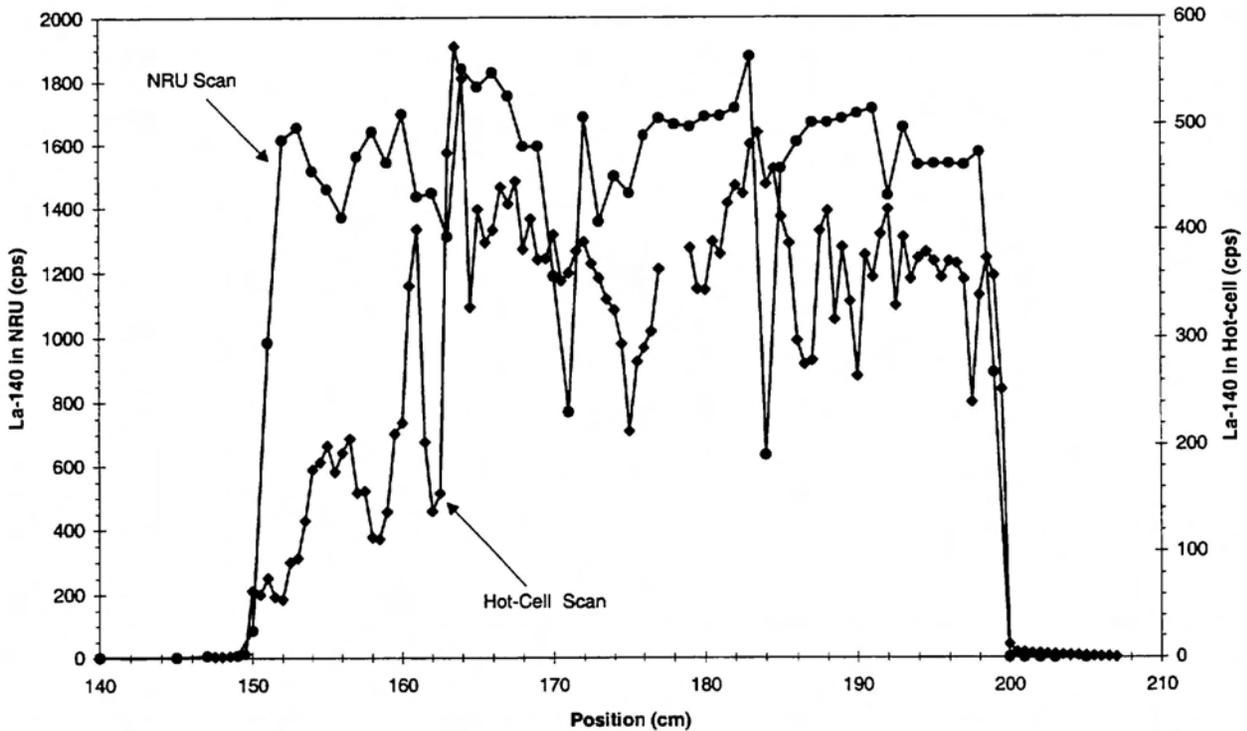
The fuel assembly was gamma scanned in a storage can in the NRU reactor building after the test. The scan revealed a relatively intact fuel element (Figure 5). A decision was made to transfer the assembly to the hot cells without epoxying the assembly. This allowed much more information to be gained about instrumentation and the condition of the thermal shroud than would have been possible if the stringer had been epoxyed initially. The ZIRCAR thermal insulation was cut longitudinally and the upper and lower halves were separated to expose the inner Zircaloy wall of the thermal shroud. In Figure 6 it can be seen that the inner Zircaloy wall is heavily oxidized and broken up at the elevation of the lower bearing pad of the fuel element. Evidence of steam ingress into the ZIRCAR insulation can be seen in the mating half of the thermal shroud where this ingress has discoloured the initially white ZIRCAR insulation. The insulation is mainly intact except for a through-wall crack that appears to line up with the zone of heaviest damage on the inner Zircaloy wall. It is possible, that the rapid injection of steam into the shroud following failure of the inner wall caused the through-wall crack in the insulation to form, which in turn, provided a path for the hot steam to heat the outer wall of the shroud directly. This would explain the rapid rise in temperature following shroud failure observed by a thermocouple located on the outside of the shroud [1]. This outer shroud thermocouple was located axially within a few millimetres of the observed crack in the insulation. A second gamma scan done in the hot cell showed some fuel relocation (Figure 5). A comparison of the two gamma scans indicates that most of the damage to the fuel element occurred during handling after the element was removed from the reactor. "Fuel powder" consisting of loose UO_2 fuel

Figure 5: Comparison of La-140 Gamma Scans Performed in the NRU Storage Block and in the Hot Cells

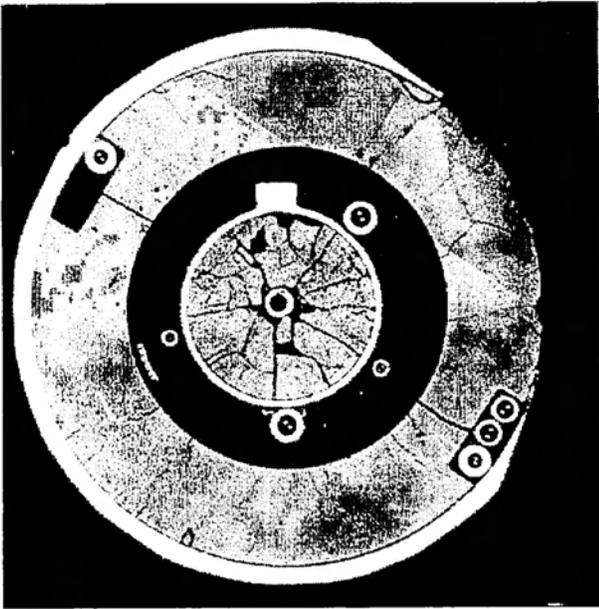
FS 30 2X
 Figure 8: Met 1 Upper Bearing Pad - TFC01

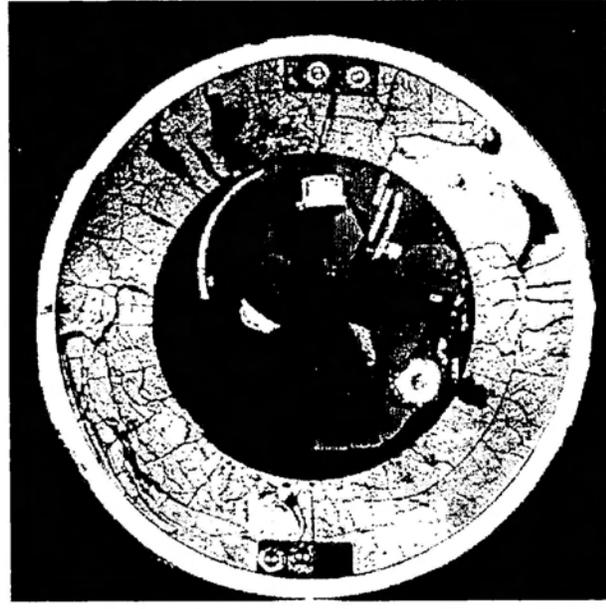
FS 25 2X
 Figure 9: Met 2 Middle Bearing Pad

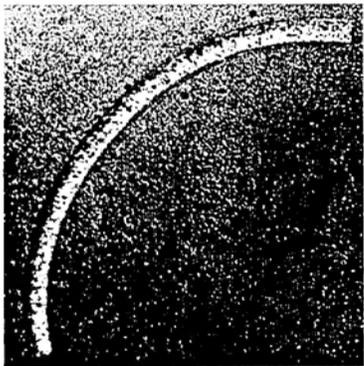
JJ 7D2 5.2X
 Figure 10: Met 3 Fully Oxidized Sheath

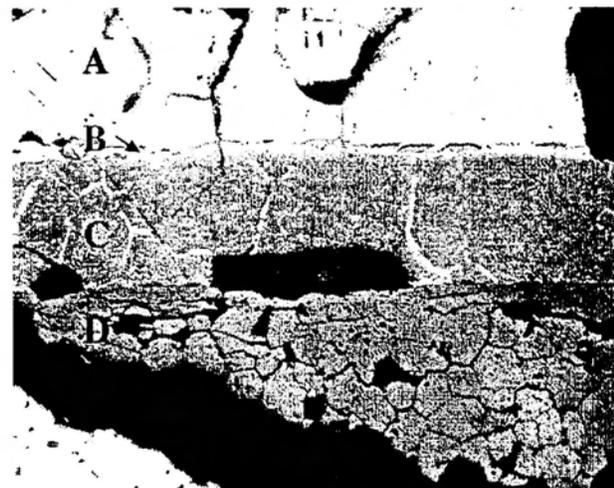
II27H34 110X

Interaction of UO_2 and the Zircaloy-4 fuel sheath is shown in Figure 12. This sample was from the lower bearing pad region. The interaction may have been facilitated by the close contact between the fuel and sheath at the Zircaloy clamp area [3]. It appears as though an $\alpha-Zr(O) + U(Zr)$ layer has formed at the interface between the fuel and sheath. The sheath has been oxidized by oxygen which has diffused out of the fuel.

- A - α - Zr(O)
- B - U(Zr)
- C - α - Zr(O) + U(Zr)
- D - UO_2 Fuel

Figure 12: Interaction of UO_2 and Zr-4 Fuel Sheath at Lower Bearing Pad

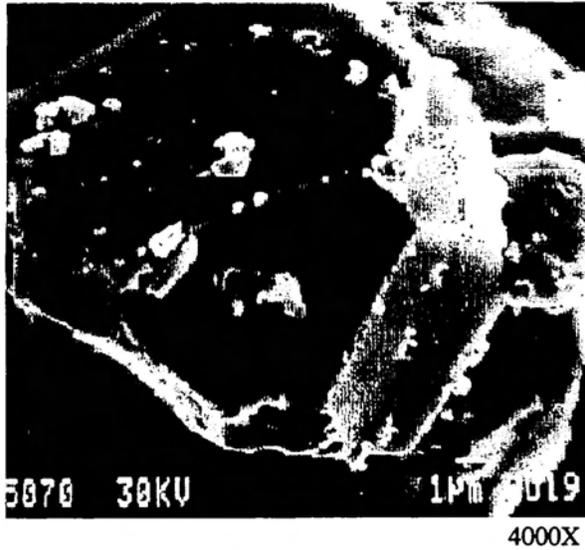
The powdering of the UO_2 near the bottom of the fuel element could have been caused by the thermal quench. However, the fuel powdering could also be due to UO_2/Zr interaction. Figure 13 shows a SEM photo of a UO_2 grain. Analysis indicates that the grain contains U and Zr. It is possible that there are some zirconia fragments on the surface of the grain since the powder is a mixture of material from the fuel element and the shroud. The small white particles which are imbedded in the grain are very similar to the "flowers" of UO_2 observed by Evans et al. [4] when excess U (due to the UO_2/Zr interaction) which had deposited on the grain boundary was oxidized by steam. The fuel temperatures of $300-500^\circ C$ for the 5 minutes immediately following the quench are just those identified by Evans as most likely to lead to fuel fragmentation following U/Zr interaction. An SEM of the powder, Figure 14, shows the presence of UO_2 fuel

Figure 13: SEM Photo of UO₂ Grain with Small Particles Present, Possibly Imbedded
