## FUEL RE-ORDERING IN THE BRUCE A REACTOR CORES

E. KOHN AND J. NOVAK  
Ontario Power Generation  
700 University Avenue, H11  
Toronto, Ontario, Canada, M5G 1X6

### ABSTRACT

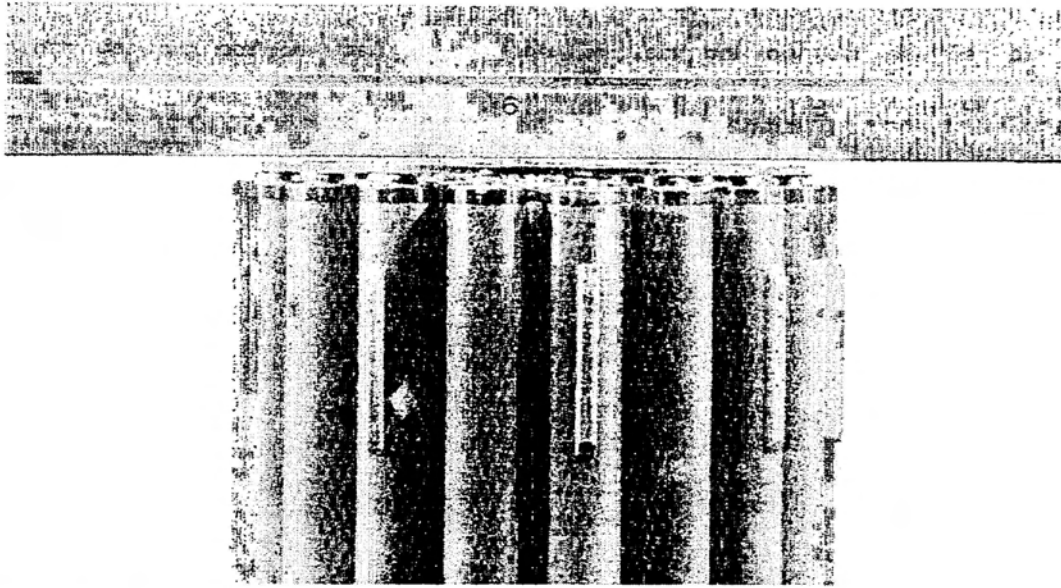
Bundle doming occurs in CANDU fuel when it is supported by fuel latches and the hydraulic loads result in a small amount of deformation of the end plate in the direction of flow, Figure 3. Recycling from one channel to the next (part of the change-over of an existing core to FWF) causes the flow direction on a bundle to be reversed, so a bundle with a domed endplate may find itself against the latch subjected to a flow direction which reverses the doming, thereby increasing the strain cycle and increasing the possibility of failure. It should be noted that once the changeover is completed and equilibrium fuelling is proceeding, this condition (doming reversal) ceases to exist.

Figure 3 Side profile of a bundle showing end plate doming, a small gap against the straight edge at the outer elements of the bundle

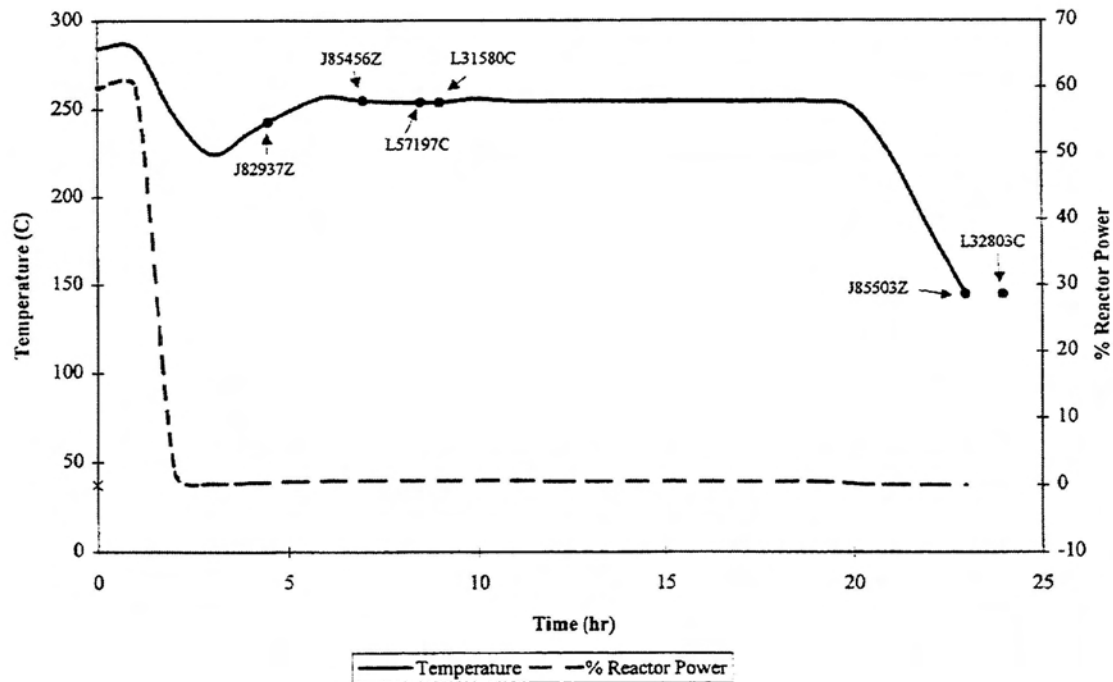
Several hundred bundles have been recycled in Ontario Power Generation reactors and have resided against the latch for significant periods. These have experienced normal operation including reactor shutdowns with the occasional associated period of lower-temperature operation (Figure 4); they were hydrided and many of them had been subjected to flow reversal during recycling. There were no instances of abnormal fuel behaviour, but the bundles had not been examined closely enough to determine if there was an incipient performance problem or not. Ten of these high burnup bundles were examined in the fuel bays and no endplate cracking was observed.

Figure 4 Thermal cycle of the fuel placed on the latches in the reversed direction

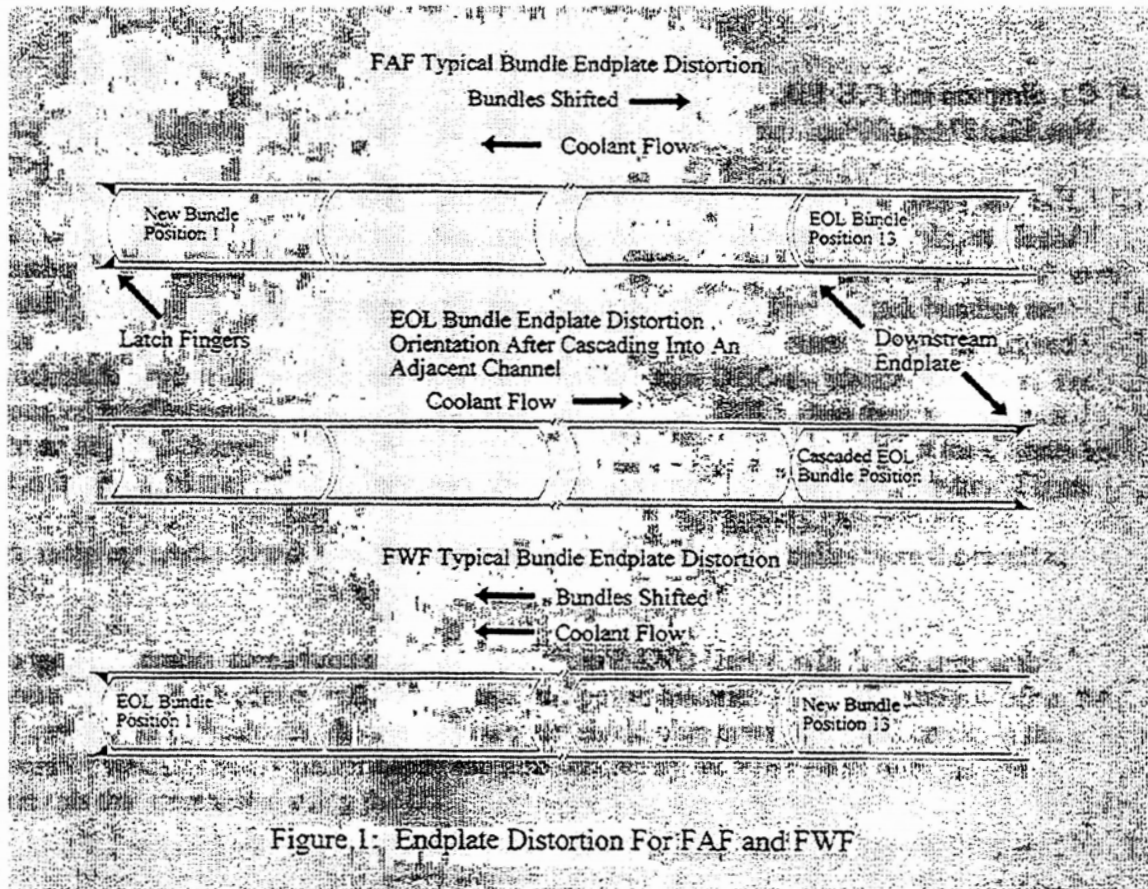
In order to qualify the changeover to FWF, twelve bundles were selected for recycling, with flow reversal. These had been irradiated in BNGS-A Unit 2. These bundles were fuelled such that they placed onto the latches in a channel such that the rest of the fuel string (normal doming in flow direction) applied a larger load to the latch bundle, (see Figure 5). Consequently, this was a very severe test. In addition, the bundles were placed in channels that had been identified as acoustic in the Bruce B reactors. The bundles and channels were:

Figure 5 Schematic of fuel doming of test fuel on the latches

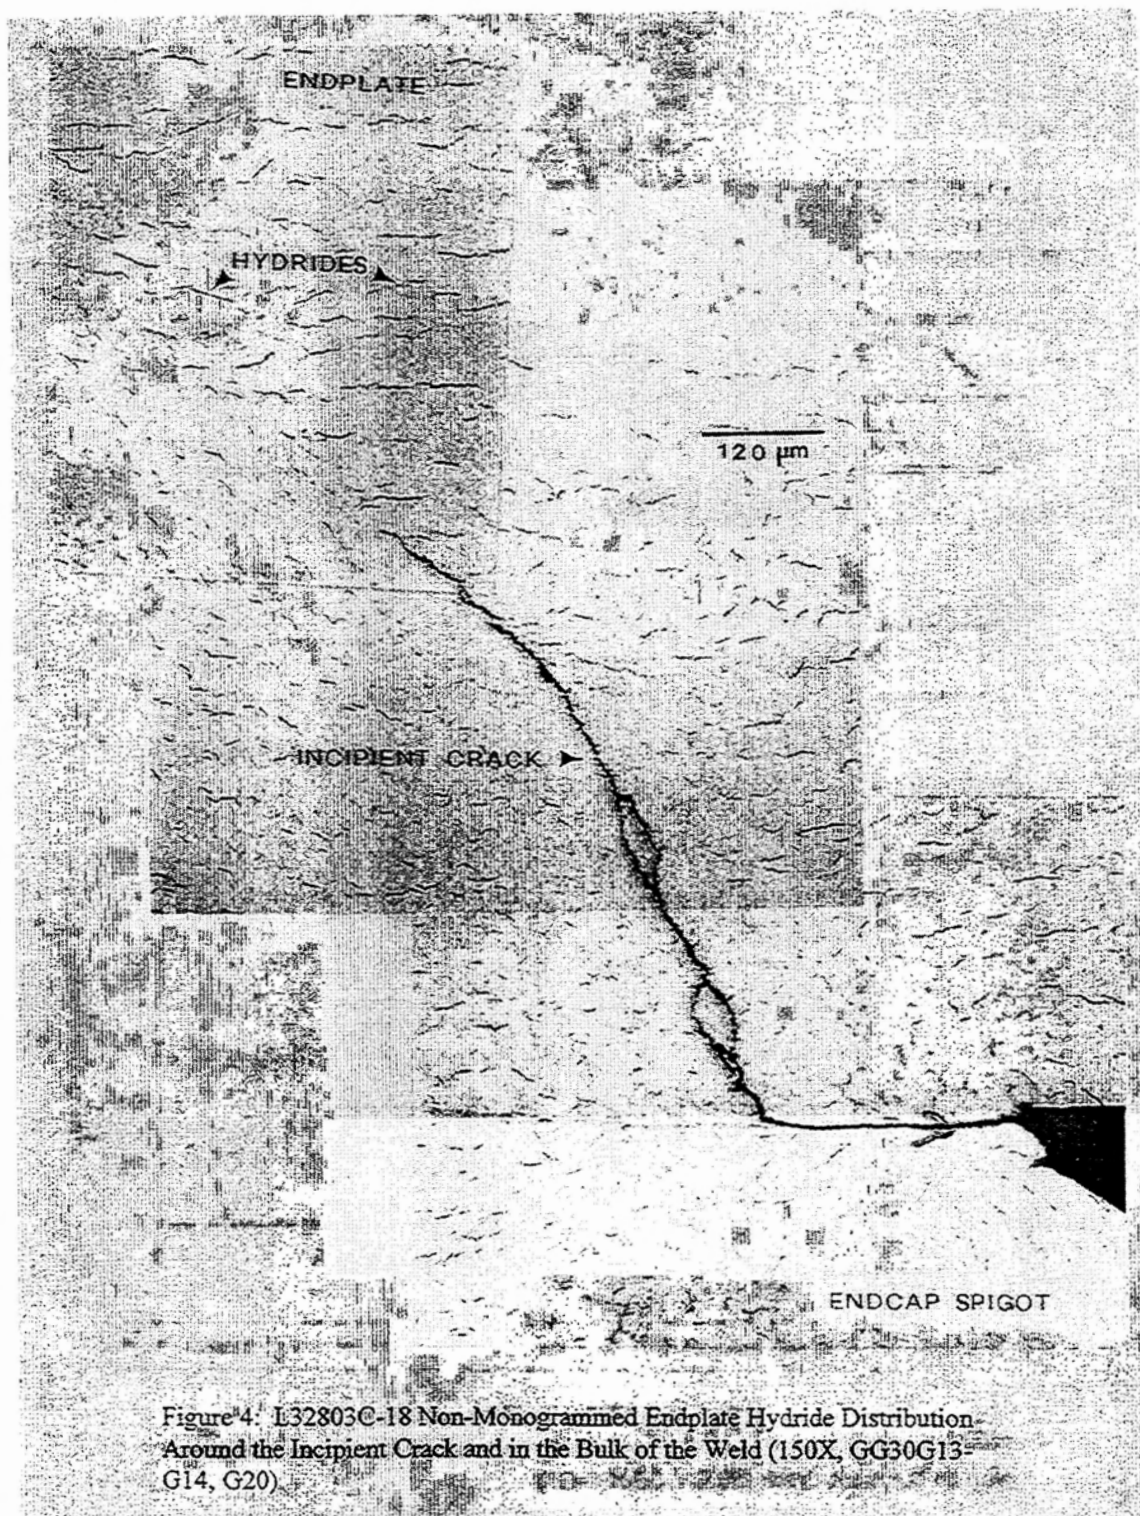
This initial evaluation was later proven to be mistaken. The reactors have a requirement to be able to run in the hot shutdown condition at a coolant temperature of about 265°C. This was pointed out by the workers on pressure tubes (M.Leger, and G.Shek of Ontario Power Technologies (OPT), who also had to contend with this problem. Thus the fuel might be subjected to a decrease in fuel temperature from about 300°C, while highly stressed on the latch, promoting delayed hydride cracking. Delayed hydride cracking (DHC) can occur when the hydrogen concentration is above solid solubility and is particularly fast when the temperature is decreased. This leads to a super saturated condition in the Zircaloy which causes hydrogen to diffuse and migrate in the stress gradient to a notch or crack tip. Hydrides precipitate and then crack in the stress field. The process then repeats causing a measurable propagation rate. Since the end plates were highly stressed, could contain high concentrations of hydrogen, and contained stress raising notches at the end cap to end plate welds, there was a strong potential for this failure mechanism to occur.

In order to examine whether there really was a practical problem, the fuel bundles that had been tested in the reverse dome condition, a very severe test, were examined for delayed hydride cracking, since it was determined that this fuel had also experienced a hot shutdown transient. The fuel was examined at Atomic Energy of Canada Limited –Chalk River Laboratories (AECL-CRL), and DHC was found, Figure 6 (2).

Figure 6 Delayed hydride Cracking of end plate (From Reference 2)

This immediately led to a re-evaluation of the FWF program. Although, it was possible that the severe stress condition of the end plate in the test bundles might have been avoided with the cascade fuelling scheme, management opted for a fuel supporting shield plug, F3SP. This concept, championed by GEC, was a normal Mk3 shield plug, but at the core end was machined to allow an additional nose piece Figure 7. The nose piece was held in the channel lugs to prevent rotation on fuelling and protruded into the channel in front of the latches so that the shield plug would support the three rings of the fuel. This was felt to be an assured option but required the development and installation of the F3SP's before the core re-ordering could start. The F3SP was evaluated for its effect on the fuel behaviour. Qualification testing of the F3SP revealed that no deleterious vibrational effects existed. The F3SP underwent a full design review that considered all operational and safety factors. It was accepted and implemented.

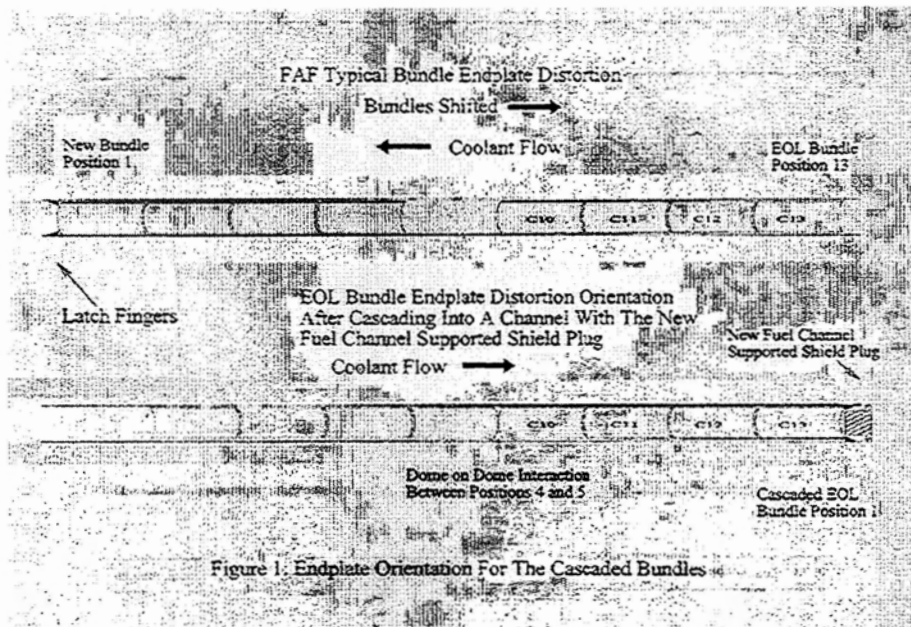
The in-bay inspection of test channels and of the trial cascade fuelled channels resulted in no cracks detected. The bundle configuration is shown in Figure 8. The program could proceed with full implementation.

Figure 8 Cascade 4 bundle shift re-order
