GENTILLY 2 STEAM GENERATORS SPRING 2000 OUTAGE: TUBESHEET WATERLANCE CLEANING AND INSPECTION; UPPER BUNDLE INSPECTION

A review of the secondary side maintenance activities recently completed during the Gentilly 2 Annual Spring 2000 Maintenance Outage. Activities included: 1) Tubesheet intertube waterlance cleaning and visual inspection, 2) First tube support plate, in-bundle visual inspection of the hot leg, and 3) Upper bundle tube support plate visual inspection. A description of the waterlancing and inspection equipment and setup in the RB at Gentilly 2 is provided. Several innovative techniques were successfully employed and yielded savings in critical path duration, labour and personnel radiation dose. These included accessing the SG tubesheet region through one handhole only and sludge removal utilizing the SG blowdown system. Plant personnel judged tubesheet sludge removal successful. Before and after results of the cleaning process along with samples of the visual inspection results are provided. Inspection of the first support plate, which was a repeat of an inspection done in 1997, was conducted along with an in-bundle inspection of the upper tube supports. Results are p

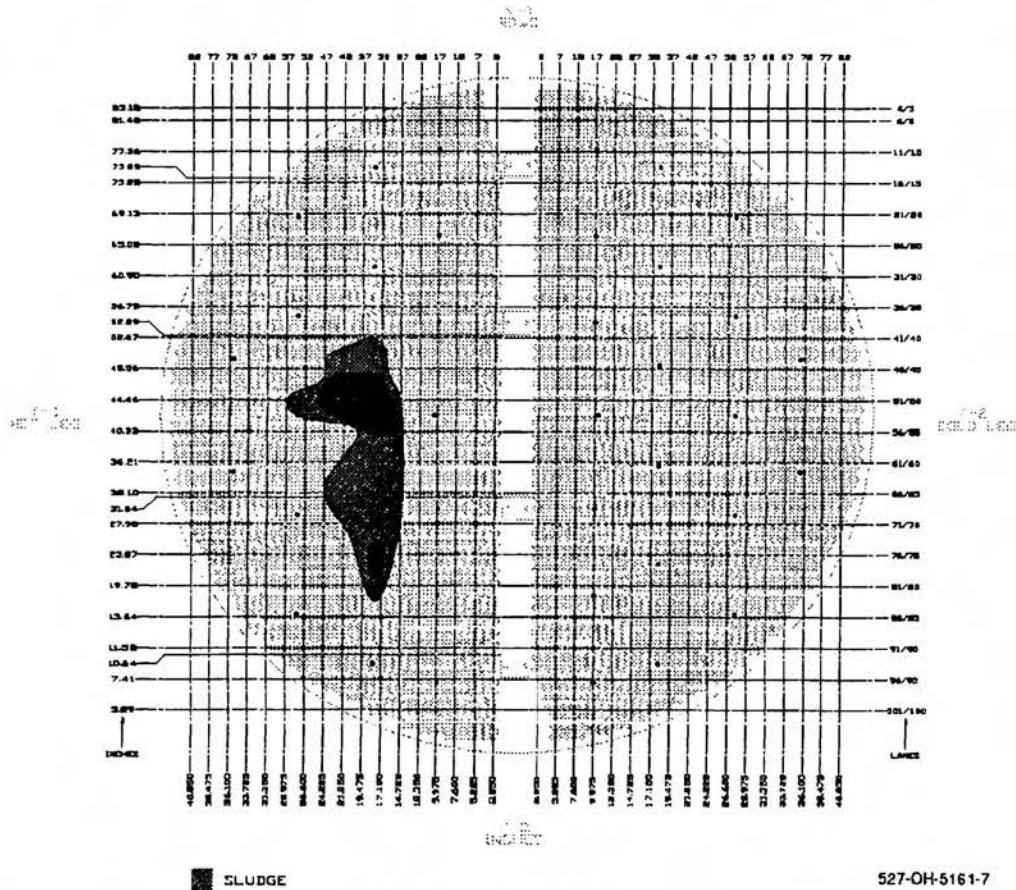
The post barrel spray [after Step 1 but before Step 2] waterlancing inspections found the "hot leg" region of the tubesheet was similar in all boilers. Hard sludge deposits approximately 1/2 in. to 1 in. high remained in a central portion of the tubesheet (see maps). These deposits were located at an approximate depth of 14 in. to 20 in. into the tube bundle from the no-tube-lane, and from 27 in. to 41 in. from the handhole. These deposits were subsequently removed by the [Step 2] hard sludge lancing process. Scale (or collars) still remains on the tubes in this area.

At the completion of high-pressure water lancing final condition maps of remaining tube scale are made. At Gentilly the tubesheet surface was exposed in all areas of the steam generator. Areas where tube scale was observed to remain is recorded on Tubesheet

Figure 7. Tubesheet map of final condition. The large area is the footprint of the sludge pile after barrel spray flushing. The smaller dark area records areas of tube with scale "collars" remaining

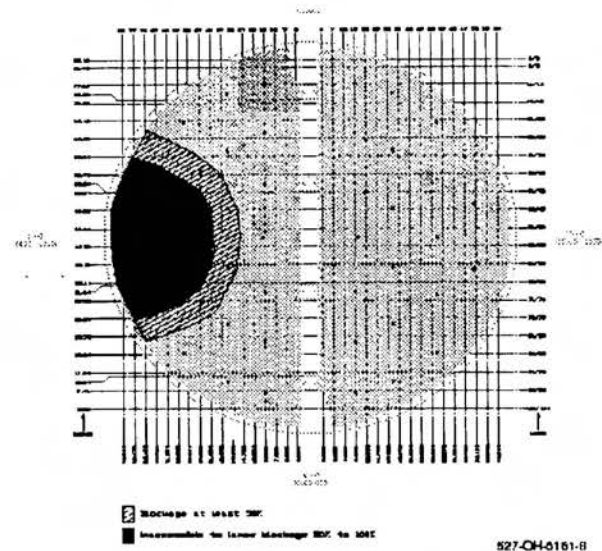
The upper bundle inspection using a CECIL® lance and fiberscope achieved good quality video records of the tubes and broach support condition. Visual observation identified that plugging is occurring in the support plates at this elevation.

Scale deposits (fouling) on the tubes made progression of the lance along the tube lanes very difficult. In a large part of the bundle the lance could only move approximately 24 in. along the lane from the NTL. At this depth the broach flow lobes were observed to be significantly blocked and many were closed.

Figure 8 records the blockage observed at the top support plate.

Plugging of the tube support flow holes is significant and may cause a number of possible detrimental impacts on steam generator life. Potential impacts that should be examined further include:

1. Reduced steam generator circulation. Blockage of the supports will add resistance in the two-phase riser section of the steam generator.
2. Water level instability (water level oscillations directly attributable to support plate blockage occurred at OPG's Bruce A Units). If water level

Figure 8. Plot of support plate #9 flow blockage

oscillations begin the only remedy to control oscillations is a power reduction or cleaning.

3. Tube lockup in the tube supports. Due to the difference in thermal expansion coefficient between the carbon steel steam generator shroud and the Incoloy 800 tubes the tubes must slide relative to the support plates during heat-up and cool-down. This effect is much more pronounced than in an I600 tube steam generator [Bruce A]. If the tube is locked it will bow as well as seeing higher stresses at the support.

Bowing of the tubes may be the reason why the lance was not able to pass through the tube bundle.
