# PRIMARY SEPARATOR REPLACEMENT FOR BRUCE UNIT 8 STEAM GENERATORS

## ABSTRACT

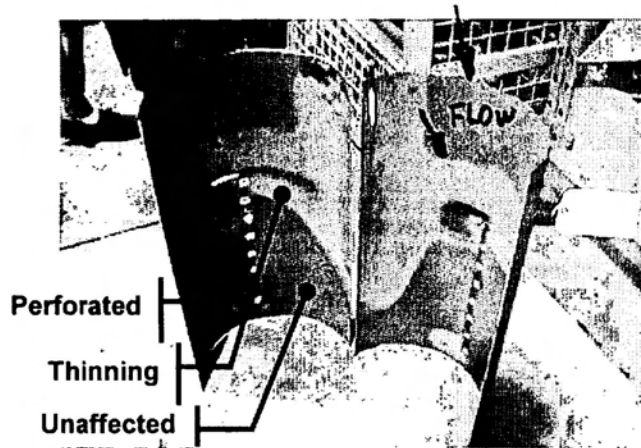
The degradation was first noticed in the removable primary separators on BO 3 and BO 8 of Unit 8. Erosion damage was observed to be primarily in the outershell and the internal flow baffles in the region where these internal flow baffles or scoops (Figure 3) direct the flow from the annulus into the inner separation chamber. Through wall perforations were found in the outer cans of four of the eight separators (Figures 4 and 6). In situ inspection of the fixed separators confirmed the damage extent to be about 90% and 100% perforation in BO 3 and BO 8 respectively. The secondary separators were not damaged. One separator was disassembled and the outer and inner cans were removed for detailed examination (Figure 4). Metallographic examination, thickness survey and visual inspection were carried out on the removed sections.

Figure 3  
GXP Separator— Outer Can Removed to Show Inner Flow Scoop.

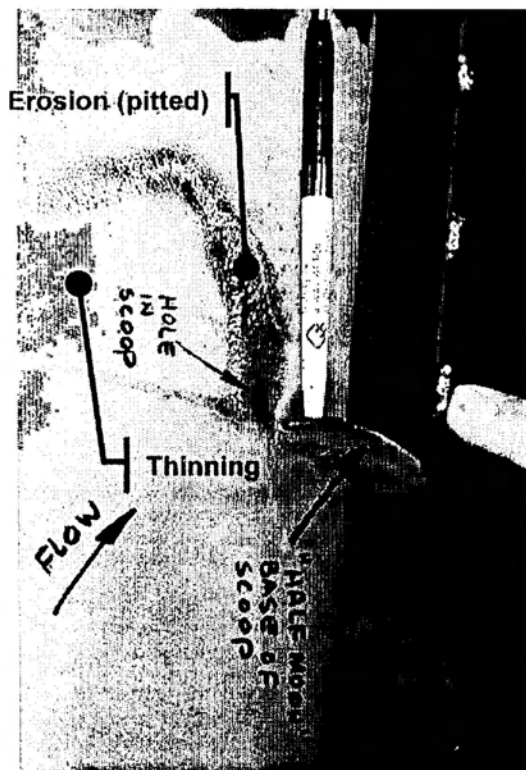
In the outer can there was a wall loss up to 40% in the area above the perforation and less than 20% in the area below. At the vertical weld seam, about 60% wall loss was seen.

Figure 4  
GXP Outer Can – Removed to Show Thinning and Perforations (Can is Inverted).

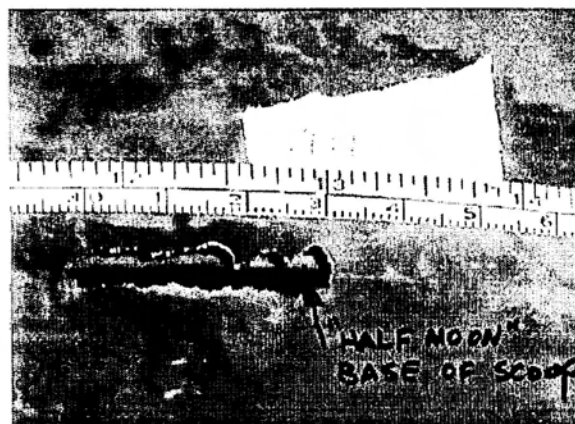
Perforations were also seen in the inner can, generally at points across the flow passage from the holes in the outer can (Figure 5). In general, the inner can also showed dimpled surface and polished areas. The outline of the circumferential weld joining the two halves of the inner could be seen in the sectioned inner can.

The inner can showed an average wall loss of 60%. The lower section was made from different plate. It was found to have slightly higher chromium and manganese and showed a lower rate of erosion.

Figure 5  
GXP Separator— Inner Can and Scoop Showing Thinning and Perforation.
