Fuel Experience in QinShan CANDU

Mingjun. Chen

Third Qinshan Nuclear Power Company Ltd,

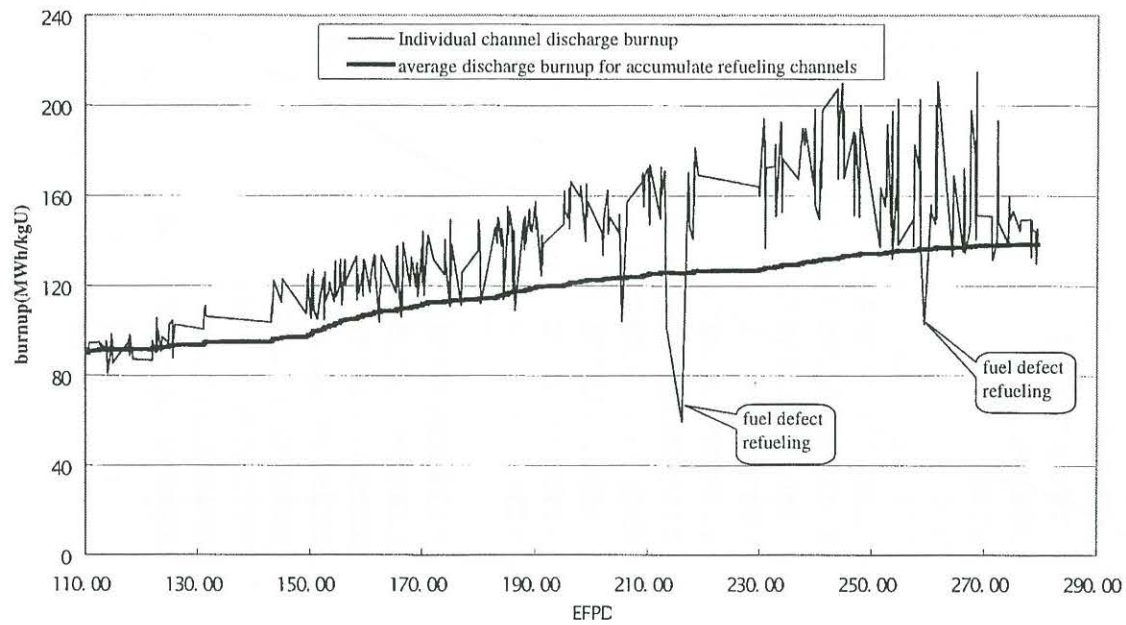
Figure 4 Defective Fuel Channels Display

From June to now, 5 channels (P08, S10, G17, P12 and M15) as shown in figure 4 were found to contain fuel defects in Qinshan CANDU Unit1. They were confirmed by GFP system and FFL system and refueled on time. During discharging all defective fuel bundles, the maximum activity concentration of Xenon 133 (figure 6) detected by GFP was lower than 20 MBq/kg, and no Iodine 131 apparently in the core.

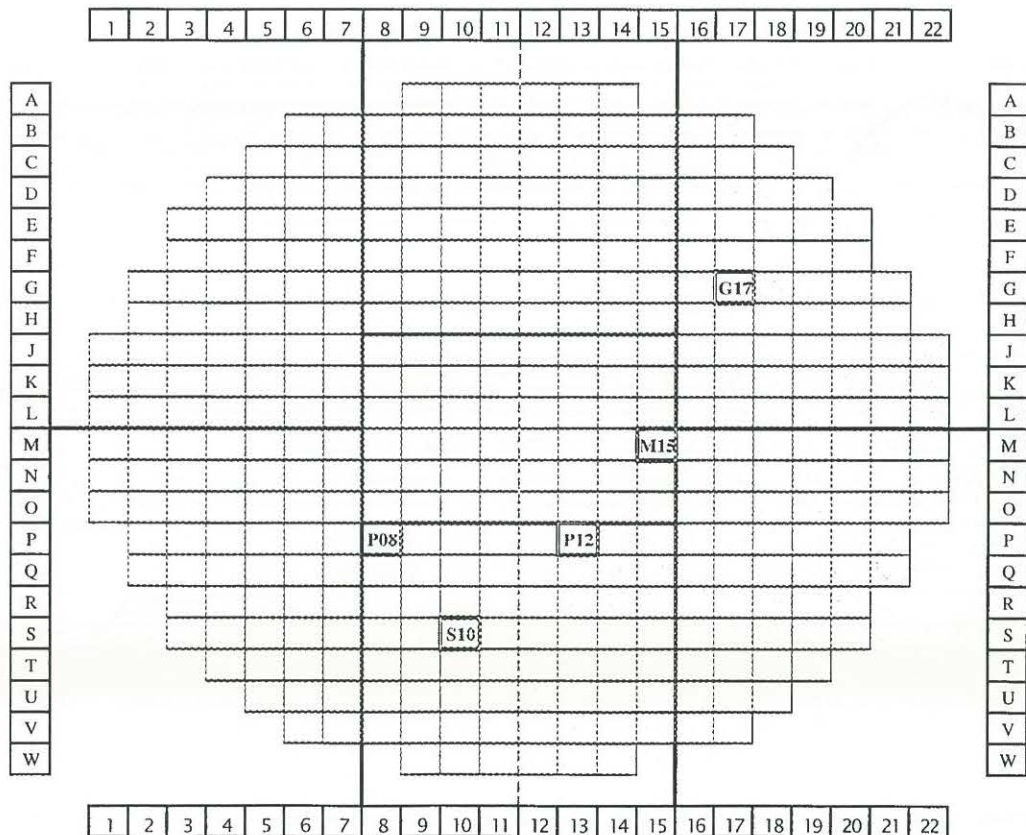
Figure 5 History Trend of DN Count Rates in Qinshan CANDU

In July 2003, activity concentration of Xe-133 increased to a high level of 3MBq/kg due to refuel of a channel contained a defective fuel bundles. It was fortunate that FFL system could identify the suspect channels (figure 5), whose count rates of delayed neutron increased much higher than the other channels and the DR values increased, too.

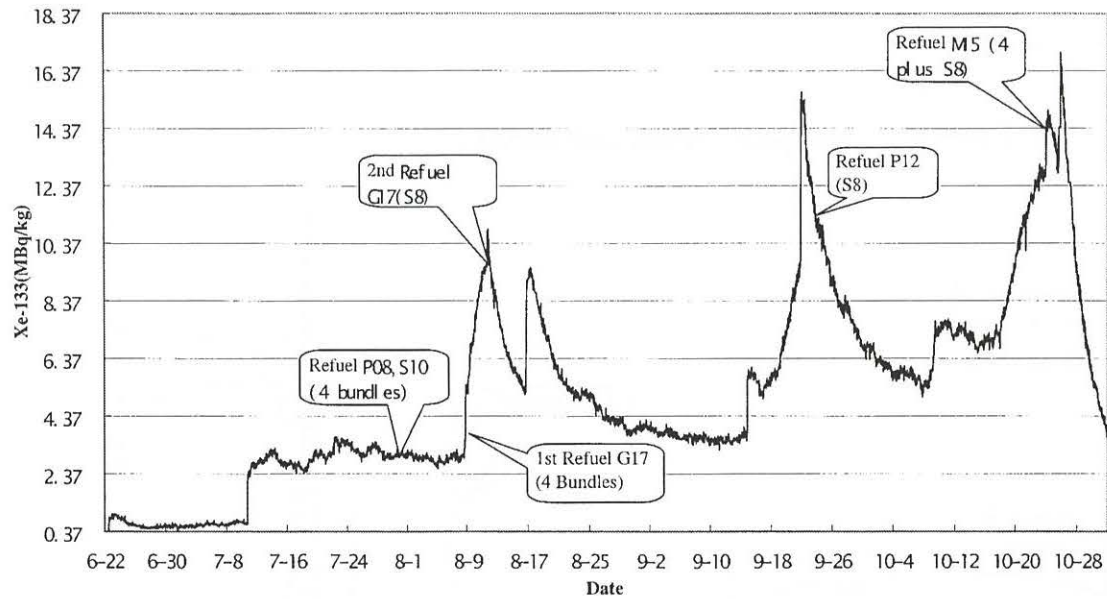
Figure 7

TQNPC successfully located the position of defect bundle by GFP and FFL and Gamma Monitoring System. During refueling, we can easily confirm whether defect fuel has been taken out, based on analysis of history data and trend for GFP and delayed neutron and Gamma dose in R012, R013, R014 and R001 (figure 7,8). During discharging spent fuel in discharge bay room (R001), we monitor Gamma trend in R001 in order to locate which pair of bundle is defective. A few days after spent fuel discharged in R001, further investigation was taken to identify the exact position of defect bundle from the pair of fuel bundles, which have been confirmed defect during discharging. The two bundles have been back transfer (out of and into the water in discharge bay) in order to monitor the Gamma trend in R001. In all the defective fuels bundles, ZPI fabricated three and domestic manufacturer fabricated the others. All fuel defects occurred to the lower power bundles.

Gamma dose in R-001 during P08 refuelling

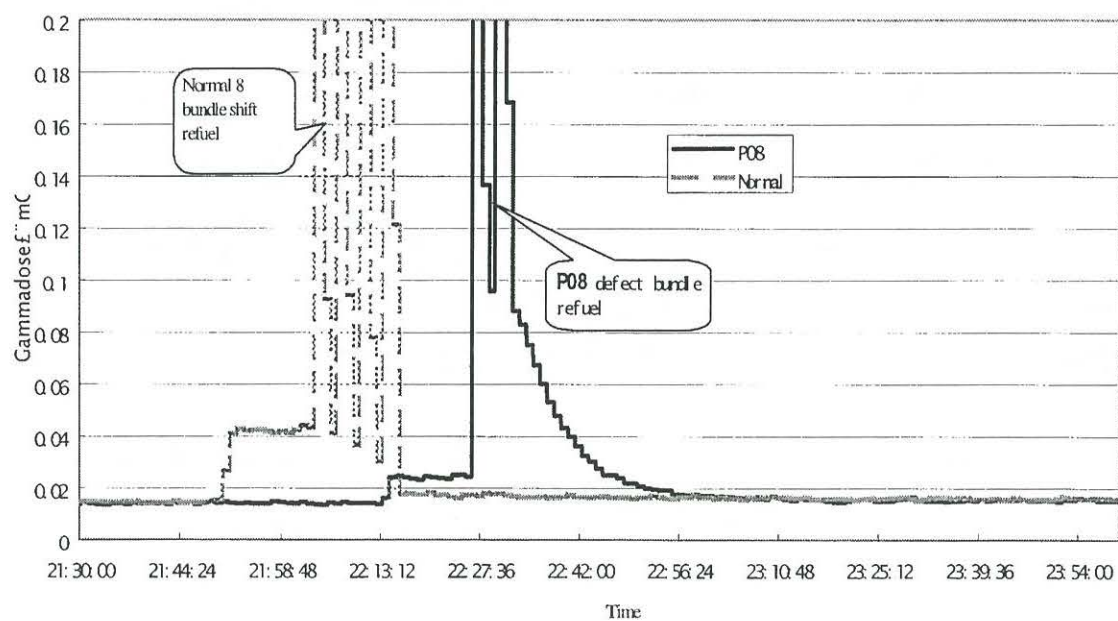
Figure 8

Gamma dose monitored in R-012/013/014
