## **Bruce B Fuelling-With-Flow Operations: Fuel Damage Investigation**

A.M. Manzer\*, D. Morikawa\*\*, A.J. Hains\*\*\*, W.M. Cichowlas\*\*\*, J.G. Roberts\*\*\*\*  
And J. Wylie\*\*\*\*

\*CANTECH Associates Limited, \*\*Atomic Energy of Canada Limited, \*\*\*Nuclear  
Safety Solutions Limited, and \*\*\*\*Bruce Power

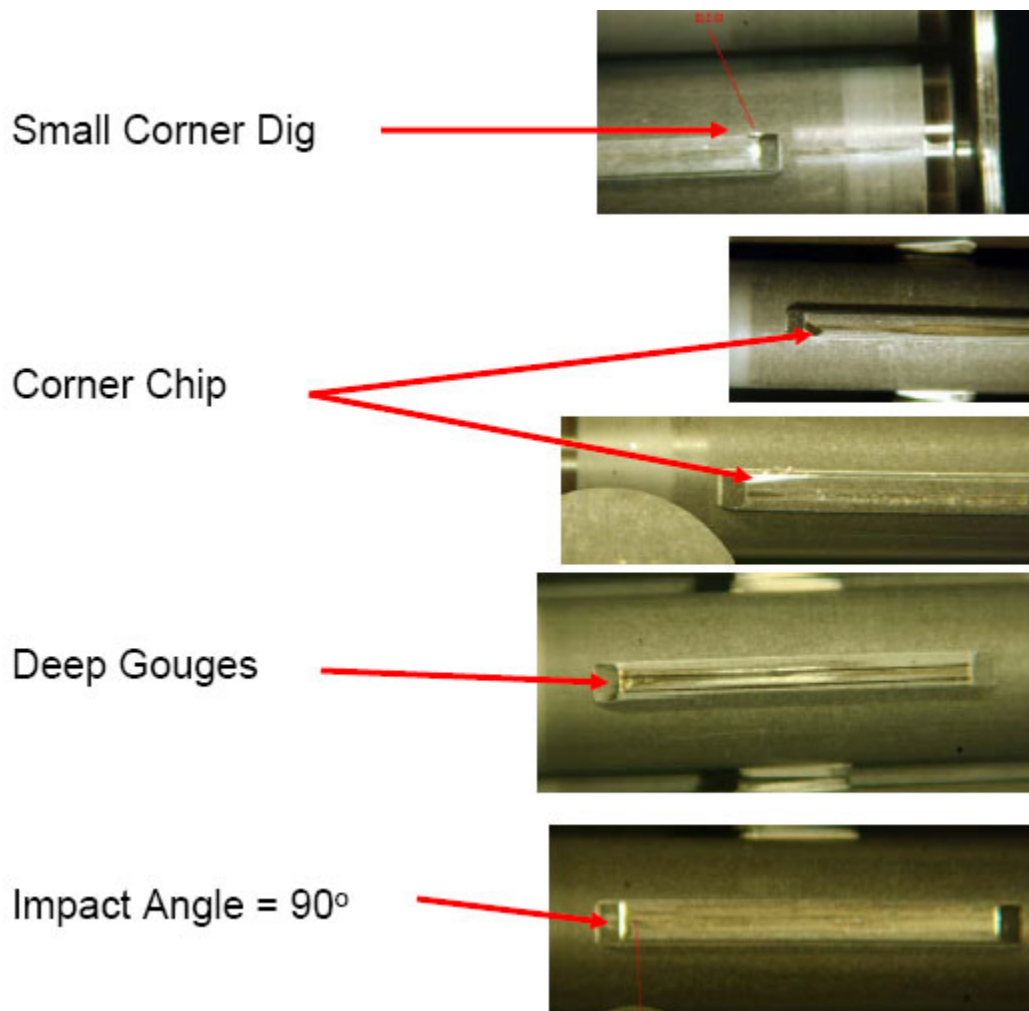
FIGURE 1: BEARING PAD DAMAGE CATEGORIES

There were 47 bundles with mechanical damage to 117 bearing pads (about 2.5 bearing pads per bundle). Of these bundles, 44 were discharged using FWF and flow defuelling operations. Both operations involved discharging irradiated bundles, two at a time, through the latch, and into the fuel carrier parked at the downstream endfitting. The downstream bundle in each pair had

almost three times the damage as the upstream bundle and 50 per cent of all bearing pad damage for both bundles occurred at the centre bearing pads which represents one third of all pads.

Generally, there were four bearing pad damage categories identified, see examples in Figure 1:

- small corner dig or small nicks on one side of the bearing pads near its bearing surface;
- corner chip same location as above, but bearing pad material appears to have been removed.
- impact angle 90° scraping or material loss across the leading edge of the bearing pad near its bearing surface.
- deep gouges or scrapes along the entire bearing surface of the bearing pads.

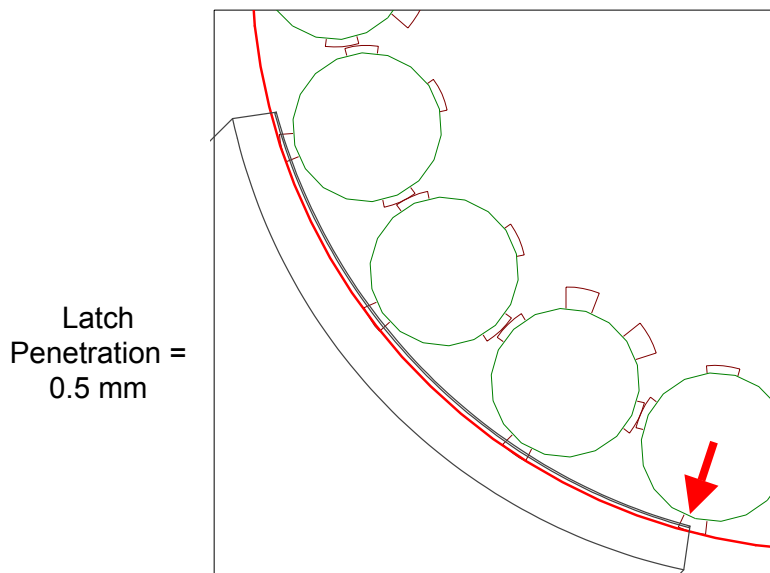
FIGURE 2: AXIAL VIEW OF BOTTOM LATCH FINGER PARTIALLY OPEN SHOWING POTENTIAL INTERFERENCE WITH BEARING PADS

- Theory 1 The bearing pads were nicked by the latch fingers that were not completely opened by the carrier nosepiece (see Figure 2 and 3a),
- Theory 2 The bearing pads were impacted on the carrier nosepiece which was not completely inserted or was tilted while parked inside the latch cage (see Figure 3c), and
- Theory 3 The bearing pads were scraping along the latch cut out (see Figure 3b).
