## ANALYSIS OF THE PRESSURE TUBE FAILURE AT

## PICKERING NGS "A" UNIT 2

G.J. FIELD\*, J.T. DUNN\*\*, and B.A. CHEADLE\*\*\*

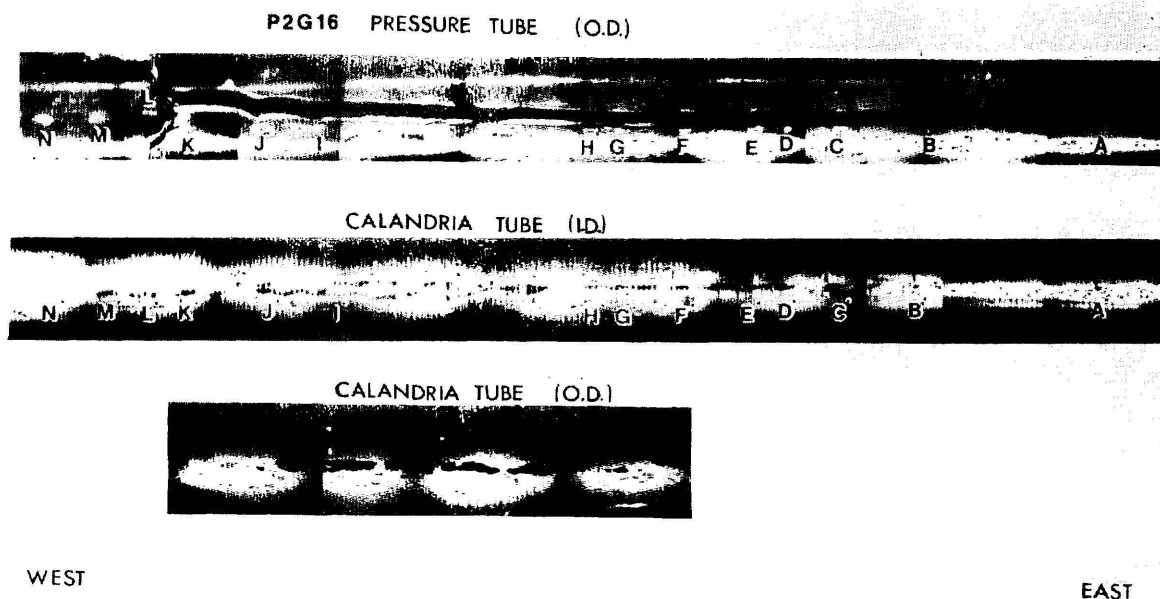
FIGURE 1: BLISTERS ON EAST OUTLET SECTION OF P2 G16 PRESSURE TUBE  
AND CORRESPONDING CONTACTING SECTION OF CALANDRIA TUBE

The examination of the outside of the pressure tube began with a close inspection using a Questar Telescope through 12 feet of water in the fuel bay at CRNL. This was the first time the actual extent of the crack could clearly be seen. The crack was very long extending from just inside the rolled joint to a point about 2 metres along the tube (approximately the design location of the outlet garter spring). It ended at this point in a T configuration of two circumferential tears from the axial crack. Parts of the fracture surface could be seen which showed a radial crack in many areas but developing into a ductile failure towards the outboard end of the crack. Near the T of the crack several dark round marks could be seen which were unexpected. About 14 of these were seen in the zone from about 1.5 metres to 2 metres from the outlet end of the pressure tube. The marks and the crack can be seen in figure 1 along with the inside and outside of the calandria tube which is discussed later.

Examination of the inside of the tube revealed dark marks which correlated with the marks on the outside surface of the pressure tube and confirmed that the two tubes had been in contact, figure 1.

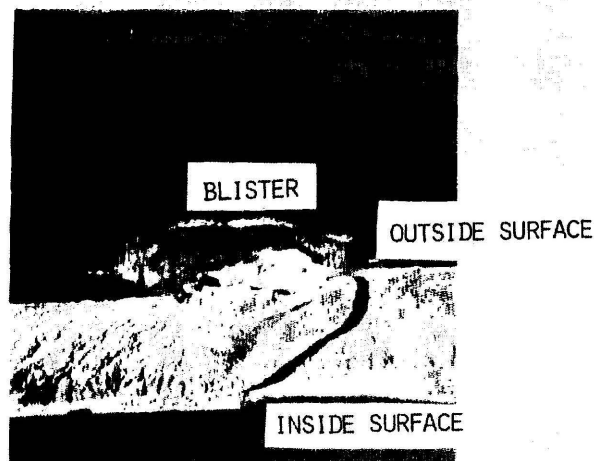
When the tube was cut lengthwise to allow closer examination the unexpected marks were seen to extend into the pressure tube wall and at the outside surface of the tube had the form of a small crater. For want of a better name they were called blisters. Fourteen clearly identified blisters could be seen together with a fairly large dark patch (later shown to be a concentration of zirconium hydrides near the outside surface of the tube). Figure 2 shows a typical blister before sectioning. The brittle nature of the material in the blister can easily be surmised. The crack ran through several of the blisters but in only one case did it pass through the middle of the blister.

FIGURE 2: TYPICAL BLISTER AT FRACTURE SURFACE

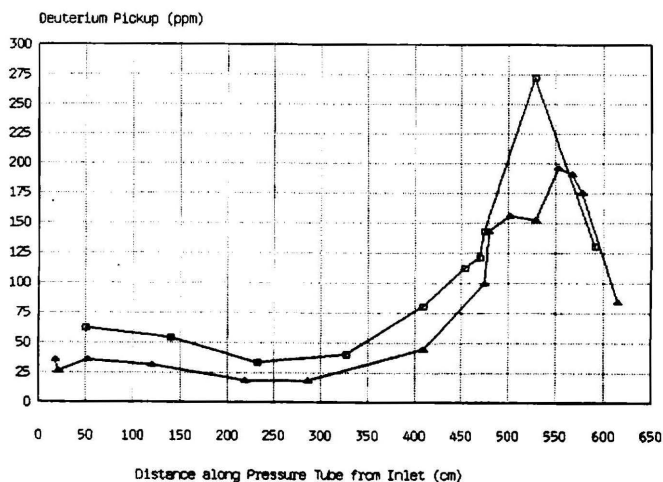
Figure 4

FIGURE 4: DEUTERIUM CONCENTRATIONS IN ZIRCALOY 2 PRESSURE TUBES FROM PICKERING UNITS 1 & 2

The peak in oxide thickness and deuterium level at the outlet of the pressure tubes appears to have arisen from an enhanced corrosion rate which started when the oxide reached a thickness of about 15-20 microns. In effect the local environment within this thick oxide, where the corrosion process was occurring, assumed the worst characteristics of both reducing and oxidizing chemistries and appeared to be independent of the bulk chemistry of the primary heat transport system.

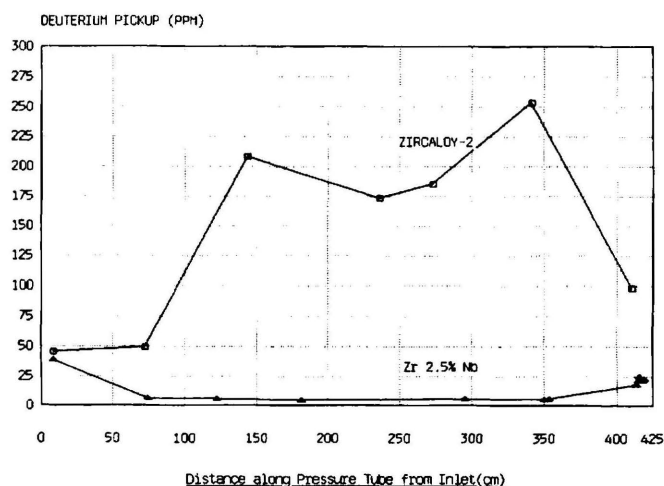
The results were very encouraging for zirconium niobium as can be seen in figure 5. The Zircaloy 2 tube appeared to behave in a similar manner to those in Pickering "A" units 1 and 2 whilst the deuterium level was very low in the zirconium niobium tube - a maximum of 5 ppm.

FIGURE 5: DEUTERIUM CONCENTRATIONS IN ZIRCALOY 2 AND Zr 2½Nb TUBES FROM NPD

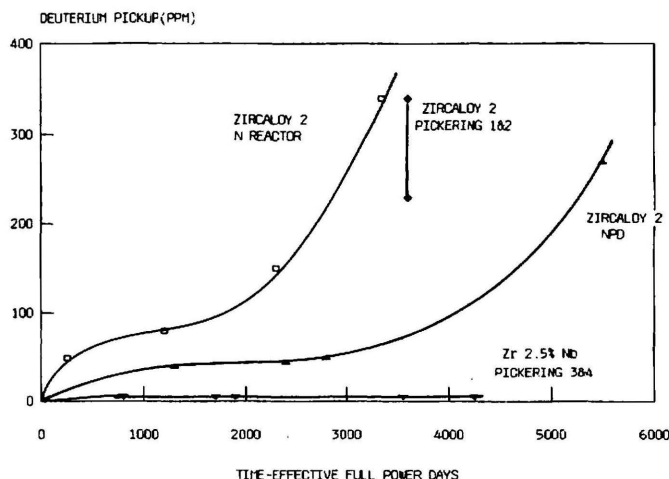
This pressure tube had been in contact with the calandria tube for about 4 years and early visual examination of the tube showed evidence of this. The results confirm the data from the Bruce 2 and NPD zirconium niobium pressure tubes in that the deuterium concentration was again approximately 5 ppm along the length of the tube. Metallography of the contact area revealed no signs of hydride concentrations. The deuterium pickup rate for several pressure tubes is illustrated in figure 6.

FIGURE 6: DEUTERIUM PICKUP RATES FOR ZIRCALOY 2 AND Zr2½Nb PRESSURE TUBES FROM DIFFERENT REACTORS
