## **EVOLUTION OF MANAGEMENT ACTIVITIES AND PERFORMANCE OF THE POINT LEPREAU STEAM GENERATORS**

**John Slade, Janice Keating,  
NB Power Nuclear  
Tracy Gendron,  
Atomic Energy of Canada Ltd.**

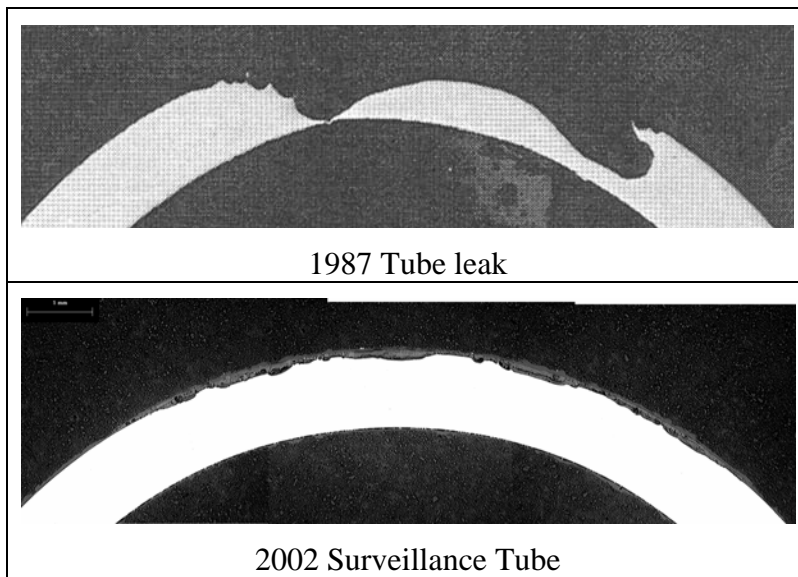
In the early years of operation, there was a significant amount of unplanned maintenance resulting from steam generator tube degradation. Fretting and localized corrosion has led to six tube leaks (1985, 1987, 1992, 1994, two in 1996), two unplanned outages (1994, 1996), and plugging of about eighty tubes. Pitting or phosphate wastage has occurred in thirty-one tubes caused by aggressive chemistries developing beneath fouling deposits and exacerbated by aggressive impurities introduced during condenser leaks. Figure 2 (top) shows a metallographic cross section through the pitted region that caused the tube leak in 1987. This pit was under fouling at the hot leg first support plate and was associated with mechanical damage on the tube surface. PLGS pitting has often shown undercutting as in Figure 2, and has been attributed to the local presence of copper and chloride ion.

**Figure 2: Tube Pitting at Fouled First Support Plate that Led to 1987 Leak (top) and Tube Removed for Surveillance in 2002 showing an Indication of Arrested Phosphate Wastage (bottom)**

- Early 1990's - The sodium/phosphate ratio was optimized to minimize the development of the aggressive underdeposit environment that was considered to be the primary cause of the observed tube wastage.

- 2000 - Changed from congruent phosphate treatment to all-volatile treatment (AVT) due to concerns over continuing phosphate wastage.
- 2000- Full flow condensate polishing was suspended and only put in service during full power operation in the event of condenser leakage. Condensate polishing is still performed during start-up to remove feedwater impurities and to reduce iron transport.

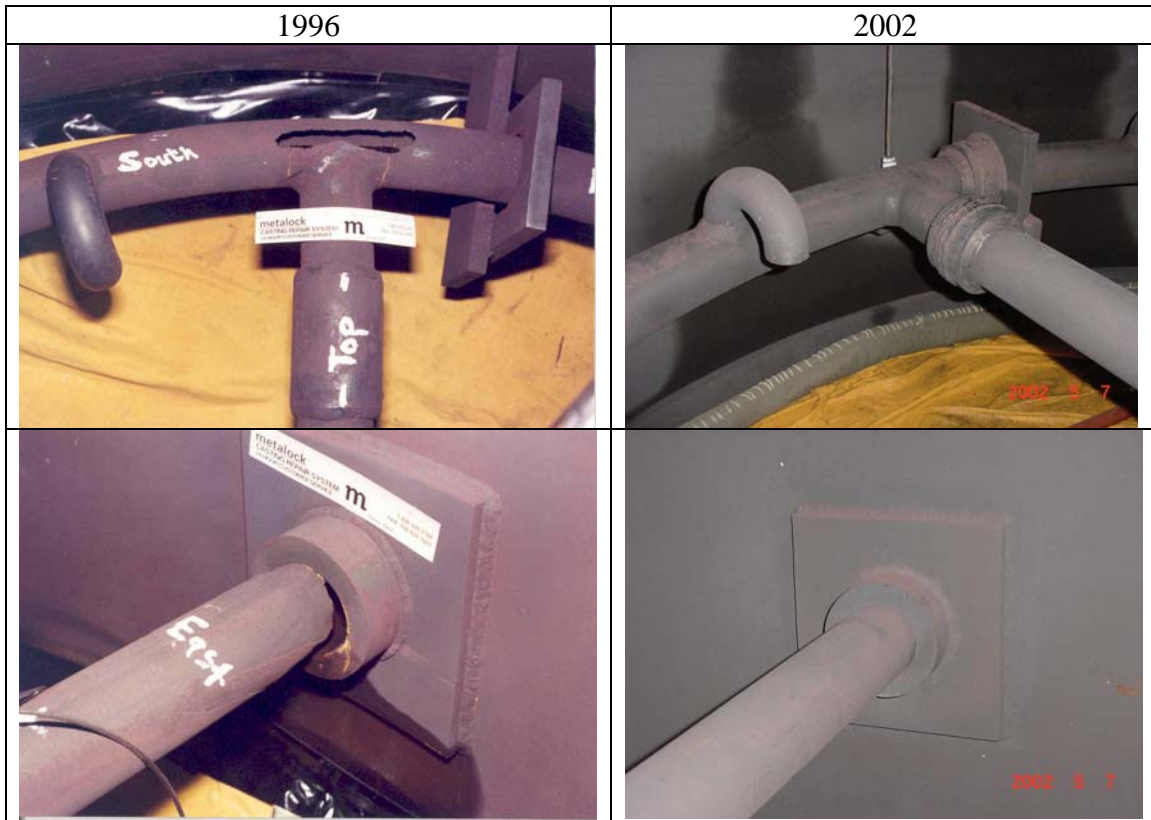
Severe FAC degradation of the EWS header and J-tubes led to their replacement with more resistant Cr-Mo steel in 1996. FAC from the inside surface caused perforation at the T-joint and several J-tubes to break off. FAC on the outside surface at the low clearance gap with the thermal sleeve also led to perforation. Figure 3 shows this FAC damage to the original header in 1996 and the good condition of the same locations of the replacement header in 2002.

**Figure 3: FAC Damage to the EWS Header T-joint (top) and Thermal Sleeve Connection (bottom) in 1996 and the Good Condition of the Replacement Header in 2002**

- As discussed in section 3.3, steam generator internals that have experienced severe FAC (EWS header and primary side divider plate) have been replaced with a more corrosion resistant design. Subsequent inspections have shown no significant degradation of the replaced components.
- Between 1986 and 1990, secondary side carbon steel piping significantly affected by FAC was replaced. Those components with the highest FAC rates in the extraction steam, heater drains and vents, reheater steam, and steam drain systems were replaced with austenitic stainless steel or in a few cases, Cr-Mo steel.

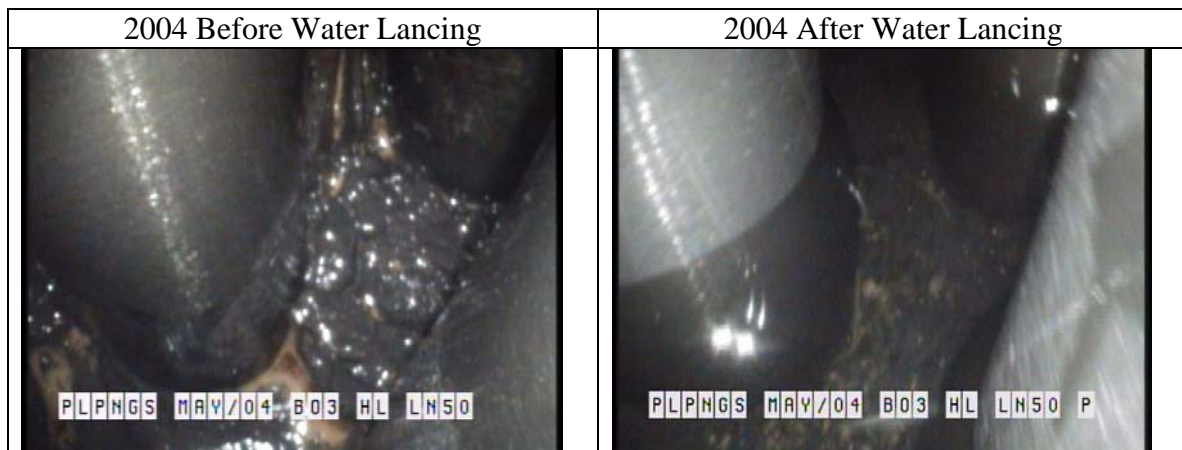
- Secondary side tubesheet water lancing has been performed on one or more steam generators during outages in 1987, 1991, 1992, 1993, 1995, 1999, and 2004. Figure 4 shows the deposit removed from the steam generator 3 tubesheet hot leg by water lancing in 2004, after five years accumulation. Water lancing of all four steam generators is planned every four years in future.

**Figure 4: Hot Leg Tubesheet Deposits Before and After Water Lancing in 2004**

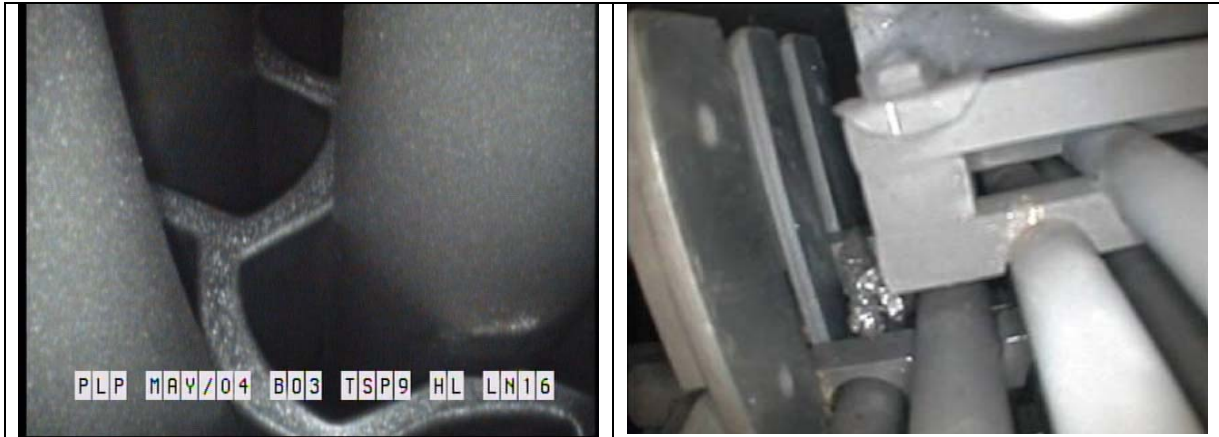
Eddy current inspections of tubing and secondary side visual inspections indicate that the fouling rate of upper tube supports has also been reduced by these activities. Tube inspections in 2006 continue to show that broached hole blockage has not re-occurred. The visual inspection images in Figure 6 shows how clean the hot leg broached holes and upper tube supports were in 2004 and 2006, respectively, a decade after chemical cleaning.

**Figure 6: Visual Inspection Images Showing Lack of Fouling in the Upper Bundle**  
**Left) hot leg broached holes in support 9 in steam generator 3 in 2004**  
**Right) U-bend scallop bar supports in steam generator 4 in 2006**
