## **MAINTENANCE AND LIFE ASSESSMENT OF STEAM GENERATORS AT EMBALSE NUCLEAR STATION**

**Pablo Luna, Gustavo Díaz, Hugo Sveruga, Ricardo Saínz,  
*Embalse NGS***

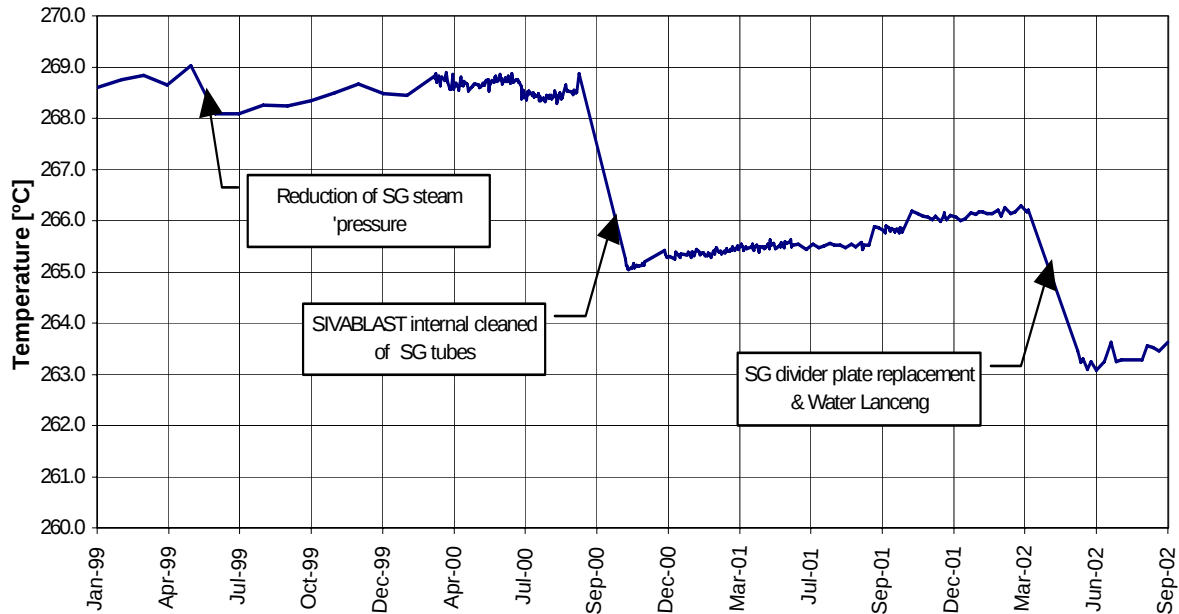
Figure 2: Average Reactor Inlet Header Temperature

Any reduction in SG thermal performance is reflected by an increase in the average temperature of the PHT system and in particular, an increase in the Reactor Inlet Header (RIH) temperature. Loss of heat transfer efficiency at Embalse SGs was caused mainly by three separate aging mechanisms which are described in the following paragraphs, *tube surfaces Fouling* (inner and outer), the pass trough between legs of primary coolant due to *erosion of the divider plates* (old design) and the *tubesheet sludge pile accumulation*.

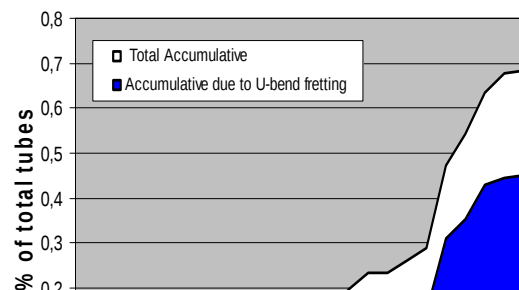
Figure 3: Accumulative tube plugging trend

The first signs of U-bend defects on tubes were detected by EC inspections in 1991 in SG#1 but rapid fretting damage in the cold leg side of the U-bend region has been experienced by SG#1 and SG#3 since 1996. The fretting damage is the main cause of tube plugging and has caused several tube leaks and forced outages (Table 3 and Figure 3)

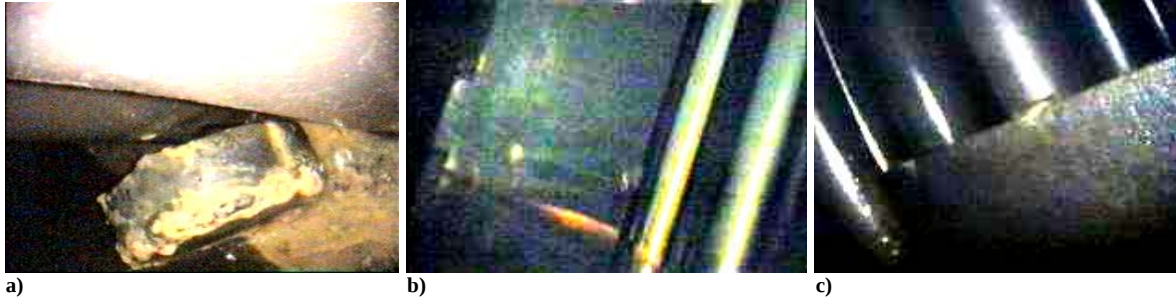
Figure 5: Foreign objects in SG#1

of 74% on the cold leg side near the tubesheet appeared and developed during a three years operation period. Later on in 2004 an indication in tube X51-Y06 also on the cold leg near the tubesheet was detected and still being monitored. The LA-frame visual inspections performed in 2005 (described in later section) confirmed that those indications were caused by a foreign object deposited on the cold leg side of the tubesheet adjacent to tubes X17-Y24 and X51-Y06 (Figure 5, a) At present the origin of the object is unknown and actions have been taken to extract the object during the next scheduled outage.

The second confirmed case occurred in 2003 when the plant had to be shut down because a leak in SG#1. The damaged was in tube X03-Y56 and the EC inspection detected the defect on the hot leg side near the tubesheet, also tubes X02-Y57 and X02-Y55 were preventively plugged due to indications in the same region. Visual inspections performed in 2004 confirmed a metal-sheet-type foreign object of about 8"x 8"x1/8" jammed between the damaged tubes (Figure 5, b and c). At present the origin of the object is also unknown and an extraction procedure that will be implemented in the next scheduled outage has been developed. Because its size, extraction of this object is complicated because requires cutting-off operation inside the SG but is no urgent because it seems to be stacked between plugged tubes only.

| ARDM | Comment on corrective actions | Morphology | |
|---|---|---|--|
| Foreign object damage at tubesheet level | Extraction is planned for the next outage and to include a Foreign Object Exclusion program in the ISI is recommended in the SG LA report. | Figure 5, a | |

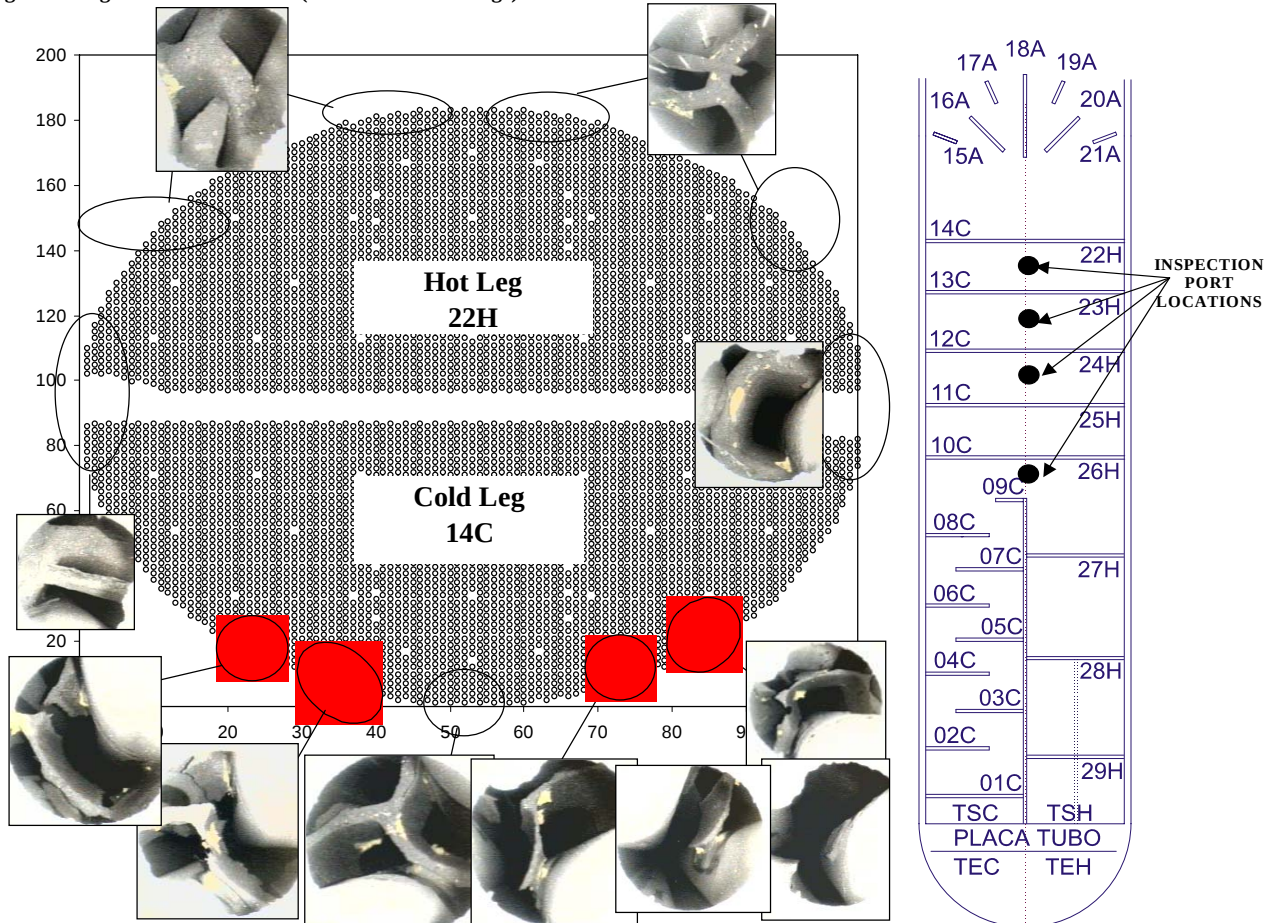
Figure 6: Degraded TSP 14C-22H (2004 scheduled outage)

During the scheduled outage of 2004 visual inspection of the U-bend region of the four SGs was performed after the AVBs installation in order to detect any foreign object from the activity. Because of TSP FAC degradation noticed trough COG, an unplanned visual inspection of the upper TSP (14C-22H) was carried out. The results showed signs of advanced FAC degradation and even ligament breach on the periphery of the Cold Leg side (Figure 6)

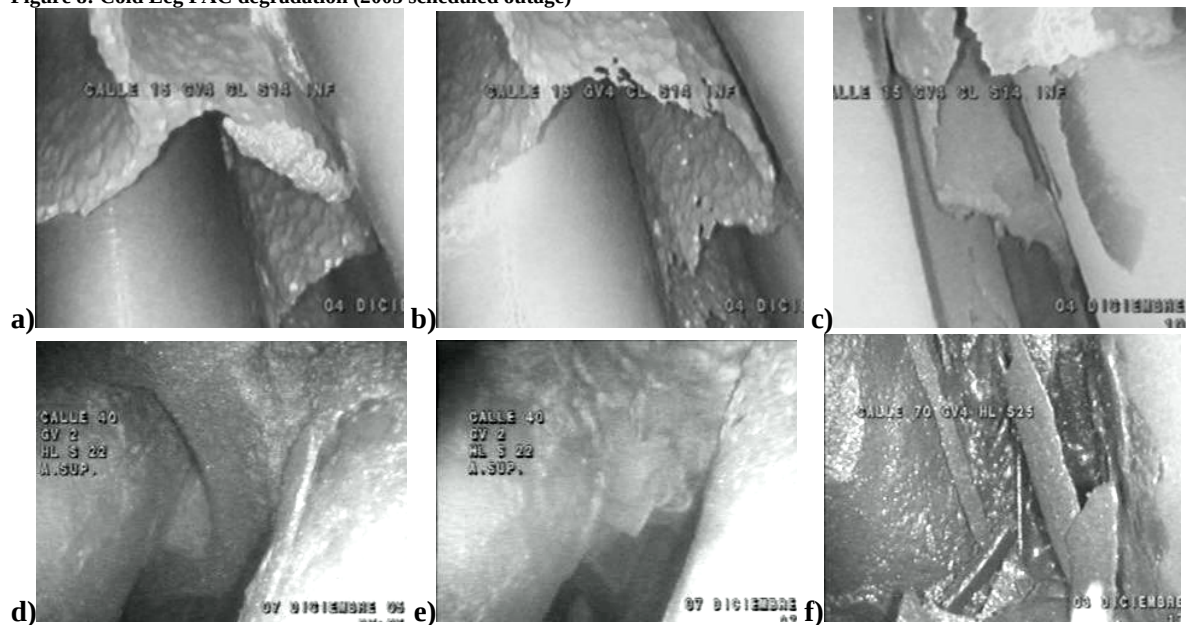
Figure 8: Cold Leg FAC degradation (2005 scheduled outage)

The inspections showed that the TSPs are degraded. In particular, the ligaments between the broach plates are thinned and in some cases breached in the cold leg region (Figure 8 a, b and c). Material is missing from the TSPs, particularly at supports 14C (most severe degradation), 13C, 12C, 11C, and 10C (progressively less degraded). The TSP conditions in terms of thinning and breaching has been characterized jointly by Atomic Energy of Canada Limited (AECL) and NASA from the EC data (Ref. 2).

At the same time, fouling deposits were observed on the hot leg TSPs. At some locations, sufficient deposits were present to classify the broach holes to be partially or completely blocked, e.g., in supports 29H, 27H, 26H, 25H, and 24H (Figure 8 d, e and f).

- ii) *Water chemistry conducive to FAC*: Specification for the pH-controlling amine concentration was low; MPH, the amine used for pH control is suboptimal (another amine could provide a higher  $pH_T$  in the SG);
- iii) *Suitable thermo-hydraulic conditions*: relatively high flow velocity on the SG cold leg, caused by a partial blockage of the broach holes by fouling deposits at the SG hot leg, due to heavy localized fouling of TSPs.

At present urgent corrective actions to assess TSPs FAC in order to keep safe operation and minimize degradation up to the end of the design life are being to be implemented and considered:

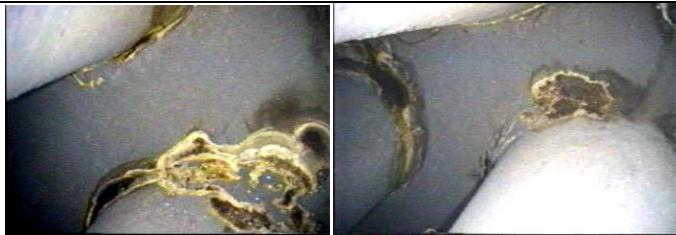
| ARDM | Comment on corrective actions | Morphology | |
|---|---|---|--|
| Pore indication in an old tube plug weld | A 100% of the tube plug welds are being included for leak inspection and monitoring. | | |
| Possible corrosion at the thermal plate-tube gap | In depth X-probe EC inspections are planned for the next scheduled outage in order to determine if there is any degradation on the tube surface. | | |

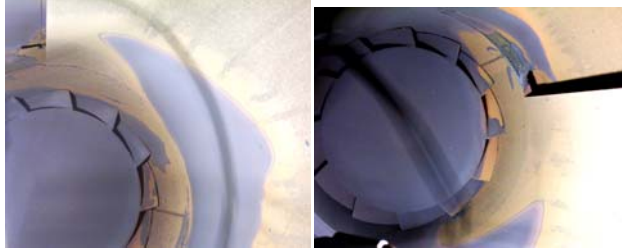
| ARDM | Comment on corrective actions | Morphology |
|---|---|---|
| Possible FAC in primary cyclones | Thickness measurements and metallographic surface characterization are planned for the next outage in order to identify the degradation. | |

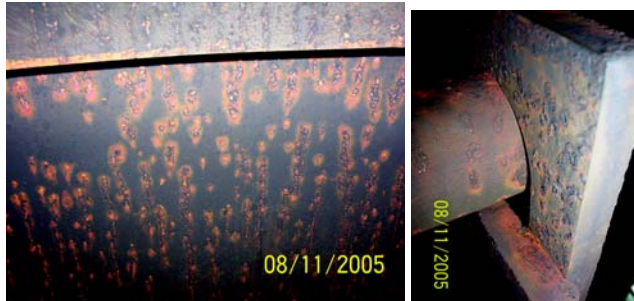
| ARDM | Comment on corrective actions | Morphology |
|---|---|---|
| Possible pitting at the EWS header level region | This ARDM doesn't seem to be a critical issue, but samples for chemical composition analysis have been taken anyway. | |

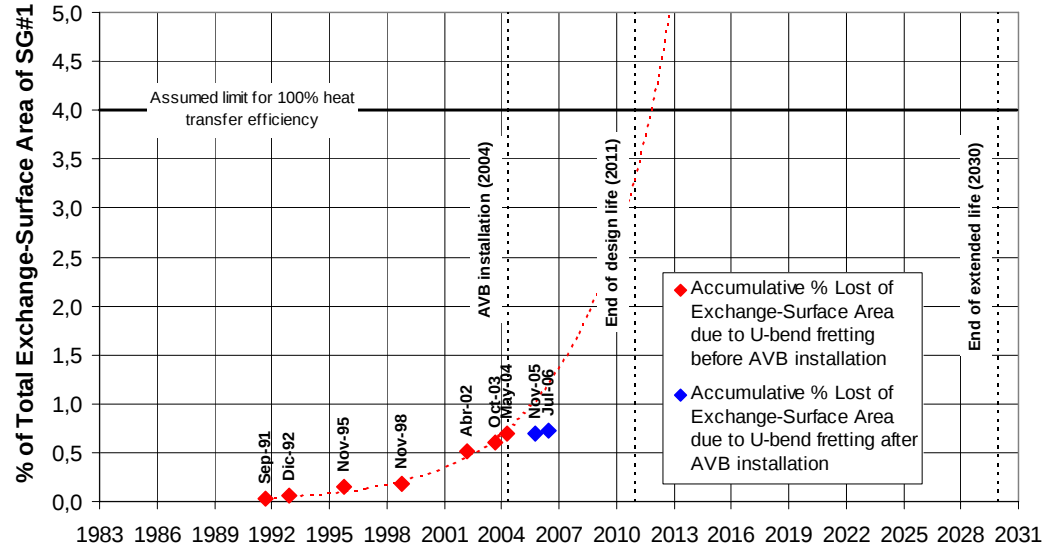
Figure 11: Tube U-bend fretting evolution in SG#1

The efficiency of the new supports is currently being monitored by vibration measurements on the shell of the SGs at the U-bend height and by tracking of tube plugging. Currently, vibration condition was reduced by 40% in average and an incipient decrease of the exchange-surface area loss rate due to U-bend degradation tube plugging in SG#1 has been detected (Figure 11)

The scallop bar FAC and tube fretting at the U-bend is one of the important ARDM that caused most of the tube plugging. The exchange-surface area loss due to this mechanism has been tracked, and showed a critical rate from the point of view of life extension in SG#1 (Figure 11). Fortunately since the corrective action has been implemented (AVB installation) an average improvement of 40% of the vibration condition has been obtained and an incipient decrease of the exchange-surface area loss rate has been detected in SG#1(Figure 11) It is preliminary concluded that the rate will still decrease allowing to postulate that this ARDM wouldn't be a life-extension limiting. Have to be taken into account that Loose Part Damage due to broken scallop bars could compromise this conclusion if it becomes an issue and more EC inspections have to be performed before to confirm the mitigation of the U-bend fretting.
