REGULATORY ACTIVITIES ON STEAM GENERATOR TUBES IN KOREAN NUCLEAR POWER PLANTS

Myung-Ho Song, Ho-Sang Shin, Suk-Chull Kang,
Korea Institute of Nuclear Safety

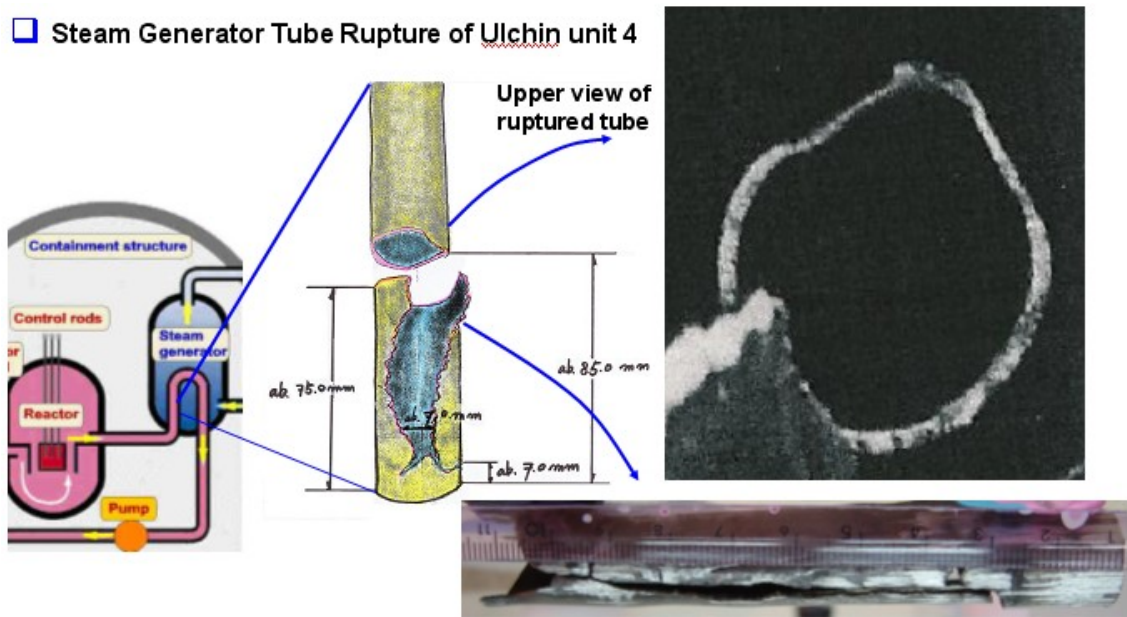
Figure 1 Failed tube of Ulchin unit 4

On April 5, 2002, a single tube in one of two steam generators at Ulchin unit 4 (UCN 4) was failed during the shutdown. This failure is tube-specific and not generic [5]. The failed tube was identified as the row 14, column 38 tube of steam generator #2, in which no sludge had piled up. Observation of inside of the failed tube (R14C38) confirmed that the tube had been ruptured circumferentially at the location of about 75mm above the top of tube-sheet. The ruptured tube was broken off 10mm apart from the upper remaining tube after the rupture. Axial crack with fish mouth opening shape was also observed from about 3mm to 78mm above the top of tube-sheet, the upper end of which was connected to the upper circumferential crack (ruptured). In addition, another circumferential crack connected to the lower end of the axial crack was found between about 3mm to 10mm above the top of tube-sheet. Figure 1 shows the failed tube of UCN 4.

The investigation on the cause of failure was conducted in two approaches: the metallurgical examination and reevaluation of the eddy current records of the failed tube were performed. The circumferentially severed section showed that there were two tearing areas. The one is located at the junction area with longitudinal split at the top of tube sheet and the other in the final ligament that seemed to rupture when the ligament could not sustain the transient loads. The severance propagated in helical way through the direction of 45° against the horizontal direction. This indicates that the circumferential severance developed after the longitudinal failure occurred as the secondary effect. The upper propagation went through the circumferential severance changing its orientation about 45° to the circumference of the tube. The lower propagation arrived at the top of the tube sheet and continued in the circumferential direction to about 240° of the tube circumference. The failure shape is a “T” type that is a combination of normal fish-mouth opening in axial direction and circumferential severance. The rupture was caused mainly by PWSCC with minor indications of IGA developed in the longitudinal direction from the top of tube sheet to the location of circumferential severance on the inside diameter of the tube. The cracks are shown to penetrate through wall of the tube in about the all along the longitudinal failed section. Several secondary cracks branched from the main axial crack were also observed. At the near longitudinal crack, a deformed area in a banded shape was observed along the crack faces. So far, the root cause is not clear, but this banded area seems to provide some primary effect on developing stress corrosion cracks. The metallography of the failed tube showed typically well-structured grains of Alloy 600 HTMA. From this

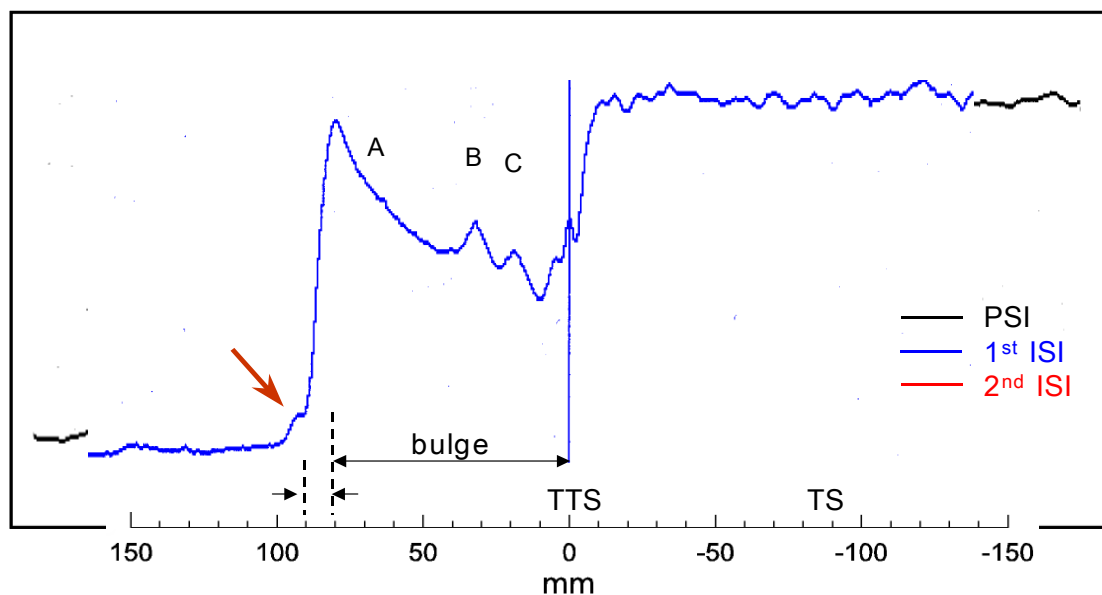
Figure 2 Changes in profile between the PSI, the first ISI, and the second ISI.

metallography, it was difficult to conclude that the material of failed tube is susceptible to stress corrosion cracking. On the other hand, from the revaluation process, it was concluded that the difference in the signals obtained from the PSI, the first ISI, and the second ISI could be distinguished only if we scrutinize those signals. Unfortunately, the +point probe that is known to be sensitive to crack like defect was almost incapable of identifying the defect developed at the bulged section. The pancake probe was better in detecting the meaningful signals from the defect but most of them were masked by the relatively strong signals of the bulge. The profilometry is a powerful tool to detect not only the geometrical variation but also development of defect in the deformed section. The differential mode does not provide any meaningful change in comparison with the previous inspection but the profilometry shows small change in the profile as shown in Figure 2.

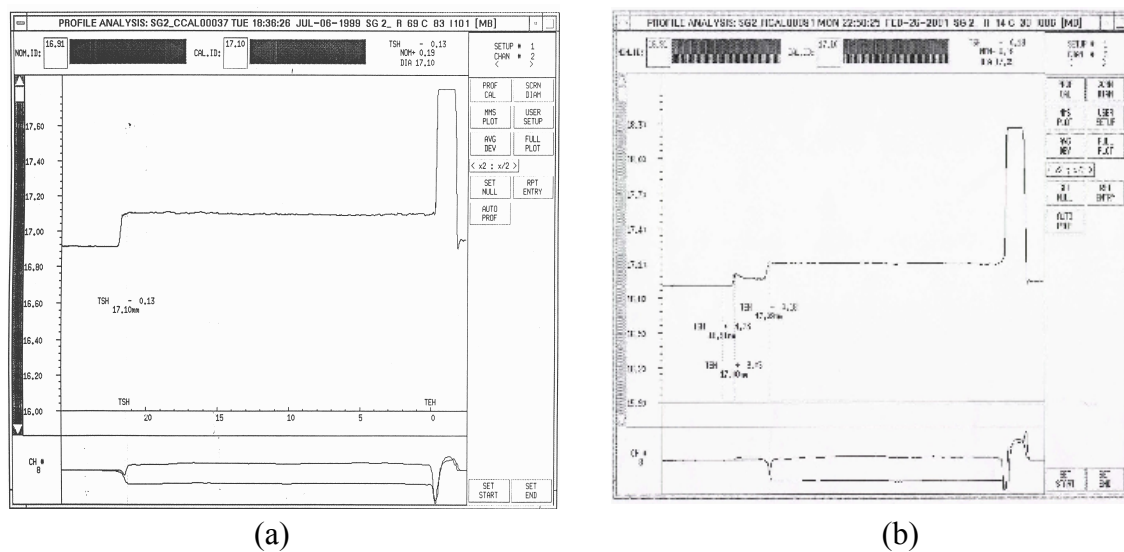
Figure 3 Profilometry of (a) sane tube and (b) profilometry of failed tube

In order to demonstrate that the failure is due to a specific problem and not a generic issue, the KHNP performed extensive inspections on the entire steam generator tubes of UCN 4 and found that the peculiarity of the failed tube was in the longitudinal SCC cracks developed in bulge section. The KHNP also found that such characteristic could be identified with a profilometry that shows the profile with intermediate over expansion as shown in Figure 3. The conclusion from the examination of pulled tube is that the crack began to develop at the bulged section in the longitudinal direction and propagated at high growth rate enough to penetrate the tube wall in three years of operation.

In the past, the steam generator tubes had no weld points except the seal weld between the tube and bottom of tube sheet, the inspection was in place from the PSI. But since the original cause considered that bulge existed in the failed tube probably made during manufacturing process promoted the development of SCC, the nondestructive examination was enhanced from this point. Once a steam generator is in service, the in-service inspection is the most effective way to prevent the steam generator tube failure. So KINS requested the augmented inspection not only on the concerned steam generators but also on all the steam generators in service in Korea. According to enhanced inspection strategy, every steam generator has been subject to the augmented inspections up to date: ECT on 100% of tubes with bobbin probe, and 100% of hot leg tubes and 20% of cold leg tubes with MRPC probe and profile evaluation on 100% of tubes at a time.
