## SOME RECENT OBSERVATIONS ON STEAM GENERATOR TUBING DEGRADATION

**Gabriel Ogundele, Malcolm Clark, Guylaine Goszczynski, Amy Lloyd,  
*Kinectrics Inc.*  
Sandra Pagan,  
*Ontario Power Generation*  
Ken Sedman,  
*Bruce Power*  
Peter King,  
*Babcock & Wilcox Canada***

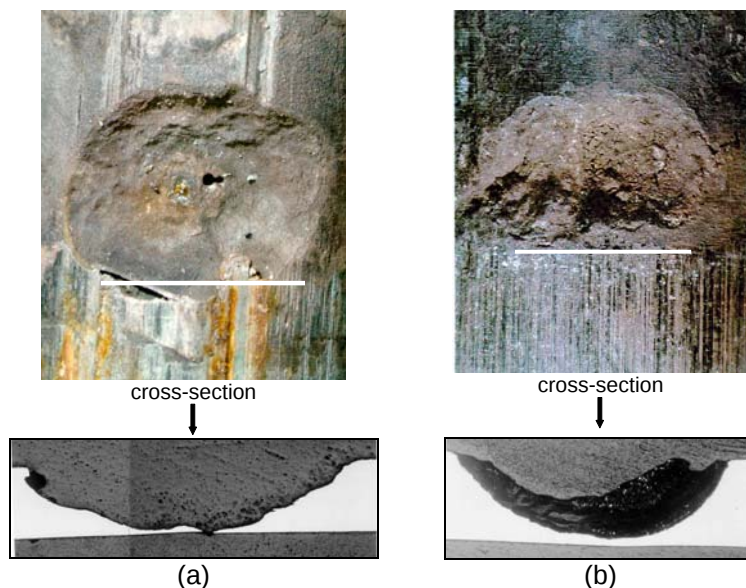
**Alloy 400:** For many years, the main type of degradation observed in Alloy 400 was underdeposit pitting corrosion that initiates from the outside surface of the tube [5]. Figure 2 shows some pitting corrosion degradation observed on the outside surface of the alloy. The pitting occurred mostly just above the upper rolled joint. In general, the degradation was characterized by wide-mouthed, dish shaped pits with a low aspect ratio, with no undercutting at the tube surface. Analysis of the deposits inside and around partial through-wall pits revealed the presence of chloride and sulfur ions. This is indicative of the presence of an environment conducive to underdeposit pitting. The likelihood of the initiation or growth of pits is dependent on the presence or absence of oxidizing species during SG operation. Layers of metallic Cu and metal oxides were observed in the sludge pile deposits and in some pits. This indicates that there was a cyclical variation in the oxidation potential during the SG operational cycle particularly during start-ups when higher levels of dissolved oxygen are present in the SG.

Figure 2: Pitting corrosion on Alloy 400; the pits are located just above the upper end of the rolled joint represented by the white horizontal line

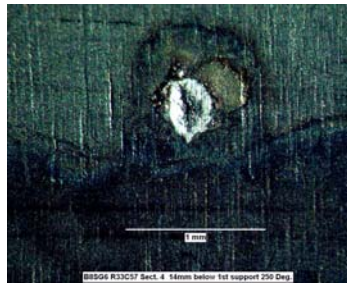
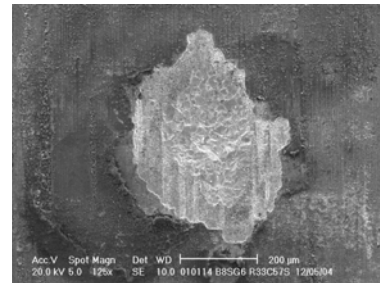
**Alloy 600:** Figure 3 shows the nature of pitting corrosion observed on the outside surface of Alloy 600 tubing. The micro-pitting was usually associated with circular stains. The deposits in the pitted region were subjected to EDS (energy dispersive spectroscopy) analysis to determine the elemental composition. The general deposits contained contaminants commonly found in the secondary side tube deposits: Al, Si, S, Cl, and Ti. High Fe contents were observed (above that in the base metal). This indicated that the deposits likely contained magnetite. Two of the locations directly over the pits contained unusually high Cl contents but less Fe than in the general pit deposit. This finding strongly suggests that chloride ion played a significant role in the pitting process.

(a) pit on the outside surface

(b) SEM image of the bright spot in 'a'

Figure 3: Details of shiny pit showing optical micrographs and SEM micrographs of the pit center with crystallographic features and etched grain boundaries

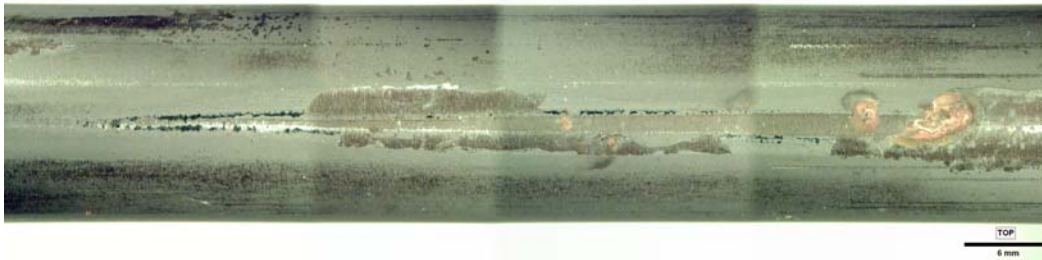
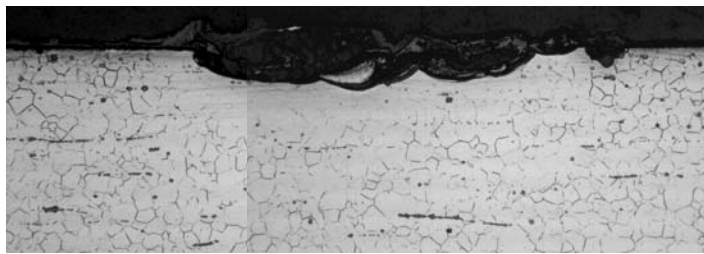
**Alloy 800:** More recently, shallow pitting corrosion was observed on the outside surface of Alloy 800. The shallow wall loss, 10% through-wall (tw), appears to have occurred as a result of uniform localized corrosion rather than from a mechanical process. Figure 4 shows the degradation just above a tube support. Preliminary evaluation of this degradation suggests that the affected SG tube material may contain some unique characteristics. The most significant finding from the material characterization was the titanium concentration which might have affected the corrosion resistance.

(a) outside surface of the tube

(b) pitted region

(c) cross-section through the pit

Figure 4: Pitting in Alloy 800

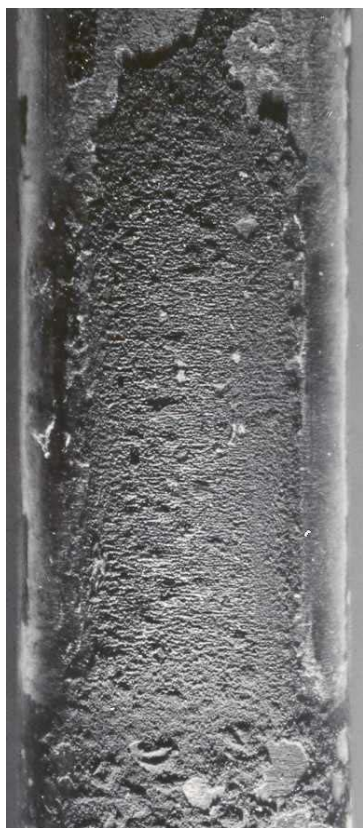
Light erosion corrosion feature at  
1<sup>st</sup> Support

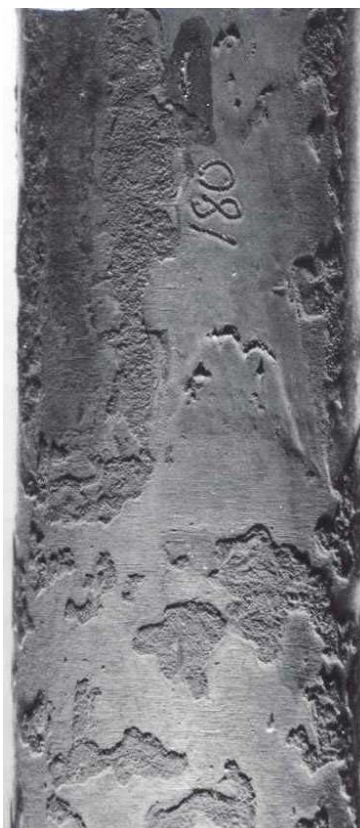
Moderate erosion corrosion  
feature at 3<sup>rd</sup> Support

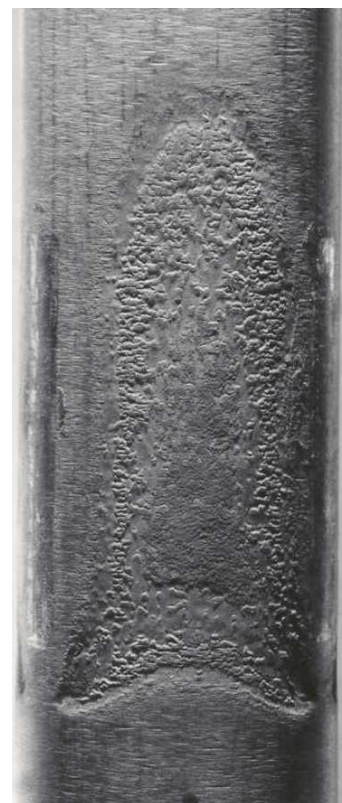
support to beyond its upper edge. Figure 6a shows typical surface characteristics of a fully developed feature with light deposits lodged in the groove of the facets created by the erosion-corrosion mechanism. This type of flaw is also called a “top hat” (TH) due to the overall physical characteristics of the degradation.

Fully developed erosion  
corrosion feature at 8<sup>th</sup> Support

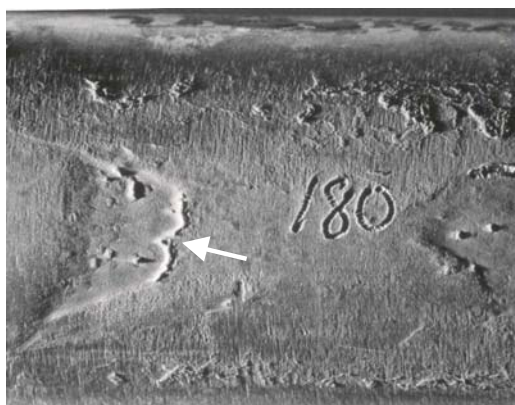
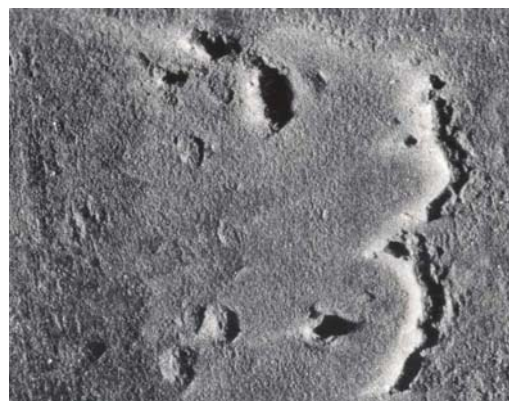
This mechanism has only been observed in Alloy 400 tubing. Figure 5 shows the outside surface of Alloy 400 that corroded due to erosion-corrosion. No erosion-corrosion degradation exceeding 20% tw has been observed from the first detection in 1997 to the present. This mode of degradation was initially observed to be most significant on the hot-leg side at the upper support plates in regions of high fluid flow during plant operation; but other SGs were also affected at the lower support plates [8-9]. The wall loss was present in the three flow holes (lobes) of the broached support plates and typically extended from the lower edge of the tube

Cleaned surface at the affected region

Close-up view of the affected region

Figure 5: Morphology of erosion-corrosion degradation on the outside surface of Alloy 400

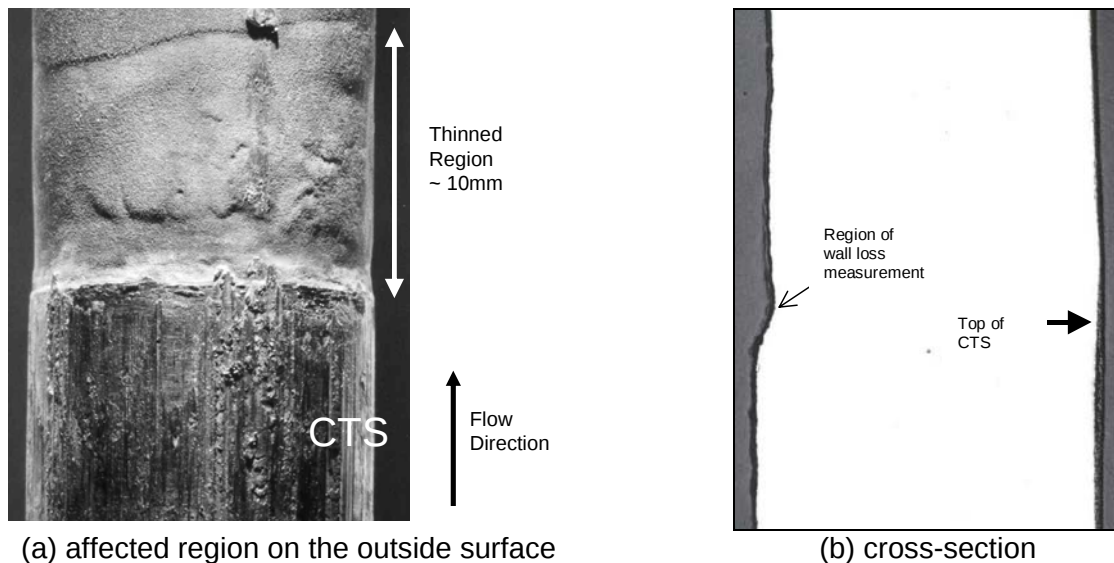
Some general wall thinning has also been observed on Alloy 400 SG tubing. Figure 6 shows the nature of the degradation observed on the outer diameter surface of a tube removed from the cold leg region of the steam generator. This degradation occurred as volumetric wall loss (thinning) on the outside surface of the tube around the circumference and was associated with the support intersections (preheater section) or at the tubesheet [5]. The wall loss at the top of tubesheet ranged between 9% and 11%tw. There was no appreciable deposit at the support locations but there was evidence of patchy bright areas. Scanning electron microscopy (SEM) examination revealed general corrosion and minor intergranular (IGA) in these areas. No evidence of pitting or stress corrosion cracking was found in any of the corroded areas. The cause of this mode of degradation is not well understood.

Figure 6: Wall thinning in Alloy 400 (a) outside surface, (b) Axial cross-section through the flaw

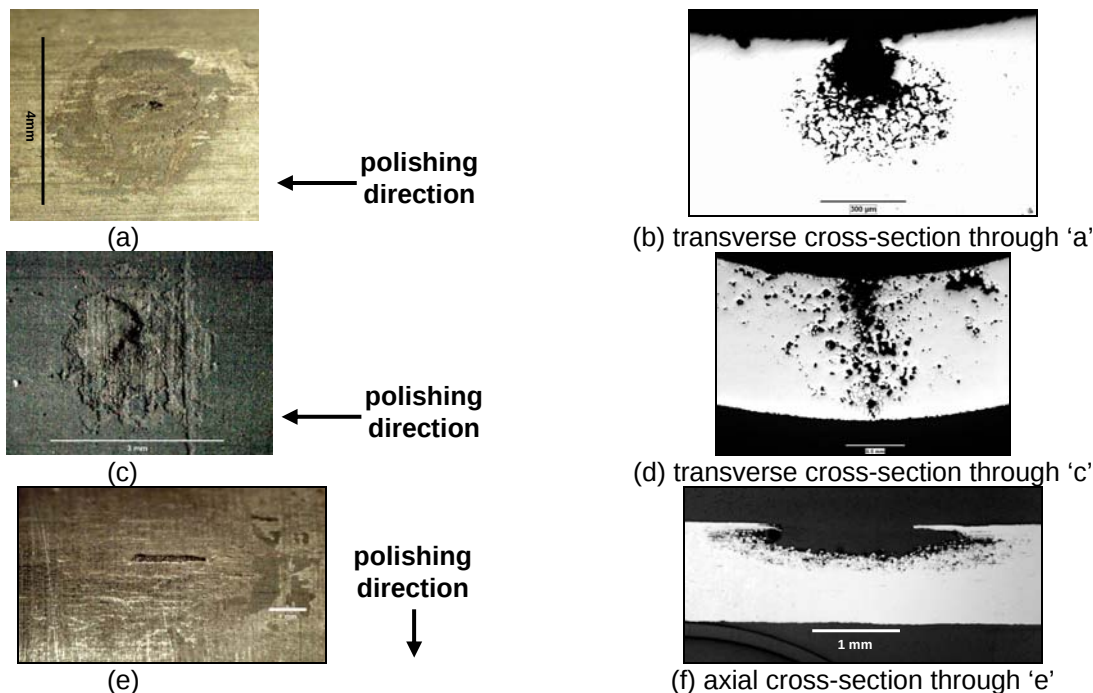
**Alloy 400:** Figure 7 shows typical characteristics of an area affected by IGA on the primary heat transport (PHT) "pure" heavy water side surface of Alloy 400 on the cold leg side. The flaws are characterized by a localized surface deposits with possible penetration through the thickness. Before destructive examination, the deposit (Figures 7a,c,e) were analysed and were found to consist mainly of Ni and Cu with Fe in the centre. Figures 7b,d show the transverse cross-sections revealing the extensive IGA morphology. The axial cross-section in Figure 7f revealed a larger axial subsurface extent. Metallic copper platelets were seen within the grain boundaries in the IGA region. As this type of degradation had not been previously observed on the Alloy 400 SG tubes, the flaw was subjected to further analyses using orientation imaging microscopy (OIM) to determine if there are strain concentrations along the IGA front. From the OIM analysis, no coherent strain field existed beneath the IGA front. Accordingly, there was no basis to suggest that these defects would lead to the nucleation and propagation of stress corrosion cracking (SCC). Though the damage displayed by the cross-sections was characteristic of IGA, the morphology, extent, and its presence on the inside surface is unusual in Alloy 400 from field experience and is considered to be most likely associated with historical primary side decontamination processes.

Figure 7: IGA patch on the inside surface of Alloy 400 (a,c,e) inside surface features, (b,d,f) cross-section through the flaw.

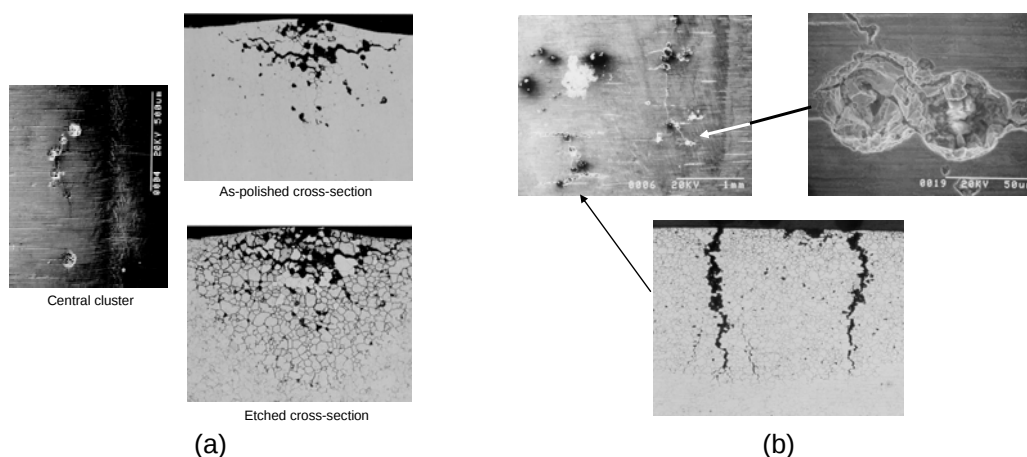
**Alloy 600:** Some localized outside surface flaws have been observed on Alloy 600 tubing. The flaws were found on the hot leg of the tube in the free span region. The outside surface of the tube and cross-section through such flaws can be seen in Figures 8 and 9. The indications were found to originate from oval or circular shaped patches of intergranular attack (IGA) located between 10 and 22 mm above the top of the tubesheet (Figure 8) and at the tubesheet (Figure 9). The orientation imaging microscopy (OIM) analysis conducted on the flaws indicated that the IGA propagated without any strain accumulation at the interfaces or along the crack-like features within the IGA patches. This observation suggests propagation of the IGA patch *in advance* of the crack-like features. The presence and location of the IGA does not appear to be related to any anomalies in grain size or texture effects. Dynamic secondary ion mass spectroscopy (SIMS) results suggested that sulfur or sulfur bearing compounds likely had a role in the IGA in the steam generator tube. No other species that could cause localized corrosion of the tube were detected.

Figure 8: IGA in Alloy 600 (a) transverse cross-section, (b) axial cross-section

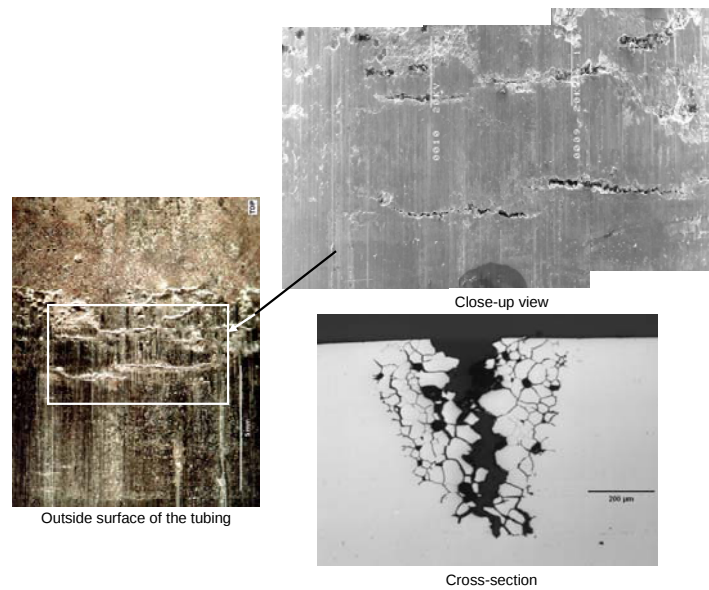
Figure 9: IGA in Alloy 600 with the transverse cross-section

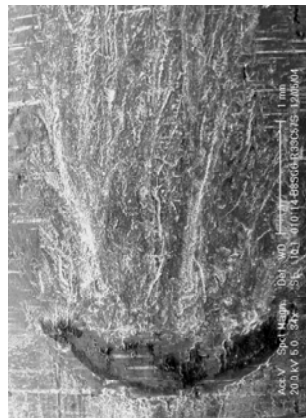
**Alloy 600:** Figure 10 shows a fretting-type damage on the outside surface of Alloy 600. The fretting types of surface flaws are characterized as originating from the interaction of the tube and the broach plate land contact. This was aggravated by the tube support degradation in Unit 8.

Figure 10: Fretting damage on Alloy 600

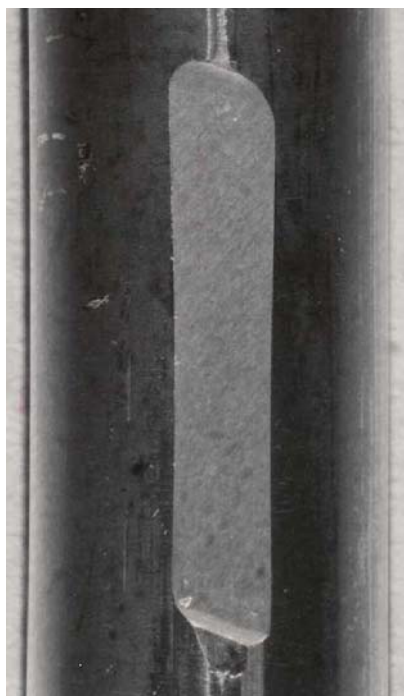
**Alloy 800:** Tube fretting in the U-bend region, due to the interaction of the tubes with anti-vibration bar (AVB) support, has been observed at all Darlington steam generators [5]. Figure 11 shows the typical fretting feature found on the tube at the U-bend region. In the straight leg region, the fretting damage was much less severe and appeared different. The metallographic examination of Alloy 800 shows a region of fretting damage (“maple leaf” flaw) at the H04 support. As seen in Figure 12, the flaw consisted of very fine grooves that appear to be due to some type of mechanical micro-deformation process. The location at the bottom of the contact area with the lattice bars, suggested an interaction between the initial deposits and the lower edge of the bar producing this unusual deformation pattern. The features within and around the fine grooves do

Figure 11: Fretting on Alloy 800 at U-bend support

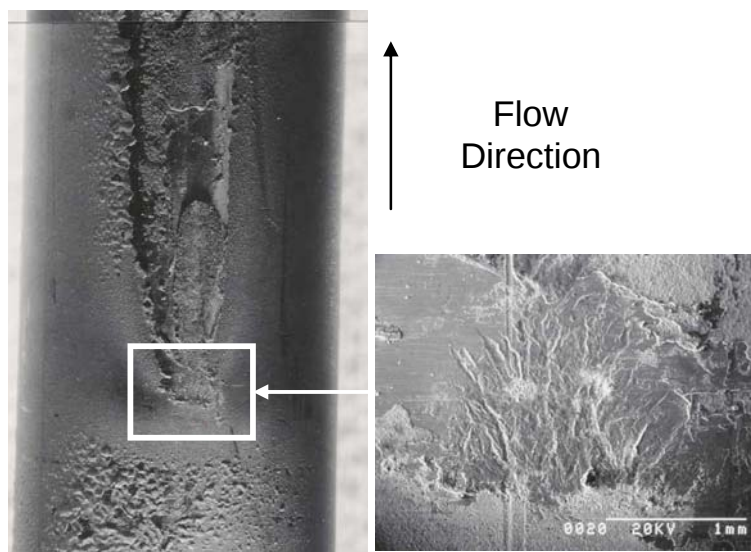
not suggest that they were produced by a flow-induced type of mechanism, gross mechanical deformation or steam cutting. The flaw is typical of a traditional fretting mechanism whereby fine metal particles removed by the mechanical movement of the tubes are oxidized and provide an abrasive surface for continual metal removal. This feature is similar to those observed on Alloy 600.

Figure 12: Fretting (maple leaf) damage on Alloy 800; right micrograph is an SEM image of the flaw

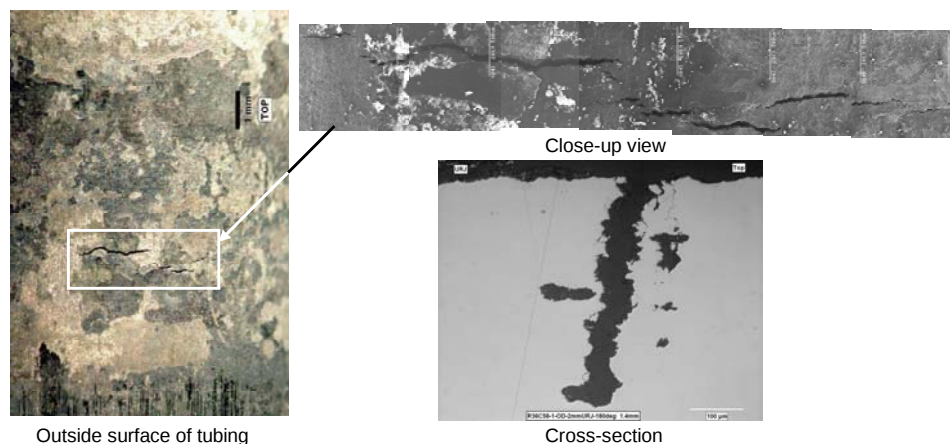
Some Alloy 600 tubing were observed to have experienced significant cracking in the roll transition zone (RTZ). These cracks were circumferential, OD initiated, and progressed in a fully intergranular manner as shown in Figure 13. The location of the cracking suggests that the cracking environment is formed inside the crevice between the tubesheet and the tube roll transition. Secondary side intergranular attack and stress corrosion cracking (OD IGA/SCC) in the upper roll transition region are the confirmed degradation mechanisms. Cracking is often accompanied by extensive intergranular attack and grain dropping around the main crack.

Figure 13: Circumferential cracking on the outside surface of Alloy 600

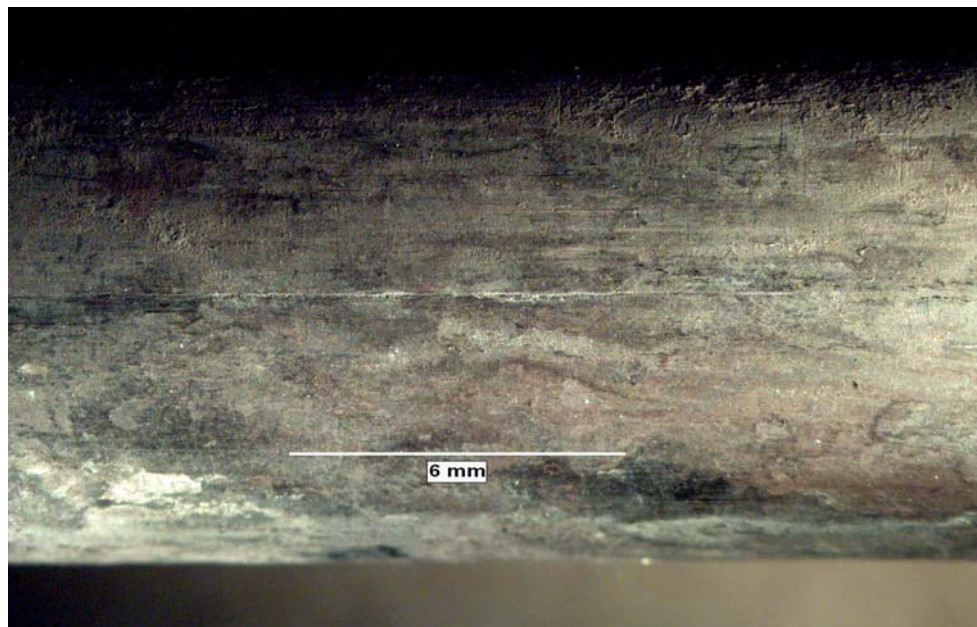
An unusual type of degradation was observed on two Alloy 400 tubes. The observations indicated a crack-like flaw, which originated from the outside surface of a tube removed from the hot leg of a SG at Pickering NGS. The unusual characteristics of the degradation and ensuing analysis termed this degradation as a form of environment assisted cracking (EAC) that is non-classical in nature. This is because this type of morphology has not been reported elsewhere. The features did not display the characteristics of classical stress corrosion cracking (SCC) mechanism that generally includes multiple initiation sites and secondary branching. Figure 14 shows the feature as observed on the outside surface of the tube. The flaw was characterized as straight and axially oriented. Figure 15 shows the cross-section through a part of the flaw.

Figure 14 Appearance of the flaw as visible on the OD and is oriented in the axial direction of the tube.

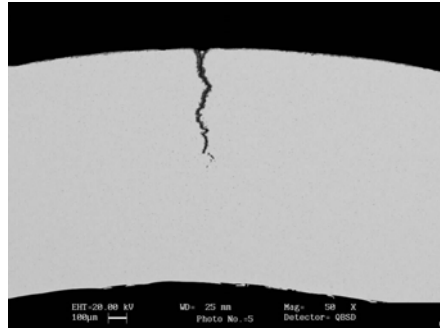
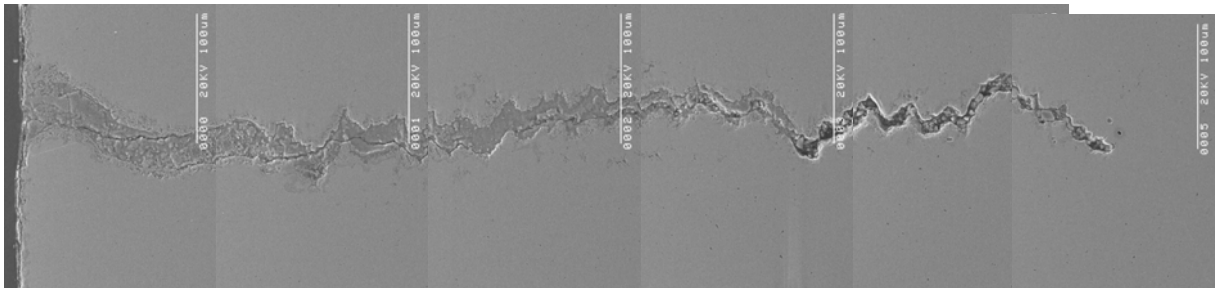
The pertinent parameters required for stress corrosion cracking (material/environment/stress factors) of Alloy 400 tubing material were individually examined. Based on the analyses, it was difficult to attribute the flaw to a typical stress corrosion cracking mechanism and as a consequence it would be more appropriate to define it as environmental assisted cracking (EAC) that likely initiated at a manufacturing defect (lap-type defect).

(a) transverse cross-section

(b) SEM montage of the crack

Figure 15 Cross-section through a part of the flaw

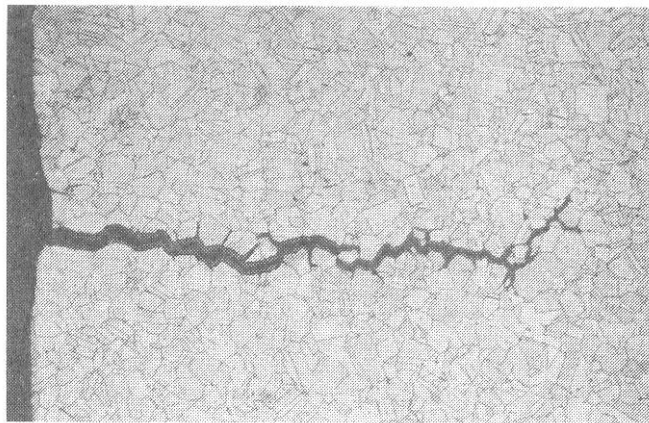
Stress corrosion cracking in UNS N04400 (Monel 400) is relatively rare, but there are documented cases in high pressure feedwater heaters from fossil-fired power stations with Monel 400 tubing operating in steam environments [10, 11]. The reported cracking was totally intergranular with some but not extensive side branching. Small parallel secondary cracks were sometimes reported. The crack appearances were similar to those seen in the present case with the exception of the apparent sideways intergranular corrosion of the crack surfaces (see Figure 17) and the lack of secondary cracking. The cracking in feedwater heaters was usually attributed to high residual stresses in the as-manufactured tubes (also absent in the present case) is not located in the rolled joint region but rather is in the free span.

Figure 16 Cross-sectional views of cracking in Monel alloy 400 tubing from a high pressure feedwater heater [12]. This image is compared to that presented in Figure 15.
