# A LAST LOOK AT PLGS LIFE-LIMITING FEEDER DEGRADATION

**J.P. Slade<sup>1</sup>, T.S. Gendron<sup>2</sup>**

<sup>1</sup> NB Power Nuclear, Lepreau, New Brunswick, Canada

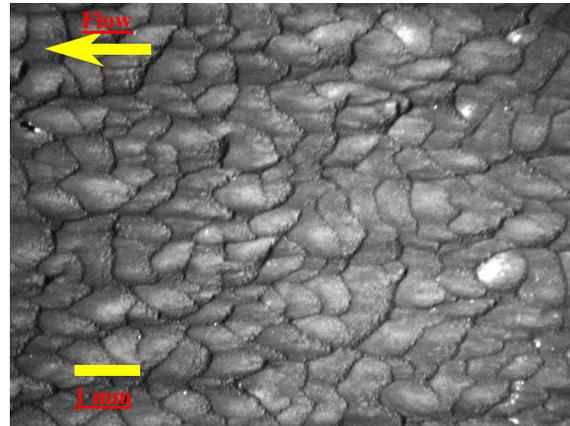
The mechanism of wall thinning was identified as Flow Accelerated Corrosion (FAC) based on the thin magnetite film (~1-4µm) and scalloped appearance of feeder inside surfaces (Figure 1), and the constant corrosion rates. FAC is caused by coolant flow and chemistry conditions that remove the magnetite film that normally protects the feeders from corrosion, and promote a high transport rate of corrosion reactants and products to and from the surface, respectively.

Figure 1: Scallops on Feeder S08a

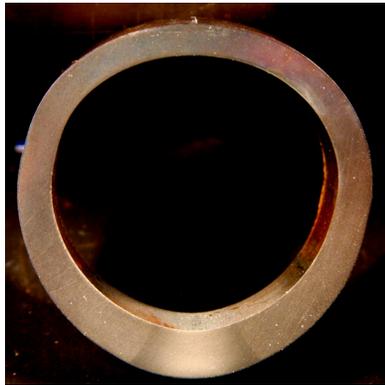
Another important factor that affects the lifetime of piping affected by FAC is the initial pipe wall thickness. Locations where the initial thickness is relatively low from fabrication steps such as bending and grinding are more susceptible to life-limiting wall thinning. The “warm bending” procedure [6] used to bend PLGS feeders thickens the bend intrados and thins the extrados, as shown in Figure 2.

Figure 2: Spare Bend Apex

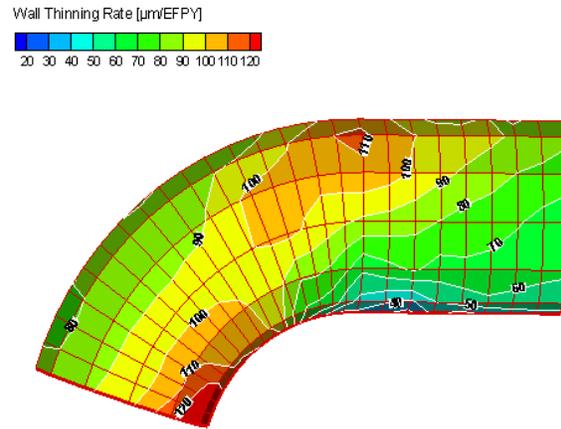
The variation in key factors present in the outlet feeders gives rise to varying wall thinning rates and patterns. Maximum rates of individual feeders estimated by repeat wall thickness measurements made beginning after ~12 FPY range from ~0.03 up to ~0.13mm/FPY for the highest velocity channels. The highest rates are at the intrados upstream of the first two tight radius bends and at the bend extradoses near the bend apex. The pattern from a PLGS removed single bend is shown in Figure 3.

Figure 3: P09a Wall thinning Rate Pattern

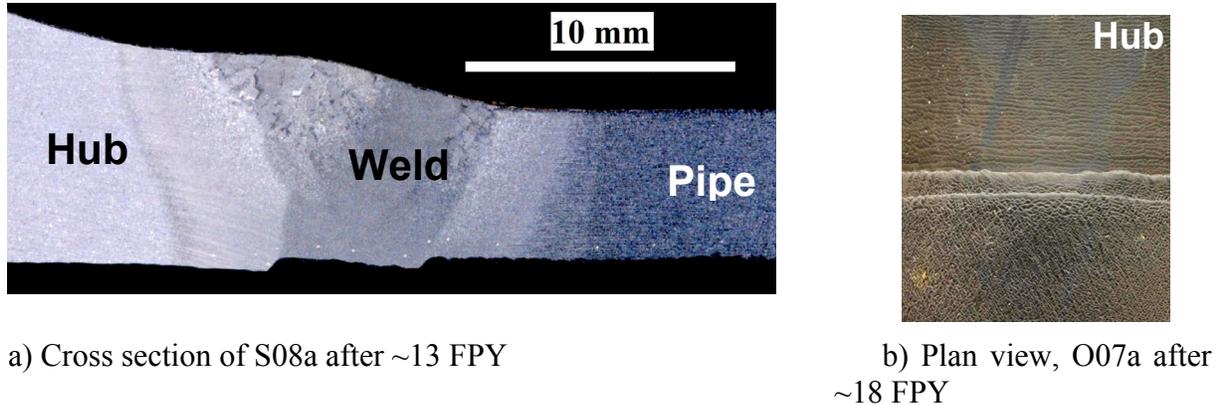
At the outlet Grayloc connection, the variation in chromium content between the hub (~0.12wt%), the pipe (~0.02wt%), and the weld between (~0.07%), led to different FAC rates, and the creation of a surface step profile in the axial direction. Figures 4a and b illustrate this in cross-section and plan-view. This profile has been observed on all removed PLGS feeders and is most pronounced at the intrados, where FAC rates are higher. The preferential wall thinning of welds reported by EPRI [7] has never been observed on PLGS

Figure 4: Step profile of the Grayloc hub-feeder weld location

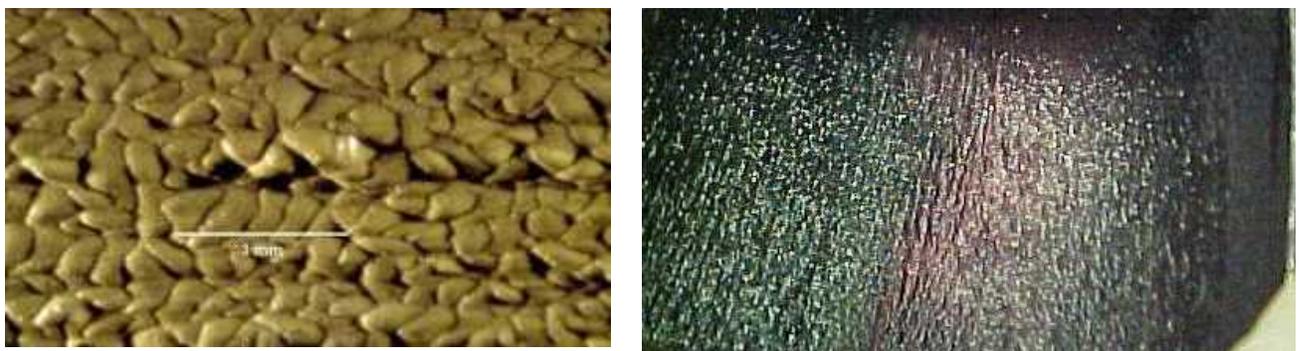
feeders. However, thinned areas adjacent to the Grayloc welds with subtle profiles have developed. The dark patch in the center of Figure 5b (beneath the weld) is the most acute thinned area of this type observed at PLGS. This is discussed in more detail in the subsection below.

The development of surface scalloping is worth further mentioning because some of the false positive crack indications in 2005 were attributed to scallop patterns. All four feeders that were repaired because of false positive indications of inside surface cracks (Table 1) were examined in the locations of the rejectable indications. In each case, axially aligned scallops, which had created groove-like features, were observed (Figure 5) with some individual scallops as deep as 0.4mm. When these features were mechanically removed, the ultrasonic indications also disappeared. A review of past inspection reports suggests that these axial patterns became more distinctive with time and created ultrasonic indications that only became rejectable after ~18 FPY. Use of a modified COG crack inspection procedure since 2005 has been successful in distinguishing indications between scallop patterns and cracks. There have been no additional false positive indications.

Figure 5: Axially aligned scallop patterns created after ~18FPY in feeder E14c

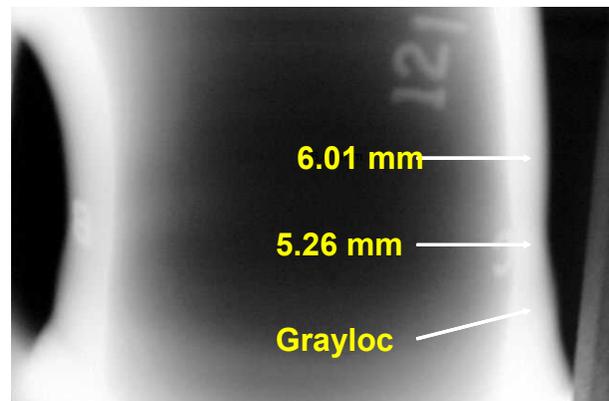
Grinding was performed on the hub-to-pipe weld caps to aid the radiographic inspection of the weld region and also at the weld root to remove any protrusion or mismatch of the internal pipe surfaces exceeding 1/32”. Pre-service radiographs and metallographic examination results have provided evidence of the degree of material removed from individual feeders. The radiograph in Figure 6 indicates the location of initial minimum wall thickness, adjacent to the weld.

Figure 6: PLGS Feeder-Hub Weld Pre-Service Radiograph

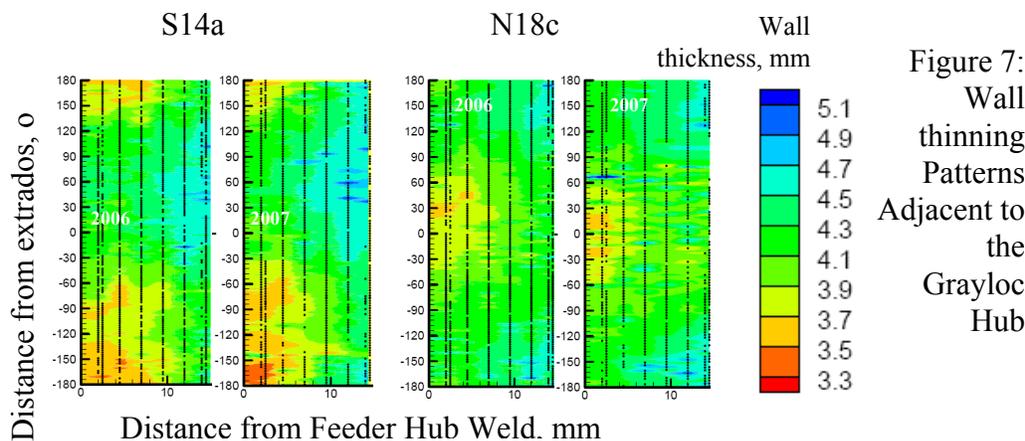
This location was inspected using a COG Grayloc-Area Inspection Tool. Figure 7 shows the wall thickness pattern for two PLGS feeders over a two-year period. Feeder S14a had the least margin to the minimum allowable thickness but was not life-limiting by 2008.

Figure 7:  
 Wall thinning Patterns Adjacent to the Grayloc Hub

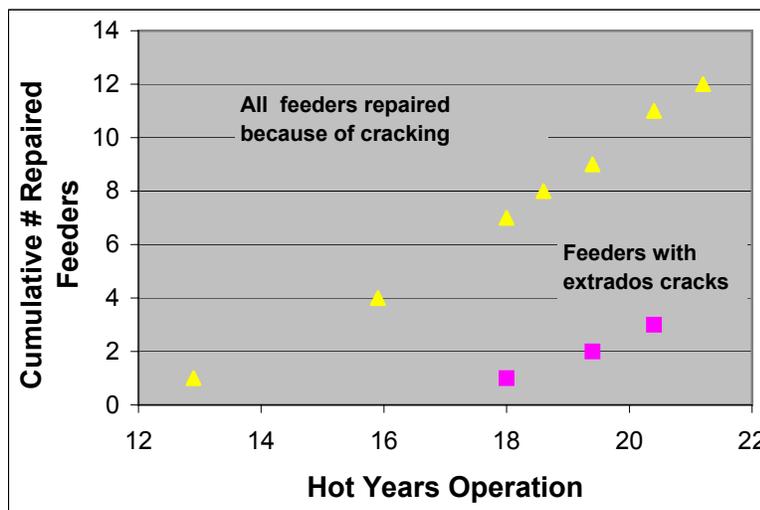
Since 1997, feeder bends have been replaced because of cracking at a rate of about 1 to 2 per year. A linear fit of the data for all repaired feeders in Figure 8 shows a failure rate of 1.3 per hot year. All twelve life limiting cracks were in 2.5" diameter outlet tight radius first or second bends with an external angle of  $>45^\circ$ . Eleven of the twelve bends had significant cracks that had initiated on the inside surface between  $\sim 30$  to  $75^\circ$  from the intrados. Beginning in 2003, significant cracking on the outside surface of three bend extradoses was also discovered; two of those bends also had deep inside surface cracks (Table 1). Figure 9 illustrates the three locations of cracking on the second bend of feeder N19a. Examinations of removed bends have revealed that a high percentage of tight radius bend extradoses contain very shallow (50-200 $\mu\text{m}$  deep) outside surface incipient cracks, that are assumed to have developed during operation. All of the observed cracking is in the location of high residual tensile stresses from the bending process [6]. In-situ ultrasonic inspection and destructive examination of removed Grayloc hub-to-feeder welds did not reveal cracking on any PLGS feeder welds. No cracks were detected in 100% inlet bends inspected.

Figure 8: Rate of Feeder Repair due to Cracking

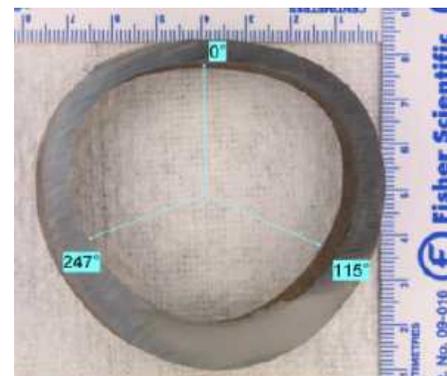
Figure 9: Feeder N19 2<sup>nd</sup> Bend. Outside surface cracks at the extrados ( $0^\circ$ ) and inside surface cracks at  $115^\circ$  and  $247^\circ$

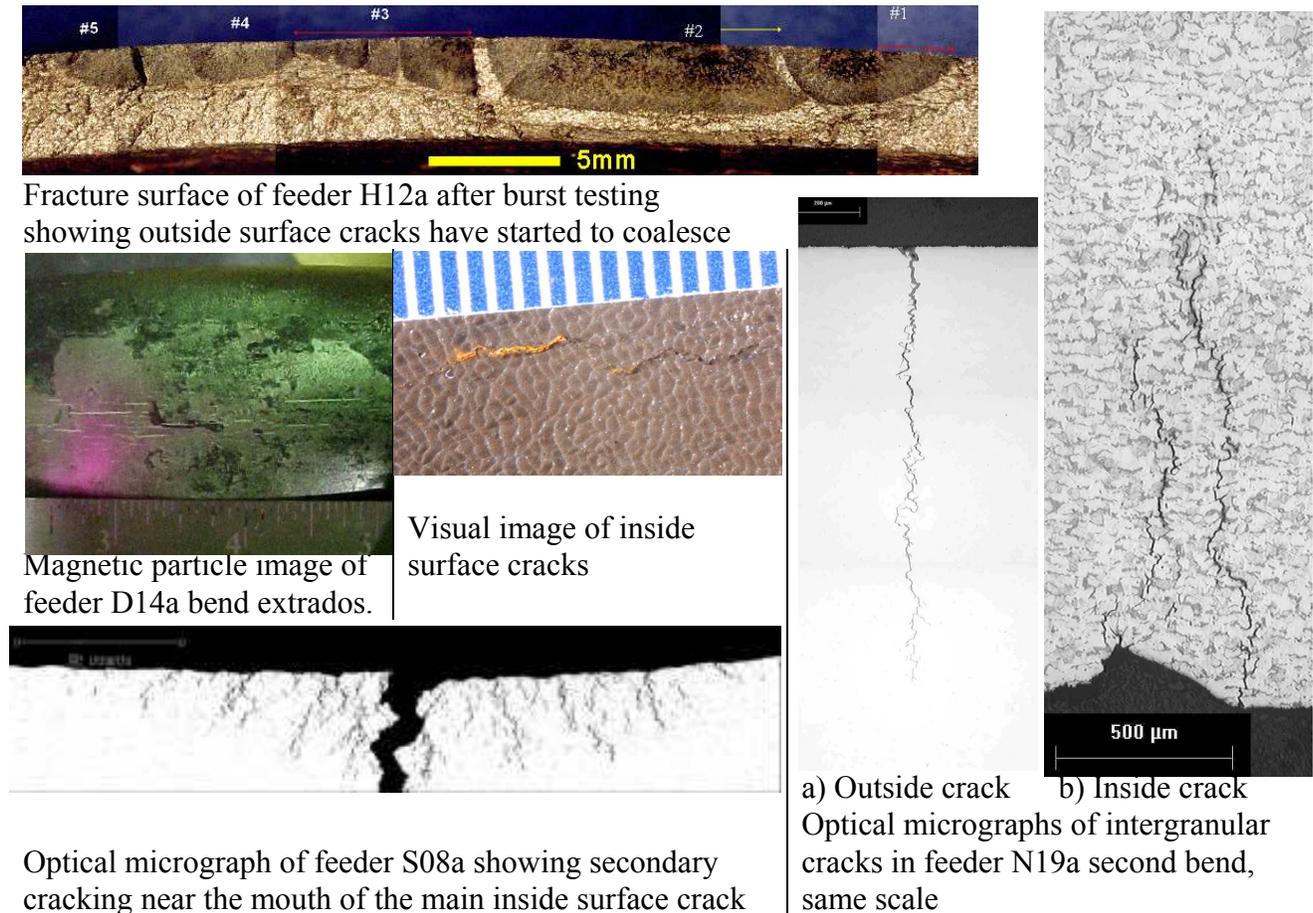
All cracks are axial in orientation and entirely intergranular. No physical feature or surface contaminant has been observed to identify a specific mechanism of failure. Outside surface cracks tend to be straighter and have fewer secondary cracks near the main crack. Cracks initiate in multiple locations and with time, some of those that are axially aligned, coalesce to form larger cracks. Figure 10 illustrates some of these features. Additional details about the physical

Figure 10: Images of PLGS Feeder Cracks

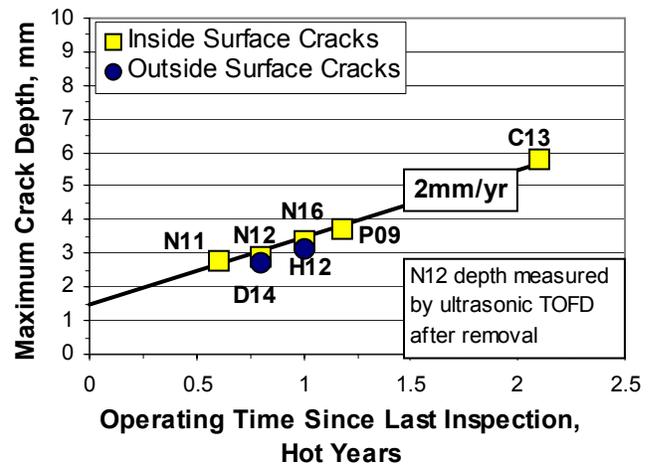
Crack growth rate has been estimated from OPEX (Figure 11) to be ~2mm/year in the through-wall direction. This is an average growth rate once cracks reach a detectable size. Figure 11 plots the maximum crack depth in an individual feeder versus the operating time since the last inspection when no crack was detected. Other assessments from laboratory examinations of artefacts have concluded similar rates with variation suggested with crack age (size) and slightly slower rates for cracks initiated on the outside surface.

Figure 11: Average Crack Growth Rate

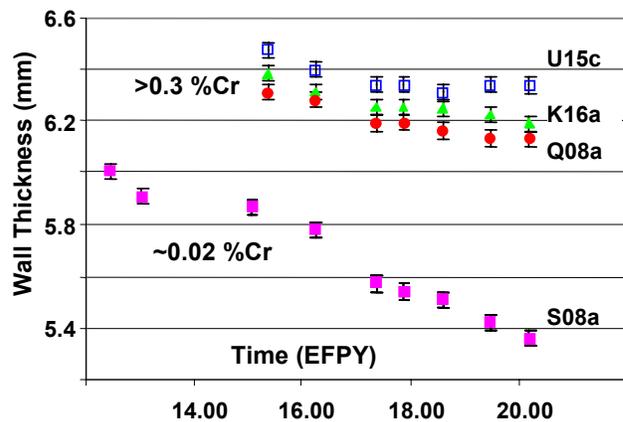
rate by at least 50% compared to the original PLGS feeders. This is based on experimental loop tests and wall thinning measurements of some PLGS replaced feeder bends [10]. Figure 12 compares measured minimum wall thickness data from bend S08a which was replaced with original PLGS steel in 1997 and three feeder bends replaced with >0.3%Cr steel in 2001. The estimated reduction in FAC rate from this data for steel with higher Cr is ~65% [10].

Figure 12: Wall thinning of replaced bends [10].

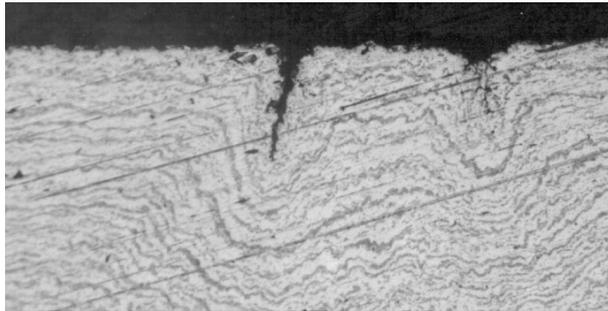
NBPN plans to discontinue using a Feeder Piping Management Plan after refurbishment and will include all feeder inspection activities in the periodic inspection plan (PIP). Table 6 compares the planned inspection scope with CSA N285.4-05 minimum requirements. The planned scope exceeds CSA requirements mainly for insurance against any unforeseen degradation. An extensive wall thickness baseline is included because a known initial thickness eliminates significant uncertainty when assessing wall thinning rate, if required later on. A limited inspection for feeder cracks is included even though stress relieved bends are very unlikely to crack. This inspection is considered to be an added measure to ensure high stakeholder confidence in reliable post-refurbishment operation, in view of the unique PLGS cracking OPEX in the past ten years. A partial baseline crack inspection is also included because some manufacturing features were observed in the replacement feeders (Figure 13), which caused rejectable crack indications using the COG in-service crack inspection procedure. These features were assessed to be benign and baseline results will prevent them from causing false positive indications in future crack inspections.

Figure 13: Benign manufacturing features in PLGS replacement feeder piping (maximum depth 200 $\mu$ m)
