## **BRUCE UNIT 1 & 2 PREHEATER CONDITION ASSESSMENT & REFURBISHMENT**

P. King, C. Machowski, R. McGillivray, B&W Canada Ltd.

For the 8<sup>th</sup> International Conference on CANDU Maintenance

### **ABSTRACT:**

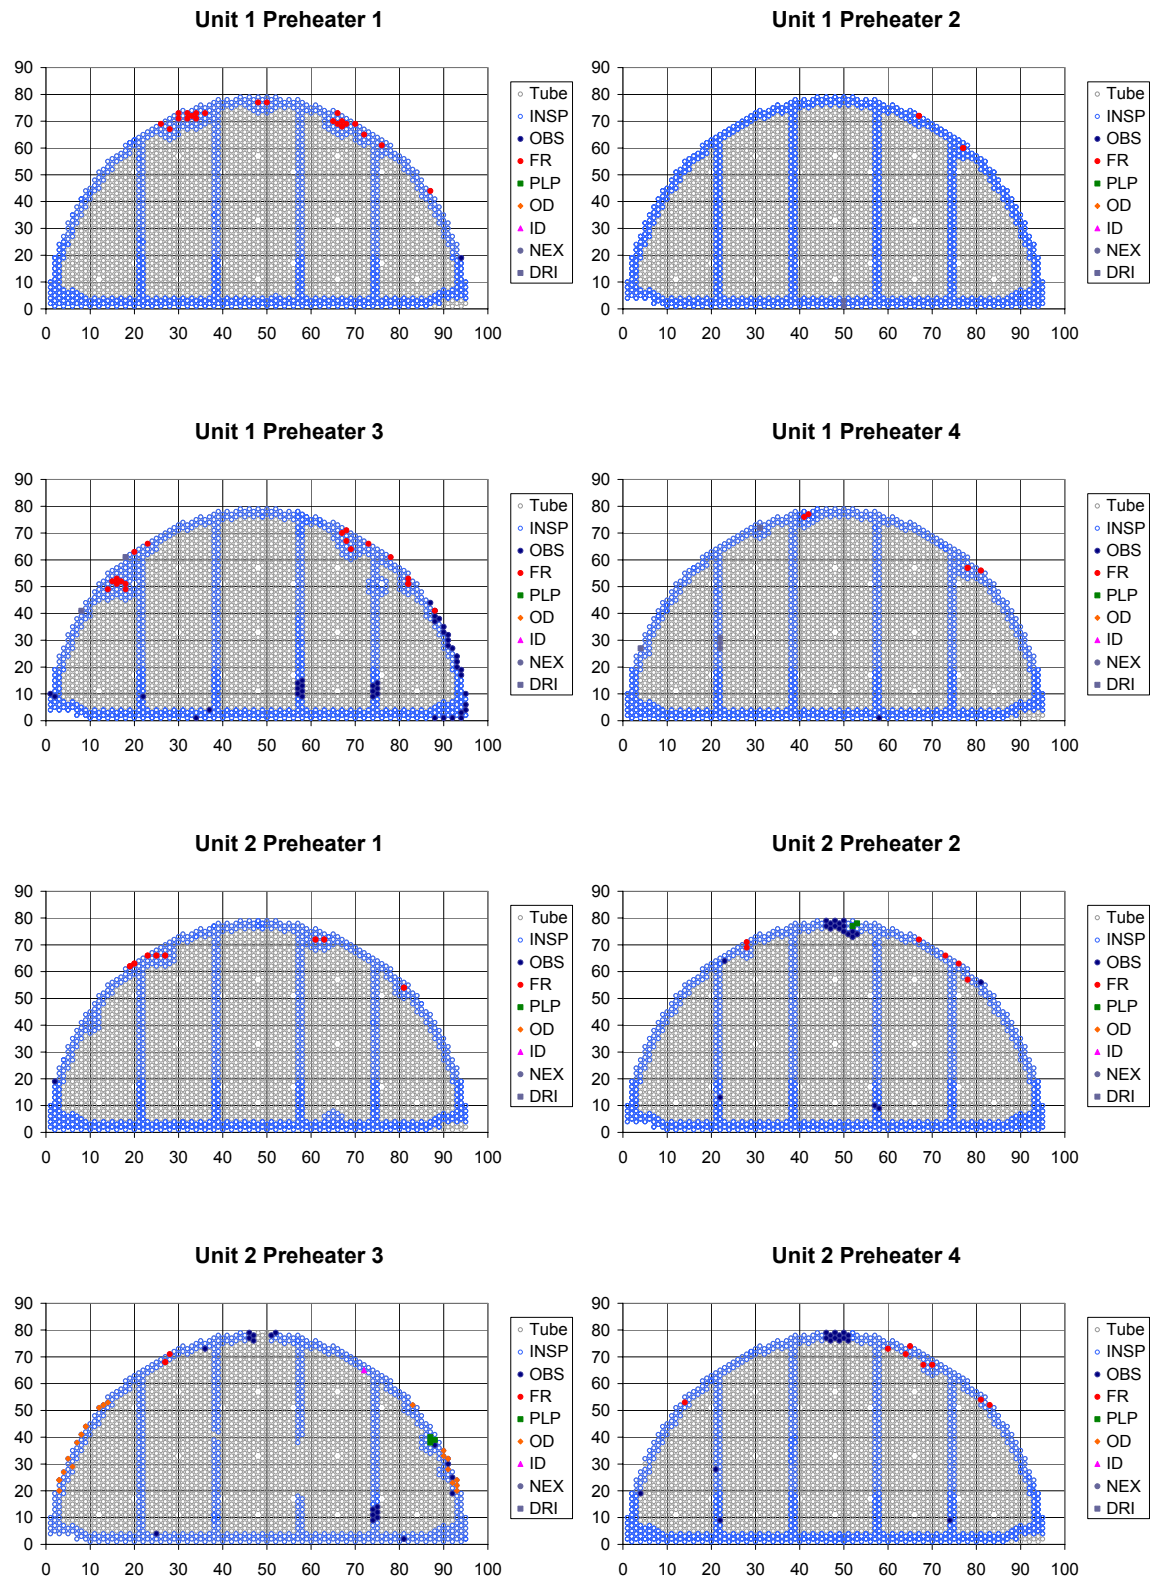
**Figure 5 – Eddycurrent Indications**

A number of OD indications were detected by bobbin in peripheral tubes of Unit 2 preheater 3. In total, twenty peripheral or near peripheral tubes were affected, with the indications located in the free span near the feedwater inlet. The bobbin signal voltage was small in all cases, indicating a small defect volume and potentially questionable sizing. The majority of the indications were reported to be less than 20% tw, with a small number of indications in the 20%-40% range and a single indication with a reported depth of 71% tw. The tube with this largest indication has been removed and will be metallurgically examined to determine the degradation mechanism.

Because of the location of the indications, debris fretting or manufacturing related damage are considered the likeliest damage mechanisms. Although not detected previously in Bruce A preheaters, pitting and/or IGA are present to a limited extent in Bruce B preheaters and have not been eliminated as potential causes of these indications.

A small number of tubes were reported to have distorted roll indications by bobbin. These tubes were further inspected with X-Probe and found to have no detectable degradation.

A small number of tubes were reported to have unexpanded tubes within the tubesheet. These tubes were further inspected with X-Probe and found to have no detectable degradation.

As an interim measure, indications >20% throughwall were removed from service and it is anticipated that this preheater will be reinspected at the first scheduled outage following restart. Final determination of the degradation mechanism will be made after the metallurgical examination has been completed.

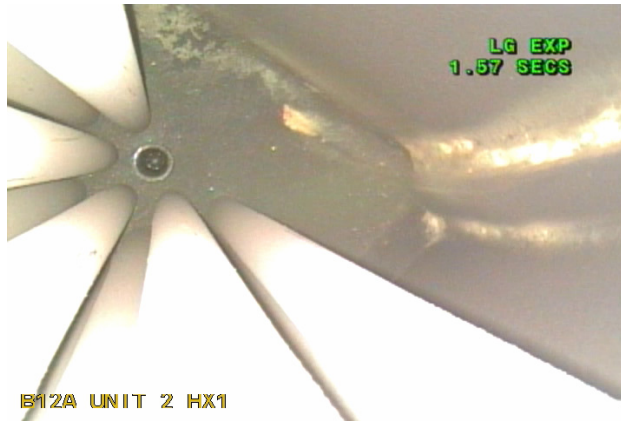
Visual inspection of the secondary side internals, conducted through removed tube holes revealed generally good conditions, with no significant corrosion or deposits detected to date. Inspection of the U-bend support structures through the drain nozzle is scheduled, but has not been completed at this time.

**Figure 7 – Preheater Secondary Side (Tubes, Baffle Plate, Shroud and Divider Plate)**

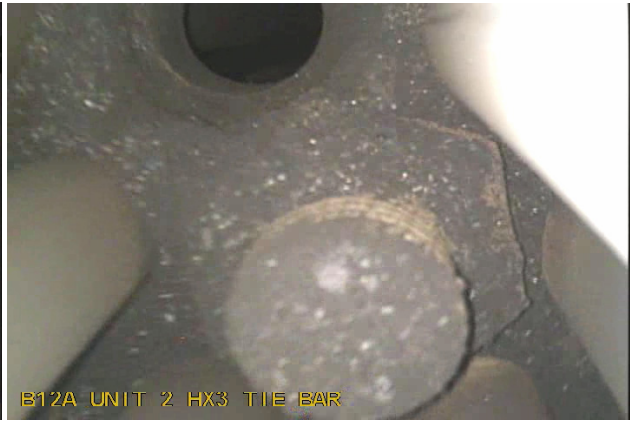
**Figure 6 – Preheater Secondary Side (Tie Rod Location on Baffle Plate)**
