## **INDUCEMENT OF IGA/SCC IN INCONEL 600 STEAM GENERATOR TUBING DURING UNIT OUTAGES**

by Dave Durance and Ken Sedman, Bruce Power  
John Roberts, CANTECH Associates Ltd.  
Peter King Babcock and Wilcox Canada  
Jeff Gorman, Dominion Engineering  
Ruth Allen, Kinectrics Inc.

### **Executive Summary**

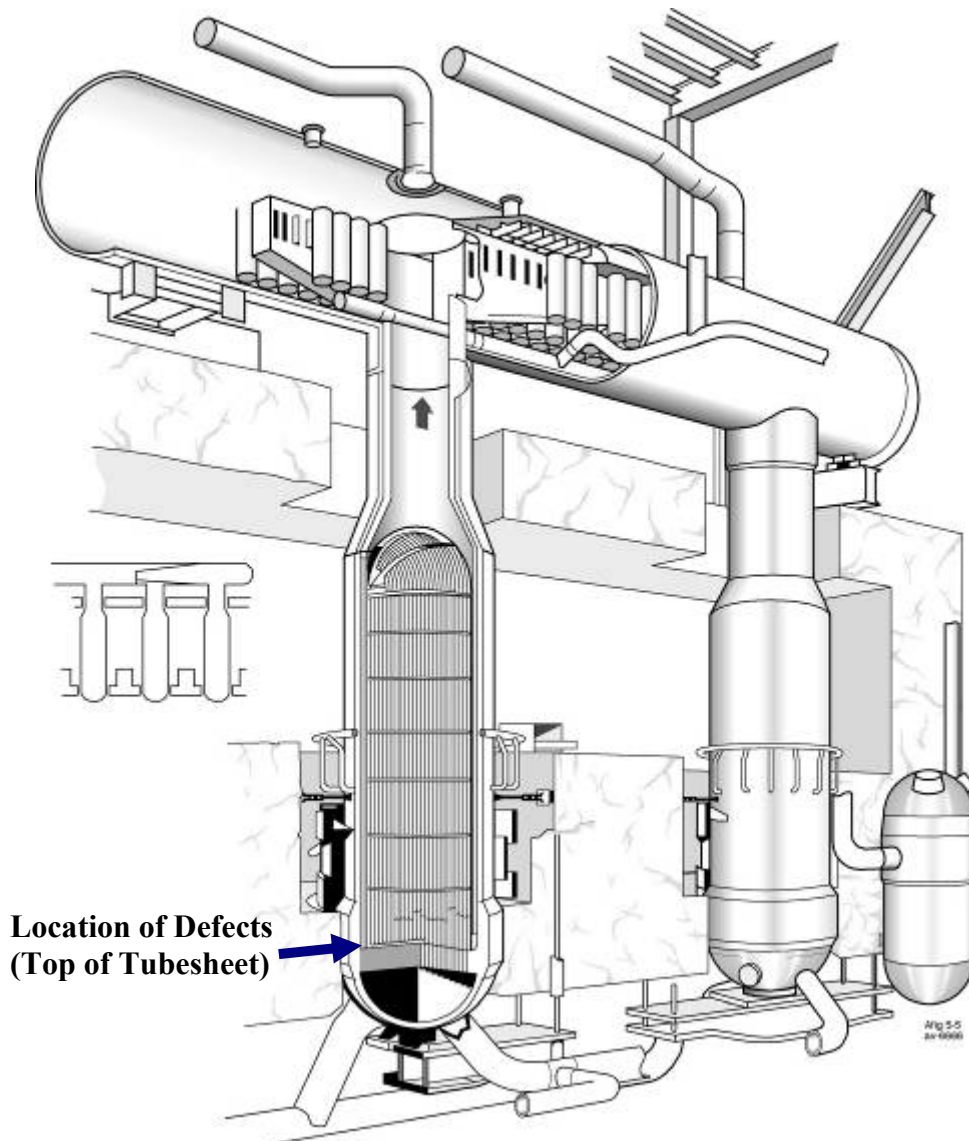
**Figure 1. Location of IGA/SCC Degradation ( HLTTS) in the Bruce Steam Generators.**

Inspections carried out in 2006 following a 12 month run revealed significant circumferential IGA/SCC in SG4 (16 Defects at the TTS in the HL RTZ, table 2). As a result of these findings, circumferential IGA/SCC defect initiation and growth rates were increased, reducing the subsequent operating interval to 9 months. Nine months later in the spring of 2007 inspections were carried out revealing another increase in both the number and size of circumferential defects, beyond the condition monitoring criteria established following the 2006 inspections. Several of these defects approached the structural limit, where tube rupture could occur under accident conditions (e.g. main steam line rupture). The subsequent operating interval was further reduced to six months. Inspections in the fall of 2007 (following 4.5 months of operation) failed to reveal any circumferential defects in SG4 and the other Unit 4 boilers. This was contrary to the predictions for high temperature damage made after the spring campaign, raising questions regarding the mechanism of attack. Following these findings, a detailed review of the SG operating and layup history was carried out in an attempt find a supportable explanation for this behavior.

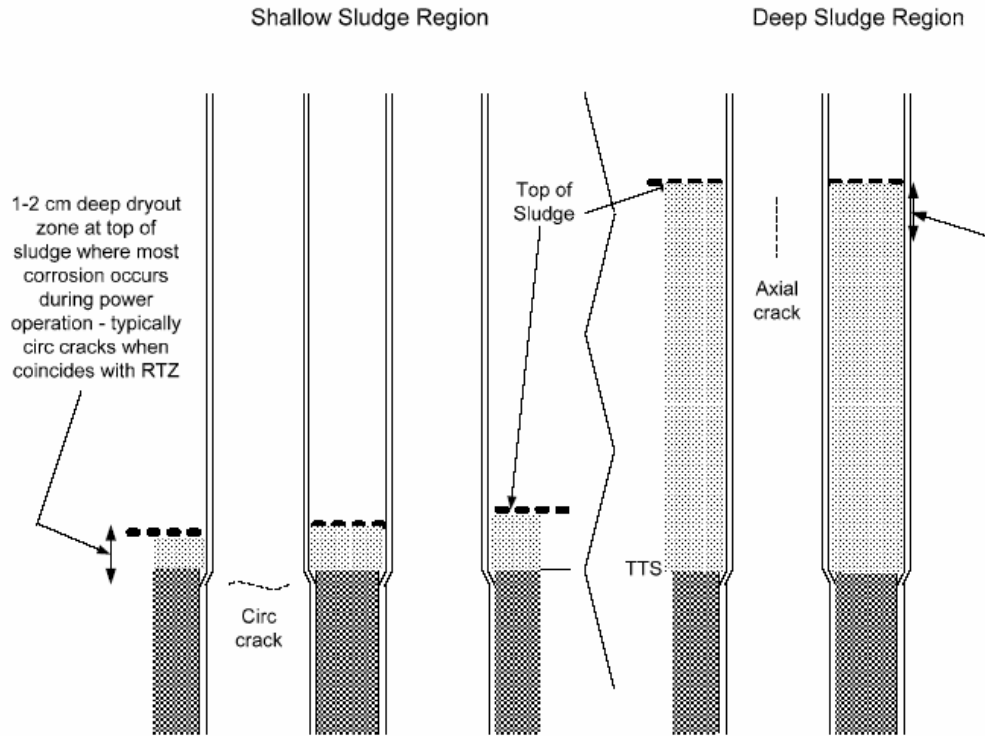
**Figure 2. Location of Typical Defects at the TTS Within PWR Boilers [6].**

The locations of the circumferential OD IGA/SCC in Bruce steam generator 4 are not consistent with the locations observed in PWRs where attack is believed to have occurred at high power. The defect location between the Bruce SGs and the PWR SGs is shown in figure 2. In this regard, model boiler tests and PWR plant experience indicate that, at high power, impurities concentrate in the top 1 to 2 cm ( $\frac{1}{2}$  to 1 inch ) of the sludge, which acts as a dryout zone, and that IGA/SCC tends to occur in this region. For this reason, circumferential cracks at PWRs tend to be concentrated near the edges of the sludge pile where the 1 to 2 cm dryout zone corresponds to the roll transition zone [6]. In the central deep sludge pile region IGA/SCC tends to occur at the top of the sludge and to be mostly axial cracking. In contrast in Bruce 4 SG4 the circumferential cracks and IGA are concentrated in the center of the sludge pile. They also are all close to the TTS, i.e., they are not near the top of the sludge. In other words, the degradation pattern at Bruce 4 is consistent with startup attack but not full-power attack.

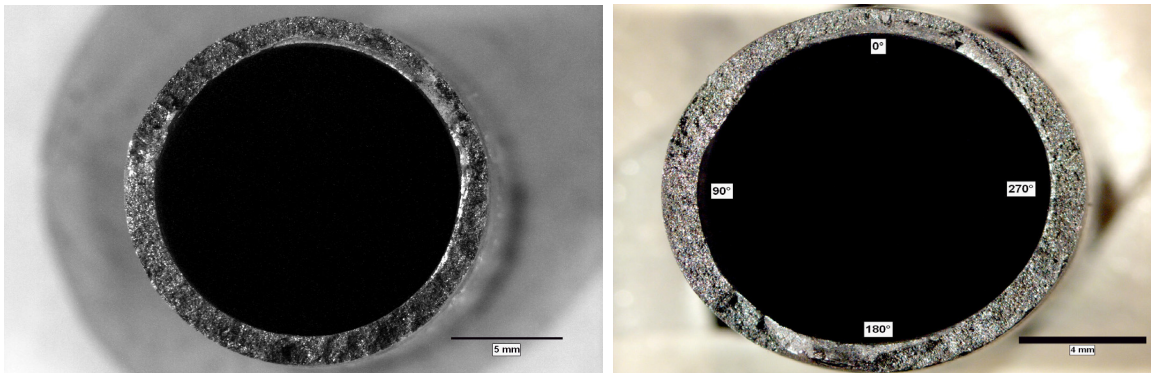
The flaw morphology exhibited by the circumferential OD IGA/SCC in Boiler 4 is characterized by very broad bands of IGA in the roll transition area (figures 3 and 4), rather than by narrow IGA with leading fingers of SCC (figure 5), and thus is more consistent with IGA caused by exposure to reduced sulfur species at low temperature than it is with IGA/SCC at high temperature.

**Figure 3. SG4 fracture surfaces from tube removals during the 2007 spring outage. (Left Tube R33C61 SG4 2007 (PDA at 84%), Right Tube R31C57 SG4 2007,(PDA 75%))**

- 1) The development of aggressive reduced sulfur species in the TTS region is being avoided or minimized by eliminating exposure to partially and fully drained conditions. The intent is to minimize exposure to oxidizing and dryout conditions. Oxidizing conditions tend to develop aggressive sulfur species and to acidify the crevices—and also to oxidize copper particle surfaces (which tend to act as oxidants during subsequent startups), while dryout tends to concentrate chemicals to more aggressive levels [6].

- 2) Following any drained periods, the duration of exposure to treated low-oxygen water is maximized to the extent practical before commencing startup. The intent is to reduce the concentration of aggressive sulfur species by allowing time for diffusion out of crevice areas, increase the pH in crevice areas by allowing impurities to diffuse out and pH agents such as morpholine to diffuse in, and reduce copper oxides by the action of hydrazine before startup and operating stresses and temperatures are applied.

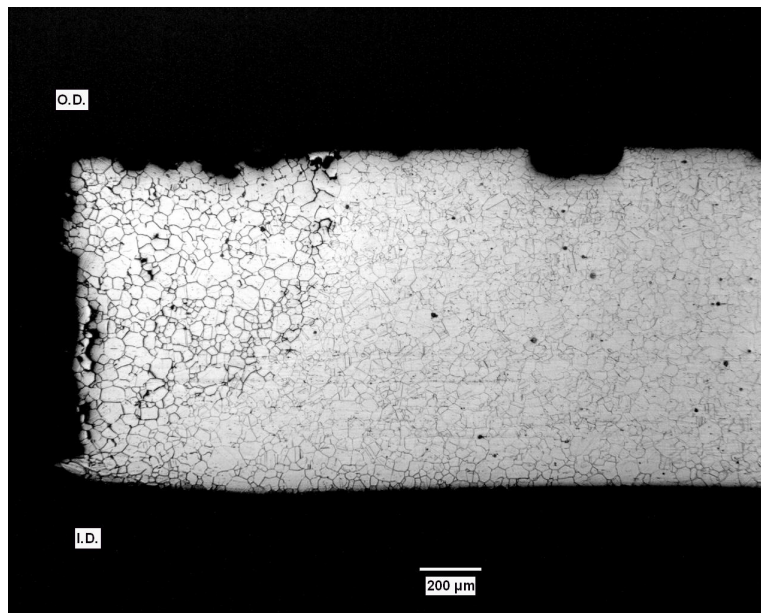
**Figure 4. Micrograph of tube R28C5 Unit 4 SG4 displaying fracture surface, on the left hand side and the adjacent extensive IGA field.**

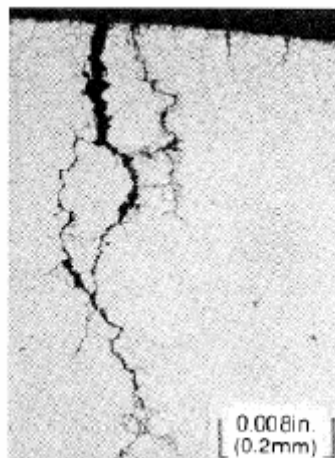
**Figure 5. Typical high temperature SCC crack morphology from PWR SG Tubing Failure [7].**
