## INSPECTION OF CIRCUMFERENTIAL IGA/SCC IN BRUCE UNIT 4 SGS

S. Fluit and H. Myderwyk, P. King, B&amp;W Canada Ltd.

D. Durance, K. Sedman, Bruce Power

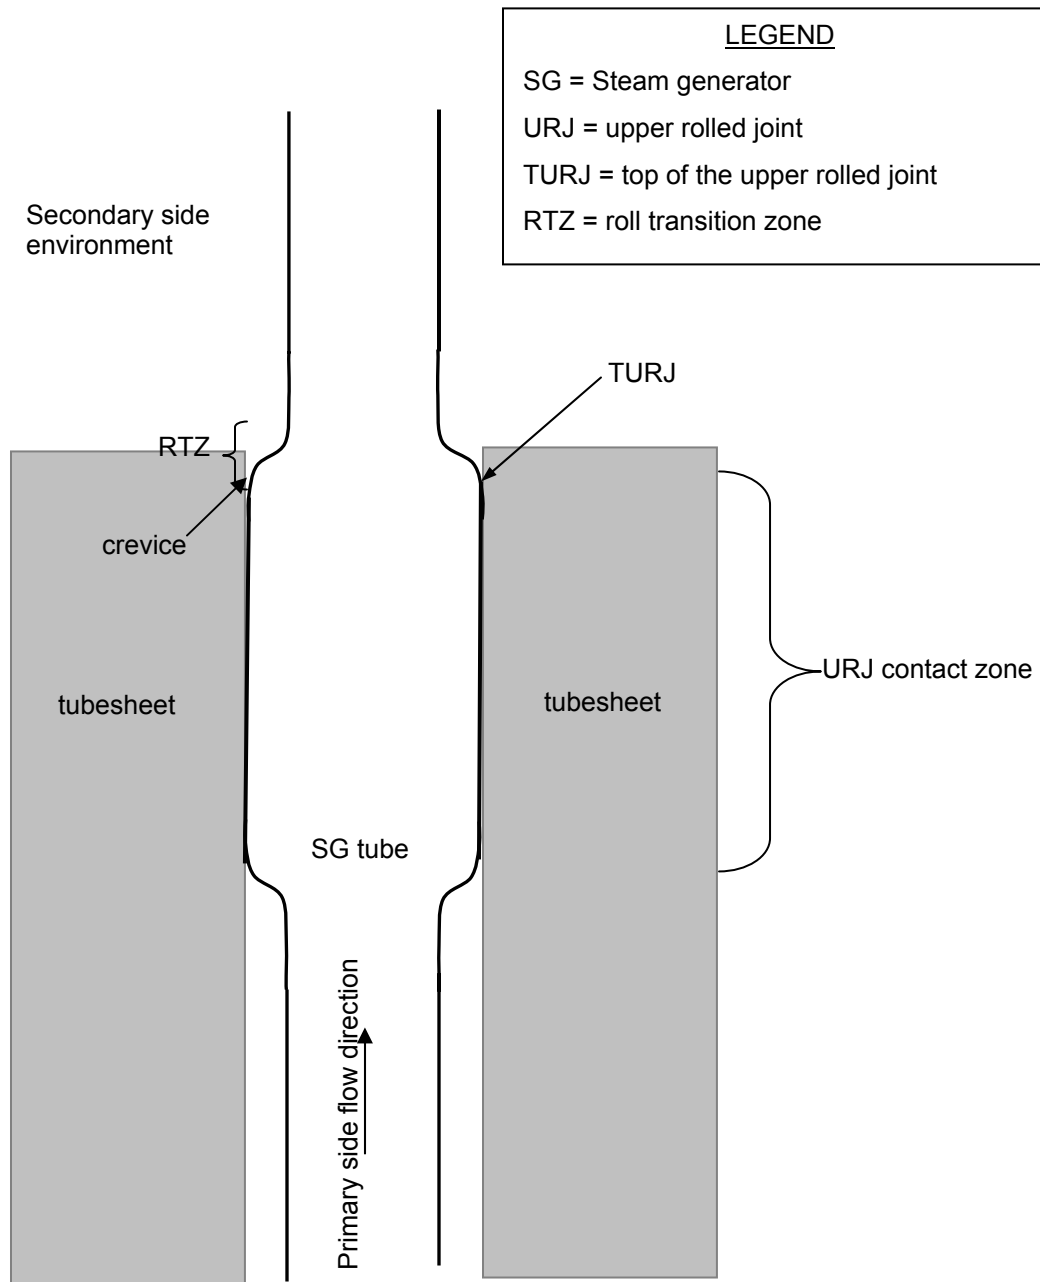
The degradation that is the focus of this paper is Intergranular Attack and Stress Corrosion Cracking (IGA/SCC) at the Hot Leg Roll Transition Zone (HL RTZ). This region is located on the hot leg of the SG, at the secondary face of the tubesheet, as shown in Figure 1. The residual strains in this region from the expansion of the upper rolled joint probably contribute to the circumferential stress corrosion cracking component of the degradation. This region is also exposed to a harsh environment during operation and lay-up as a result of sludge piles on the secondary face of the tubesheets in the Bruce A SGs.

**Figure 1 - Location of IGA/SCC at HL RTZ**

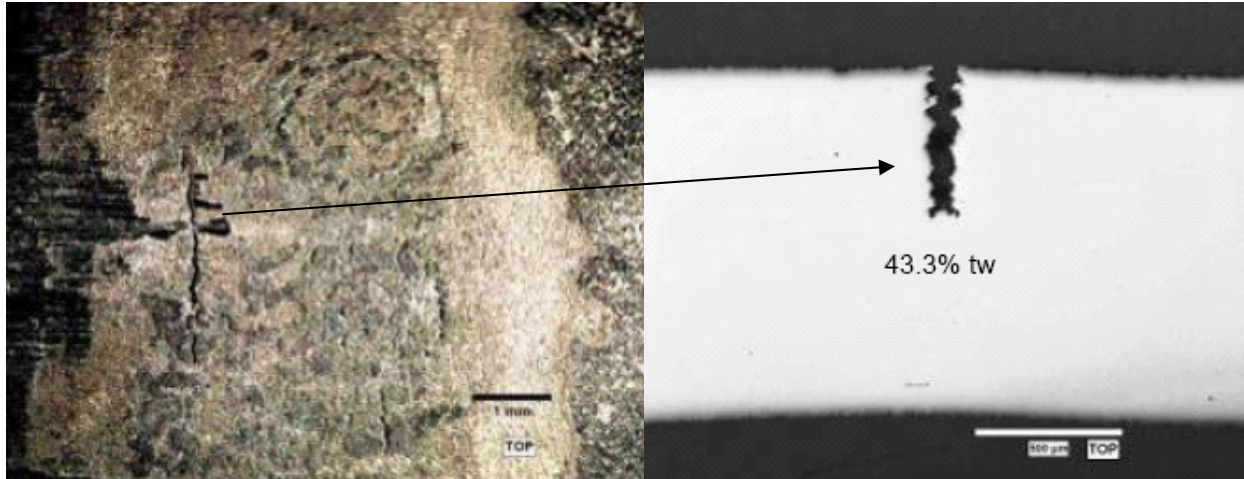
- 1 tube (BO1 R37C59) had a circumferential indication reported by both +Point and X-Probe. Examination of the removed tube confirmed a 43%tw by 20° circumferential extent crack (Figure 2), and a cluster of small crack-like features (Figure 3) having a maximum depth of 47%tw and an overall circumferential extent of approximately 60°. Similar crack-like features separated by ligaments had been observed on previous tube removals from Unit 4, and are known to be difficult to detect by any of the ET probes.

**Figure 2 – Crack-like Feature in BO1 R37C59 Detected by +Point and X-Probe, 43.3%tw x 20° Circumferential Extent**

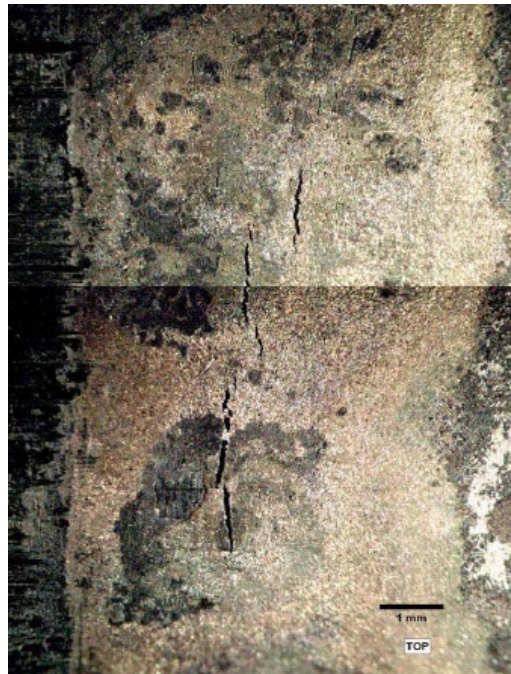
**Figure 3 - Multiple Crack-like Features in BO1 R37C59**

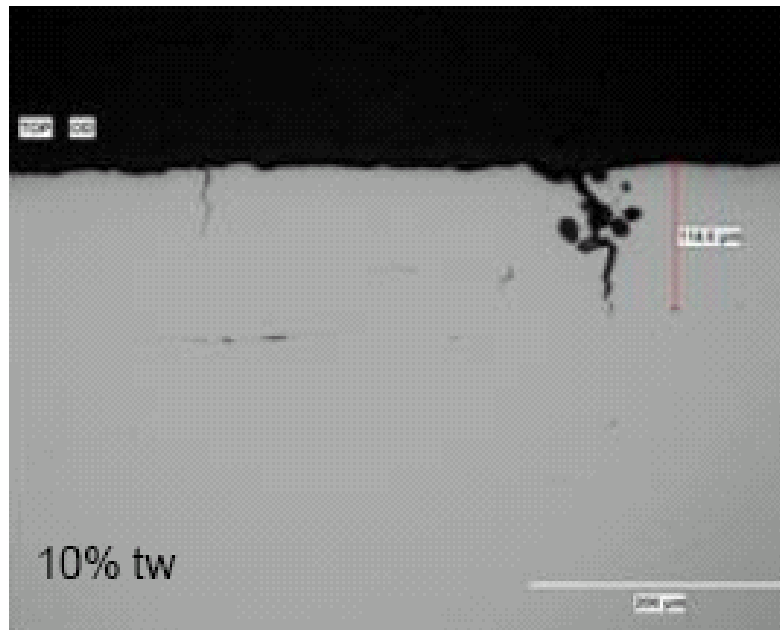
- 7 tubes had volumetric indications reported by both +Point and X-Probe. Metallurgical examination confirmed general corrosion and pitting in six tubes ranging from 0%tw to ~40%tw to 50%tw, without any evidence of IGA or cracking. The remaining tube had evidence of 35%tw general wastage, shallow IGA, including a 10%tw crack-like feature (Figure 4) and pitting with shallow IGA at the base (Figure 5).

**Figure 4 - IGA and 10%tw Crack-like Feature in BO4 R43C45**

| Year | SG | Row | Column | Reason | C-3/8 | +Point | | X-Probe | | | Metallurgical | | | |
|---|---|---|---|---|---|---|---|---|---|---|---|---|---|---|
| | BO4 | 43 | 45 | Random | NDD | VOL | | VOL | 32%tw | | | 10%tw crack, 3%tw IGA, 35%tw general | | Pitting, general corrosion and small circ. flaws. |

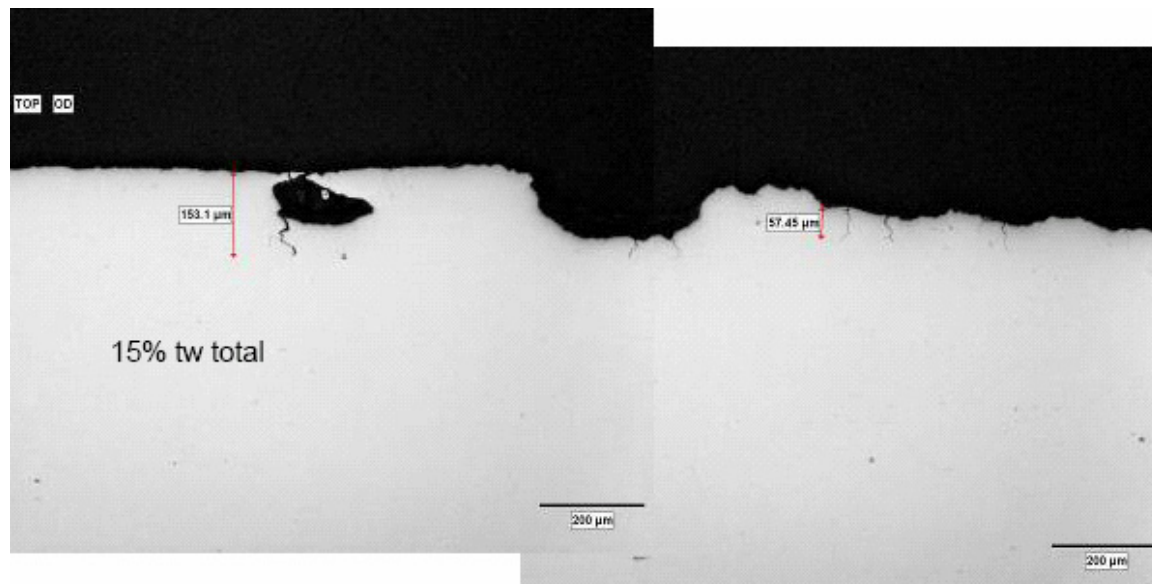
**Figure 5 - Pit with Shallow IGA at Base in BO4 R43C45**

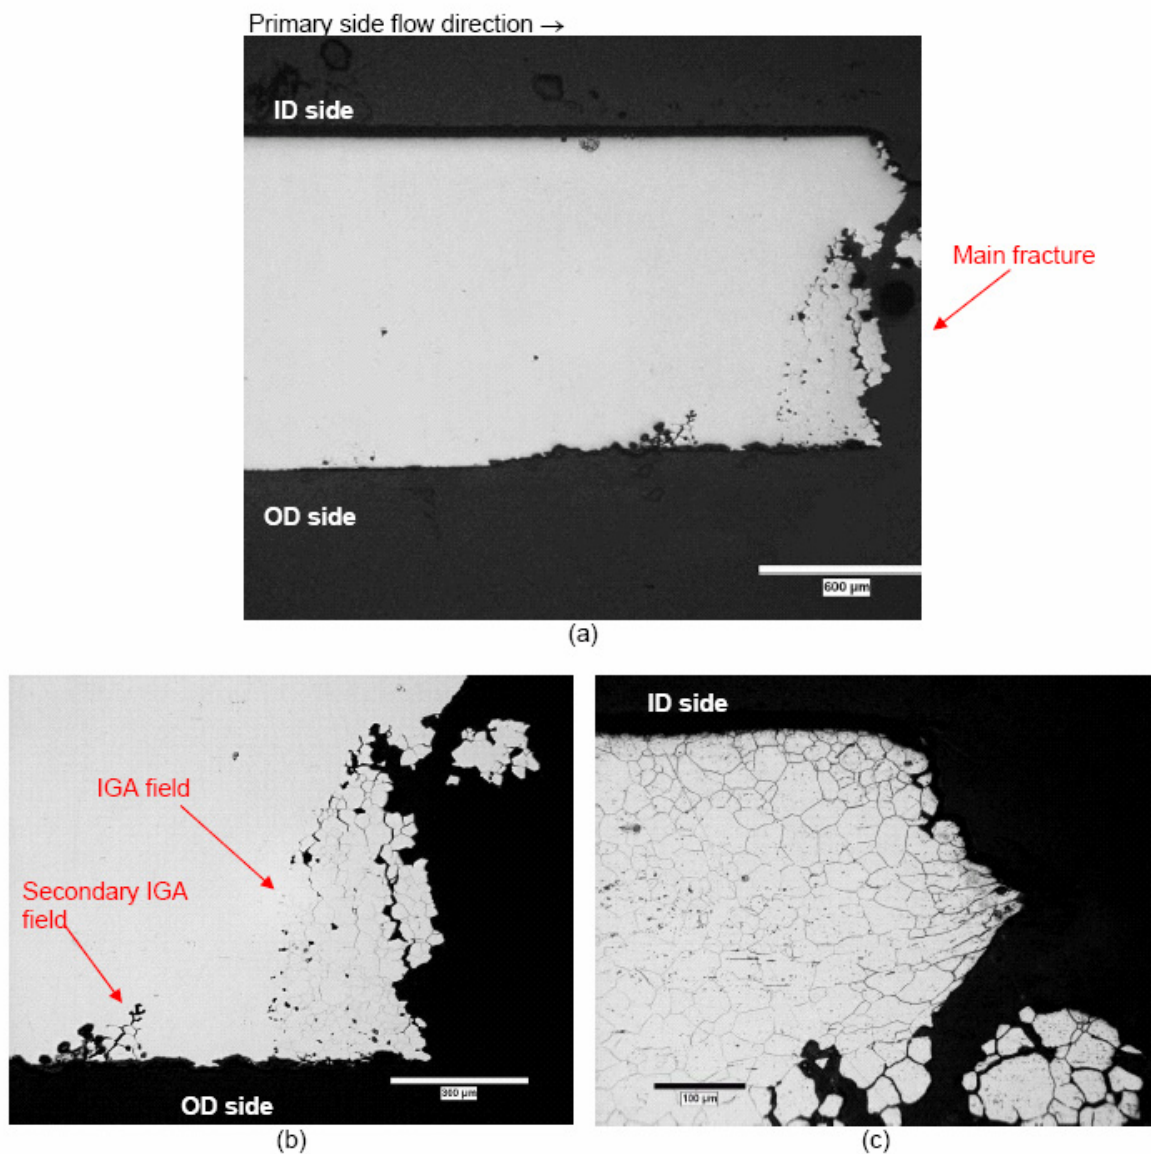
**Figure 6 - Tube Having 100%tw IGA Attack with Minimal Pitting or General Wastage (BO4 R27C59)**

| Year | SG | Row | Column | Reason | C-3/8 | +Point | | X-Probe | | | Metallurgical | | | |
|---|---|---|---|---|---|---|---|---|---|---|---|---|---|---|
| | BO4 | 27 | 59 | ET Ind. | 100%tw | SCI | 100 | SCI | 100%tw | 45 | | 100%tw | 60 tw | Broke, through-wall IGA |

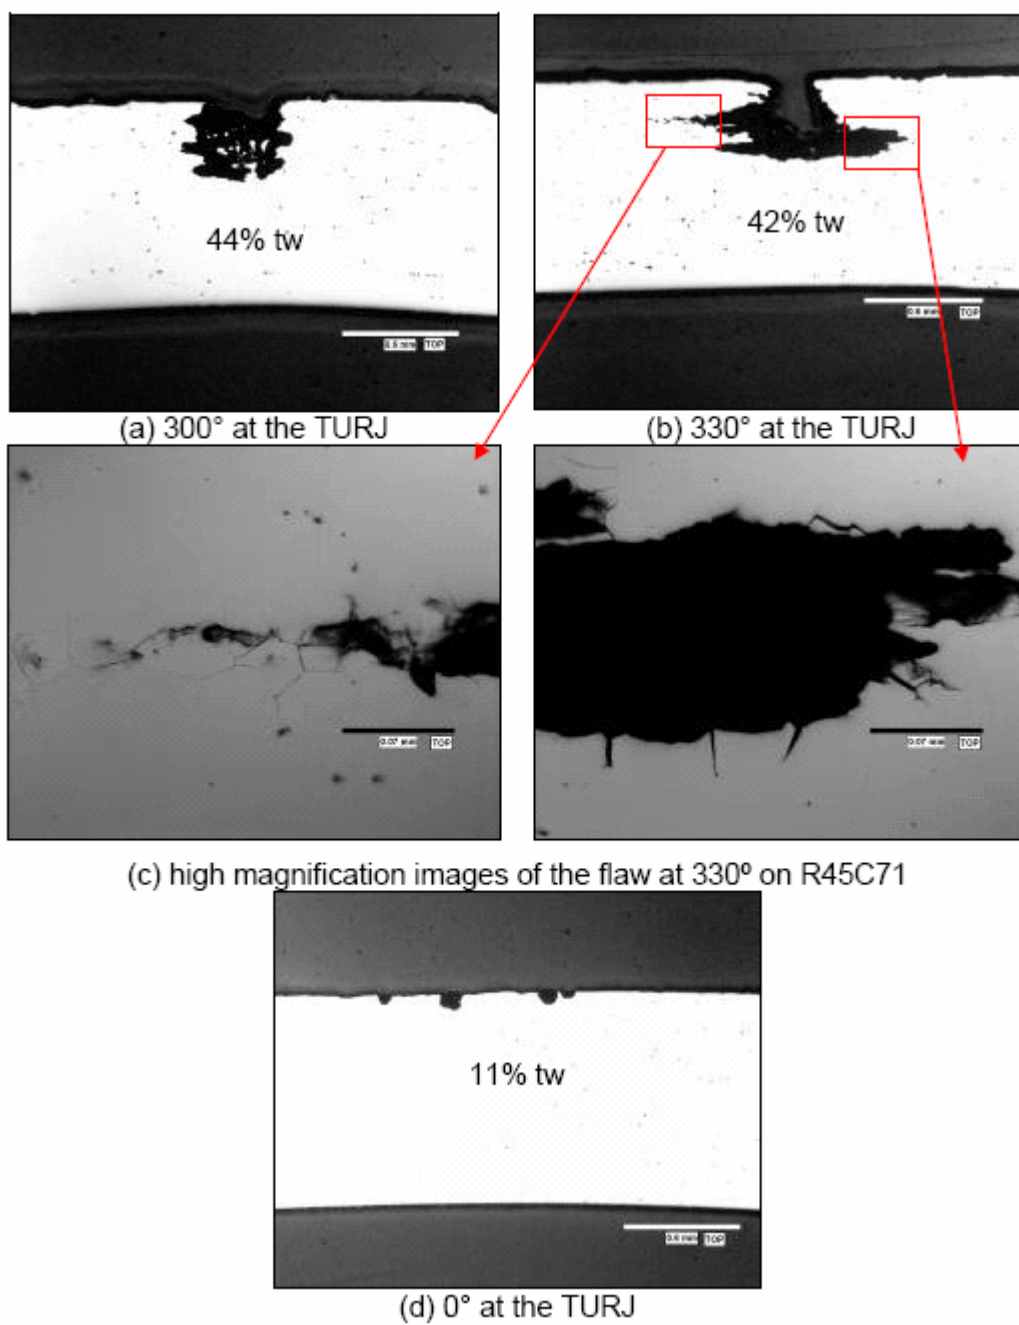
**Figure 7 – Tube Having Volumetric Pitting (BO6 R45C71)**

| Year | SG | Row | Column | Reason | C-3/8 | +Point | | X-Probe | | | Metallurgical | | | |
|---|---|---|---|---|---|---|---|---|---|---|---|---|---|---|
| | BO6 | 45 | 71 | ET Ind. | 39%tw | VOL | 72 | VOL | 30%tw | 120 | | 44%tw | | Pitting, no crack-like features. |

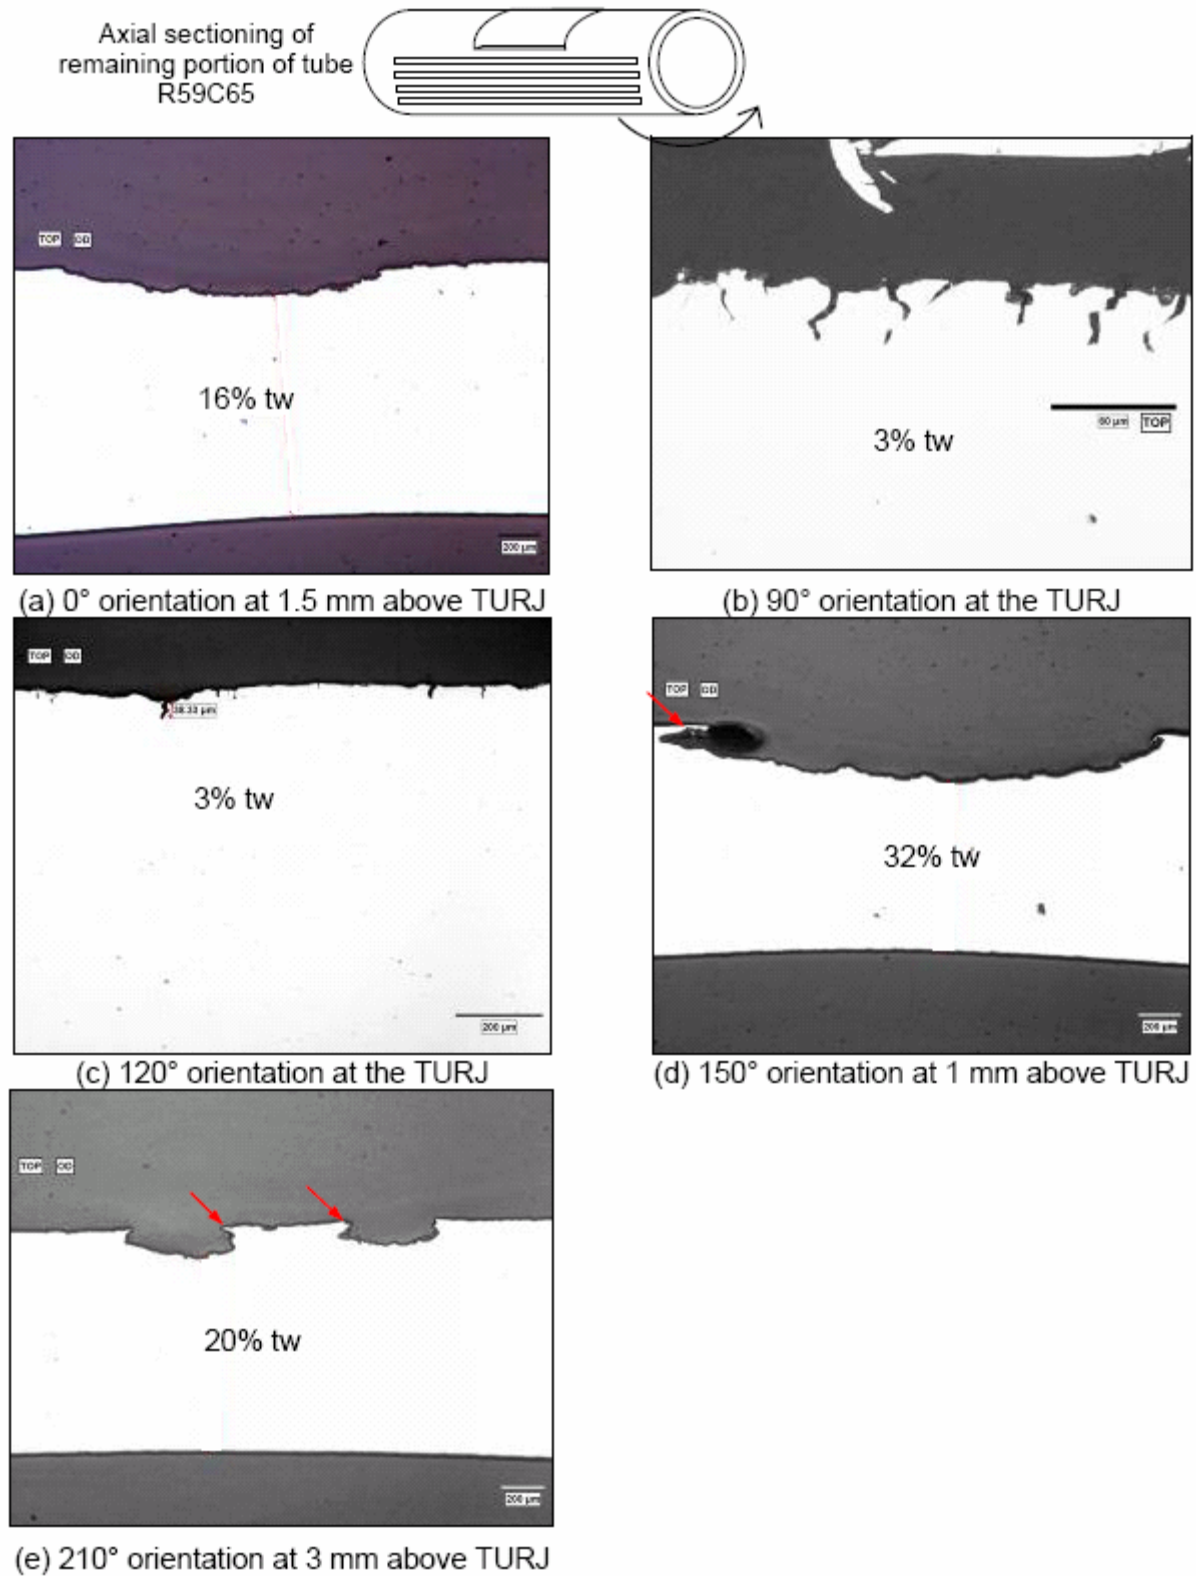
Figure 8 - Tube Having Volumetric Degradation and Wastage with some IGA (BO7 R59C65)

| Year | SG | Row | Column | Reason | C-3/8 | +Point | | X-Probe | | | Metallurgical | | | |
|---|---|---|---|---|---|---|---|---|---|---|---|---|---|---|
| | BO7 | 59 | 65 | ET Ind. | 40%tw | VOL | 145 | VOL? | 43%tw | ~45 | | 32%pit, crack not sized | < 20 | General attack, very small crack. |

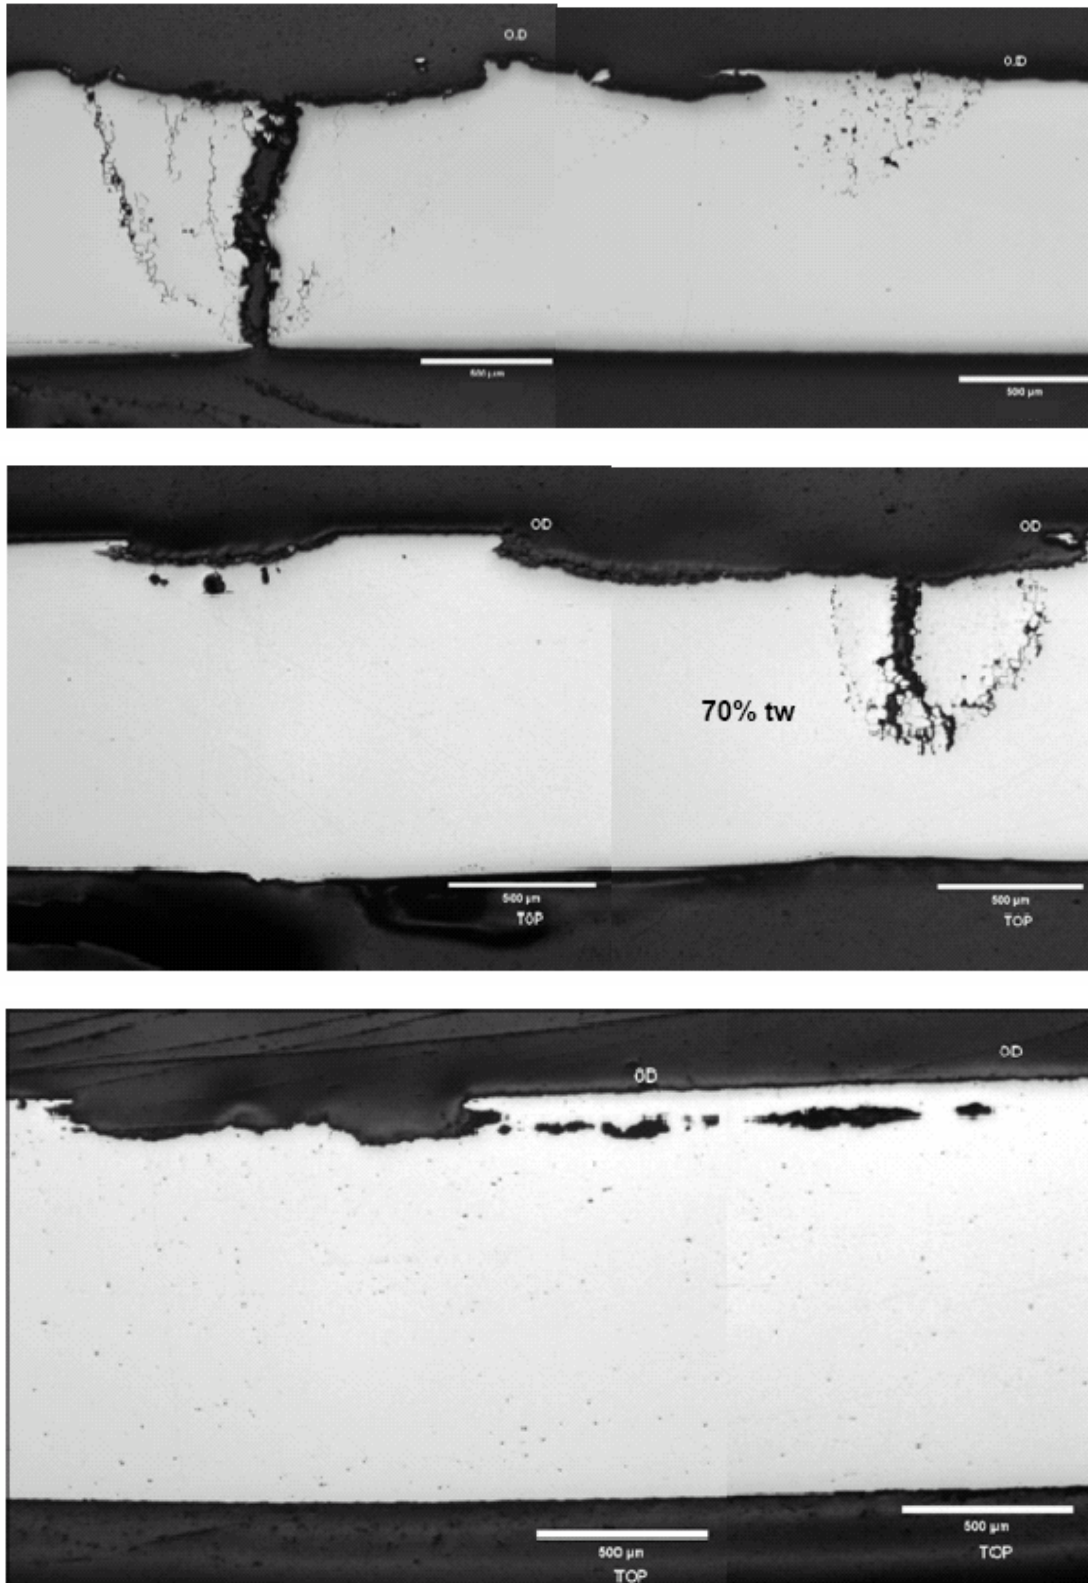
**Figure 9 - Degradation at Three Circumferential Locations Showing a 100%tw Crack in IGA, 70%tw IGA patch with Crack-Like Feature, and General Wastage (BO4 R27C55)**

| Year | SG | Row | Column | Reason | C-3/8 | +Point | | X-Probe | | | Metallurgical | | | |
|---|---|---|---|---|---|---|---|---|---|---|---|---|---|---|
| | BO4 | 27 | 55 | ET Ind. | 100%tw | SCI | 95 | SCI, VOL | 97%tw, 38%tw | 45 | | 100%tw | | Through-wall IGA, general wastage. |

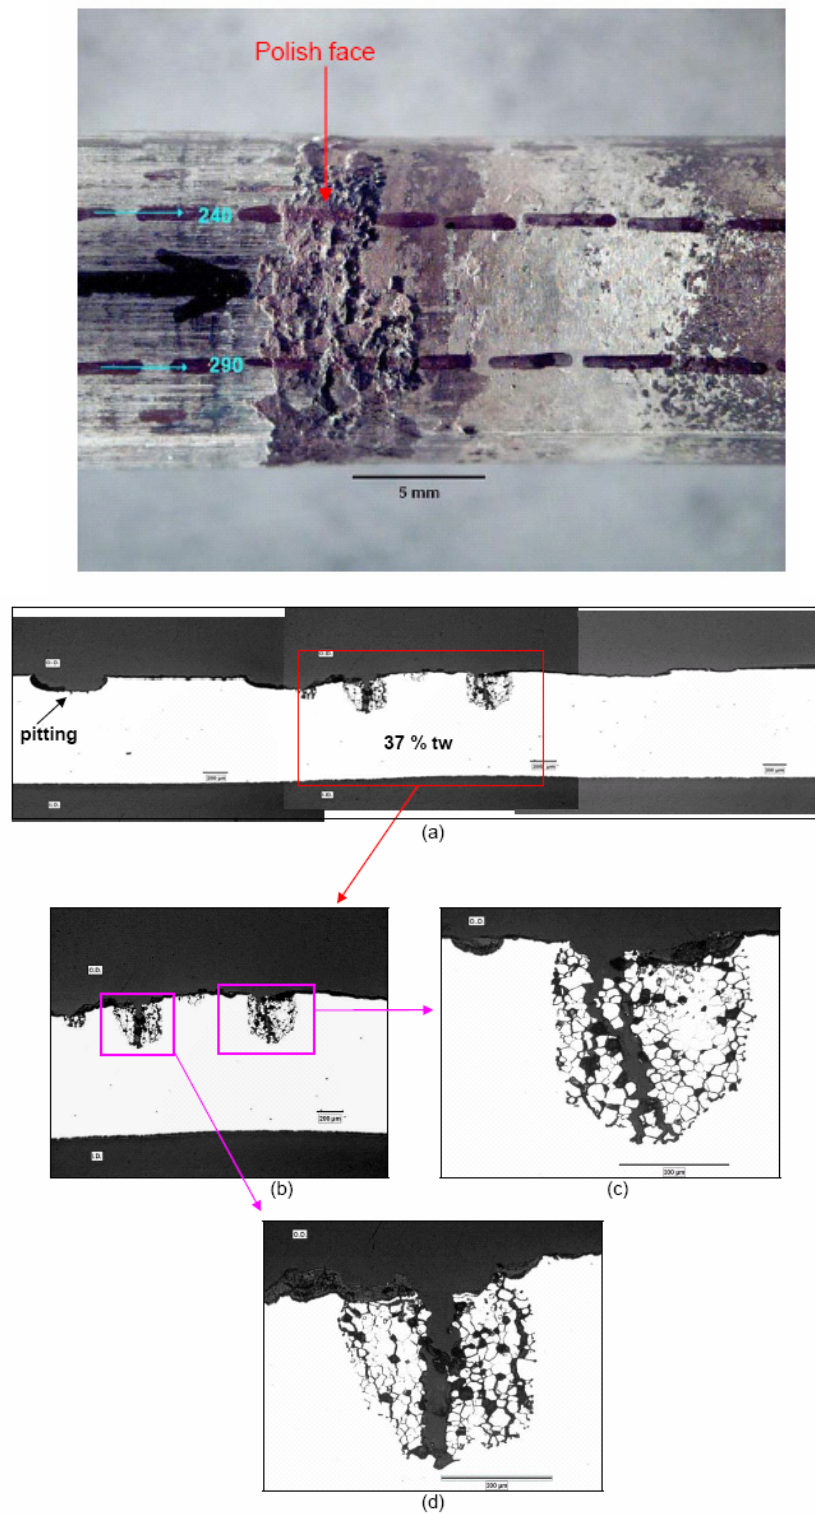
Figure 10 - Combined Volumetric and Circumferential IGA (BO4 R46C44)

| Year | SG | Row | Column | Reason | C-3/8 | +Point | | X-Probe | | | Metallurgical | | | |
|---|---|---|---|---|---|---|---|---|---|---|---|---|---|---|
| | BO4 | 46 | 44 | ET Ind. | 68%tw | MCI | 203 | SCI, VOLs | 67%tw, 34%tw | 45 | | 37%tw | ~25 | Trench-like pitting, wastage, IGA with circ features. |

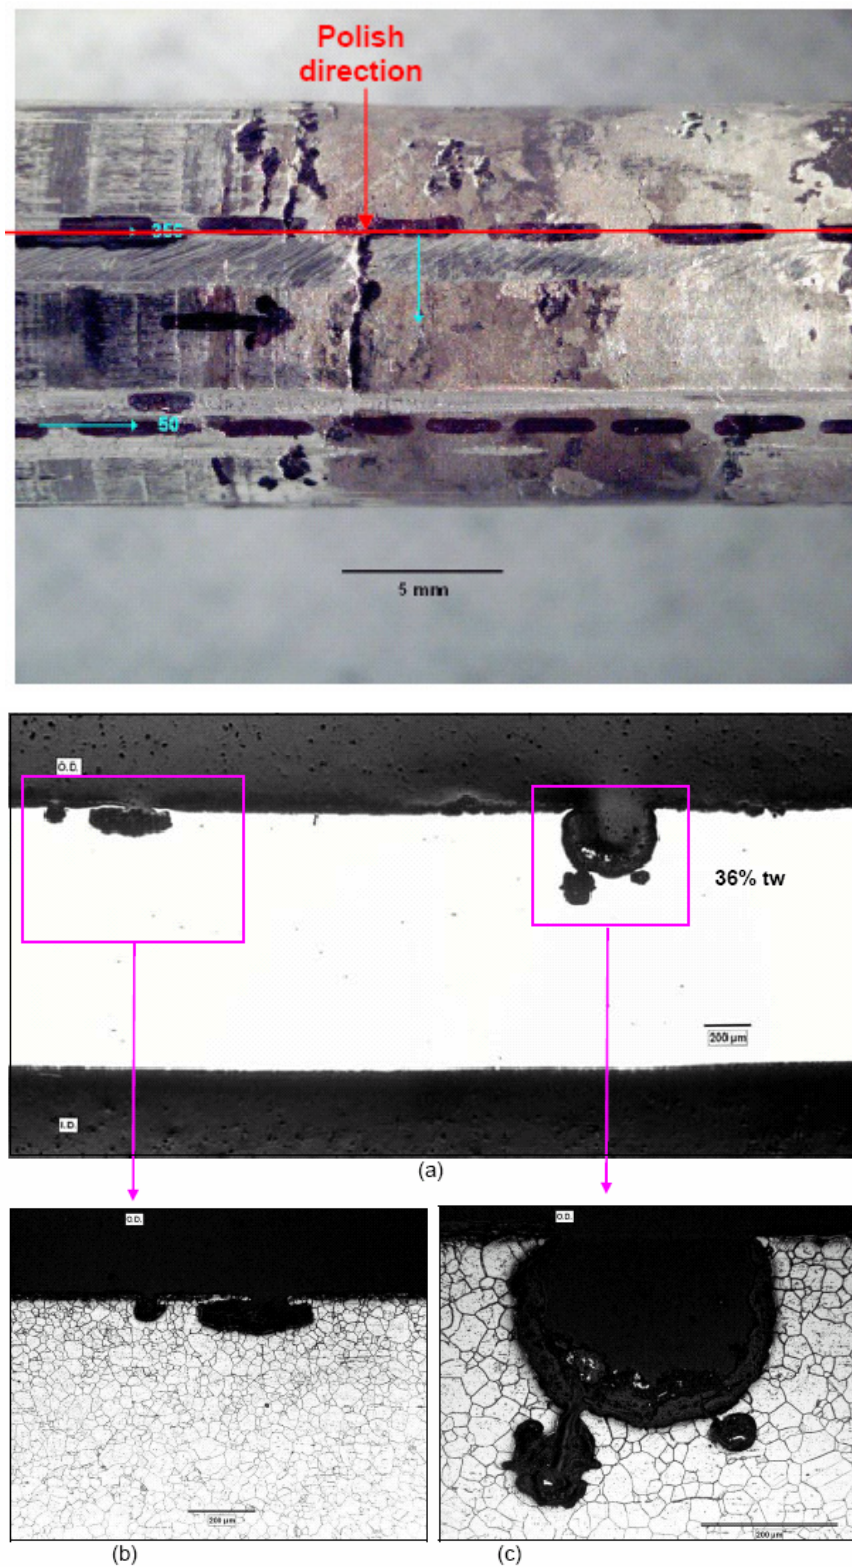
Figure 11 - Tube with Circumferentially Oriented Pitting (BO4 R36C80)

| Year | SG | Row | Column | Reason | C-3/8 | +Point | | X-Probe | | | Metallurgical | | | |
|---|---|---|---|---|---|---|---|---|---|---|---|---|---|---|
| | BO4 | 36 | 80 | ET Ind. | 67%tw | SCI | 207 | VOLs | 32%tw, 35%tw | | | 61%tw, 36%tw | | Pitting and general wastage, oriented circ. |

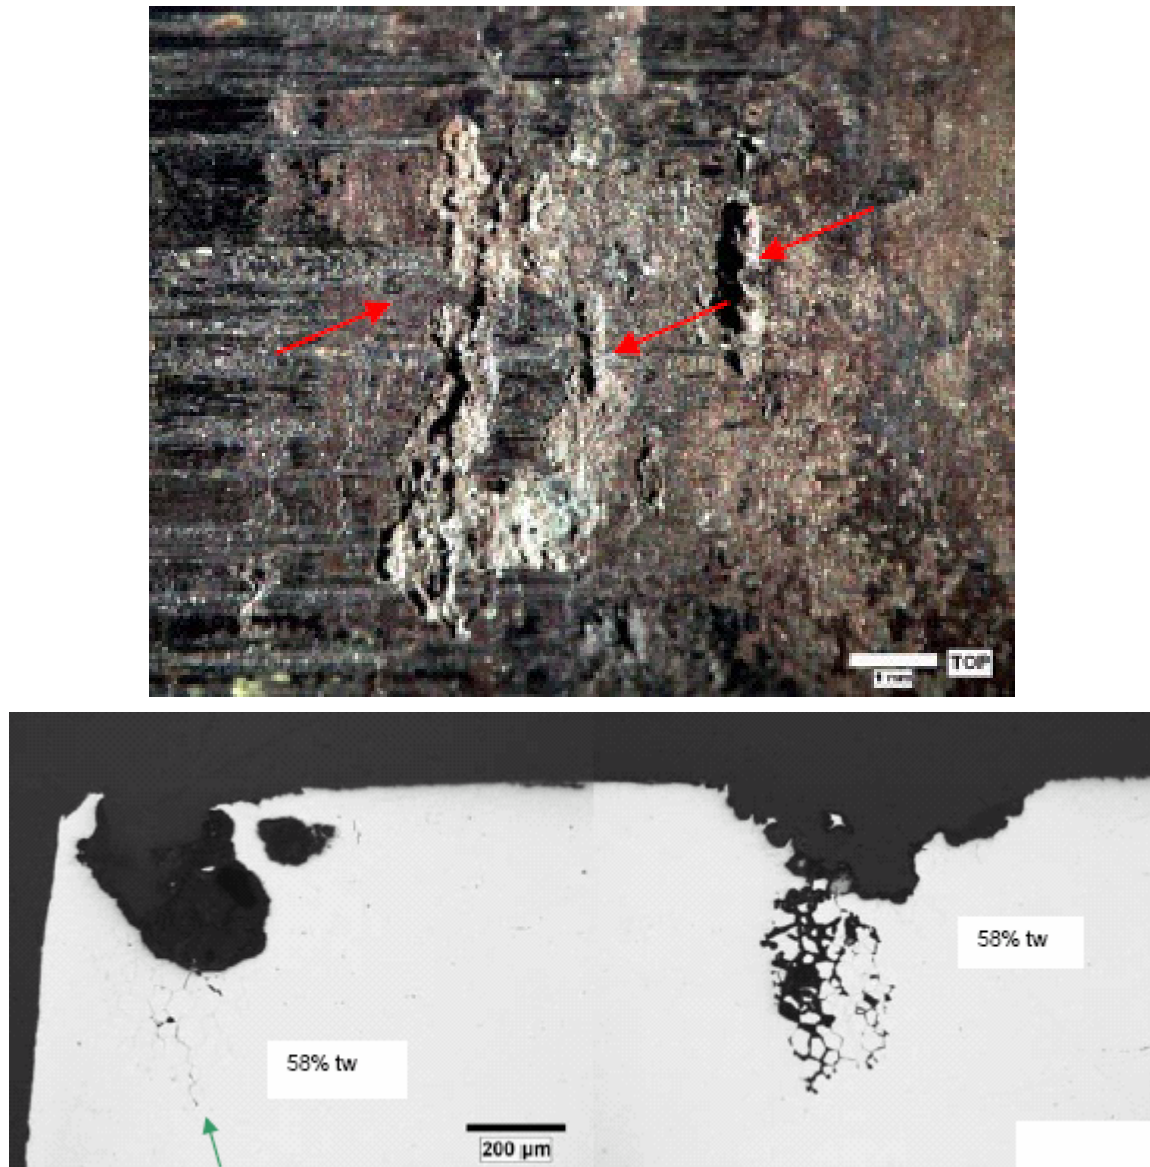
Figure 12 - Tube with Combination of Pitting and IGA (BO4 R26C34)

| Year | SG | Row | Column | Reason | C-3/8 | +Point | | X-Probe | | | Metallurgical | | | |
|---|---|---|---|---|---|---|---|---|---|---|---|---|---|---|
| | BO4 | 26 | 34 | ET Ind. | 4 NQI's | MCI | 77 | VOLs | 29%tw (72% after removal) | | | 20%tw pit, 62%tw IGA | | Multiple circumferential pits. |

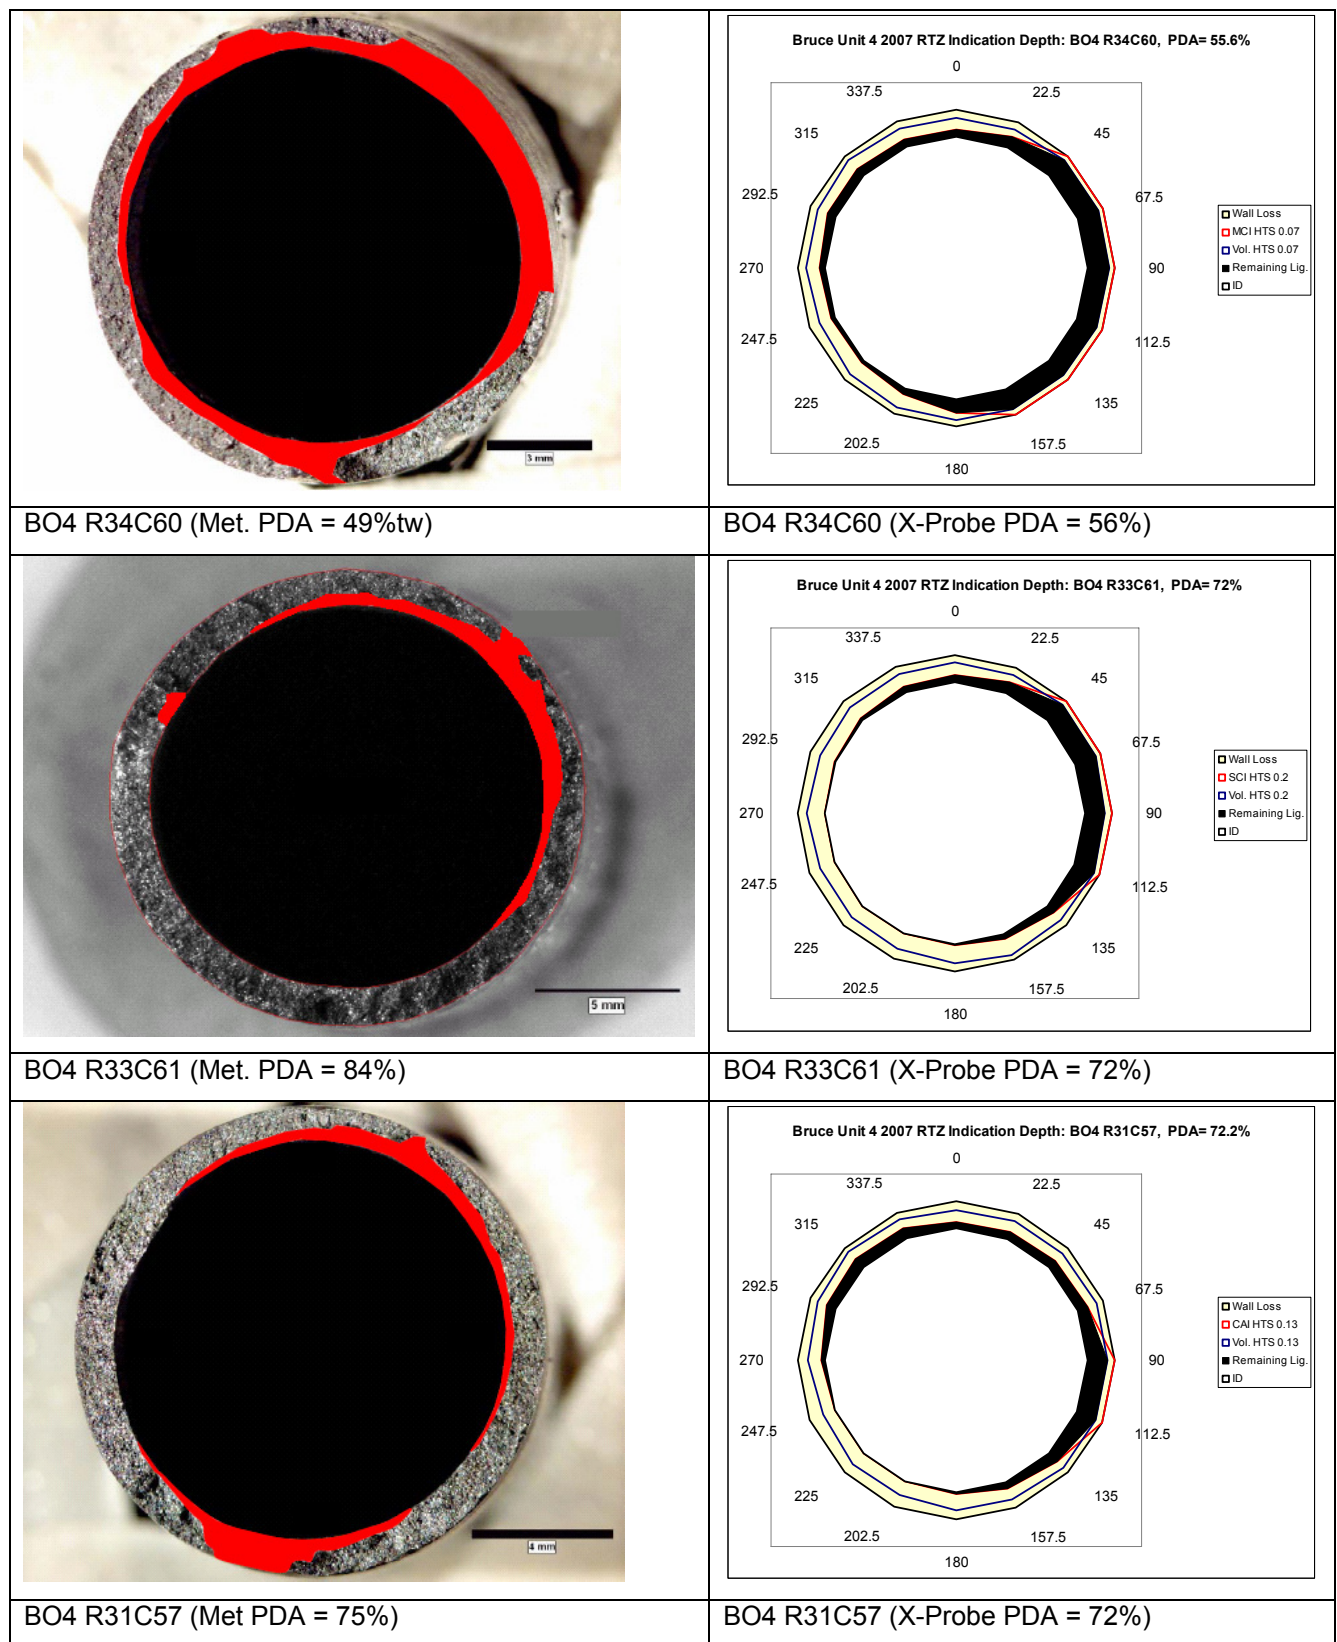
The X-Probe estimates of PDA are obtained based on the circumferential and axial (volumetric) depths reported on each of the X-Probe channels around the circumference of the tube. A comparison of the flaw profile obtained from the X-Probe with the profile obtained from metallurgical examination of three tubes removed from Unit 4 BO4 in the Spring of 2007 is provided in Figure 13. The X-Probe degradation

profiles show excellent agreement with the actual profiles obtained from metallurgical examination, and the X-Probe estimates of PDA are within  $\pm 10$  PDA of the true degraded area. As a result, it is possible to base the Fitness for Service assessments on the PDA of the observed and predicted flaw population, rather than being restricted to specific flaw models based on independently growing one or more circumferential and/or volumetric flaws.

Figure 13 - Comparison of PDA Based on Metallurgical and X-Probe Results
