# CASE STUDIES IN ROOT CAUSE ANALYSIS: IDENTIFYING OPPORTUNITIES FOR IMPROVED MAINTENANCE OF CANDU FUELLING MACHINES

M. SCHIPPKE, K. ELLISON, A. JÄRVINE<sup>1</sup>, and K. PICKLES<sup>2</sup>

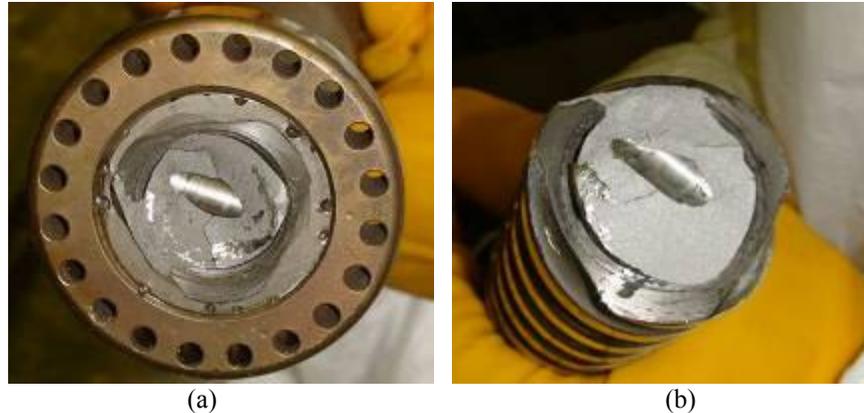
Photographs of the failed H6B Ram Ball Screw are shown in Figure 1.1. The images show the fracture of the ball screw within the extension tube and on the ball screw side. During assembly, the ball screw is threaded into the ram extension tube followed by drilling and reaming of the dowel hole and insertion of the dowel pin.

Figure 1.1: Field photographs taken of the failed ram ball screw. Figure 1a shows the ram extension tube side of the fracture and Figure 1b shows the ball screw side of the fracture.

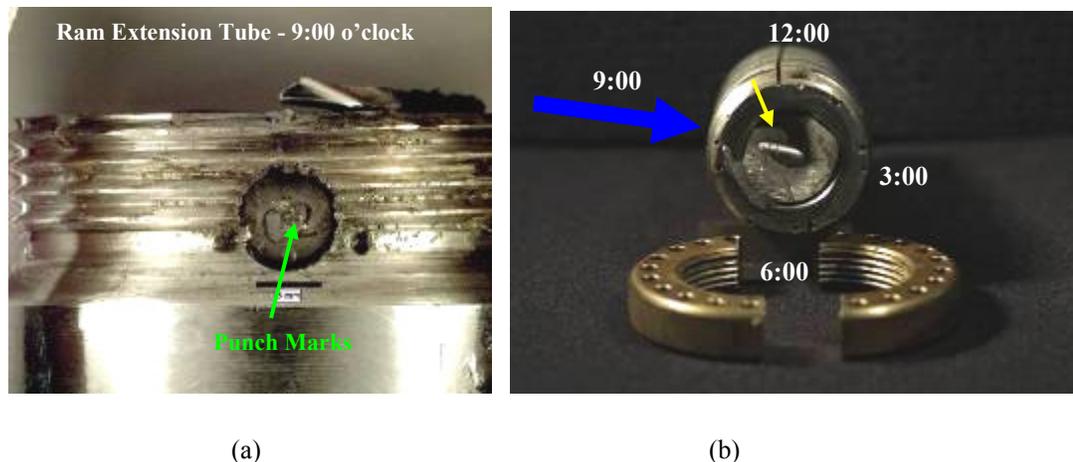
Figure 1.2: Laboratory photographs taken of the fracture surface within the ram extension tube following removal of the ring (a). Figure 1.2(b) illustrates the clock positions given to the dowel pin entrances for reference and the groove marks observed on the pin (yellow arrow).

Figure 1.2a illustrates the punch marks observed on the dowel pin, indicating the direction from which the pin was driven into the ram extension tube and ball screw assembly (9:00 o'clock). Circumferential grooves were observed on the dowel pin toward the 9:00 o'clock position (see yellow arrow in Figure 1.2a). The clock positions are slightly skewed so that the 3:00 o'clock and 9:00 o'clock correspond to the dowel hole openings. The large blue arrow shows the suspected direction of force applied to the ram tube during the staking of the dowel pin.

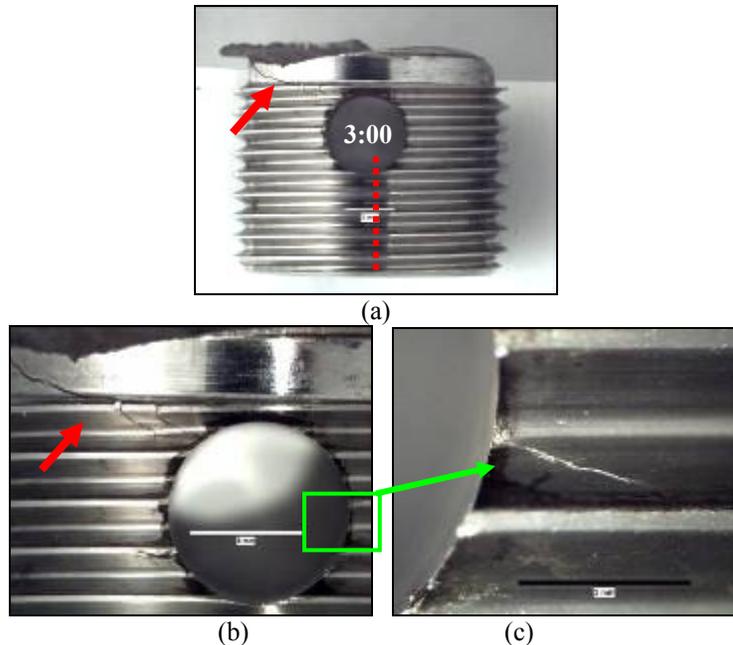
Thread damage was observed on the ram extension tube and the ball screw at the dowel hole entrances. In particular, the edges of the threads, at the entrance of both ends of the dowel hole in the ball screw, sustained obvious mechanical damage, characterized by plastic deformation. Cracks were observed, emanating from both ends of the dowel hole, which were linked to the primary fracture surface (Figure 1.3). A small secondary crack was also identified emanating from a thread root at the dowel hole entrance at the 3:00 o'clock position (Figure 1.3b&c).

Figure 1.3: Macro images of the dowel hole entrance on the ball screw at the 3:00 o'clock position. The red arrows highlight the primary fracture. The boxed region in (b) is shown at higher magnification in (c).

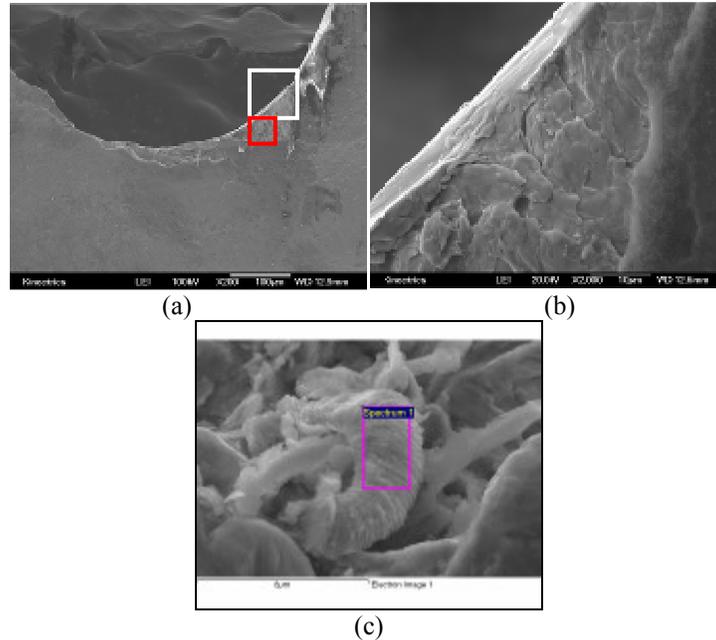
High magnification, secondary electron images of the damage observed on the threads at the 3:00 o'clock position, looking from the inside surface of the dowel hole, are shown in Figures 1.4 and 1.5. Cracks were found emanating from the thread roots and fracture surfaces were present on the thread flanks. Microscopic examination of the fracture surface morphology revealed the presence of transgranular cleavage facets (Figure 1.4b). Within the fracture surfaces, debris was observed buried within the deformed and fractured region at the root of one of the threads (Figure 1.4c). The debris appeared as curly, metal shavings, and the shape and morphology of the shavings are consistent with metal turnings produced by reaming operations. Elemental analysis of the debris revealed that the debris had a very similar composition as the ball screw base material.

Figure 1.4: Secondary electron images of a crack observed at a thread root on the inside diameter of the dowel hole at the 3:00 o'clock position. The white boxed region is shown at higher magnification in (b). The red boxed region is shown at higher magnification in Figure 11c.

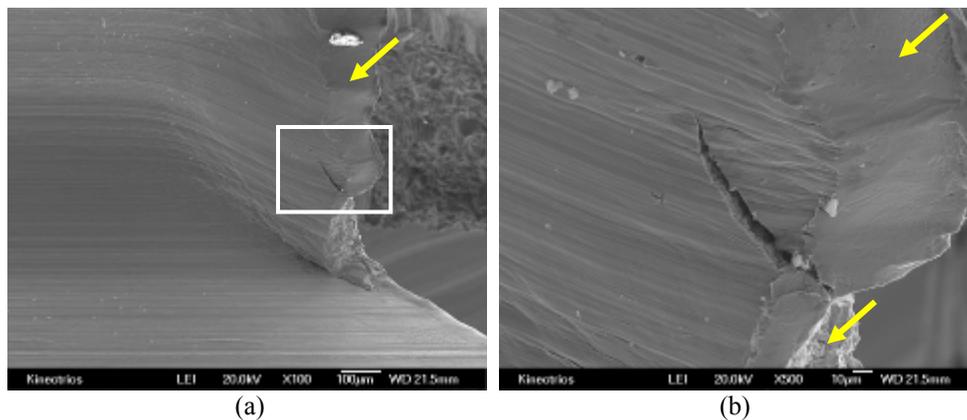
Representative SEM images of the thread damage observed on the threads at the 9:00 o'clock position are shown in Figure 1.5. Smear and folded over metal observed on the thread faces and at the thread root suggest that the threads at the dowel hole sustained mechanical damage.

Figure 1.5: Secondary electron images of one of the threads at the 9 o'clock position, showing thread deformation (yellow arrows) and secondary cracking emanating from the thread face. The image shown in (b) is a higher magnification image of the boxed region in (a).

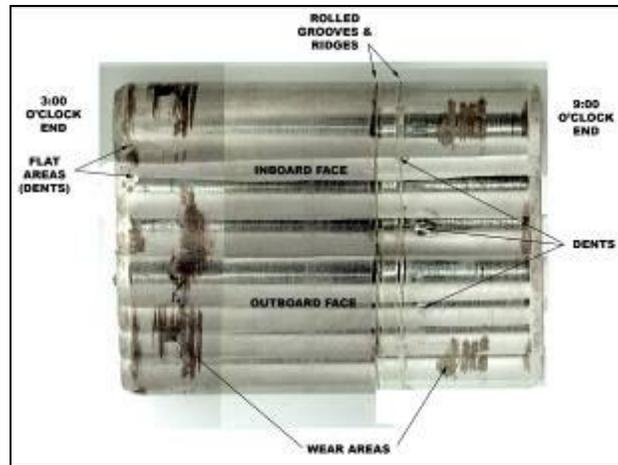
Circumferential wear marks were observed at the ends of the pin where the pin contacts the ID of the dowel hole inside the ball screw at the 3:00 and 9:00 o'clock position. A cylindrical projection of the pin surface, highlighting the rolled-in grooves and mechanical damage observed around the circumference of the pin, is shown in Figure 1.6. Areas of wear and mechanical damage were observed towards the 3:00 o'clock and 9:00 o'clock ends of the dowel pin surface.

Figure 1.6: Cylindrical projection of the dowel pin surface, highlighting the rolled-in grooves and mechanical damage observed on the pin surface.

Macro examination of the tapered ends of the pin revealed the presence of mechanical damage, which may have caused the diameter of the pin at this location to be reduced. Diameter measurements taken at indents on the tapered end of the 3:00 o'clock position (identified as flat areas or dents in Figure 1.6) revealed that the pin diameter was mechanically reduced by  $0.0054''$ .

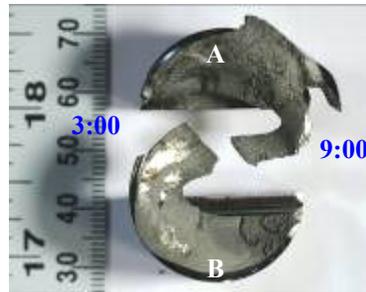
The extension tube side of the fracture surface was cut axially up to the dowel hole, as shown by the dotted line in Figure 1.3a, to facilitate further examination of the dowel hole ID and primary crack origins. Once the piece was cut, the fracture surface was opened into two pieces, which for reference purposes, were labeled A-side and B-side (Figure 1.7).

Figure 1.7: Photograph of the fracture surface of the ball screw pertaining to the extension-tube side of the fracture.

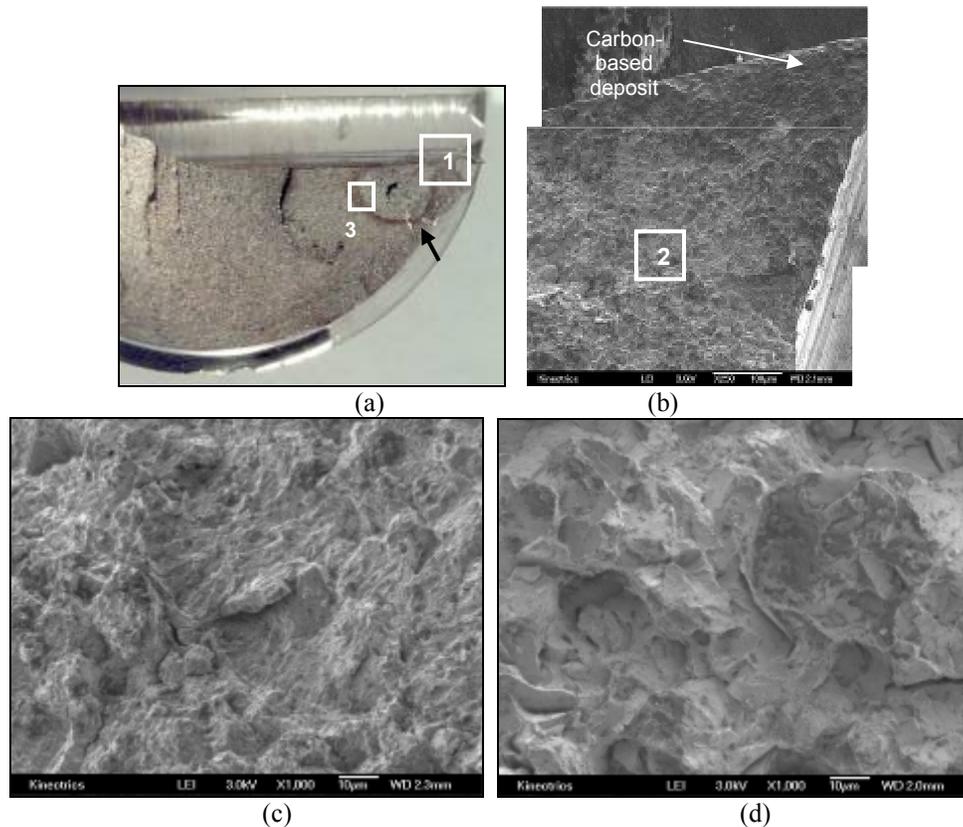
Macro image of the B-side fracture surface at the crack origin site at the 9:00 o'clock position is shown in Figure 1.8. A thumbnail crack, characterized by the dark radial stain (arrow of Figure 1.8), was observed at the intersection of the dowel hole and threads. High magnification examination of the fracture surface morphology, using SEM, was performed at the regions highlighted by the boxes in Figure 1.8. Energy Dispersive Spectroscopy (EDS) examinations of the crack origin region revealed the presence of carbon-based deposits on the fracture surface. The carbon deposits obscured the features of the underlying fracture.

Figure 1.8: Macro image of the B-side fracture surface at the crack origin site, 9:00 o'clock position, detailing the locations where high magnification SEM analysis of the fracture surface was performed (a). Secondary electron images of the crack origin; the image shown in (b) corresponds to box 1, the image shown in (c) corresponds to box 2, and the image shown in (d) corresponds to box 3.

Just beyond the carbon deposit, the fracture surface exhibited intergranular features followed by a narrow zone of transgranular cleavage. Beyond the narrow zone of transgranular cleavage, the fracture

morphology was characteristic of intergranular crack propagation. Beyond the latter and through to final separation of the ball screw, crack growth was predominantly by transgranular fracture.

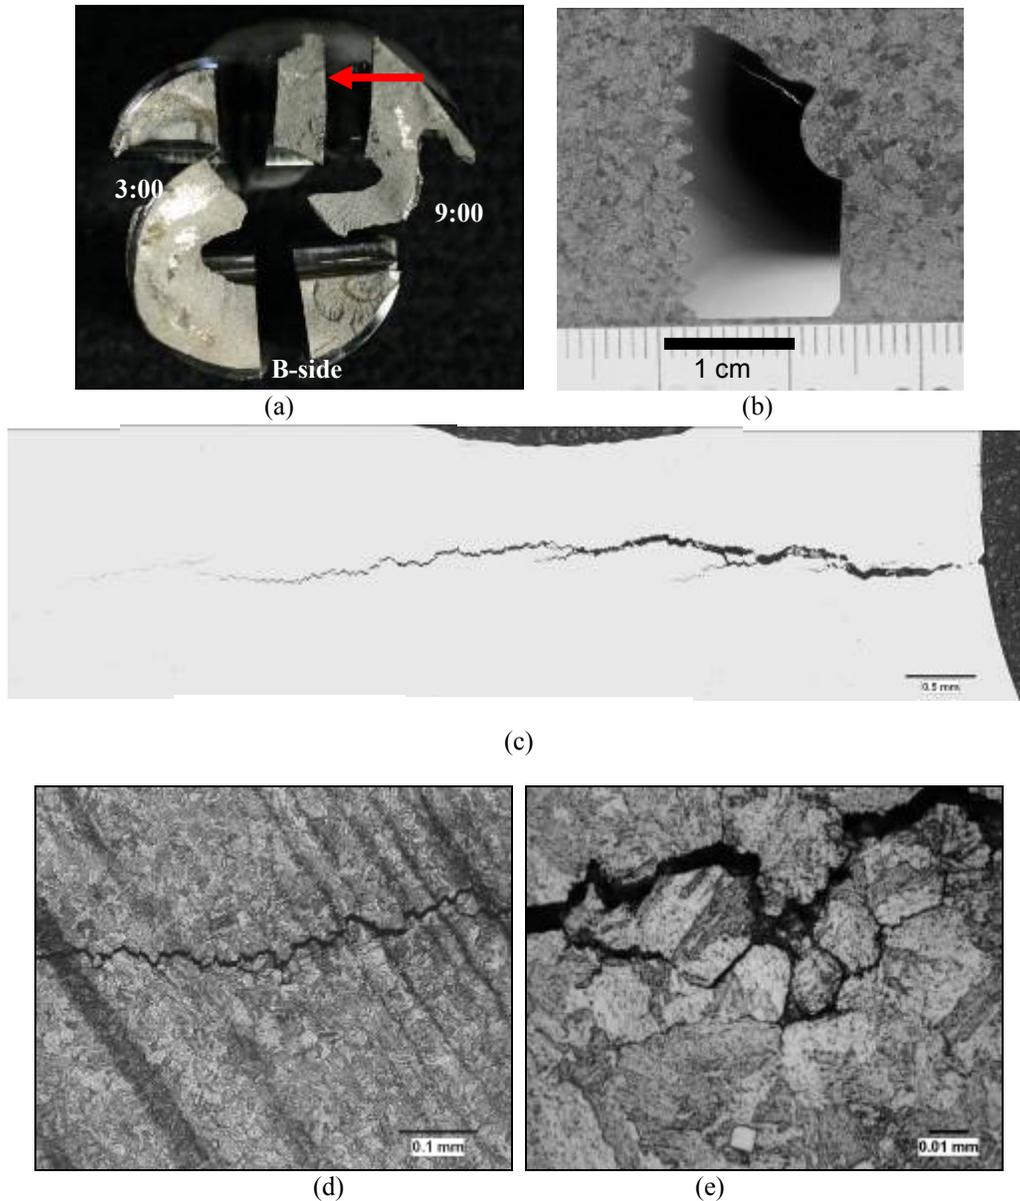
A photograph of the ball screw fracture surface, following sectioning, is shown for reference in Figure 1.9a. The arrow in the image points to the cross-sectional plane used for metallography shown in Figures 1.9b-e. The axial section shows a large crack, which propagated parallel to and beneath the main fracture surface (Figure 19.b). The crack contains several branches and its tortuous propagation path suggests that the crack propagated in an intergranular mode (Figure 1.9c). After etching, the intergranular crack propagation path was confirmed, Figure 1.9 d&e.

Figure 1.9: The cutting plan of the ball screw fracture surface for metallographic examination is shown in image (a). Image (b) shows the cross-sectional plane examined in (c) through (e). Optical micrographs of the crack, before and after etching, are shown in image (c) and (d&e) respectively.

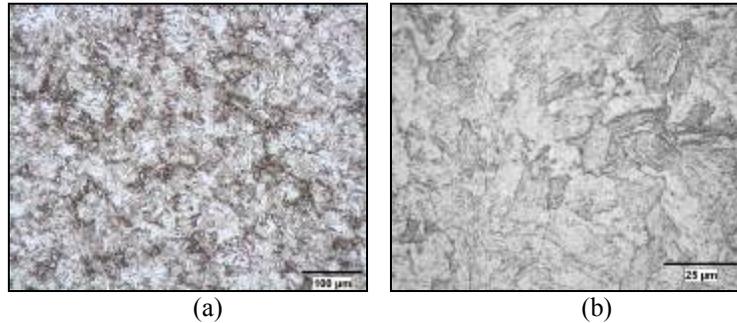
Characterization of the ball screw base material was performed. Chemical analysis by inductively-coupled plasma (ICP) was performed on the ram ball screw bulk material and indicated that the material was in conformance with Custom 455, as detailed in the specification [1]. Optical micrographs of the base metal microstructure in the transverse direction are shown in Figure 1.10. The base metal microstructure consists of a banded, martensitic structure. With the exception of the banding, the microstructure is typical of Custom 455® alloy.

Figure 1.10: Optical micrographs of the bulk microstructure in the transverse direction. Image (b) is a higher magnification image of a representative region of (a).

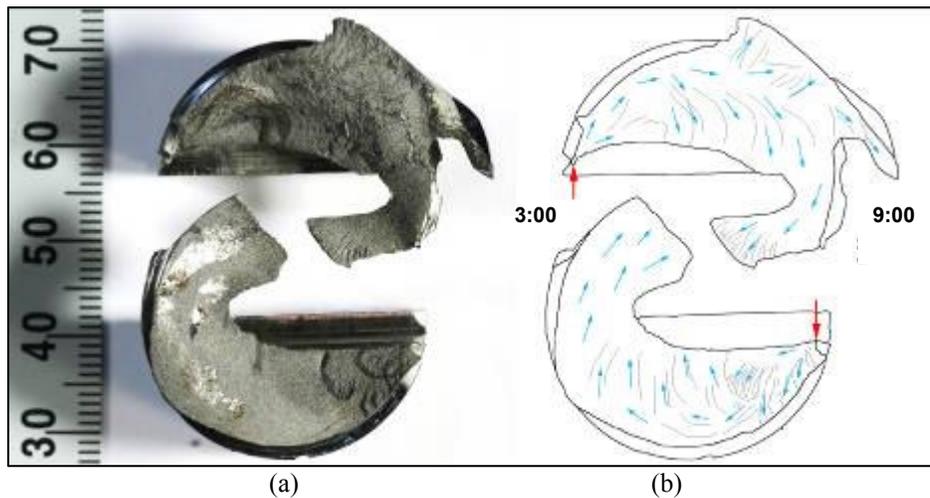
Figure 1.11: Macro image of fracture surface (a) and applied loading diagram (b). The red arrows point to the primary fracture origins where the dowel pin contacted the dowel hole and damage was imparted to the threads during installation. The blue arrows highlight the direction of crack growth, which led to the final failure of the ball screw.

Given the circumstances of the failure, and the evidence collected from this investigation, the metallurgical cause of the failure was identified as intergranular stress corrosion cracking (IGSCC), initiated from previously formed microcracks located at the intersection of the dowel hole with the ball screw threads.

The apparent root cause was attributed to improper procedures associated with the installation of a dowel pin during the overhaul of the charge tube in March 2006 and IGSCC. More specifically, micro-cracks were introduced around the entrance of the dowel hole in the ball screw during the insertion of a dowel pin. The IGSCC initiated from these micro-cracks. Literature states that tensile stresses, even below yield, are sufficient to cause SCC and may result from bolting and fastening parts that fit together imperfectly [2]. The ball screw suffered complete fracture as a result of the following contributing factors: (1) operator response to ram encoder errors on February 22, 2008 led to sustained static loads on the ram assembly, which promoted IGSCC (primary factor), (2) the ball screw alloy was aged to a condition that provided adequate hardness in this application, but did not provide optimal resistance to IGSCC (secondary factor), and (3) higher than expected hardness values point to insufficient time at temperature during aging of the ball screw alloy, resulting in an enhanced susceptibility to SCC (least significant factor).

- Non-destructive examination of all existing and in-service ram assemblies should be performed to check for evidence of thread damage. Given the size of the pre-existing microcracks observed in this

investigation, crack-like flaws capable of initiating IGSCC may go undetected using conventional NDE methods. Consequently, the standard NDE examinations should be supplemented by replica examinations of the ball screw dowel holes at the next available overhaul. This action addresses the risk to other assemblies arising from the apparent root cause of the failure.

- Installation procedures regarding drilling and reaming the dowel hole into the ram extension tube and ball screw assembly, as well as the insertion of the dowel pin, require more specific trouble-shooting criteria when over-sized pins are encountered. Therefore, revision of the mechanical maintenance procedure is recommended as a means of mitigating future occurrences.
- Minimizing the amount of time the ram is spent in the full retract position during manual operations addresses the primary contributing factor to this failure.
- Carpenter Custom 455® precipitation-hardened stainless steel, in the H950 condition, is inherently susceptible to IGSCC. It is suggested that an alternate material, such as Custom 465®, be considered for this application. This addresses the second and the third contributing factors to the failure.

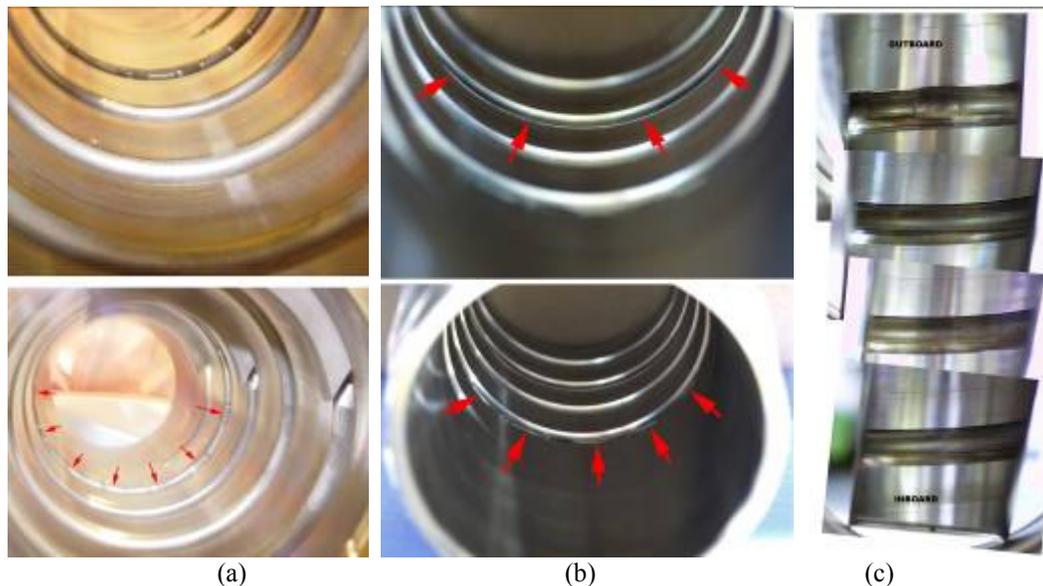
Photographs of the interior of the damaged rear nut S/N 92 from H5B are shown in Figures 2.2. When viewed from the inboard end of the nut, there was obvious wear of the outboard surface of the rear ball track, as highlighted by arrows in Figure 2a. The damage comprised an intermittent or alternating pattern of heavy wear versus light wear along the length of the ball track, as highlighted by the arrows in Figure 2.2a. The damage was confined to the last  $\sim 300^\circ$  of the ball track, ending at the outboard exit hole. The angular width of the heavily worn areas was approximately  $12^\circ$ . In addition, the heavily worn areas were separated from each other by approximately  $12^\circ$ . Thus it appeared that the wear scars were introduced at alternating ball locations. It was noted that the  $12^\circ$  angular distance was roughly equal to the width of one individual ball. The damage did not appear to be caused by plastic deformation (or “Brinnelling”) of the ball tracks, since there was no evidence of deformation of the adjacent surfaces. When viewed from the outboard end of the nut, the inboard sides of the front and rear ball tracks did not show any evidence of wear. However, the outboard edges of all tracks were raised and sharpened, presumably due to wear caused by contact with the balls (Figure 2b).

Figure 2.2: (a) Interior view of the rear ball nut S/N 92 from H5B, looking towards the outboard end (b) interior view of the rear ball nut S/N 92 from H5B, looking towards inboard end. (c) Mosaic image of the ball tracks on the left side of the nut, view looking outboard with the ball deflector stud holes facing up.

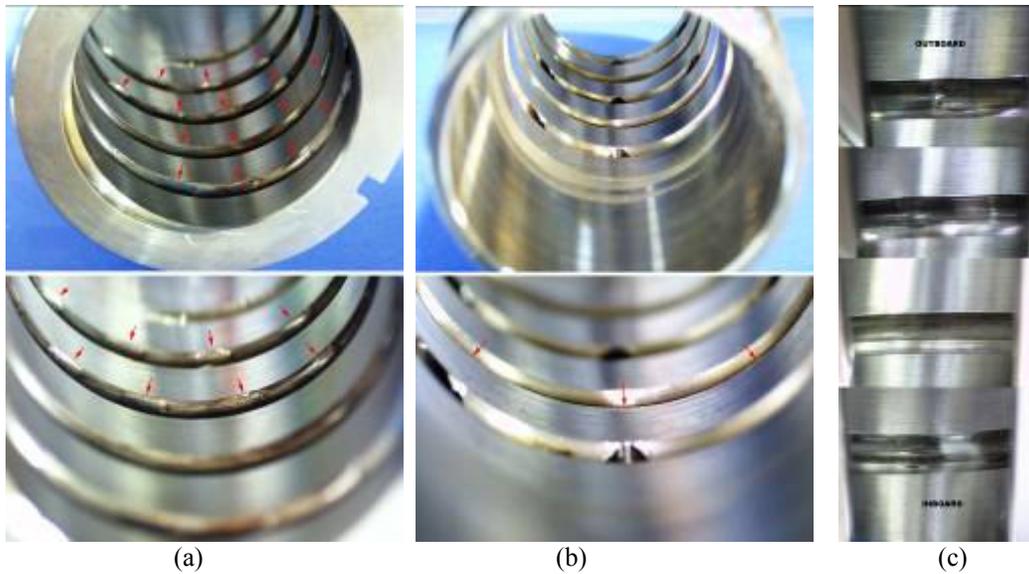
Photographs of the older rear ball nut S/N 96 are shown in Figure 2.3. Localized wear areas on the outboard surfaces of the front and rear ball tracks are indicated by the red arrows. The inboard surfaces of the front and rear ball tracks did not show any evidence of wear. The outboard edges of the tracks were raised and sharpened due to deformation or wear caused by contact with the balls. Both the front and rear ball tracks of this rear nut displayed extensive wear on the outboard surfaces, with an alternating pattern similar to that observed on the H5B rear nut S/N 92. Once again, the damage comprised an intermittent or alternating pattern of heavy wear versus light wear along the entire length of each ball track.

Figure 2.3: (a) Interior view of the older rear ball nut S/N 96, looking towards the outboard end. (b) Interior view of the older rear ball nut S/N 96, looking towards the inboard end. (c) Interior view of the older rear ball nut S/N 96. Mosaic image of the ball tracks on the bottom of the nut, with the ball deflector stud holes facing up.

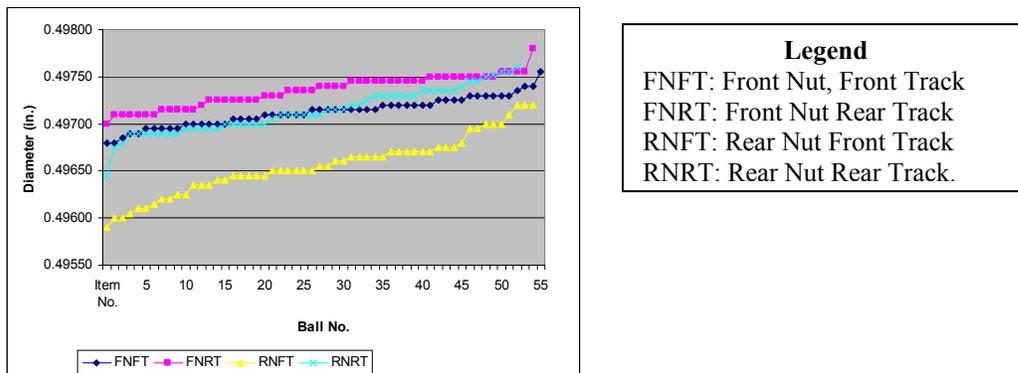
Figure 2.4. Diameter of the balls from the front and rear ball nuts from H5B.

The diameter of most of the front nut (front and rear tracks) and the rear nut rear track balls varied from approximately 0.4970 inches (12.624 mm) to 0.4975 inches (12.637 mm), representing a loss of between

0.0025 inches (0.064 mm) and 0.0030 inches (0.076 mm). In contrast, the diameter of the majority of the rear nut front track balls varied from approximately 0.4960 inches (12.598 mm) to 0.4970 inches (12.624 mm), representing a loss of between 0.0030 inches (0.076 mm) and 0.0040 inches (0.102 mm) in the diameter of the balls.

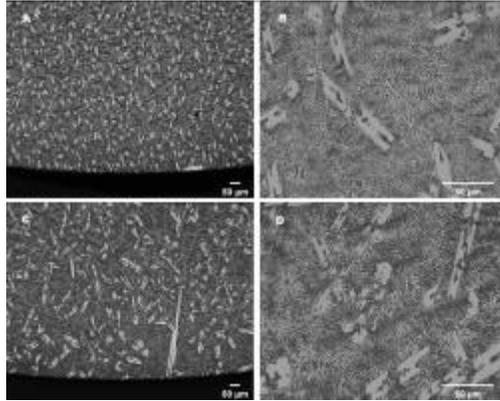
Figure 2.5: Optical micrographs obtained from two balls from H5B front nut S/N 84. A, B: front track; C, D: rear track.

Figure 2.5 shows representative optical micrographs from balls selected at random from each of the four sets. The balls displayed a cast microstructure, comprising carbides of varying length embedded in a cobalt-base matrix. In some of the cross-sections, the carbides were more elongated than in other sections (e.g., Figure 2.5c). None of the balls exhibited excessive micro-porosity.

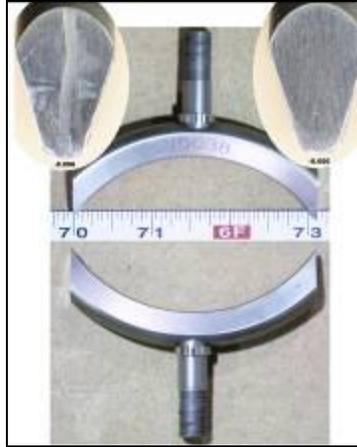
With the exception of the rear nut inboard deflector S/N 38, all of the deflectors showed evidence of wear on both ends of the deflectors. The right side of S/N 38 was unused. The maximum depth of ball wear (0.006 inches) was noted on the end of deflector S/N 38 (rear, inboard).

Figure 2.6: Photographs of rear nut S/N 92, inboard ball deflector S/N 38.

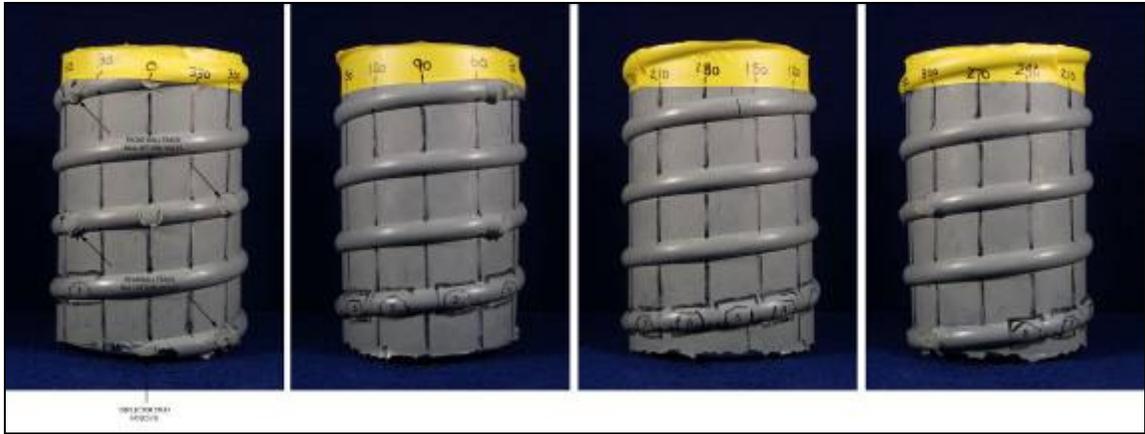
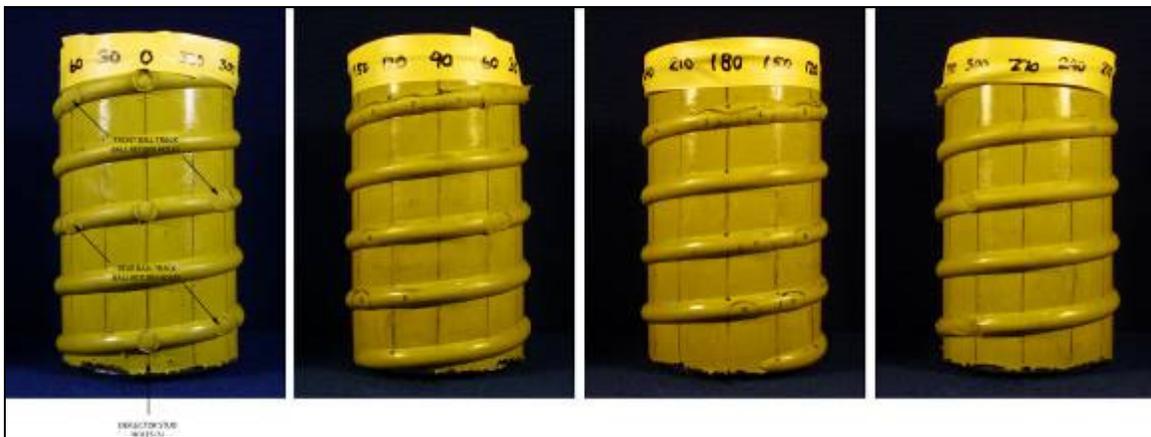
Figure 2.7: Photographs of the rubber impression mold used for measurement of ball groove wear depth in rear ball nut S/N 92 (a) and rear ball nut S/N 96 (b). Numbered circles indicate areas of enhanced wear.

The maximum depth of localized wear was 1.02 mm (0.040 inches) in the rear ball track of rear ball nut S/N 92, approximately 180° opposite from the deflector stud holes. Rear ball nut S/N 96 exhibited localized wear as deep as 0.63 mm (0.025 inches) in both the front and rear ball tracks. Front ball nut S/N

84 exhibited more uniform wear of between 0.30 to 0.43 mm (0.012 to 0.017 inches) in the front and rear ball tracks.

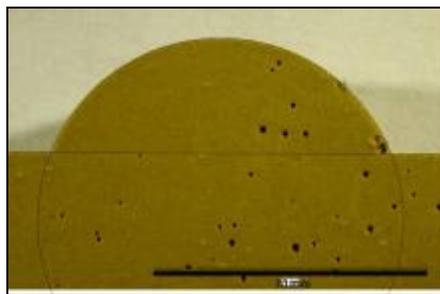
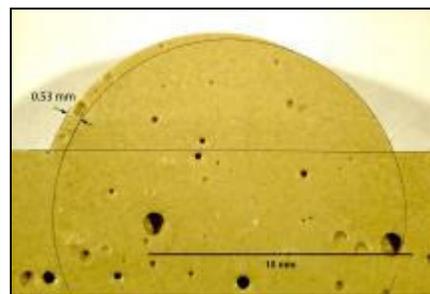
Figure 2.8. Macro photographs of two sections cut from the rubber impression mold of rear ball nut S/N 96. The left image (a) is a non-wear region of the front ball track between the deflector stud hole and a ball return hole that was used as the reference standard for the original ball track profile. The right image (b) shows a region of the ball track exhibiting localized wear.

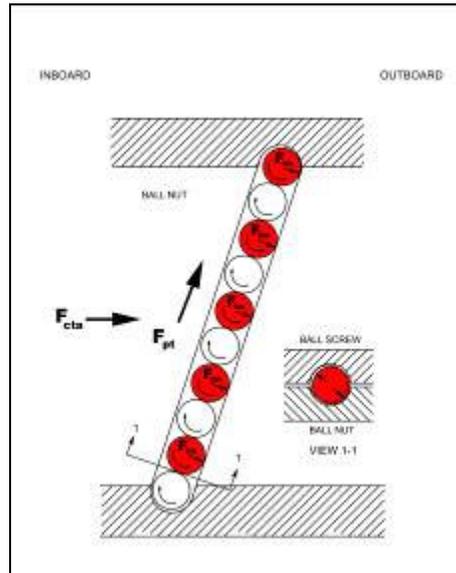
Figure 2.9: Sketch showing a cross section of a ball nut and a proposed arrangement of balls and forces that could produce the wear pattern observed on the two rear ball nuts.

The sketch represents a partial interior view of a rear ball nut and shows an arrangement of balls inside a 180° segment of one of the ball tracks. The wear model is based on the presumption that for some reason (yet to be determined), the balls are not free to move in one or both directions along the ball track(s) inside the ball nut. As the charge tube is advanced or retracted, the rotation of the ball screw relative to the ball nuts results in a compressive force,  $F_{pt}$ , on the chain of balls acting parallel to the ball track.

As shown in Figure 2.9, this compressive force results in the balls becoming jammed inside the ball tracks with an alternating pattern. The alternating arrangement of ball positions results in a certain component of  $F_{pt}$  being transmitted as a normal force between the balls and the surfaces of the ball track. Every second ball transmits a normal force,  $F_{bn}$ , onto the ball nut side of the track (red balls in Figure 2.9), whilst the remaining balls transmit an equal and opposite normal component of  $F_{pt}$  onto the ball screw side of the track. (Note that the ball screw is not shown in Figure 2.9). When the FM head is positioned at the outlet end of a fuel channel (i.e., fuelling against the flow, or de-fuelling with flow), the primary heat transport flow force produces an additional outward axial force on the charge tube (ball screw),  $F_{cta}$ . The axial flow force tends to roll the balls up the outboard side of the ball nut ball tracks and increases the magnitude of  $F_{bn}$ .

Finally, the rotation of the ball screw relative to the ball nuts causes the balls to rotate against the sides of the ball track. It is this rotation of the balls, as they are forced against the outboard surface of the ball track(s), but prevented from moving along it, that could explain the observed alternating surface wear pattern. The cobalt-based balls are harder than the Custom 455® alloy ball nuts, and would therefore tend to cause more wear on the ball nut surfaces.
