SI – DRESDEN SERVICE WATER ENGINEERING EVALUATIONS AND G-Scan™ INSPECTIONS

George J. Licina
Kenneth R. Rach
Structural Integrity Associates, Inc.
San Jose, CA 95118
glicina@structint.com

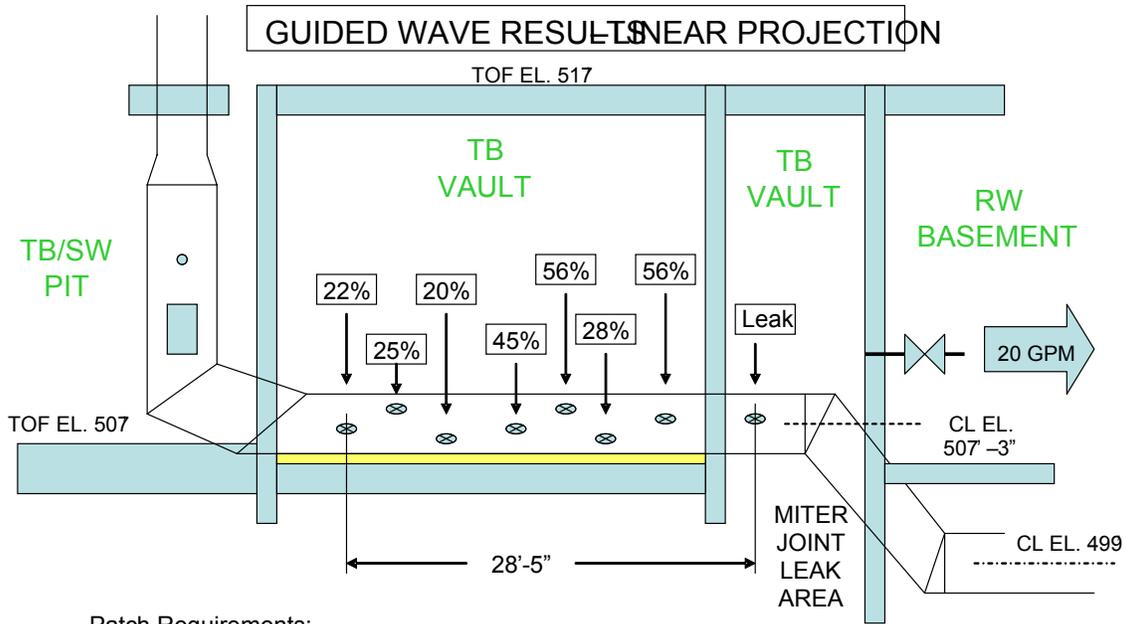
Figure 8. G-Scan Results from Dresden 54” Service Water Pipe

Figure 8 shows the 54" service water system line that had been identified as the source of the leakage at Dresden. A G-Scan collar was attached to the pipe at an accessible location inside the turbine building to assess the condition of the piping moving downward and toward the suspected location of the leak. Figure 9 provides the results of that single shot. As shown, the shot propagated downward through the building floor, through a mitered elbow and into the horizontally oriented buried pipe. Total length of the shot was approximately 80 feet, including nearly 70 feet of buried pipe. The shot revealed the probable leak location, 41'6" from the collar location, feature +F16 on Figure 9. In addition, several other degraded locations were identified with that one shot. The depth and area of the degraded areas were determined from the G-Scan examination.

The G-Scan inspection located the leak, which was determined from the G-Scan to be a hole approximately $\frac{1}{4}$ inch in effective diameter. The G-Scan inspection also provided a quantitative assessment of the degree of thinning at the leak location and in other locations along the length of the line as shown in Figures 8 and 9

Patch Requirements:

Areas with 34% or more wall thinning require 6 layers

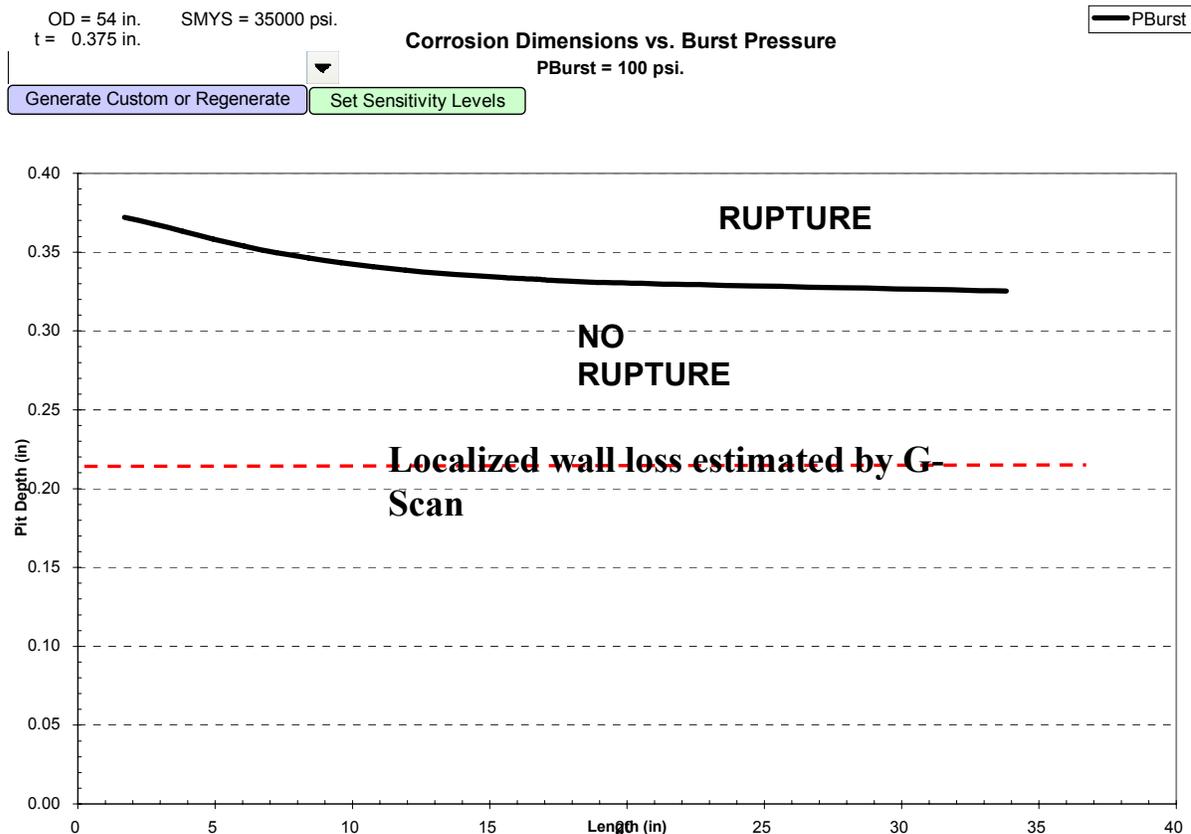
Figure 10. Engineering Evaluation of Thinned Area

In parallel with the inspection, SI performed an engineering evaluation of the most degraded area (the probable leak site) as well as conducted multiple calculations and cases to define allowable wall thickness requirements for both design and operating pressures. The Code of Construction, B31.1 (for Service Levels A, B, C, & D), and ASME Code Case N-597 (a Section XI Code Case) were used for guidance. The results of those calculations (Figure 10) showed that the structural integrity of the line was not in jeopardy and that a significant margin against rupture existed for all operating conditions. The line can tolerate a very long and deep flaw before rupture.

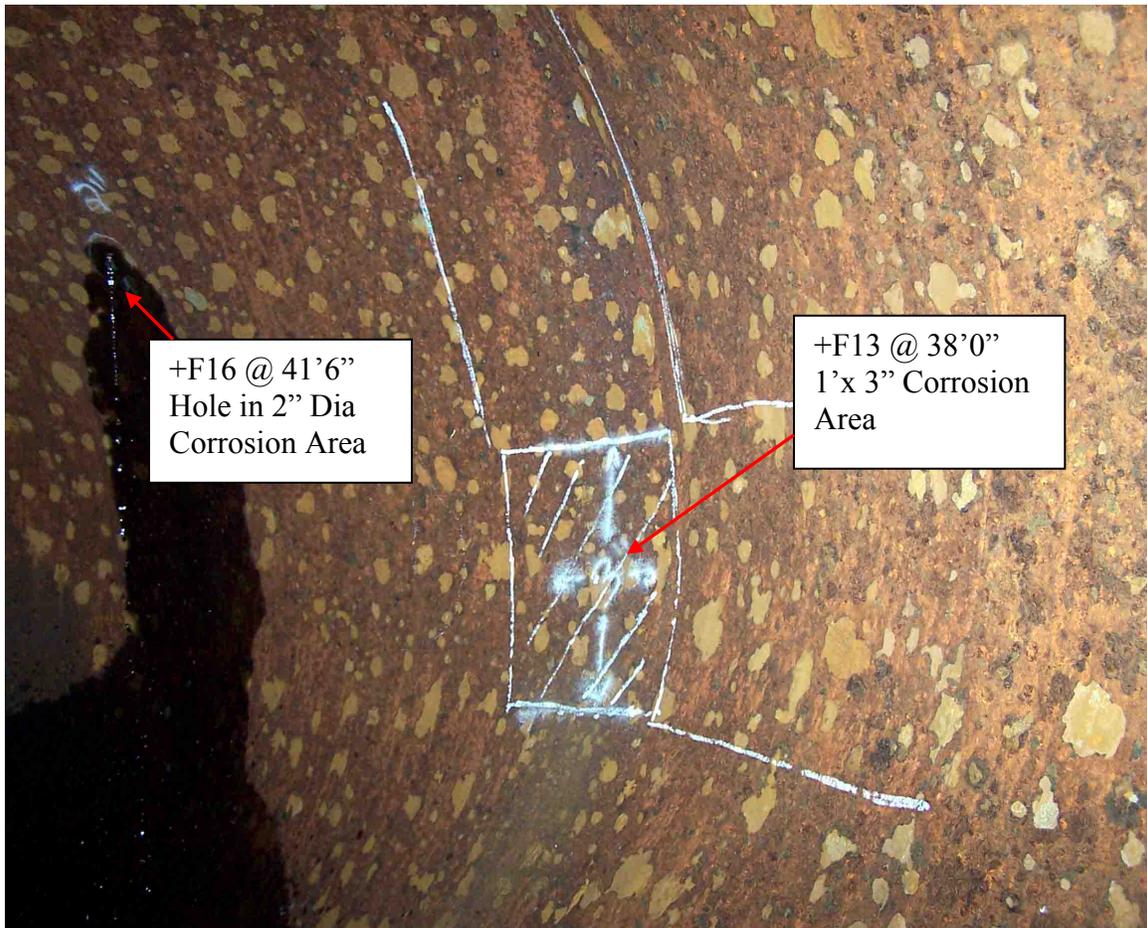
Figure 10. Location of Leak and Other Degraded Area

When the two units were brought down and the line was dewatered, inspection and repair crews walked to the leak location, at exactly the distance from the G-Scan collars that had been determined from the G-Scan inspection. Figure 10 shows that the interior of the pipe was actually in very good condition, that the leak was the result of a hole approximately $\frac{1}{4}$ inch in diameter, and that the leak was initiated from the pipe exterior. Other thinned locations as identified by the G-Scan inspection had little or no evidence of degradation from the pipe interior. Prior to the outage, a repair approach, using carbon fiber reinforced epoxy applied from the pipe interior, was designed. The repair included multiple layers of the epoxy patch, with the thickness of the patch determined from the size and thickness determined from the G-Scan inspection.

After dewatering, detailed UT and visual inspection from the pipe ID confirmed the G-Scan results and provided some additional refinements that were useful for more detailed calculations and design of the repair. Access to the pipe wall permitted the wall thickness estimates from G-Scan to be verified using B-Scan from ID. Locations were marked for the carbon fiber repair team.
