# GENTILLY-2 MODERATOR HEAT EXCHANGER REPAIR

**Steve Valois (Hydro-Quebec)**  
**David Hartwick (Babcock & Wilcox Canada, Nuclear Services)**

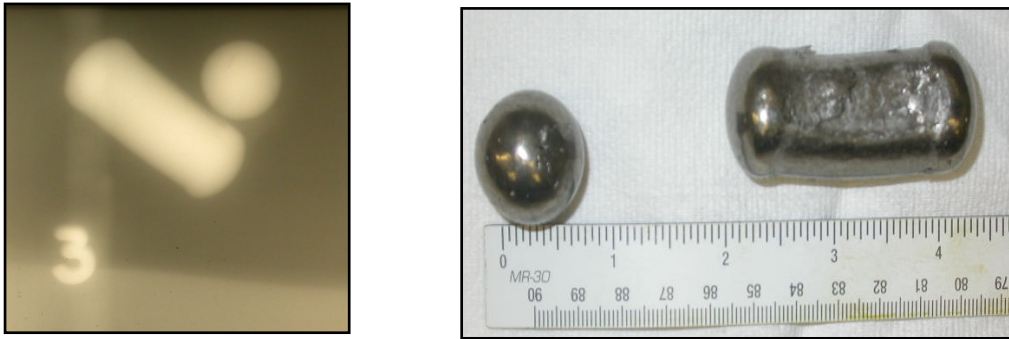
The area of concern at the moderator heat exchanger system was isolated permitting radiographic inspection of the inlet/outlet piping to be performed. The purpose was to determine the size and shape of the loose part and prepare potential repair scenarios. The radiography discovered two foreign material (FM) objects shown on Figure 1. After opening the exchanger, two pieces were retrieved from the moderator system. The first was spherical and a little less than 1 in. of diameter. The second was a cylindrical piece, approximately 2 in. long with a diameter of ¾ in. The acoustic expert was right.

After metallurgical analysis, we found that the material was a 304 stainless steel. What was the original size? Where they come from?? We still don't know yet. X-Rays were performed on majority of the valves on the moderator system providing no additional data. Reviewing moderator's chemistry over the months leading up to outage, we may have had a sign that something was going on because we found a high concentration of Cr-51 between July and November. So we think the parts might have been there for at least 5-6 months.

*Figure 1 : X-ray from the inlet piping of the heat exchanger and loose parts found*

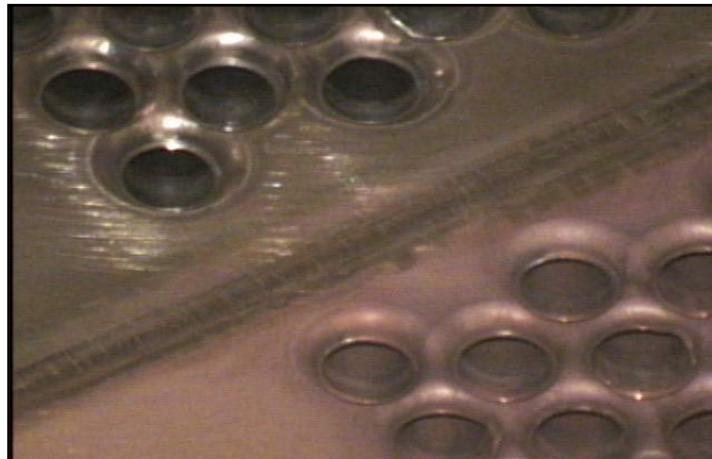
Original tube to tubesheet fabrication consisted of carbon steel plate with a stainless steel overlay and a tube extension of 0.215" with a tube to tubesheet fillet seal weld (Figure 2).

*Figure 2 : Original exchanger tubesheet illustrating fillet seal weld*

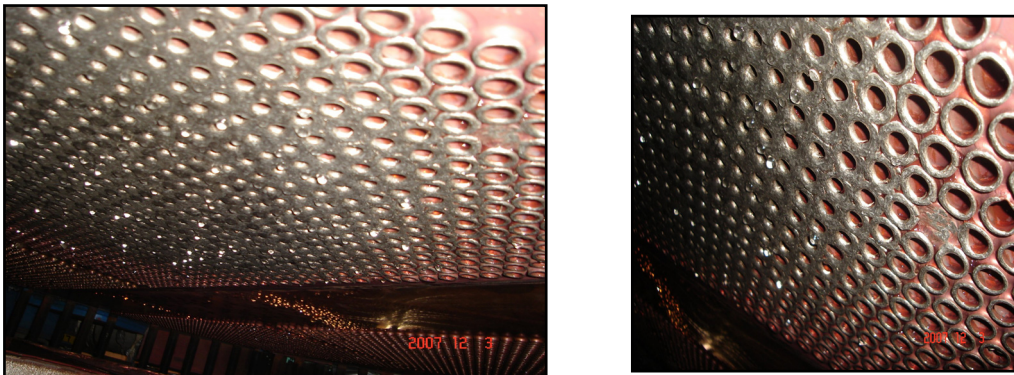
*Figure 3 : First view of the damaged tubesheet*

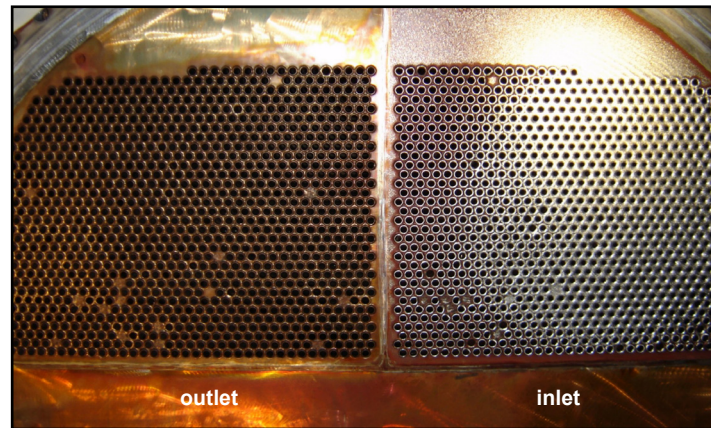
Figure 4 is showing the inlet (damaged on the right) and the outlet (untouched on the left) of the exchanger. Almost all of the inlet tubesheet was severely damaged, excepted for some areas on the periphery (lower corners on Figure 4).

*Figure 4 : Underneath view of the tubesheet*

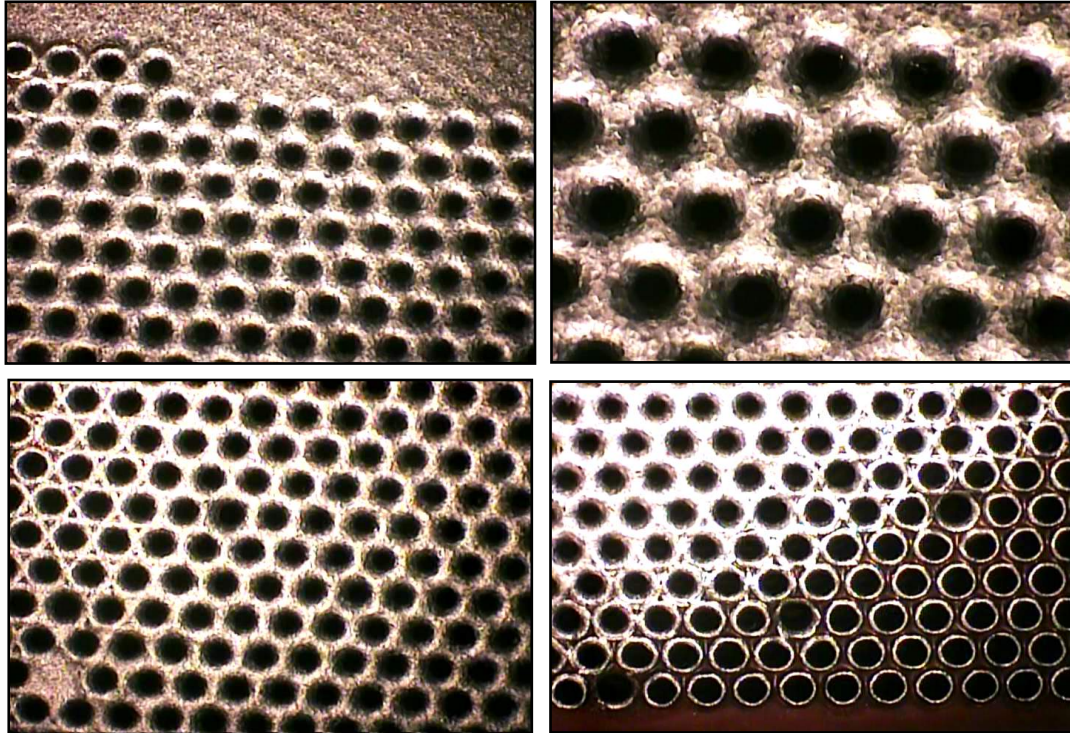
Figure 5 is showing a closer look at some of the most damaged areas of the tube sheet. In the most damaged zone, material coming from the tube extension and the seal weld were pushed into the tube ID bore. And the area right over the inlet piping was so damaged that approximately 50% of the damaged tube ends were subsurface of the tube sheet face.

*Figure 5 : Pictures of some damaged areas*

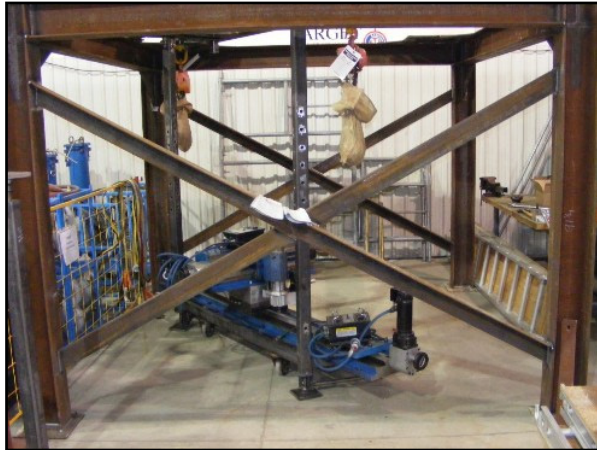
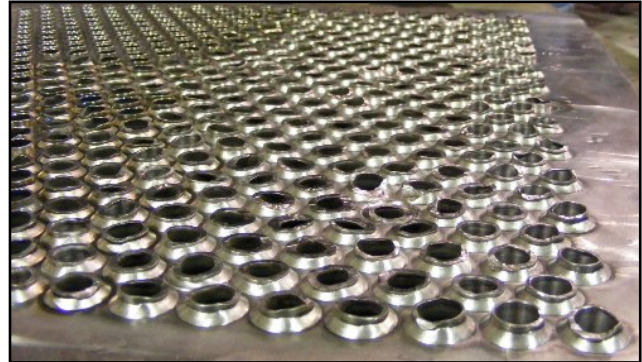
The preparation for the repair started well before getting the first pictures of the tube sheet. A replica of the exchanger stand was built to simulate the room under the vessel and a mocked tube sheet was peened. As you can see on Figure 6, the as-found tubesheet was a lot worse than the mock-up.

*Figure 6 : Mock-up to test machining*

The first step consisted of employing a portable milling machine positioned under the stand as shown in Figure 6. The cutters used are shown in Figure 7.

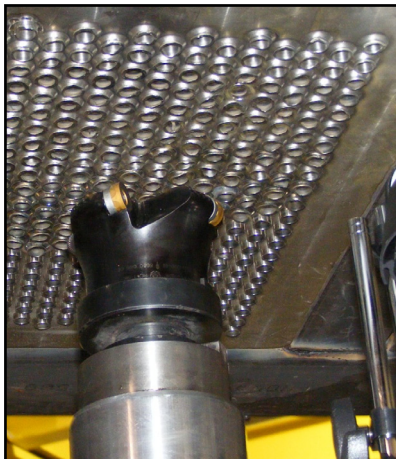
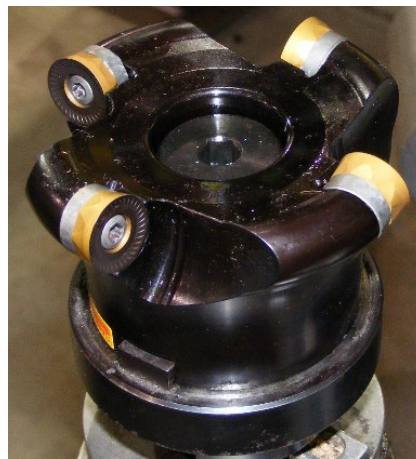
*Figure 7 : Cutters used on the portable milling machine*

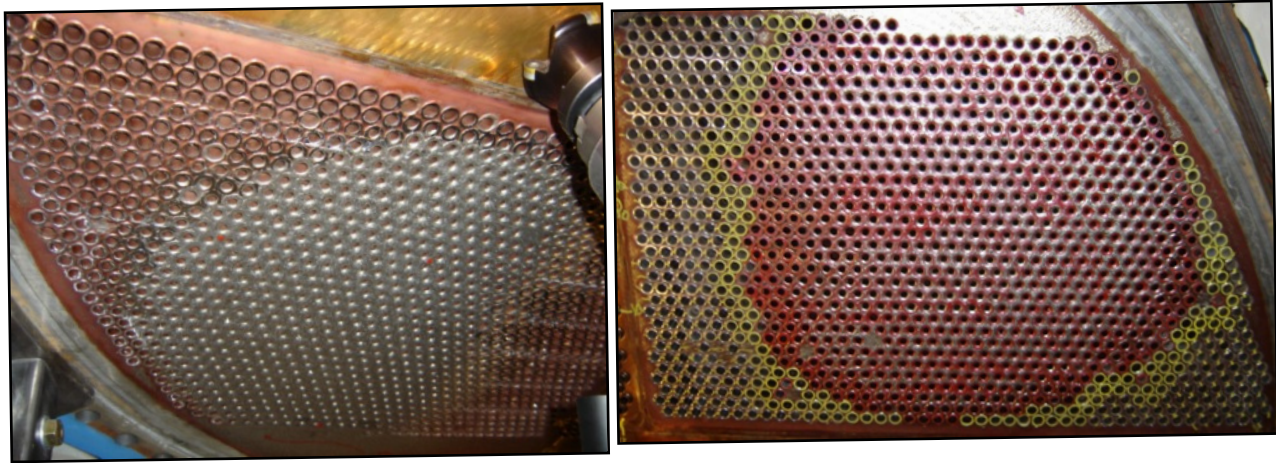
The zone where the foreign material created the most severe damaged consisted of approximately 50% of the entire tubesheet damaged. This zone consisted of fillet welds peened subsurface into the tubesheet face. The milling machine was only able to work on the tubes on the periphery.

*Figure 8 : Tubes machined with the portable milling machine*

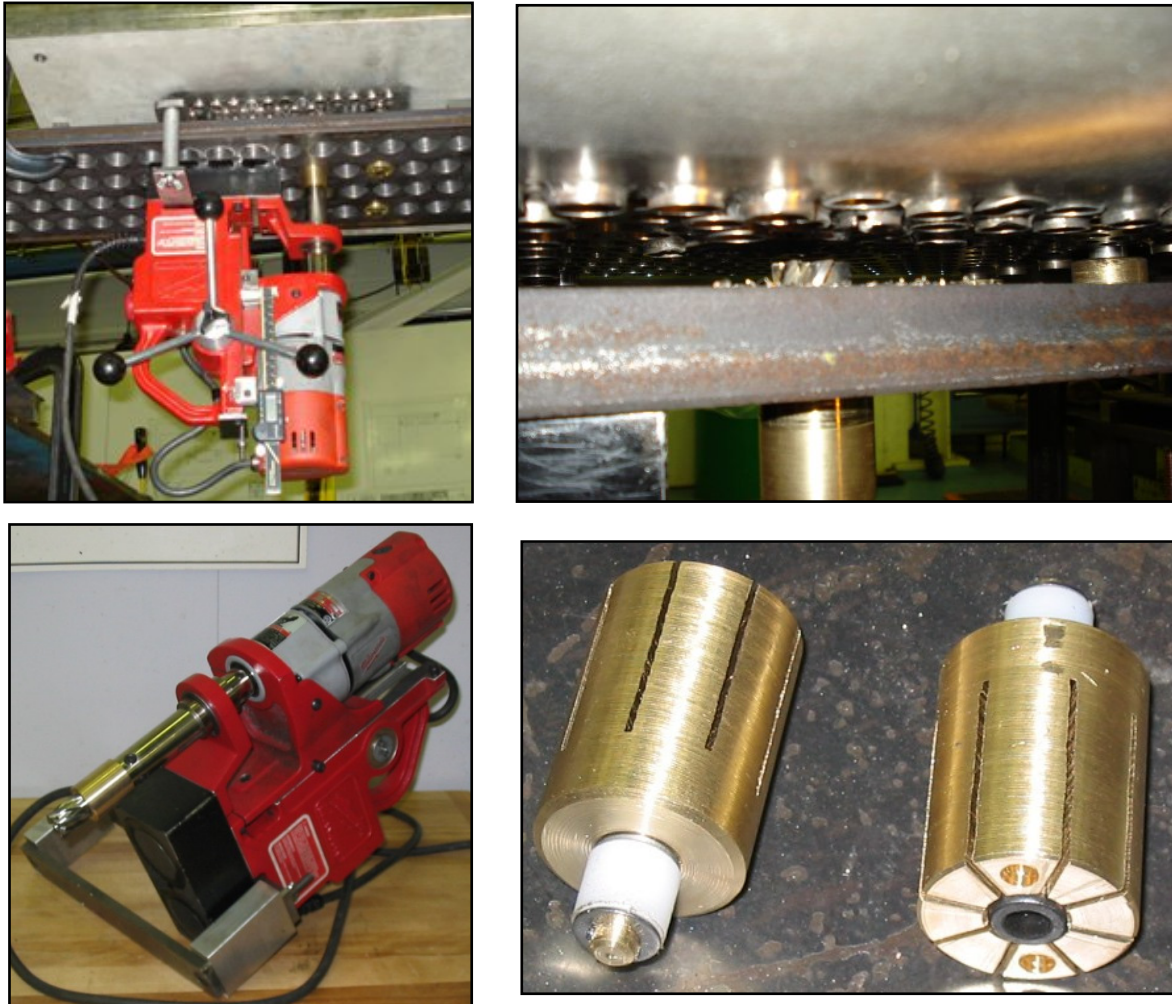
*Figure 9 : Magnetic based drill on the mock-up in the shop and the brass bushings used for the alignment of the plate*

The idea was to use a magnetic based drill mounted on a milling plate fixed on the stand and aligned on clean tubes. The plate had 108 holes drilled with the same pitch of the tubesheet with a cutter allowing to end-face the tubes. The depth of machining that was the critical parameter, was controlled with the use of a vernier and by zeroing the magnetic drill on an undamaged tube. The milling plate was aligned using brass bushings (see Figure 9).

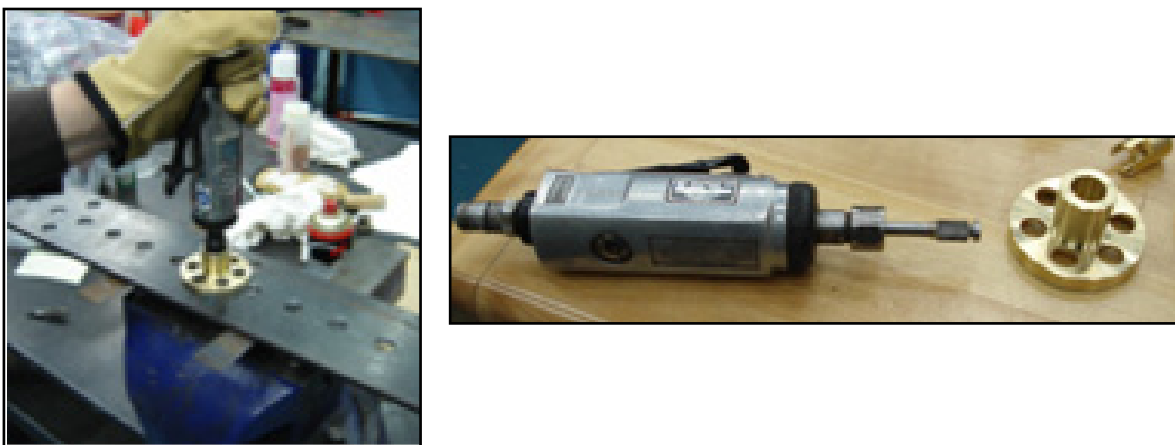
*Figure 10 : Boring tool with the deburring plate*

To achieve the final boring of the tube, another idea came up from a Hydro-Quebec machinist. It consisted of an air grinder (rotary file) and a carbide cutter / bearing tool that was inserted into a similar tube hole pattern plate (deburring plate) and a brass bushing (Figure 10).

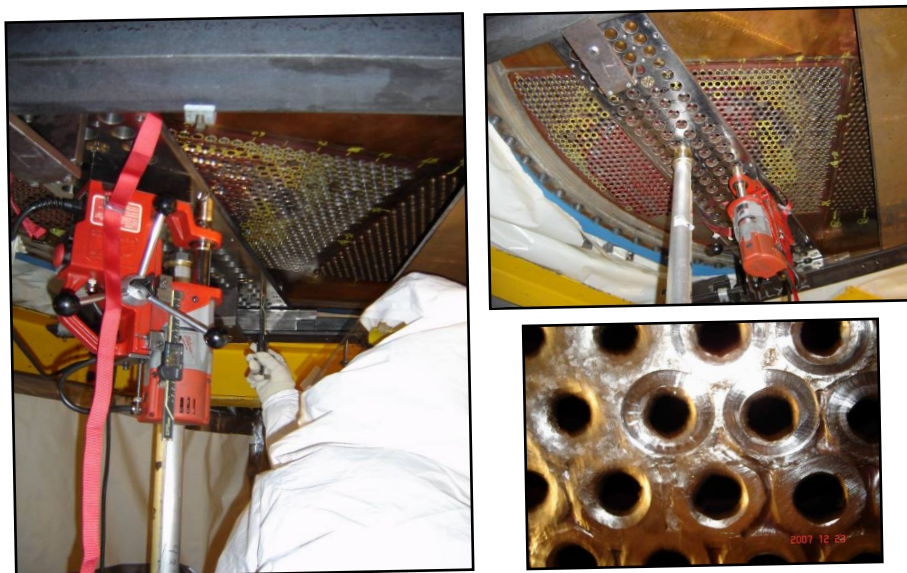
*Figure 11 : Semi-Auto End Facing Tool and example of repaired tube ends before final boring*

Refer to Figure 11 for photographs of the semi-auto device used and examples of faced tube ends prepared for flush seal welding and to Figure 12 for the final machining result.

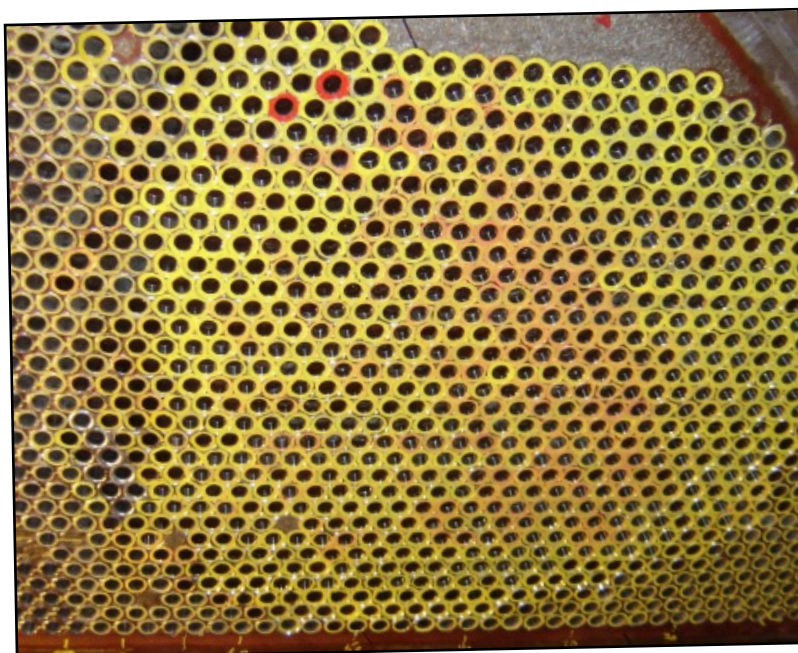
*Figure 12 : Tubesheet after machining completed*

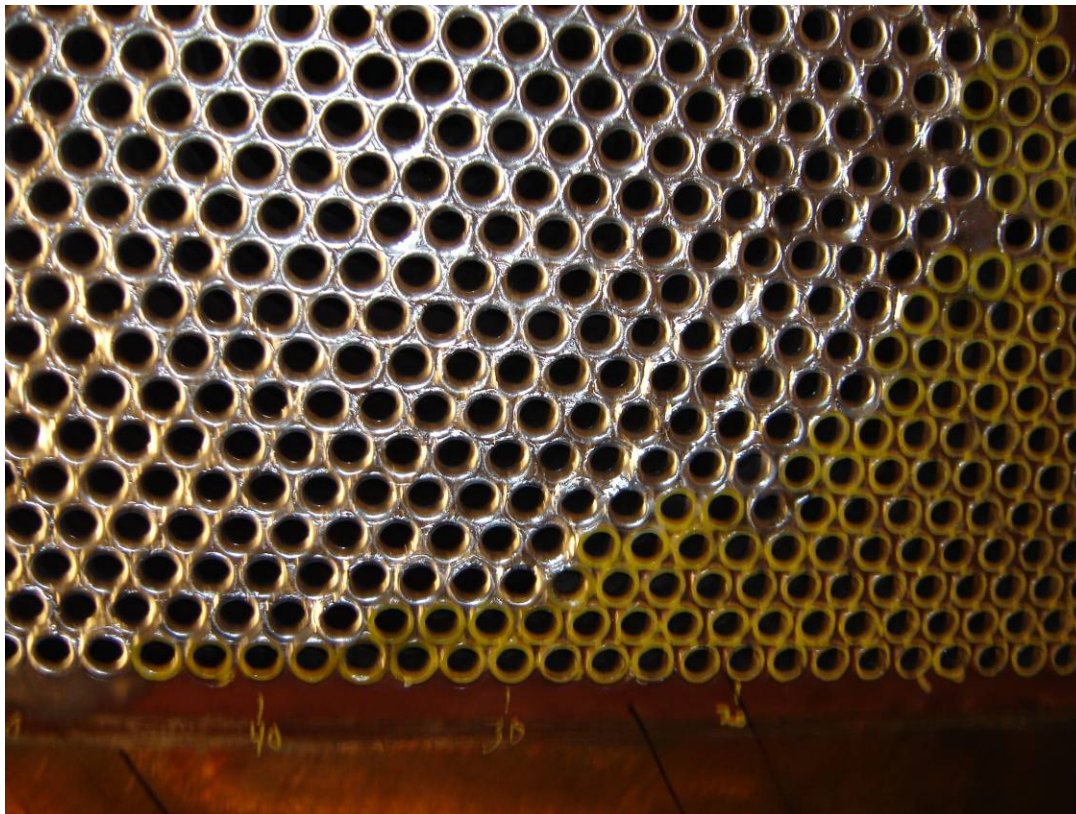
Upon completion of automatic Autogenous seal welding the entire repair area was Liquid Penetrate inspected (LPI). Of the 781 tubes repaired, 1/3<sup>rd</sup> of them encountered some form of repair after LPI. After another six LPI cycles and 35 tubes manually weld repaired, the repaired tube sheet face was found acceptable to both customer and ASME III & XI code/specifications. Refer to Figure 12 for a photograph taken in the severely damaged zone now repaired and LPI accepted. Only four tubes were required to be plugged, two due to loss of tube wall thickness and the other two due to un-repairable LPI defects.

*Figure 13 : Photograph of repaired tube ends that were in the severely damaged zone.*

Of the 1200 hot leg quadrant tube ends, 781 of them were so severally damaged they required to be seal weld repaired to recapture minimum leak path requirements. The initial weld repair process consisted of using an automatic autogenous flush seal welding machine. This process also required the weld equipment to be manually manipulated into every tube opening creating the concern of high man-dose exposures and loss of critical path schedule. The option of using remote arm manipulators was not possible due to the limited time for development.
