STEAM GENERATOR AND PREHEATER TUBE ID FOULING AND THE IMPACT ON REACTOR INLET HEADER TEMPERATURE AND EDDY CURRENT INSPECTIONS

K. Choung¹, K. Sedman¹ and A. Glover¹

¹ Bruce Power, Toronto, Ontario, Canada

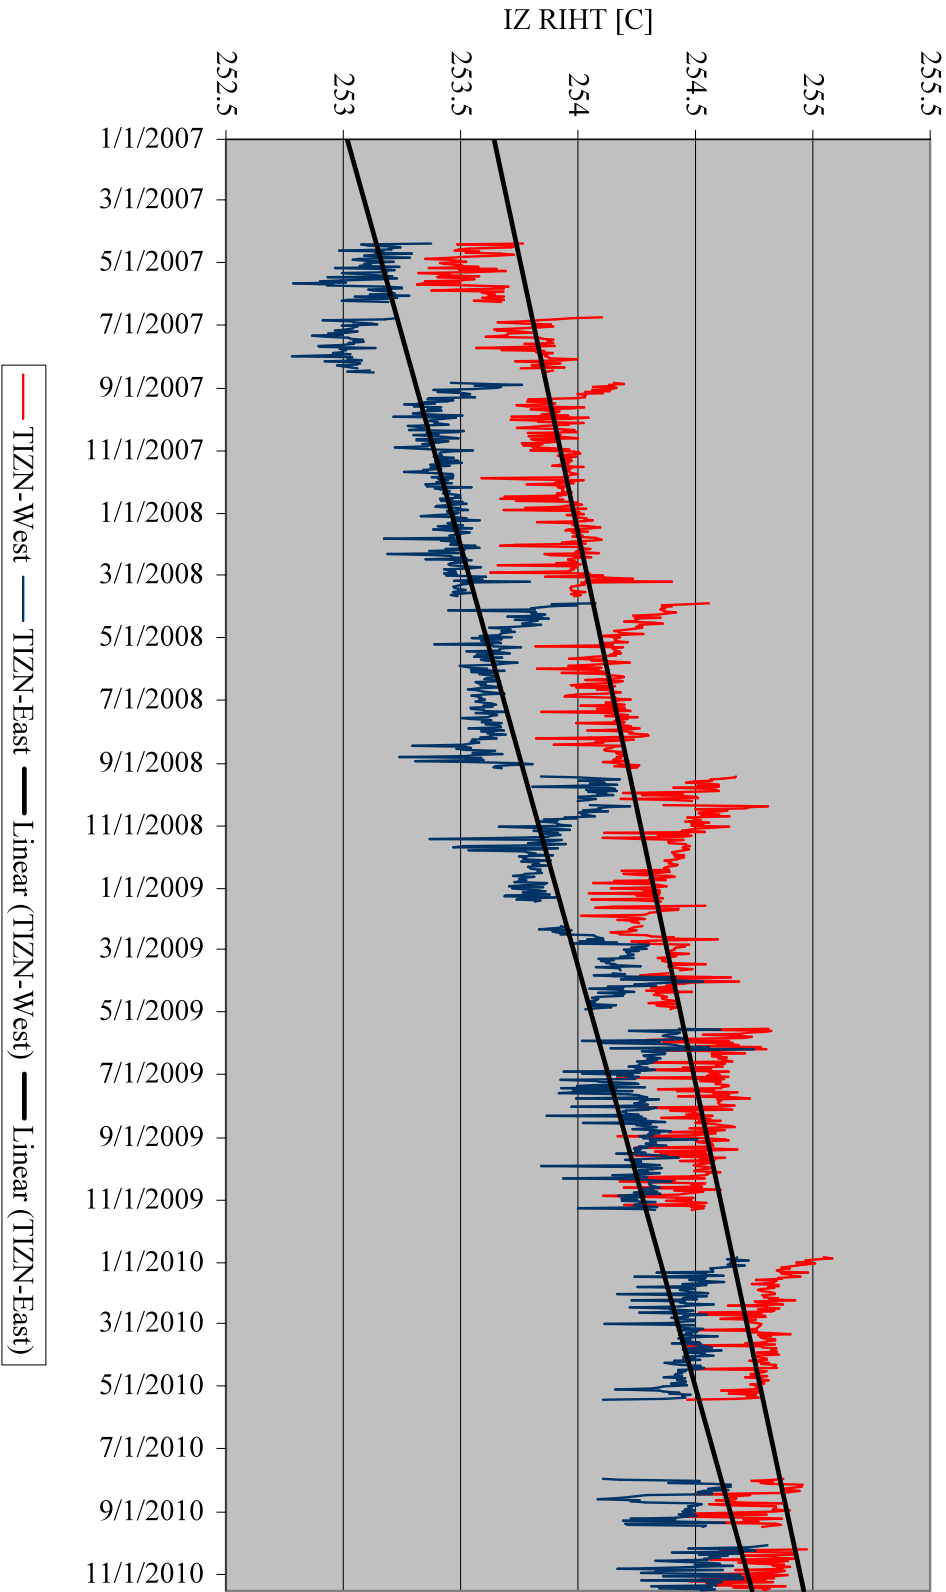
Figure 3 Example of a normalized trend for inner zone RIHT

Figure 3 is an example of the normalized inner zone (IZ) RIHT graph for one of the Bruce B units. It include the following information:

- Normalized trend of the average IZ RIHT of the west and east IZ inlet headers
- Linear regression of the west and east IZ inlet headers

It should be noted that all RIHT trends, as well as Figure 3, includes all degradation mechanisms such as OD and ID fouling as well as tube plugging. The steam generator and preheater tube plugging rate are relatively small in the recent past and therefore not expected to significantly impact the RIHT rate of rise. OD fouling impact is expected to be small [1]. ID fouling is clearly a more significant degradation mechanism. This is illustrated by the fact that the rate of rise in RIHT is similar before and after SG ID cleaning. Figure 5 illustrates this.

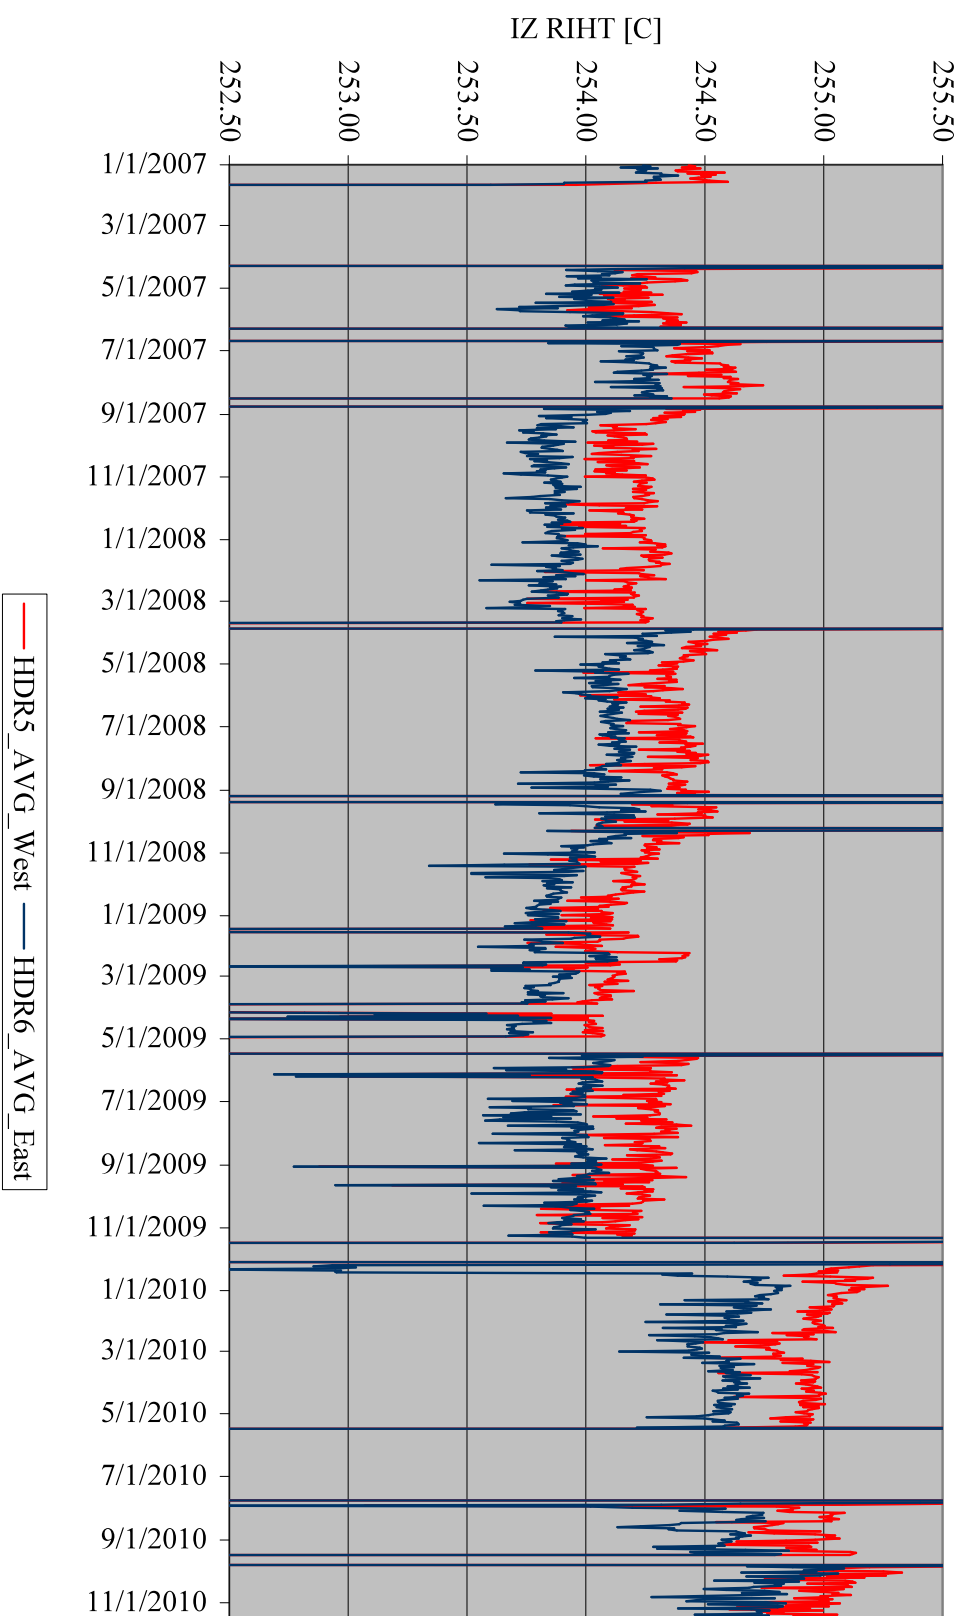
Figure 4 Example of a non-normalized trend for inner zone RIHT

Bruce RIHT data comes from the Plant Information (PI) system database. The data was normalized to a specific reference operating condition to eliminate changes that are caused by known variations in reactor power, boiler secondary side pressure and feedwater temperature. Without normalization it is not possible to determine the rate of rise in RIHT (compare Figure 3 which is normalized & 4 which is not normalized). The reference conditions in Table 1 are used in the normalization formulas (1) to (4).

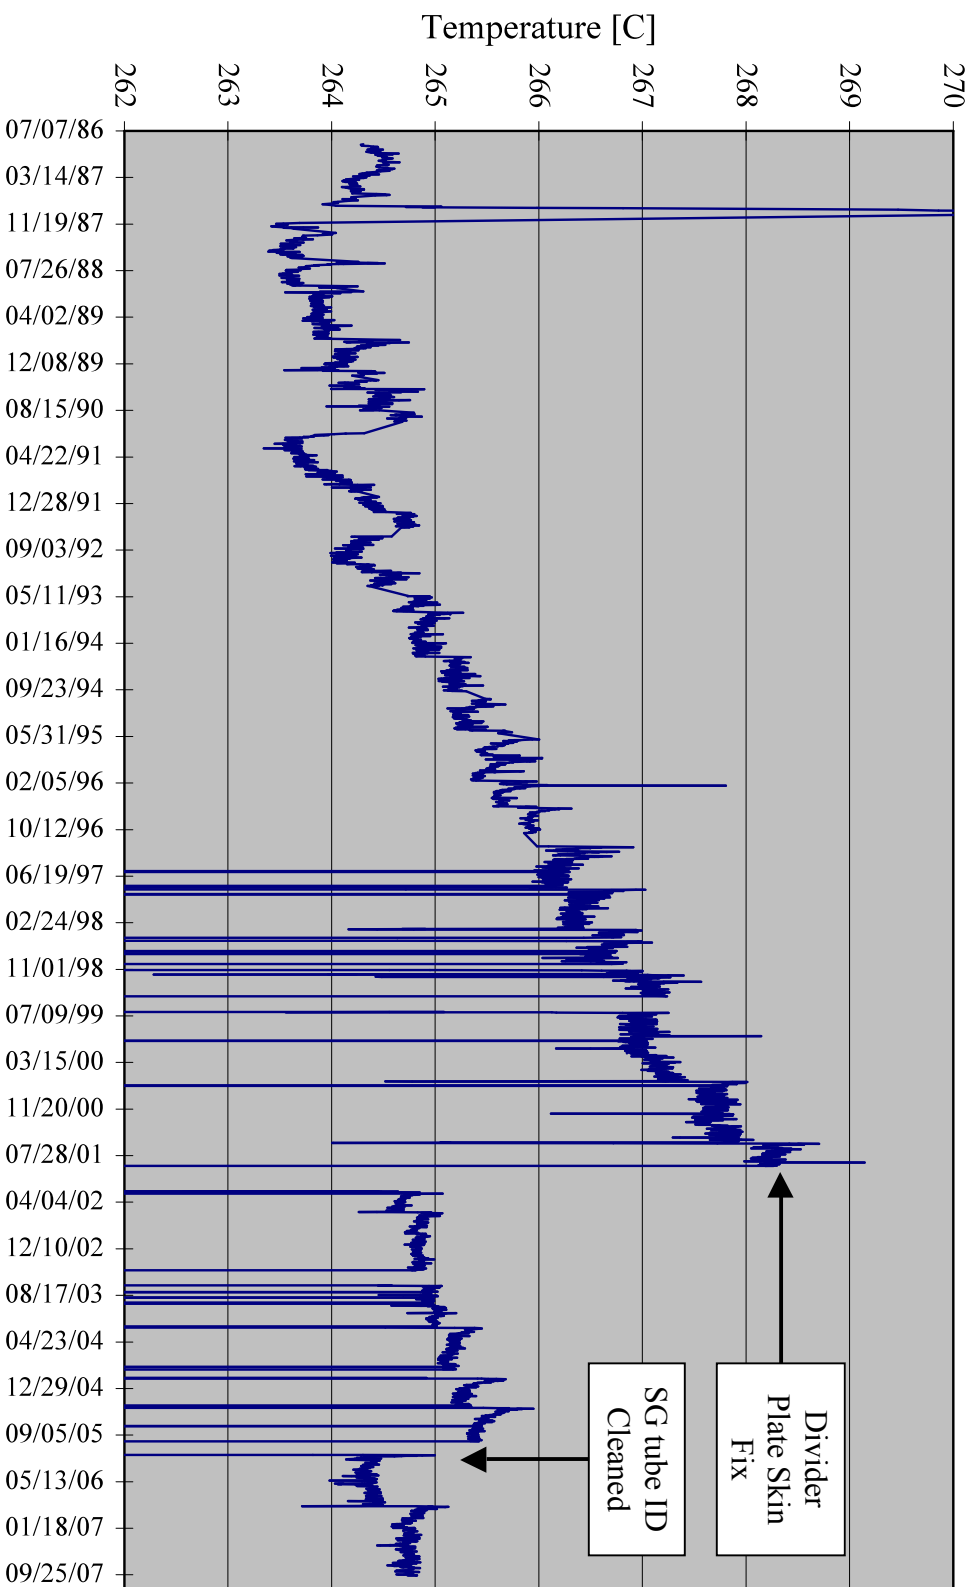
Figure 5 Illustration of the similar rate of rise in RIHT before and after SG tube ID cleaning in late 2005
