## **NRU VESSEL REPAIR AND RETURN TO SERVICE: ENHANCING A CANADIAN R&D ASSET FOR THE FUTURE**

**D.S. Cox, J.B. Arnold and J.K. Lee**

Atomic Energy of Canada Limited, Chalk River Laboratories, Chalk River, Ontario, Canada  
(613) 584-8811ext 44137; coxd@aecl.ca

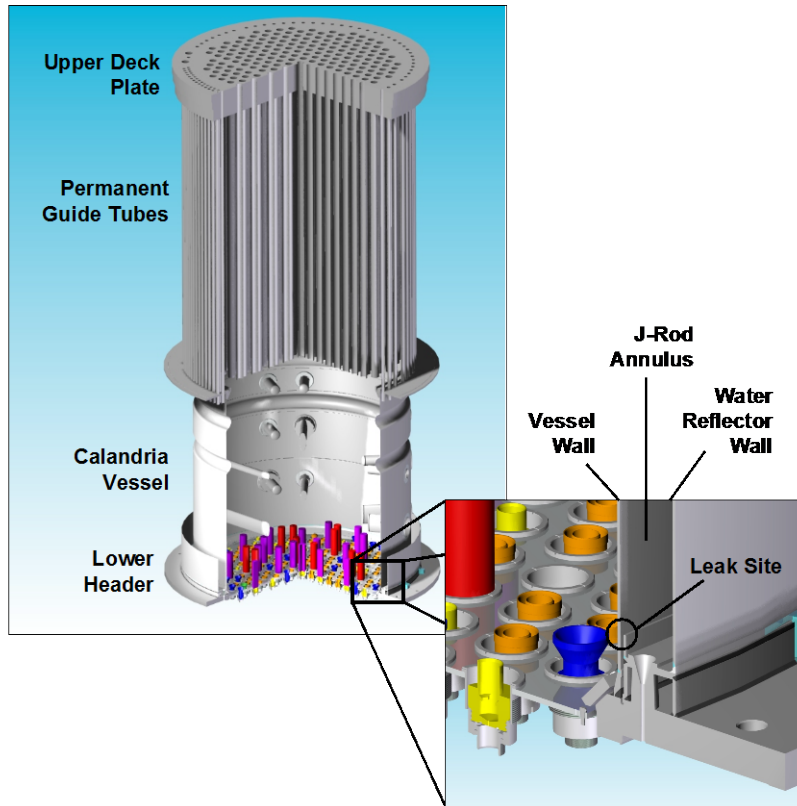
**Figure 1: NRU Reactor and Geometry of the Leak Site.**

In 2009 May, a small heavy-water leak in the calandria vessel was detected at the bottom of the CO<sub>2</sub> annulus. The leak site was about 9 m from the top of the reactor deck, accessible only through small openings, either 9 cm or 12 cm in diameter, which became a significant constraint on development of the necessary inspection and repair tools.

Specialized tooling was developed to cut a 70 mm diameter hole through the vessel wall, encompassing the leak site, in order to study the corrosion layers, microstructures and the topology of the corrosion site. Corrosion was concluded to be caused by air leakage into the annulus in the absence of a complete CO<sub>2</sub> purge, combined with moisture from the ingress of light water from the reflector, producing nitric acid by radiolysis in the high radiation fields of the annulus. After analysis of the vessel metallurgy, areas requiring repair were determined by a 3-dimensional engineering structural evaluation performed on the remaining vessel wall thickness as measured by NDE, after subtraction of a corrosion allowance. Ten regions were determined to require repair, ranging in size from approximately 8x6 cm to 20x70 cm.

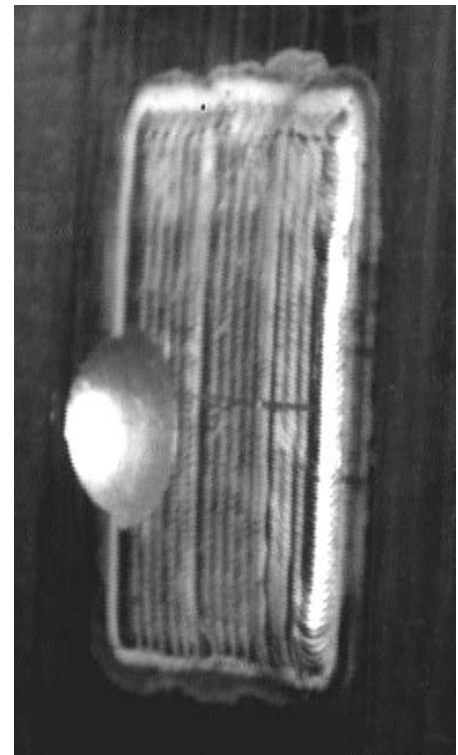
**Figure 2: In-Reactor Weld Build-up with Scoop Sample Removed for Analysis**

alloy for which special weld development would be required. Tooling was developed to cut shallow hemispherical “scoop” samples from the inside surface of the vessel wall in order to obtain representative material for metallurgical evaluation and for use in weld development trials (Figure 2).
