Assessment of Causes for Degrading Fuel Performance at Darlington NGS

Jonathan Judah (consultant) and Steve Goodchild

Reactor Safety Department, Darlington NGS, Ontario Power Generation

Paper submitted to: 12th International Conference on CANDU Fuel, 15 to 18 September 2013, Kingston Ontario

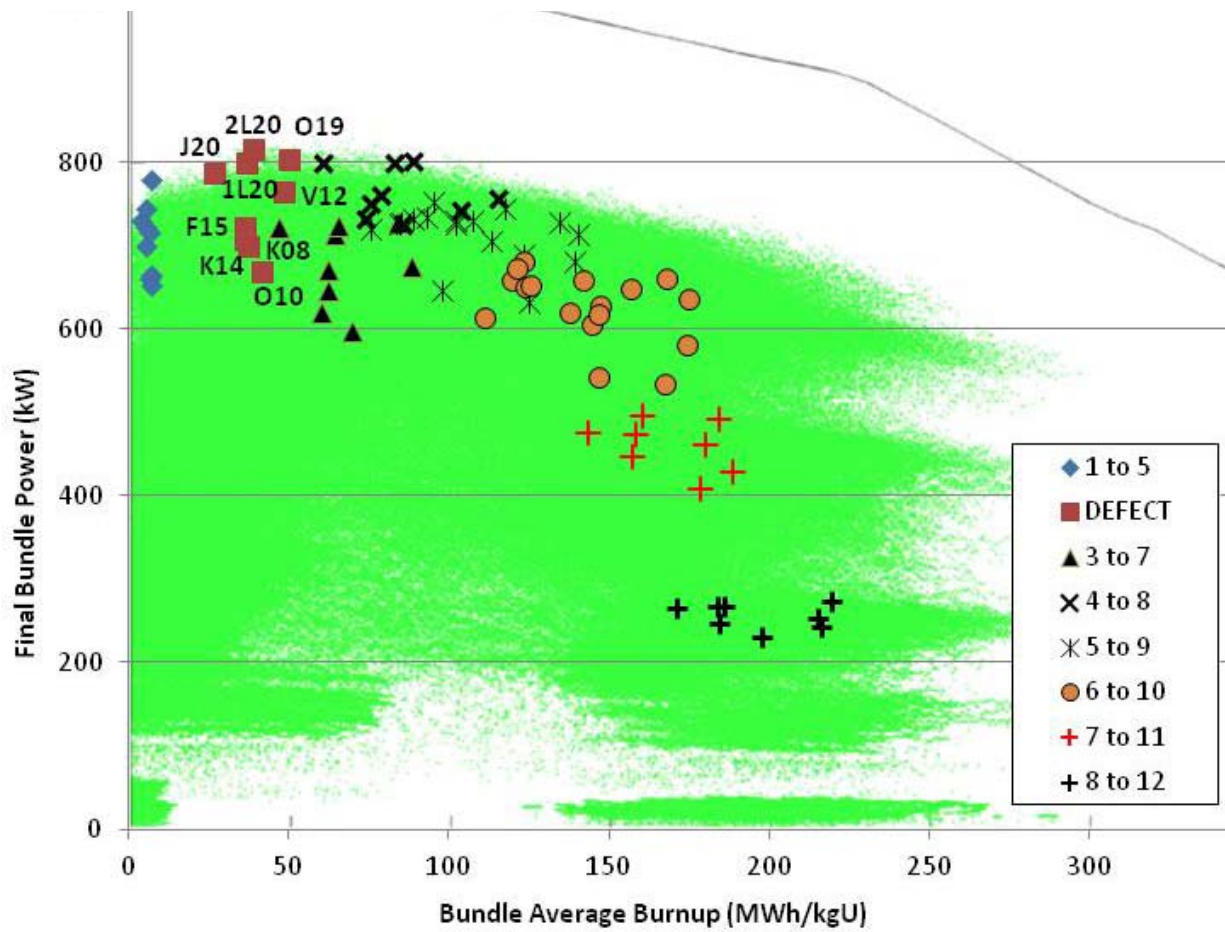
Figure 3: Fuelling power ramps

It is noteworthy that all of the defected bundles had experienced the Position 2 to Position 6 fuelling shift. Although the burnups for these bundles were low at the time of the shift, these shifts represent some the most severe fuelling power ramps experienced at Darlington as measured by power increase and final bundle power.

Figure 3 displays the final bundle power and burnups for all bundles which experienced power increases due to fuelling of these channels while the defected bundles were in-core. This data is superimposed on a background of data representing the bundle powers and burnups of all the bundles in a typical Darlington core. It can be seen that the Position 2 to Position 6 shifts do represent some of the most severe operating conditions.

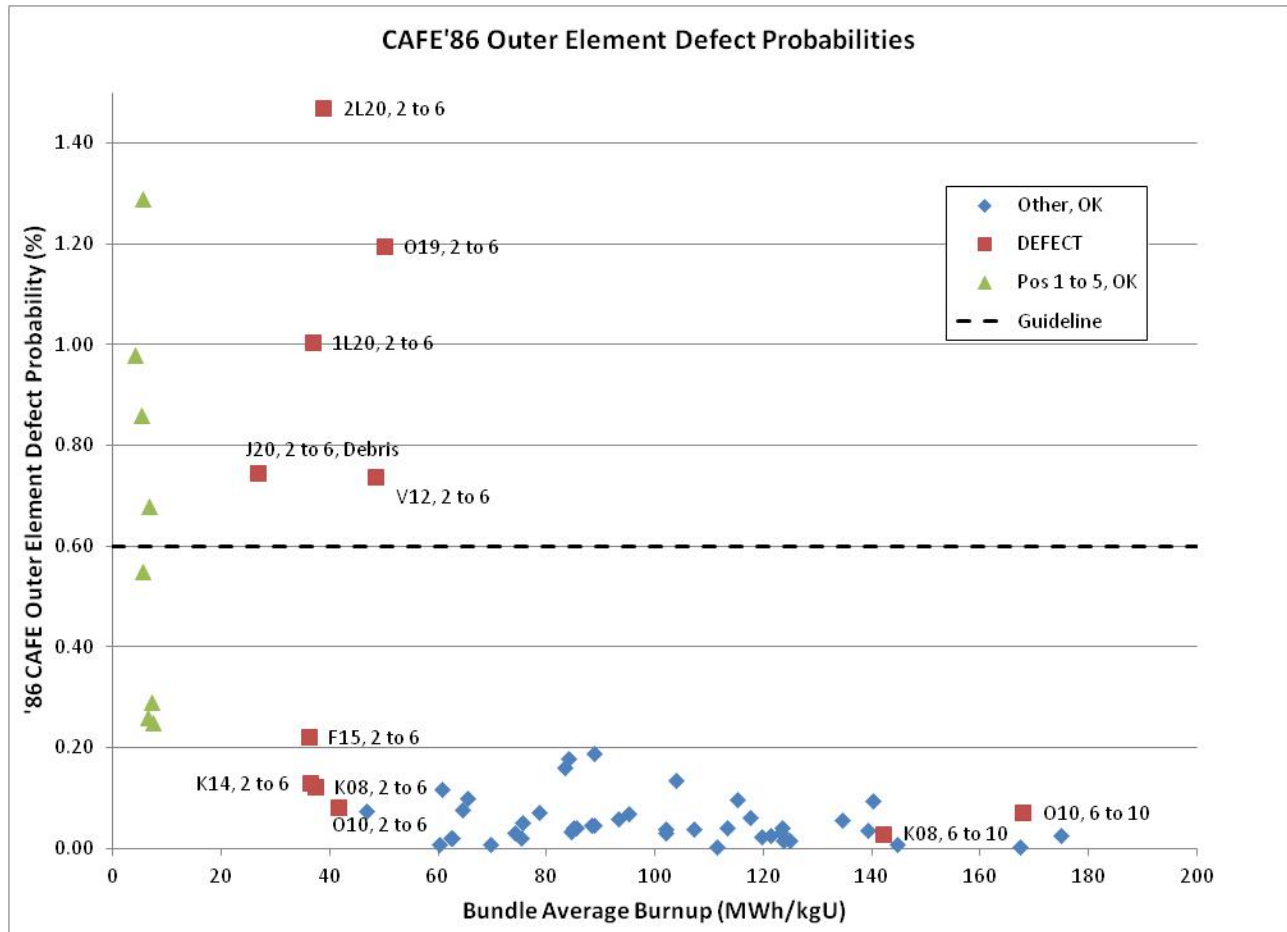
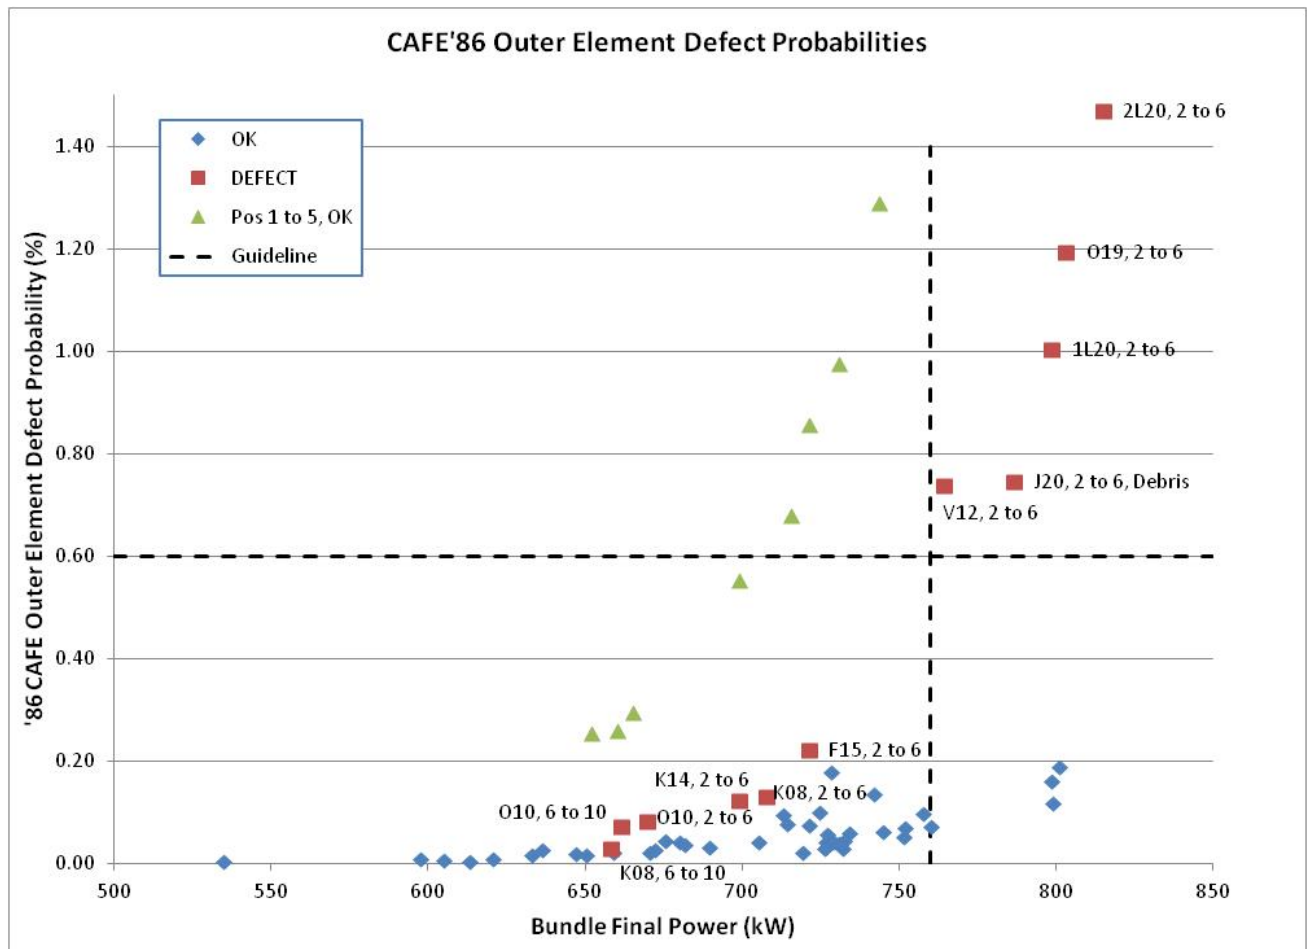
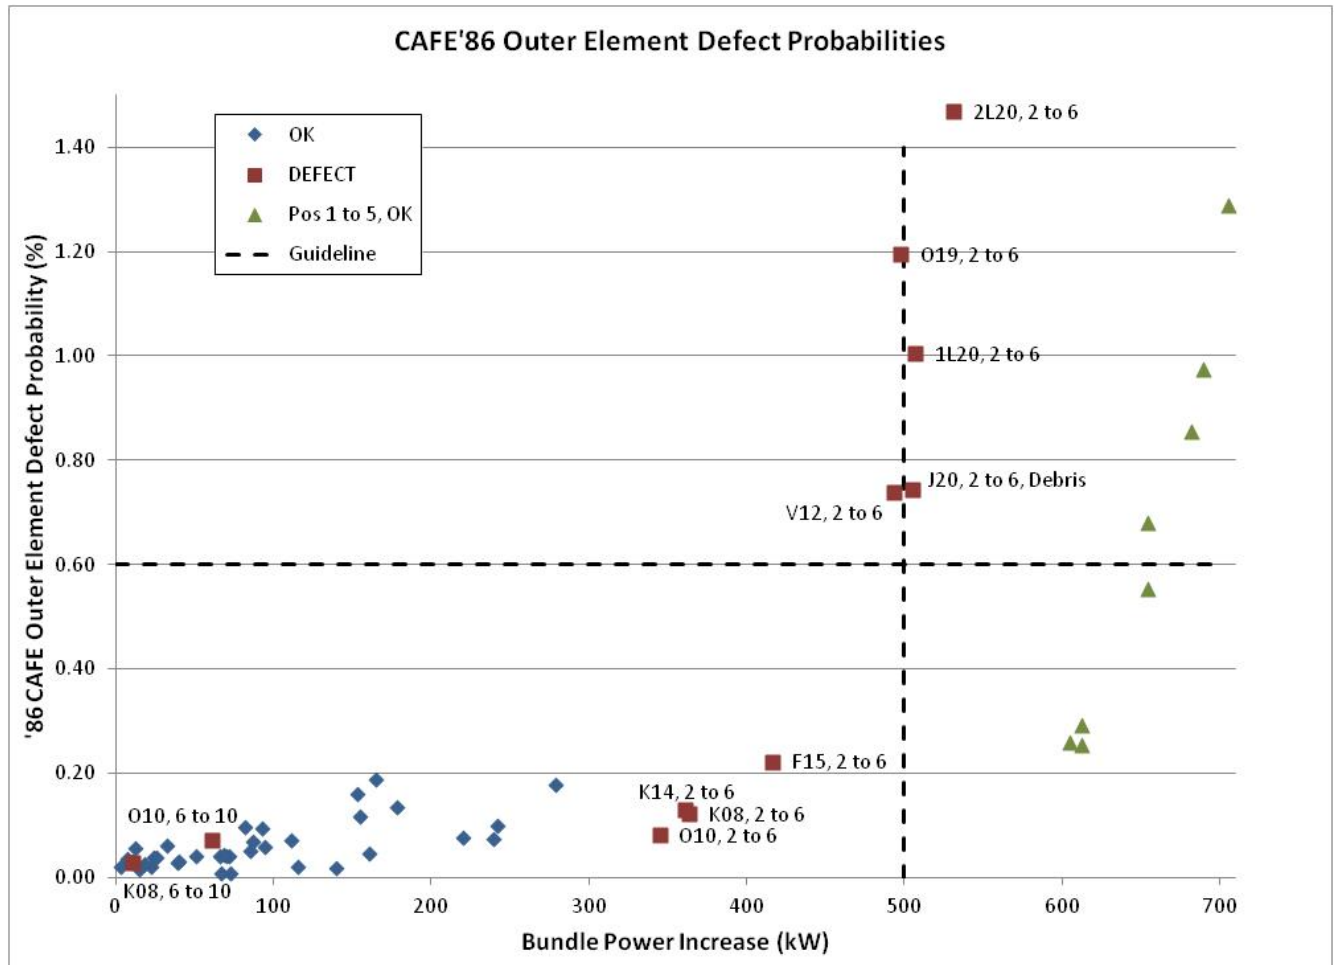
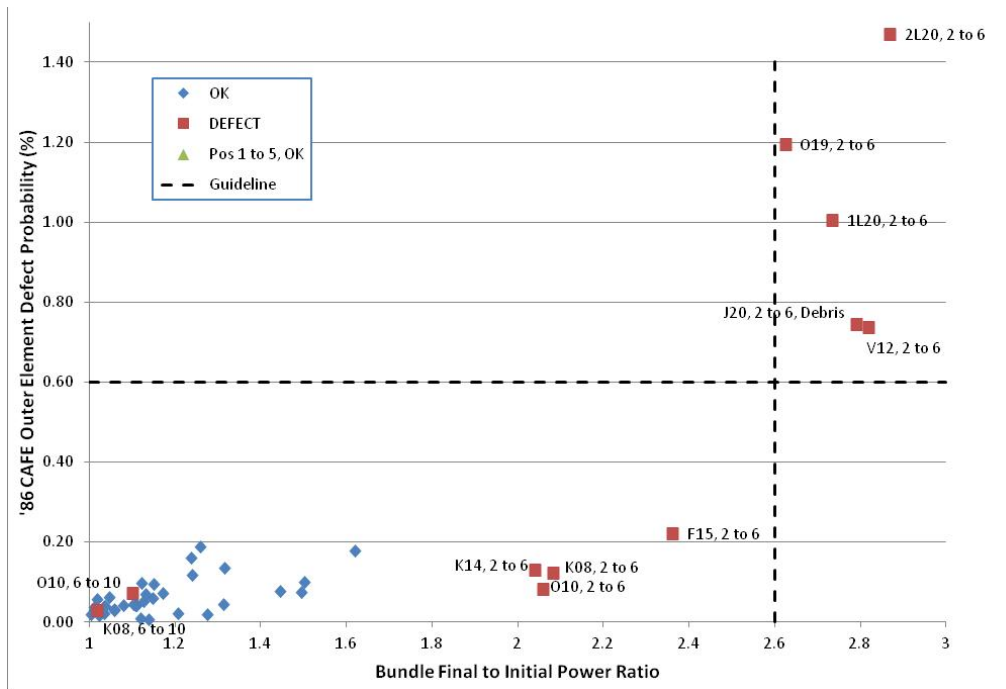
We chose to test the response of the documented CAFÉ methodology to the suspected defects at Darlington by removing the application windows. The results of this “open” calculation are provided in Figures 4, 5, 6 and 7.

These assessments demonstrate that a statistical fit of historical 37 element power ramp defect data would provide the expectation of high power ramp defect probabilities for some bundles which have experienced Position 2 to Position 6 shifts at Darlington. The historical applicability windows would have to be adjusted to a lower burnup. Complete removal of these windows is not supported by the data. Bundles shifted from Position 1 to 5 also experienced substantial power ramps, but these bundles did not defect. There appears to be a burnup threshold below which fuel elements are resistant to power ramps; however this threshold is lower than presently established, at least for the fuel bundles irradiated at Darlington.

Figure 4: Bundle average burnup vs. “open” CAFÉ outer element defect probability

Figure 5: Final bundle power vs. “open” CAFÉ outer element defect probability

Figure 6: Bundle power increase vs. “open” CAFÉ outer element defect probability

Figure 7: Final to initial power ratio vs. “open” CAFÉ outer element defect probability (excluding Position 1 to 5 shifts)

Figures 4 to 7 also display parameter thresholds which are based on this OPEX and which have now been incorporated into fuelling guidelines to reduce the risks ramp defects. These are considered to be “soft” guidelines which may sometimes be violated in the interest of good core management, but in which case remedial measures will be imposed to manage subsequent power ramps and to monitor fuel condition. The following power ramp guidelines have been developed for Position 2 to 6 shifts:

- Avoid final bundle powers after the fuel shift of > 760 kW
- Avoid increase in bundle power due to the shift > 500 kW
- Avoid final to initial power ratios of > 2.6
- Avoid “open” CAFÉ’ single outer element defect probability of > 0.6 percent.

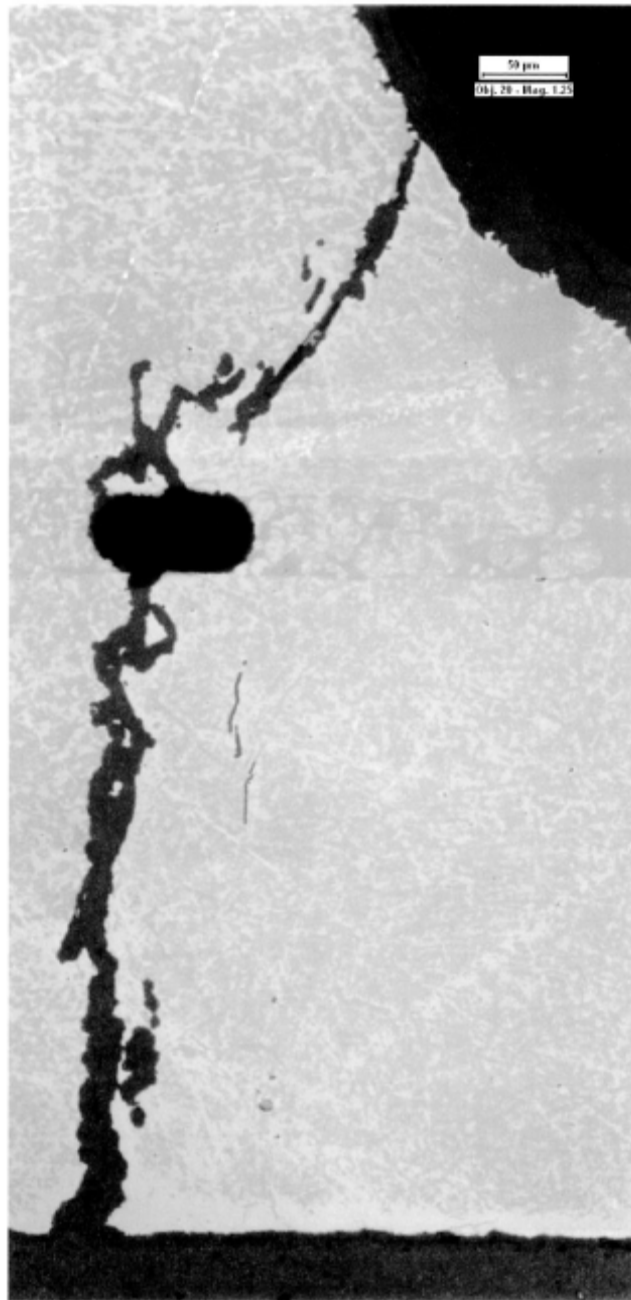
PIE has revealed a primary defect which appears to have been caused by stress corrosion cracking (SCC) at the center line of outer element 7 of 2019. One of the PIE sections of this defect is provided in Figure 9. It can be seen that the penetration line follows a meandering

path which is typical of SCC. In this case the SCC path passes through a void in the braze eutectic, and then passes through the spacer pad material.

Other sections of the 2O19-7 defect indicate fuel pellet to sheath crowding in the radial direction (i.e. low diametral clearance) and little evidence of CANLUB. However, these observations need to be validated by examination of intact neighbouring elements and by further review of manufacturing data to examine the typical frequency of voids in the braze eutectic.

Figure 9: Possible SCC penetration at spacer pad on outer element 7 of 2O19

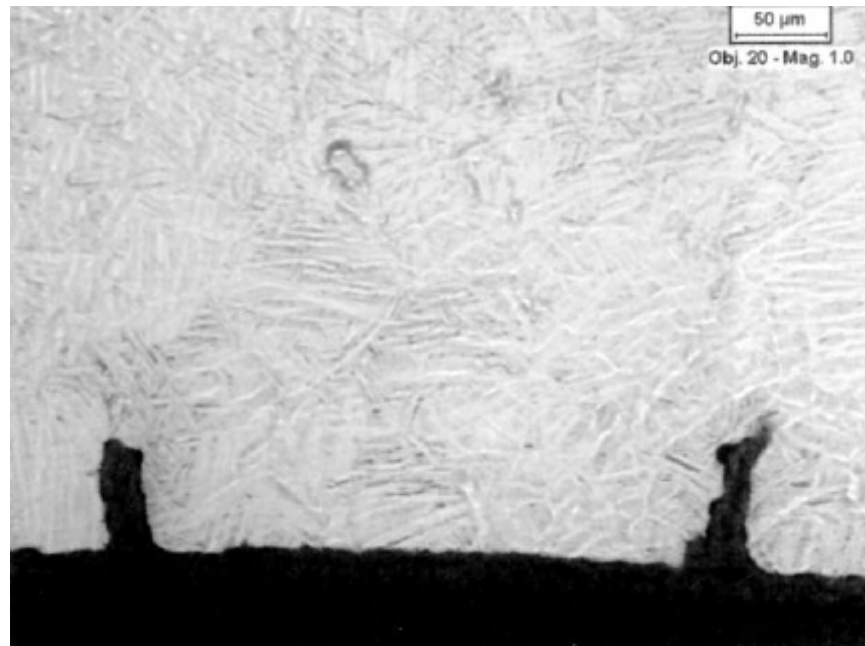
Similarly, defected element 2K14-14 showed evidence of incipient cracks on the sheath inner surface close to a bearing pad (Figure 10). The defect cause for this element has not yet been determined.

Figure 10: Possible incipient cracks on the sheath inner surface close to a bearing pad of 2K14 element 14

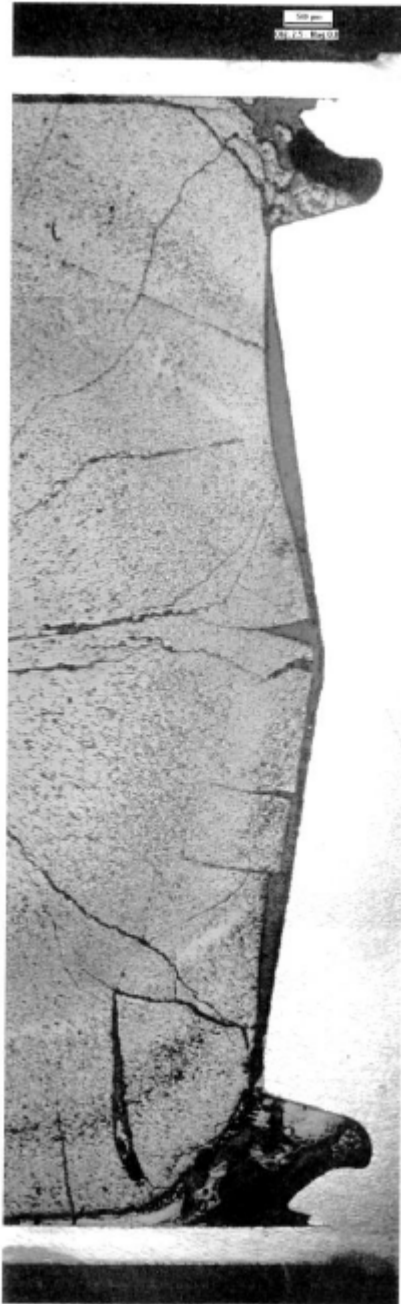
Pellet crowding has been observed at both ends of elements 1O10-8 and 2O19-7 and at one end of 2K14-14 (PIE of the other end is not available). Pellet crowding in 2O19-7 is illustrated in Figure 11. In this case the fuel pellet is observed to be residing in contact with the endcap. This observation will be validated by PIE on an intact neighbouring element.

Figure 11: Pellet to endcap crowding in 2019-7

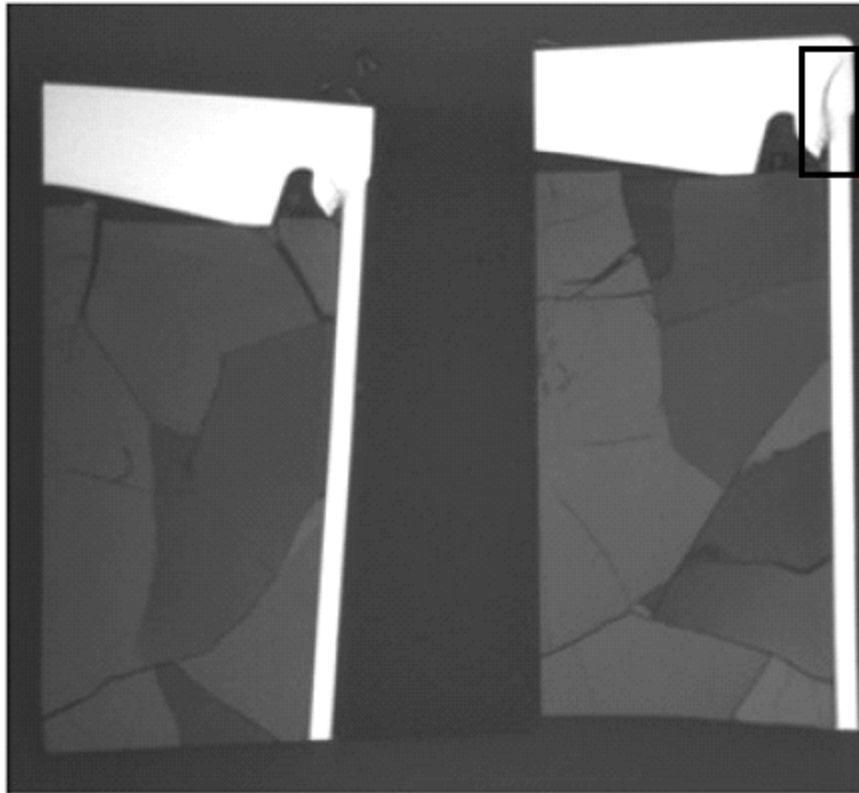
Evidence of pellet crowding in 1O10-8 is illustrated in Figure 12. In this case there are accompanying indications that these conditions may have led to hydride migration and propagation of a weld artefact notch, similar to previous experience at Ontario Hydro in the mid 1980s at the Bruce A station (Figure 13). These historic defects were assessed to have been the result of endcap crowding and the resulting strain in the endcap weld. In that case elements failed due to hydride migration to the stress riser at the weld notch. The fuel manufacturer for these historic defects and the manufacturer of the Darlington fuel are not the same. In this Darlington PIE data the evidence is complicated by the occurrence of secondary deuteriding in the same notch. Unfortunately the intact neighbouring elements which accompanied this shipment for PIE have been disposed and are no longer available for validation examinations. We will not be able to clarify these observations by further PIE, however we will examine high mass unirradiated bundles to provide some clarity regarding these conditions.

Figure 12: Contact of fuel stack with endcap in 1O10-8

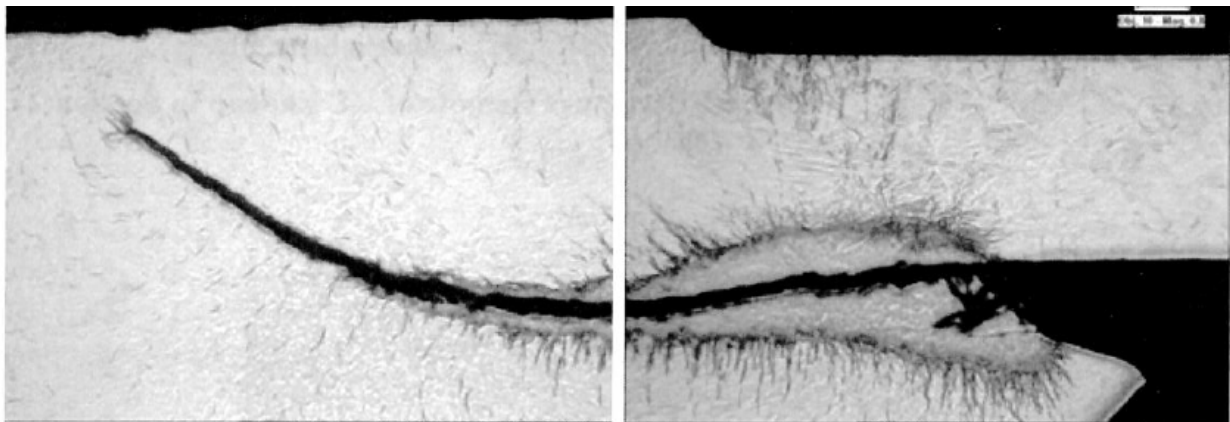
Figure 13: Circumferential cracking in 1O10-8

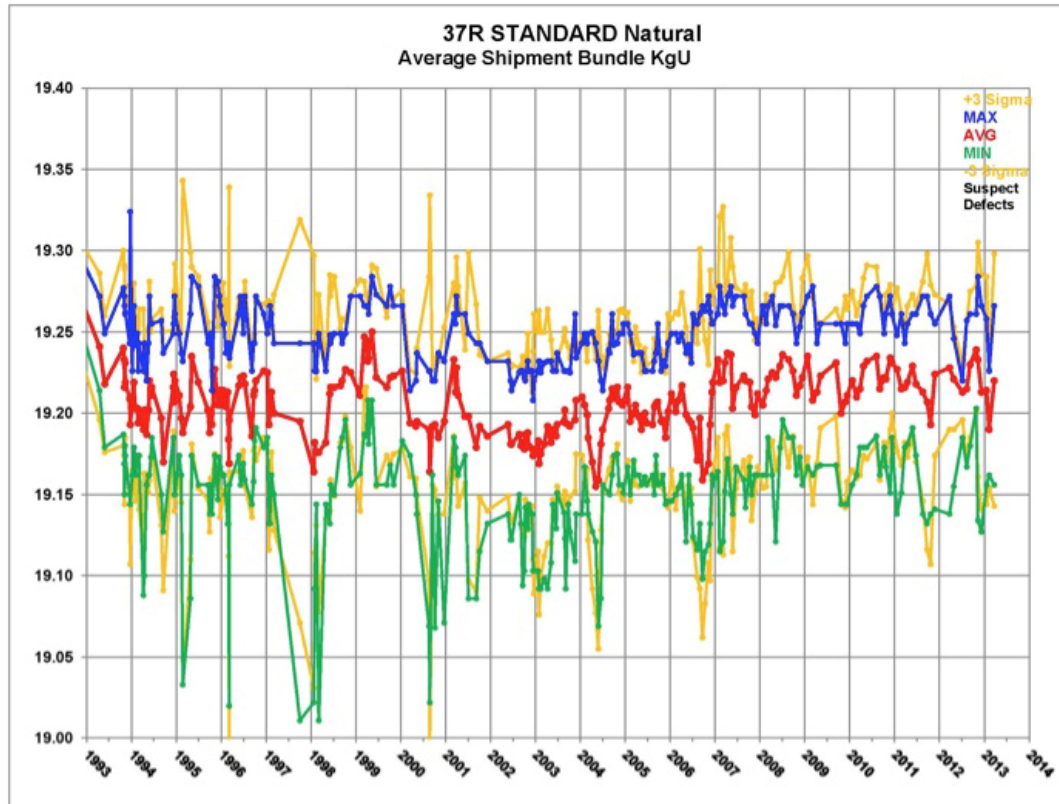
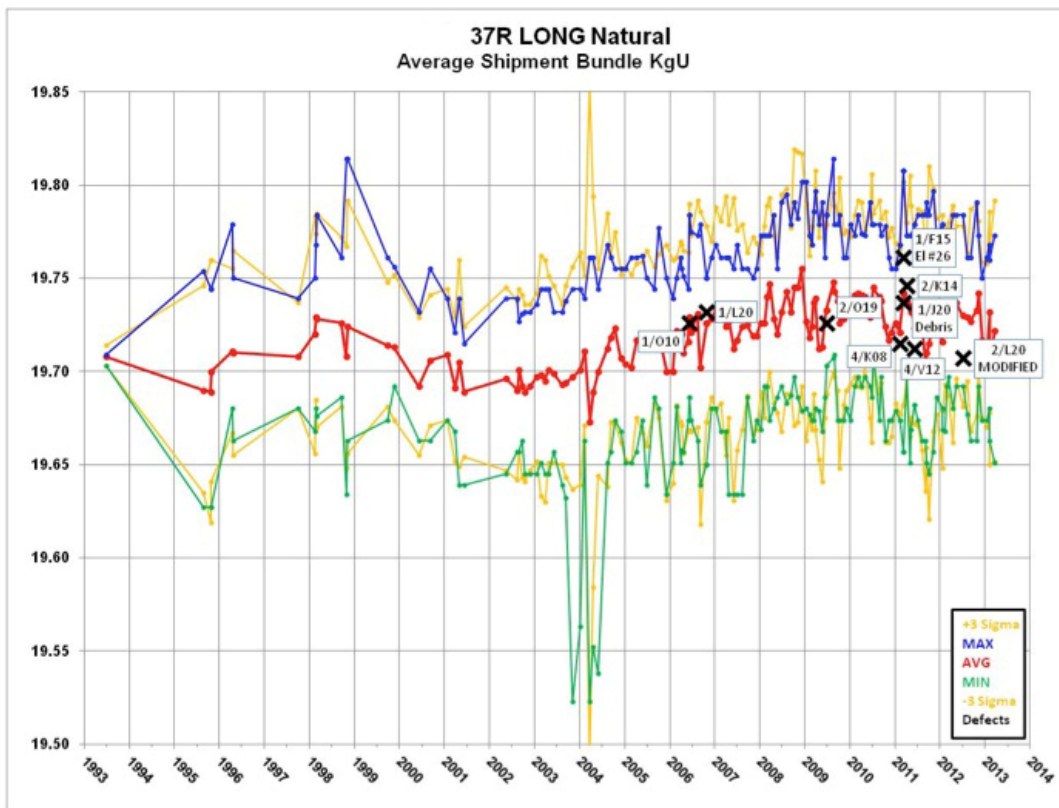
Figure 14: Bundle shipment Uranium masses for standard and long bundles

It is of interest that all defected bundles have been of the long bundle variety. These bundles are 12.7 mm longer than the standard length bundles used at Darlington. Examinations of uranium mass data provided by the manufacturer on shipment records provide some evidence regarding this observation. Note, these data provide average bundle uranium masses calculated on a pellet lot basis so they do not represent individual bundle masses, however these should provide reliable trends if taken on a shipment basis.

Figure 14 provides uranium masses for standard and long bundles on a shipment basis. These trends indicate that the uranium masses of long bundles have increased over the past decade, where the masses for standard length bundles have stayed approximately constant. If fuel pellet stack lengths are calculated using design centered values, this increase in Uranium mass is equivalent to approximately 0.7 mm, or approximately 70 % of the minimum axial clearance specified by OPG.

OPG is presently conducting a more thorough investigation of individual bundle mass records. The objective of this investigation is to determine if there is a reliable correlation between bundle mass increases and the Darlington fuel defect experience.

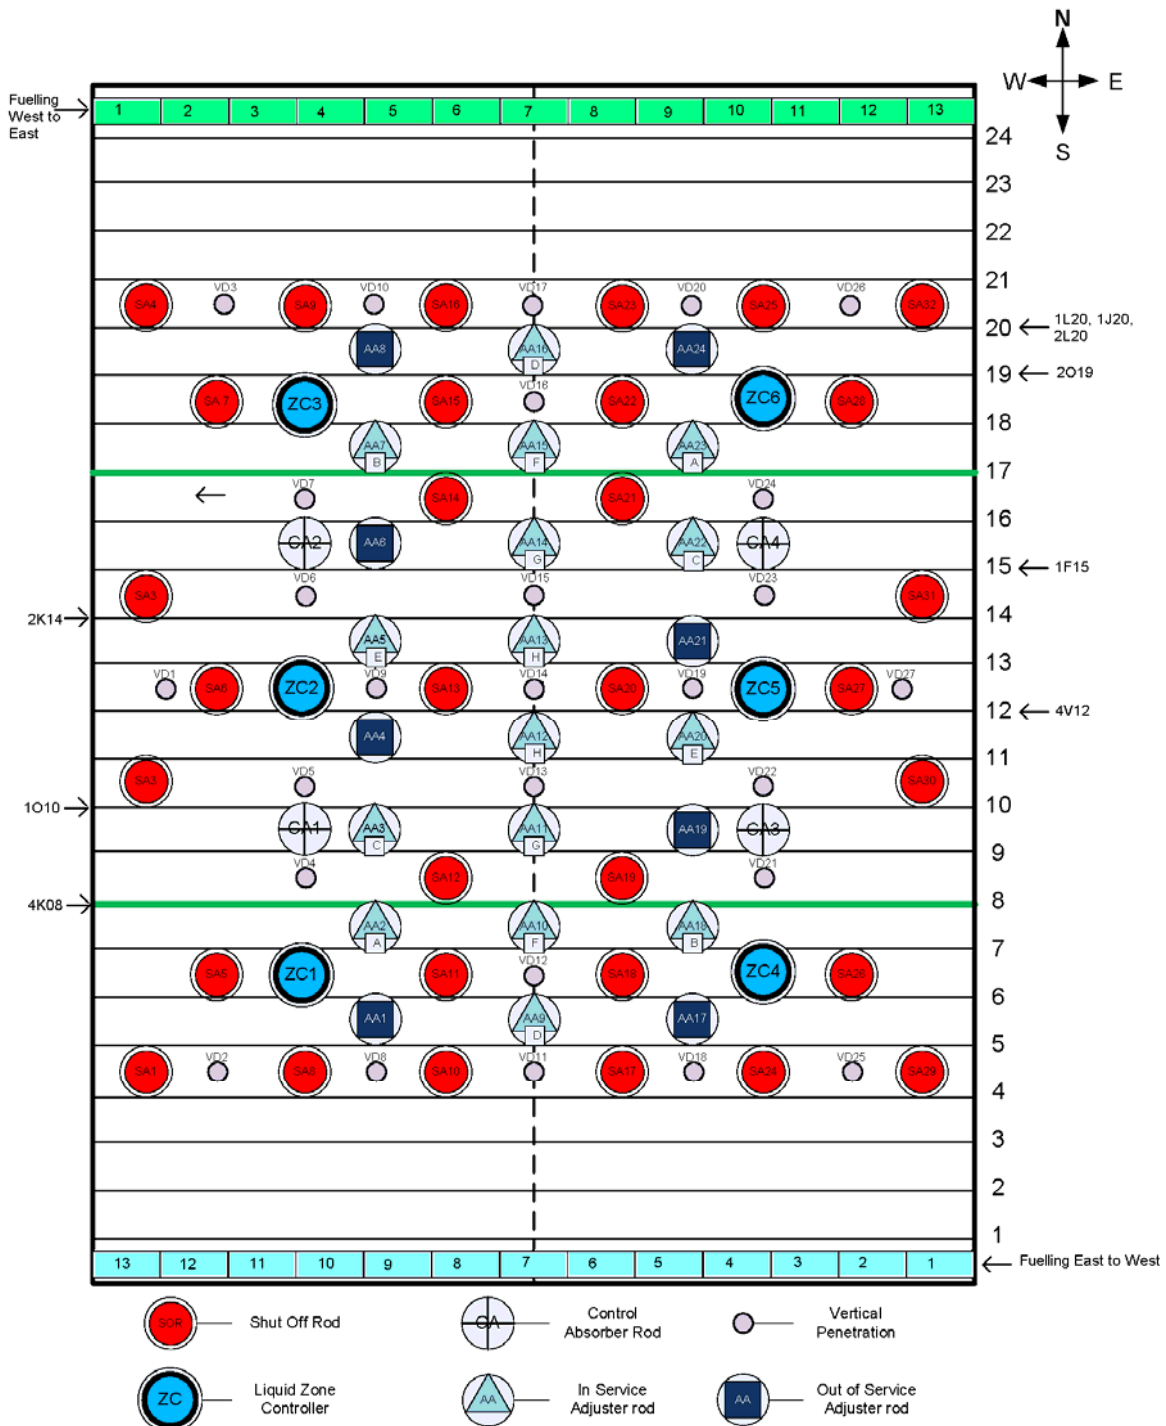
Figure 15: Top view of Darlington reactivity mechanisms showing locations of locked-out adjusters

A contributing factor to the occurrence of fuel defects may be local flux increases and the resulting bundle power increases in the locations of adjuster rods which have been locked out-of-core since the early days of Darlington operation. The severity of fuelling power ramps are assessed to have increased when these 8 adjusters were removed from core. Nonetheless, Darlington operated almost defect free for many years after the adjuster reconfiguration in the late 1990s. Assessments conducted in support of the reconfiguration revealed a large margin between the anticipated Darlington fuelling power ramps and power ramps which had been successfully experienced during the early years of operation of the unadjusted Bruce A reactors. However, it is reasonable to suggest that other factors such as low as-manufactured internal clearances may now be making these fuel bundles more susceptible to high bundle powers and power ramps.

Figure 15 displays the configuration of the vertical reactivity devices of a Darlington reactor. The identities of the 8 adjuster which have been locked out of core are indicated. Also indicated are the locations of the fuel channels from which defected bundles have been discharged. There appears to be a correlation between the locations of the defect channels and the locations of the missing adjusters. The strongest correlation is between columns 19 and 20, from which both AA8 and AA24 have been locked out of core, and defects discharged from channels 1J20, 1L20, 2L20 and 2O19. Defect channels 1O10, 1F15, 2K14 and 4V12 are adjacent to locations where single adjusters have been removed. Only defect channel 4K08 is not directly adjacent to the location of a missing adjuster, however it is only separated from such a location by one lattice pitch.
