Study of Scratch-Induced Stress Corrosion Cracking for Steam Generator Tubes and Scratch Control

Fanjiang Meng¹, Xuelian Xu¹, Jianqiu Wang² and Xiaoqiang Liu¹

¹ Shanghai Nuclear Engineering Research and Design Institute, Shanghai 200233

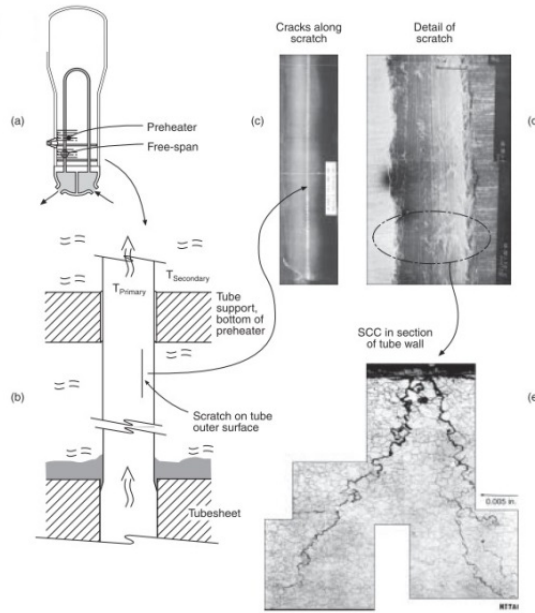
In 1989, a leak was detected on McGuire Unit 1 and the main cause was rupture of SG tubes which was Alloy 600 ^[5]. The ruptured tube was removed from McGuire Unit-1 SG and examined metallurgically. Intergranular stress corrosion cracking (IGSCC) along a shallow scratch on outer diameter of SG at cold leg was found. The maximum depth of these cracks was about 30% of the original wall thickness. Only about three years later, SG tubes in McGuire Unit 1 leaked again and the IGSCC cracks initiated at surface scratches ^[6], which was the same as before. Some cracks even reached up to 60% of wall thickness of tubes. In McGuire Unit 2, IGSCC was also found that cracks initiated along scratches in outer diameter of SG tubes as shown in Figure 1 ^[2, 3].

Figure 1 Scratch-induced SCC of steam generator tubing on secondary side in McGuire 2 ^[6]

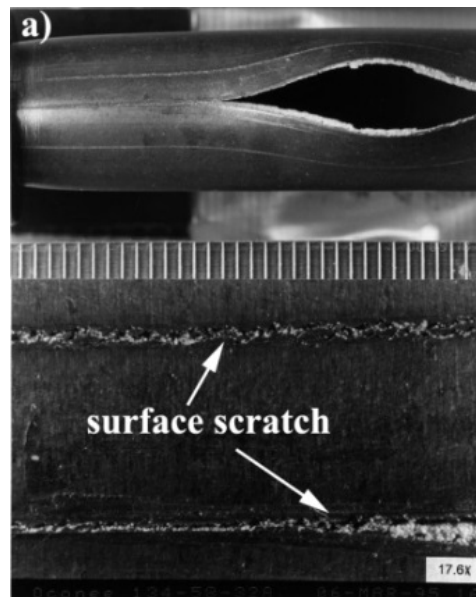
During the 1994 refueling outage, the eddy-current results indicated that some SG tubes degraded ^[2]. Defects responsible for the indications consisted of shallow cracks in the free span regions and axially aligned IGA of up to 47% through-wall. After bursting test and extensive microstructure investigation, it was confirmed that those axial cracks initiated and propagated along surface scratch. The burst result is shown in Figure 2.

Figure 2 Scratch-induced SCC of steam generator tubing on secondary side in Oconee Unit 1 ^[2]

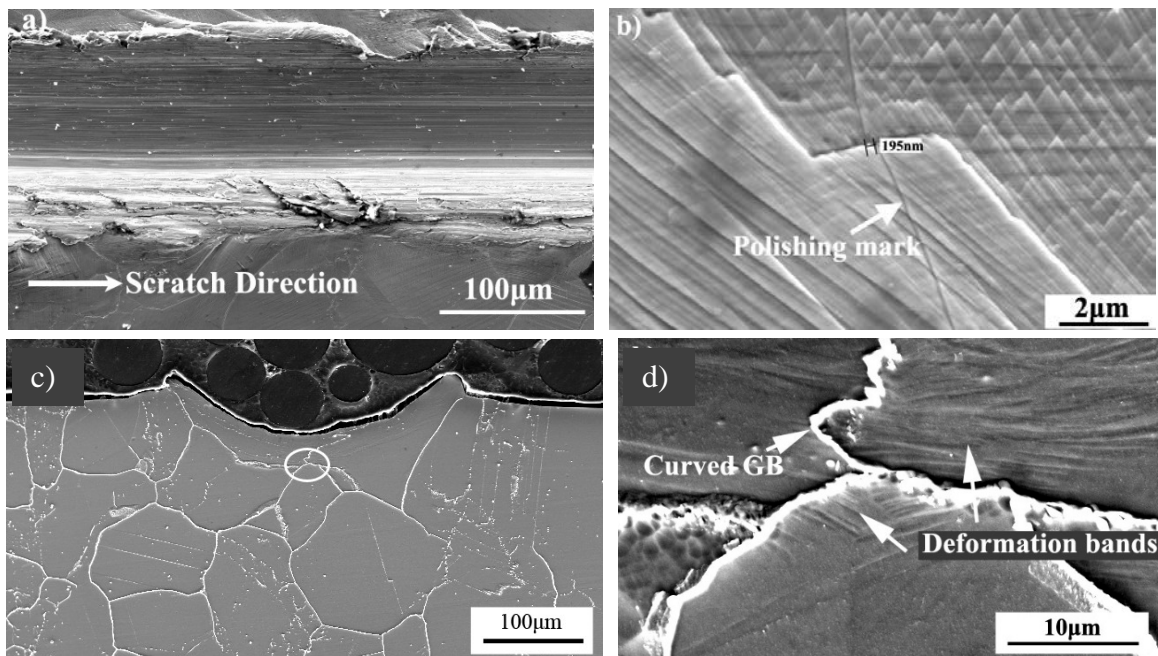
Figure 4 Microstructure of Alloy 690 after scratching process^[7]

A type of scratch (300µm in width and 50µm in depth) which has similar variables with scratches found in fields was simulated and studied in laboratory^[7]. The microstructure in the surrounding scratch is shown in Figure 4. Grains were highly deformed and exhibited slip bands as shown in Figure 4a and grain boundaries and twin boundaries were curved and visible as shown in Figure 4b. The deformed area was approximately 50-100µm from the scratch to non-deformed surface. The

triggered slip systems were different in grains with different orientations. Some grains sustained more than one slip system. Cross-section of a scratch in Figure 4c shows that there were accumulations at the edge of the scratch-bank and a deformation layer, about 30 μ m deep, beneath the scratch-bed. The grain boundary underneath the scratch-bed was curved and the deformation bands were visible as shown in Figure 4d. According to result of microhardness measured along scratch surface and cross-section, strain hardening was found at scratch bed and two banks of scratch [9]. The ratio of strain hardening zone to scratch width was about 1, which is consistent with others work [8,9]. The ration of depth of strain hardening at scratch bottom to scratch width was close to 0.5.

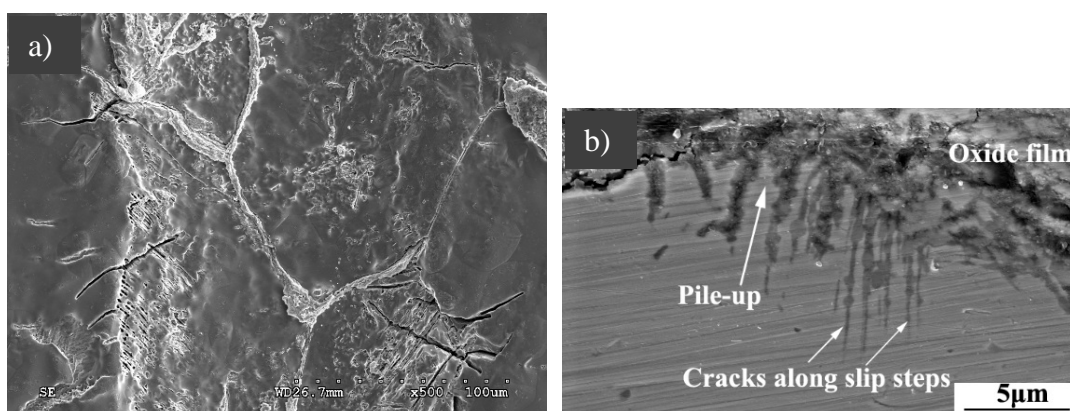
The immersion tests in caustic lead-containing solution were performed and SISCC was found on Alloy 690TT. The results also shows (Figure 5) that SCC cracks preferentially initiated along slip steps, microcracks and deformed grain boundaries produced during scratching process [7,9].

Figure 5 Growth of SCC cracks along (a) grain boundaries and (b) slip steps around scratch groove [7, 9]

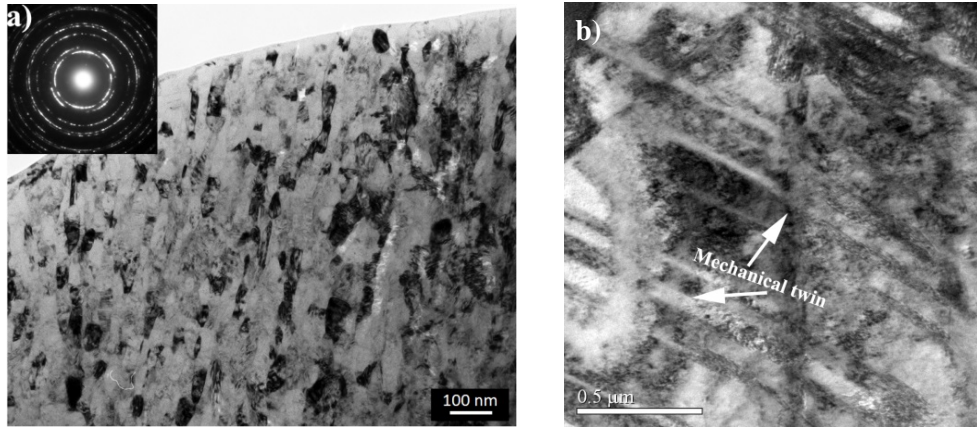
Figure 7 TEM observation of scratches for Alloy 690TT^[8, 9]: (a) bottom of scratch groove, (b) scratch banks

The microstructure of scratch groove and scratch banks on Alloy 690TT observed in TEM is given in Figure 7. As shown in Figure 7a, grains in the shallow layer around the scratch groove was nano-structured, which is consistent with fine grain produced during mechanical attrition of Alloy 690^[11]. Because of high strain and high strain rate, numbers of mechanical twins formed after scratching process at scratch bank (Figure 7b). Since Alloy 690TT possesses low stacking fault energy, mechanical twins are easier to form. Sub-grain layer was also found on scratches of SG tubes in Oconee Unit 3 which was the same results with laboratory study^[4].

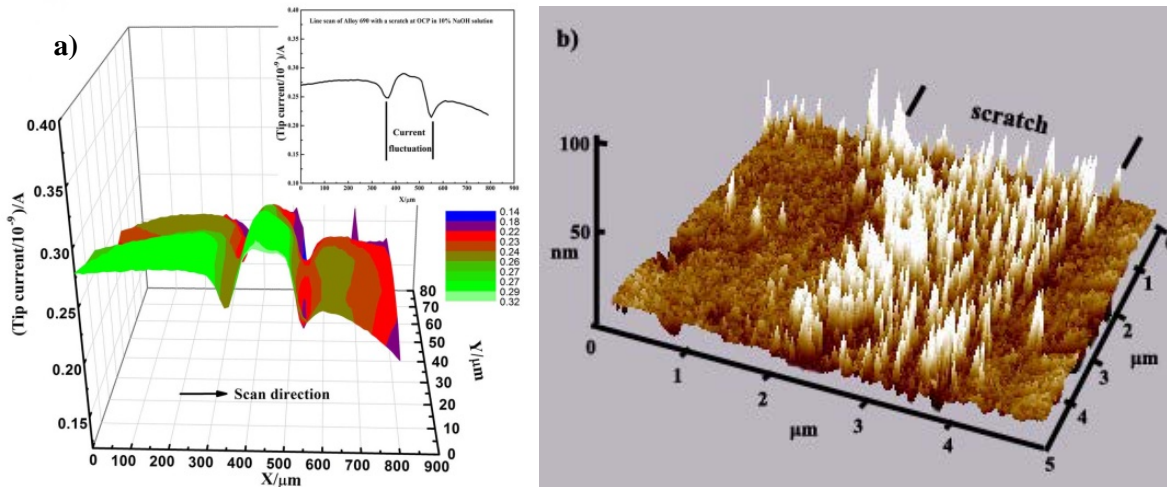
Figure 8 Localized dissolution (a) and oxidation (b) along scratch groove for Alloy 690TT^[8]

As shown in Figure 8a, the scratch affected zone turned into a local anode and dissolved rapidly. According to Gutman^[12], plastic deformation makes a heterogeneous micro-electrochemistry on material surface, and increases standard potential localized. The electrochemical activity of slip steps is much higher than surface without slip steps. Since existence of nanostructure at the scratch groove, oxides nucleated preferentially and grew rapidly (Figure 8b). This result demonstrates that

scratching process created different energy distribution around the groove, especially nano-grains on the scratch groove stored higher energy which dissolved and oxidized preferentially^[8].

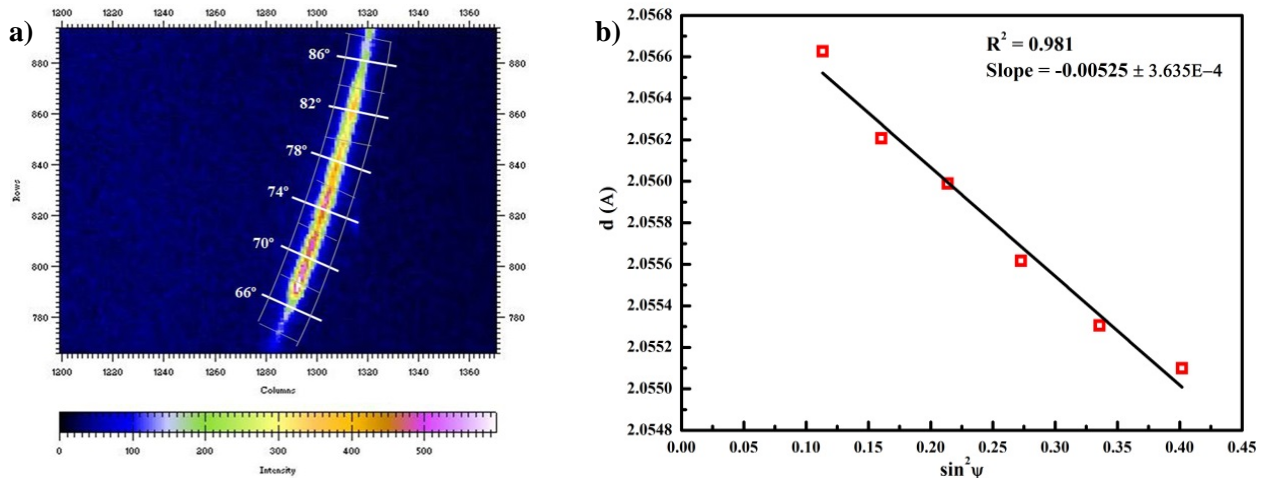
Figure 9 Calculation of residual stress at bottom of the scratch for Alloy 690^[13] (a). Integration of the Debye Ring; (b). $d\text{-sin}^2\Psi$ fitting

Compressive residual stress, which was the same with Oconee Unit 1, was measured on shallow surface of a typical artificial scratch by synchrotron radiation as shown in Figure 9. The result shows grains that 20 μm below the scratch bed was compressive and the residual stress was about $414 \pm 29\text{MPa}$ ^[13]. However, high tensile residual stress of $467 \pm 15\text{MPa}$ along scratching direction was measured^[13]. High residual stress indicated that scratching process introduced very high cold working in local surface around the scratch.

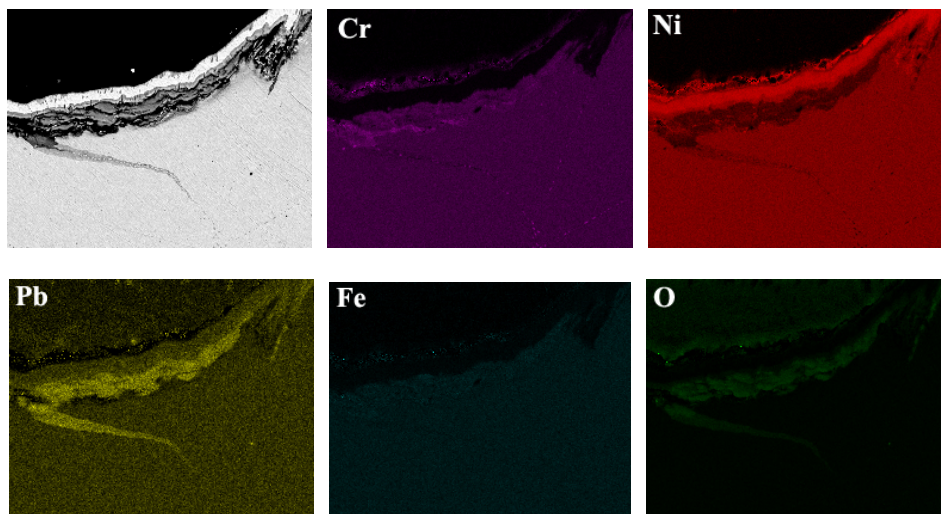
Further analysis by TEM for the SCC crack on tubes of Oconee Unit 1 was conducted and lead was examined on the crack path^[2]. It has been reported that lead can undermine the stability of oxide film, make it become loose and advance crack initiation and propagation around scratch which is evidenced in lab study. As shown in Figure 10, a mount of lead was enriched in crack path and chromium oxide nearly disappeared.

Figure 10 Elemental area scan of Alloy 690TT SISCC path (Test condition: 330°C, lead containing caustic solution)
