## **PRACTICAL CONSIDERATIONS FOR PREVENTION OF FLOW ACCELERATED CORROSION DURING REFURBISHMENT**

**J. Jo<sup>1</sup> and P. Ferdowsi<sup>2</sup>**

<sup>1</sup> Hatch Associates Ltd., Mississauga, Ontario, Canada, [jjo@hatch.ca](mailto:jjo@hatch.ca)

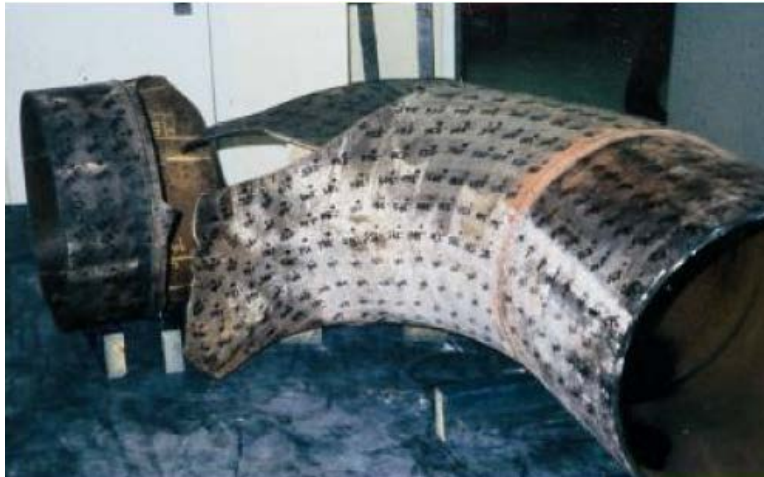
Failures and accidents resulting from FAC degradation have been reported at nuclear power plants around the globe since 1981. Some of the significant FAC events include the main feedwater line rupture at Surry Unit 2 in 1986 and the condensate system pipe rupture at Mihama Unit 3 in 2004. The 18" (450 mm) elbow, located in the suction line to the main feed pump at Surry Unit 2 (Figure 1), experienced a substantial loss of wall thickness from a

nominal 13 mm to 0.38 mm at the thinnest point[2]. As a result, when a main steam isolation valve failed closed, the elbow ruptured from the increased pressure causing four fatalities. Similarly, the ruptured condensate pipe located downstream of an orifice at Mihama Unit 3 (Figure 2) went through a loss of wall thickness from 10 mm to 1.5 mm[8].

Figure 1 A Ruptured Elbow in Feedwater Line at Surry Unit 2(W. H. Ahmed [8])

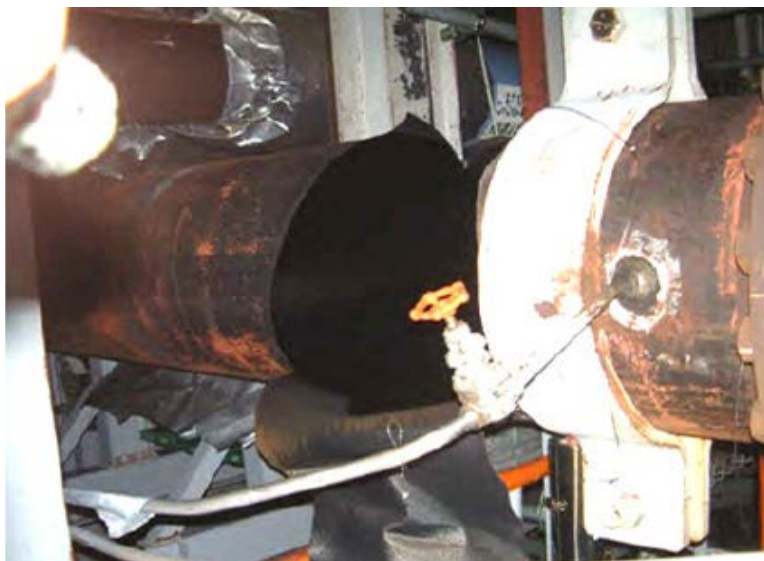
Figure 2 Ruptured Condensate Pipe at Mihama Unit 3(W. H. Ahmed [8])

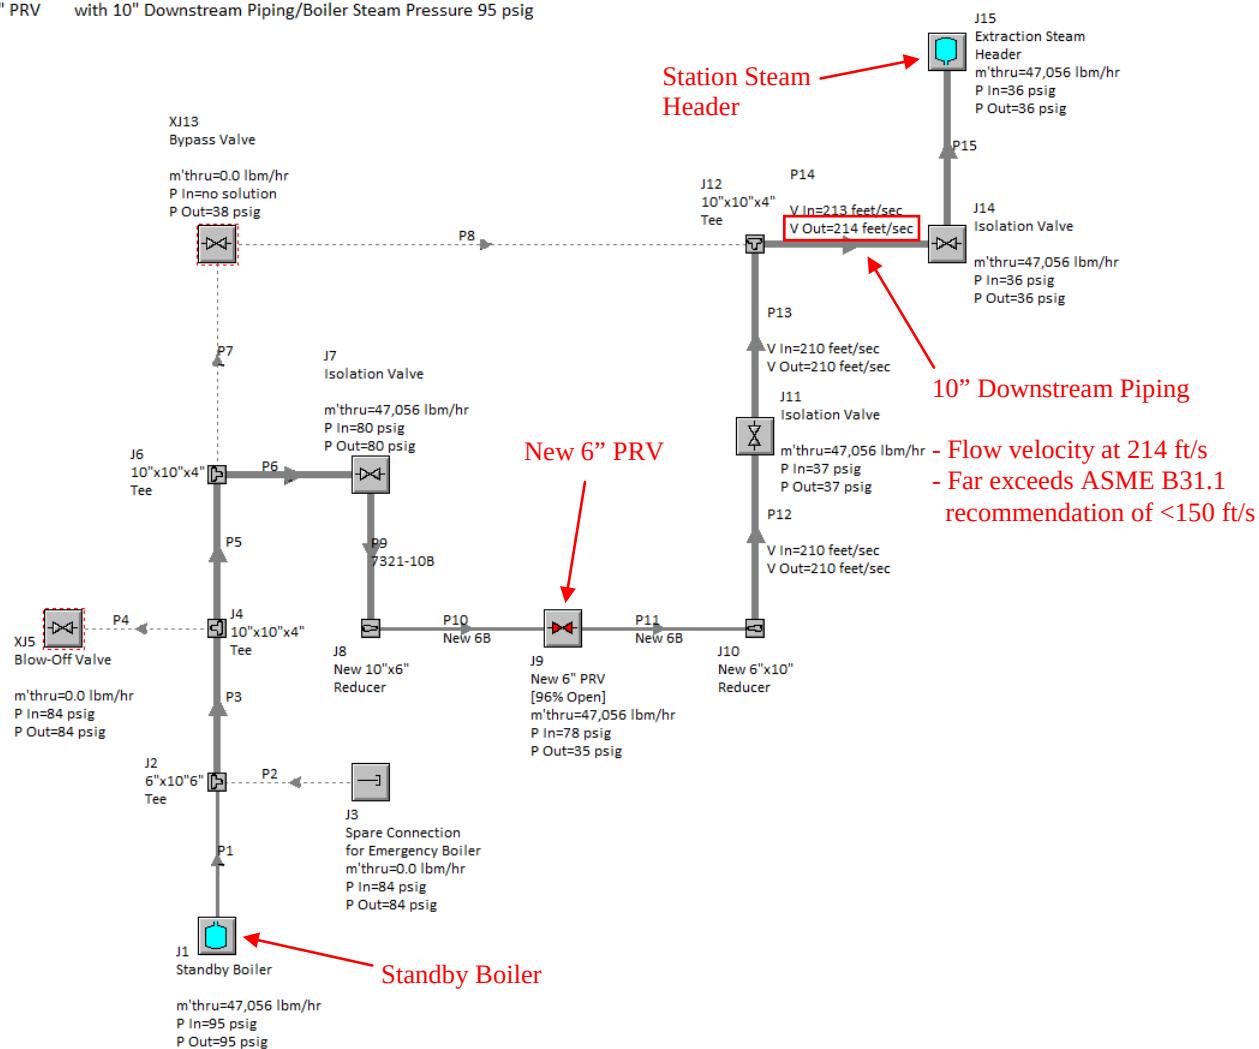
During the review stage, however, it was highlighted that the flow velocity had increased significantly in the pipes downstream of the new 6" (150 mm) PRV due to its increased capacity. In the worst case, the flow velocity reached approximately 214 ft/s (65.2 m/s), which far exceeds the maximum steam velocity of 150 ft/s (45.7 m/s) recommended by ASME B31.1 for minimizing the risk of FAC for wet steam.

Figure 4 Initial Model and Output from the Flow Analysis performed using AFT Arrow

As identified in ASME B31.1 Non-mandatory Appendix IV, the FAC rate increases when the steam flow velocity is higher than 150 ft/s (45.7 m/s). At the flow velocity of 214 ft/s (65.2 m/s), the affected steam system would experience a very high FAC rate with the new 6" (150 mm) PRV.

Coincidentally, the very case of the increased FAC rate due to locally increased flow velocity in a control valve station is presented in Section 5.4 of EPRI Recommendations for an Effective Flow-Accelerated Corrosion Program (NSAC-202L-R4)[1]. As suggested in the EPRI recommendation, the pipe diameter downstream of the 6" (150 mm) PRV was increased from the original 10" to 12" (250 mm to 300 mm).

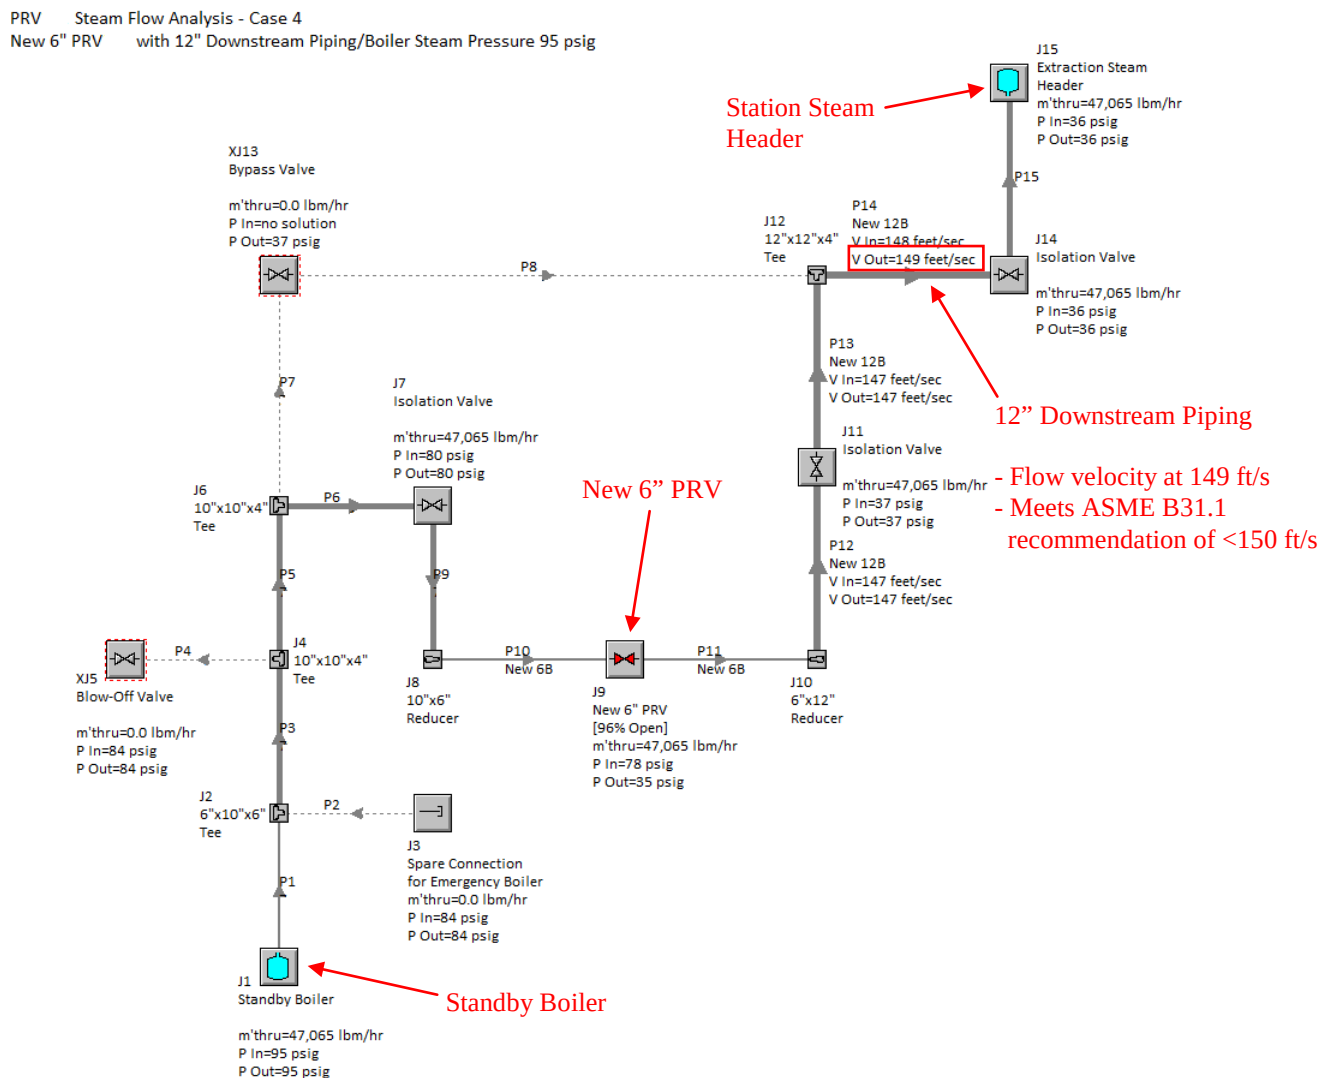
Although the increased weight and thermal loading on the pipe supports and the station steam header introduced additional challenges to the design, they were appropriately managed and, as shown in Figure 5, the flow velocity in the model was successfully reduced below the threshold of 150 ft/s (45.7 m/s).

Figure 5 Final Model and Output from the Flow Analysis performed using AFT Arrow
