## MICROSCOPIC EXAMINATION OF UNIRRADIATED CANDU FUEL FROM DARLINGTON NUCLEAR GS

**ABSTRACT** – Between 2010 and 2014, Darlington NGS experienced an increase in the number of fuel defects. Elements from unirradiated CANDU fuel bundles manufactured in 2012 and 2013 were disassembled, inspected, and compared with elements manufactured circa 2002. These inspections revealed fractured fuel pellets, debris, and internal damage to the fuel sheaths that may have been caused during pellet loading. The fractured fuel pellets and damaged sheaths were examined in detail to characterize the material damage mechanisms and investigate the underlying causes. Differences in fuel pellet fracture modes were related to variations in UO<sub>2</sub> microstructure, which is typically controlled by the UO<sub>2</sub> powder feedstock, die compaction and sintering process parameters. The OPG investigation identified that the majority of fuel defects were confined to two manufacturing clusters. The focus of this paper is on the benefits of microscopic examinations of fresh fuel.

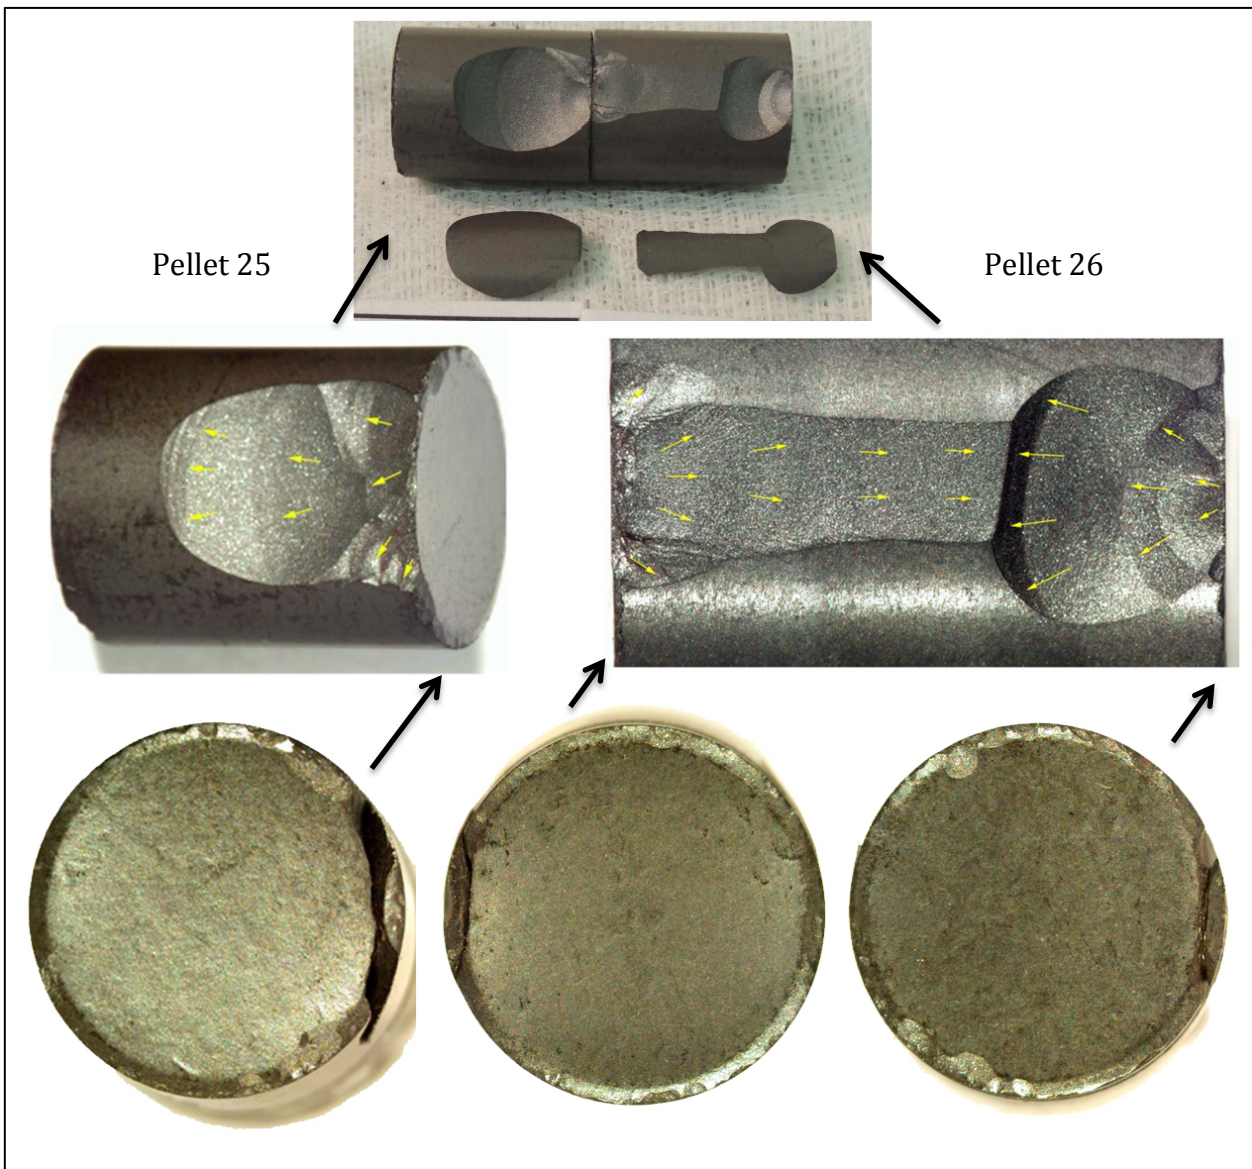
Figure 1 presents images of recently manufactured Pellets 25 and 26 from Element 16, Bundle A. These pellets displayed aligned fractures with rounded chips on one side of each cylinder. Fractures started at the ends (rims) of the cylinders and propagated in predominantly axial directions. Pellet 25 displayed a single main fracture feature that extended approximately 2/3 of the total length of the cylinder. Pellet 26 displayed two fractures that started at opposite ends of the pellet, propagated towards each other in the axial direction, and then converged near the middle of the cylinder. The latter fracture type is sometimes referred to as a ‘spoon’ shaped fracture. The general directions of primary and secondary crack growth, as determined from the patterns of Wallner lines and velocity hackle [2], are indicated by the yellow arrows. The origin area of the primary fractures were located at the rims of the cylinders within regions of edge chipping. When the pellet fragments were re-assembled, it was noted that there were gaps on either side of the origins, signifying that smaller fragments of debris had been liberated as a result of the fracture mechanism.

**Figure 1 Crack origin areas (OA) and propagation directions (arrows) for Pellets 25 and 26 from Element 16, Bundle A.**

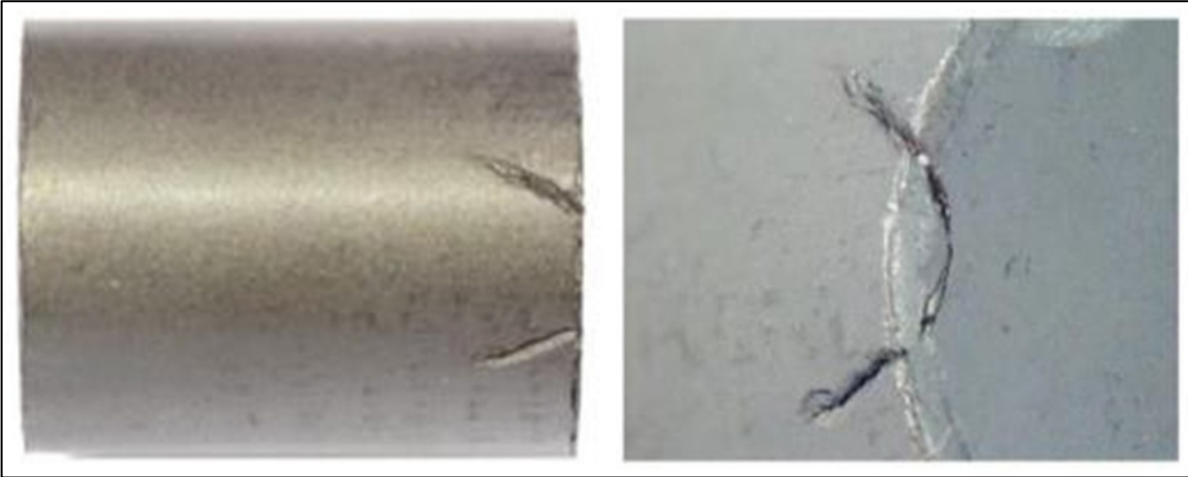
Figure 2 presents images of another pellet from Bundle A, Element 16 (Pellet 11). This pellet displayed a U-shaped linear feature at one of the cylinder ends, initially described as a ‘tunnel’ or ‘U-shaped void’. The preliminary visual inspections revealed that the orientation of this U-shaped feature was similar to the edge cracks and chips identified in Pellets 25 and 26. Figure 3 presents SEM images of the U-shaped defect in Pellet 11. This inspection revealed that the edges of the U-shaped feature were sharp and crack-like. At this stage it was recognized that the U-shaped feature was actually a large crack that had not propagated to the same extent as those displayed in Figure 1. The crack origin was centred on the rim of the cylinder in an area that displayed multiple, overlapping edge chips. Detailed SEM examinations revealed a network of secondary cracks in this area of the rim / end face of the cylinder that branched outward to the edge of the cylinder. This resulted in the breakout of small pieces of the pellet. The exposed edges of the U-shaped feature were ‘open’ with gaps between the fracture faces that were created by the break-out of material. The material break-out was caused by micro-crack convergence. The  $\text{UO}_2$  displayed a mixture of transgranular and intergranular fracture. The fracture surface also displayed numerous, intragranular and intergranular voids.

**Figure 2** A U-shaped defect in Pellet 11 from Bundle A, Element 16.

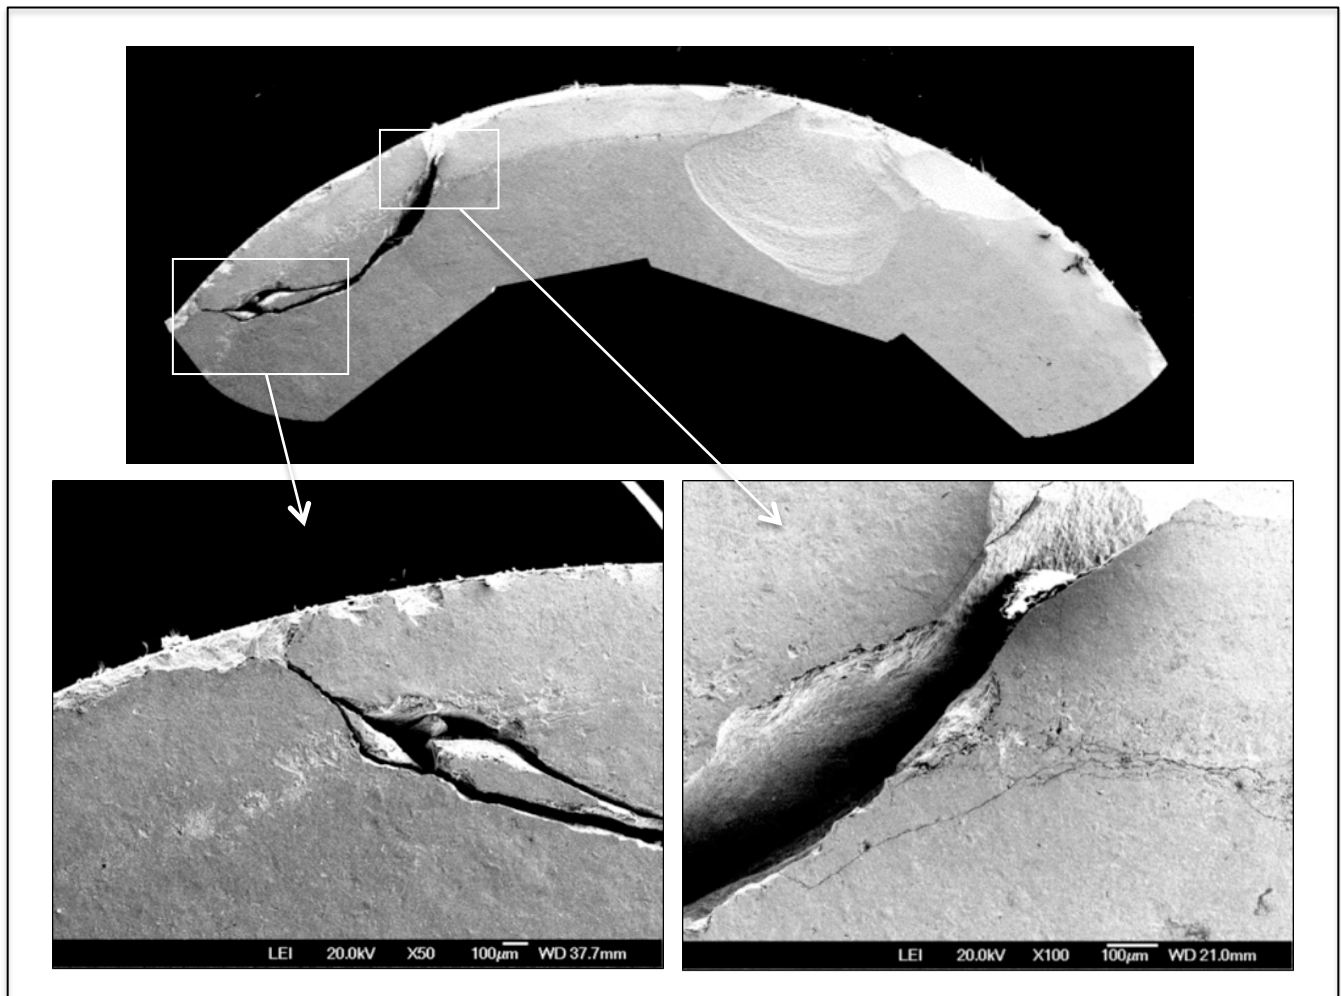
**Figure 3** SEM images of the crack origin area in Pellet 11, Element 16, Bundle A.

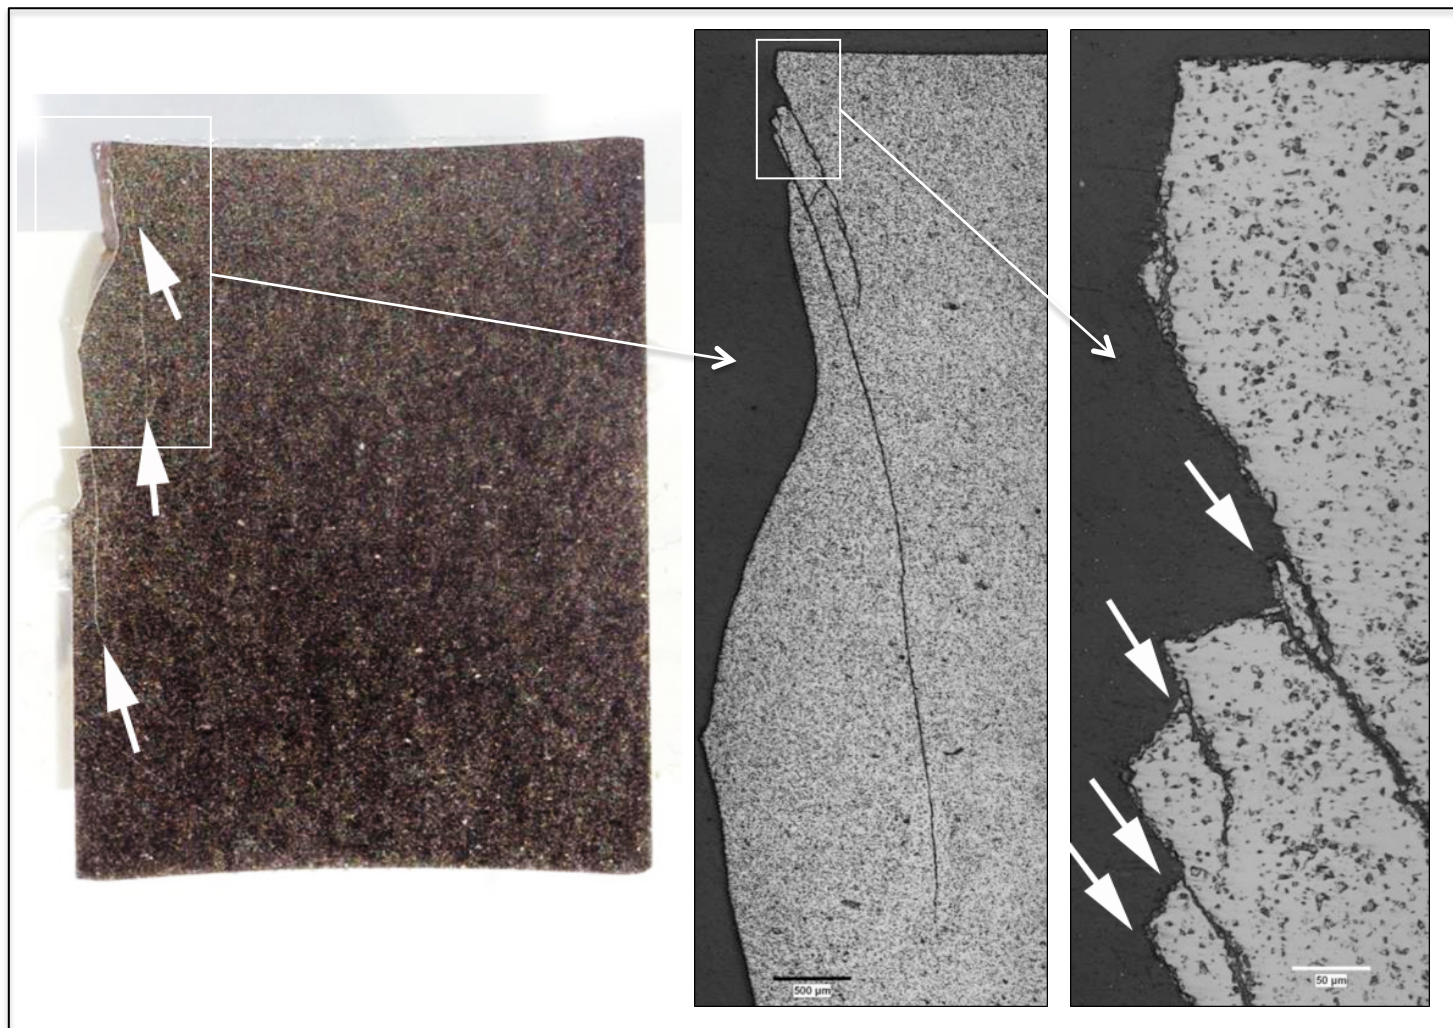
Figure 4 displays polished cross-section images of Pellet 10 from Bundle B, Element 5, which was manufactured in 2012. This pellet displayed macroscopic damage features that were in many ways similar to those just described for Pellets 11, 25, and 26 from Element 16, Bundle A. That is, multiple shallow cracks formed near the inner edge of the rim of the pellet and then propagated axially down the side of the cylinder. The axial cracks emerged at different axial positions, resulting in break-out of several pieces of  $\text{UO}_2$ . However, in spite of its condition, this pellet and most of the others removed from element B were judged to be relatively intact, compared to those

removed from Element A. Pellet 12 from Element 5 also had some large chips, one of which is very similar to Bundle A, Element 16. The SEM examinations of Pellet 10 revealed the presence of numerous secondary cracks and edge chips around the origin area. On a microscopic level, the fracture surfaces displayed a mixture of transgranular and intergranular fracture. The cross-section views displayed in Figure 4 were made through the fracture origin area and propagation zone of Pellet 10. Long secondary cracks can be seen running parallel to, but below the main fracture surface. The secondary cracks were not associated with any specific pre-existing feature of the  $\text{UO}_2$  pellet microstructure. On the other hand, the pellet displayed a relatively uniform distribution of voids (dark areas).

**Figure 4 Polished cross-section through Pellet 10 from Element 5, Bundle B.**

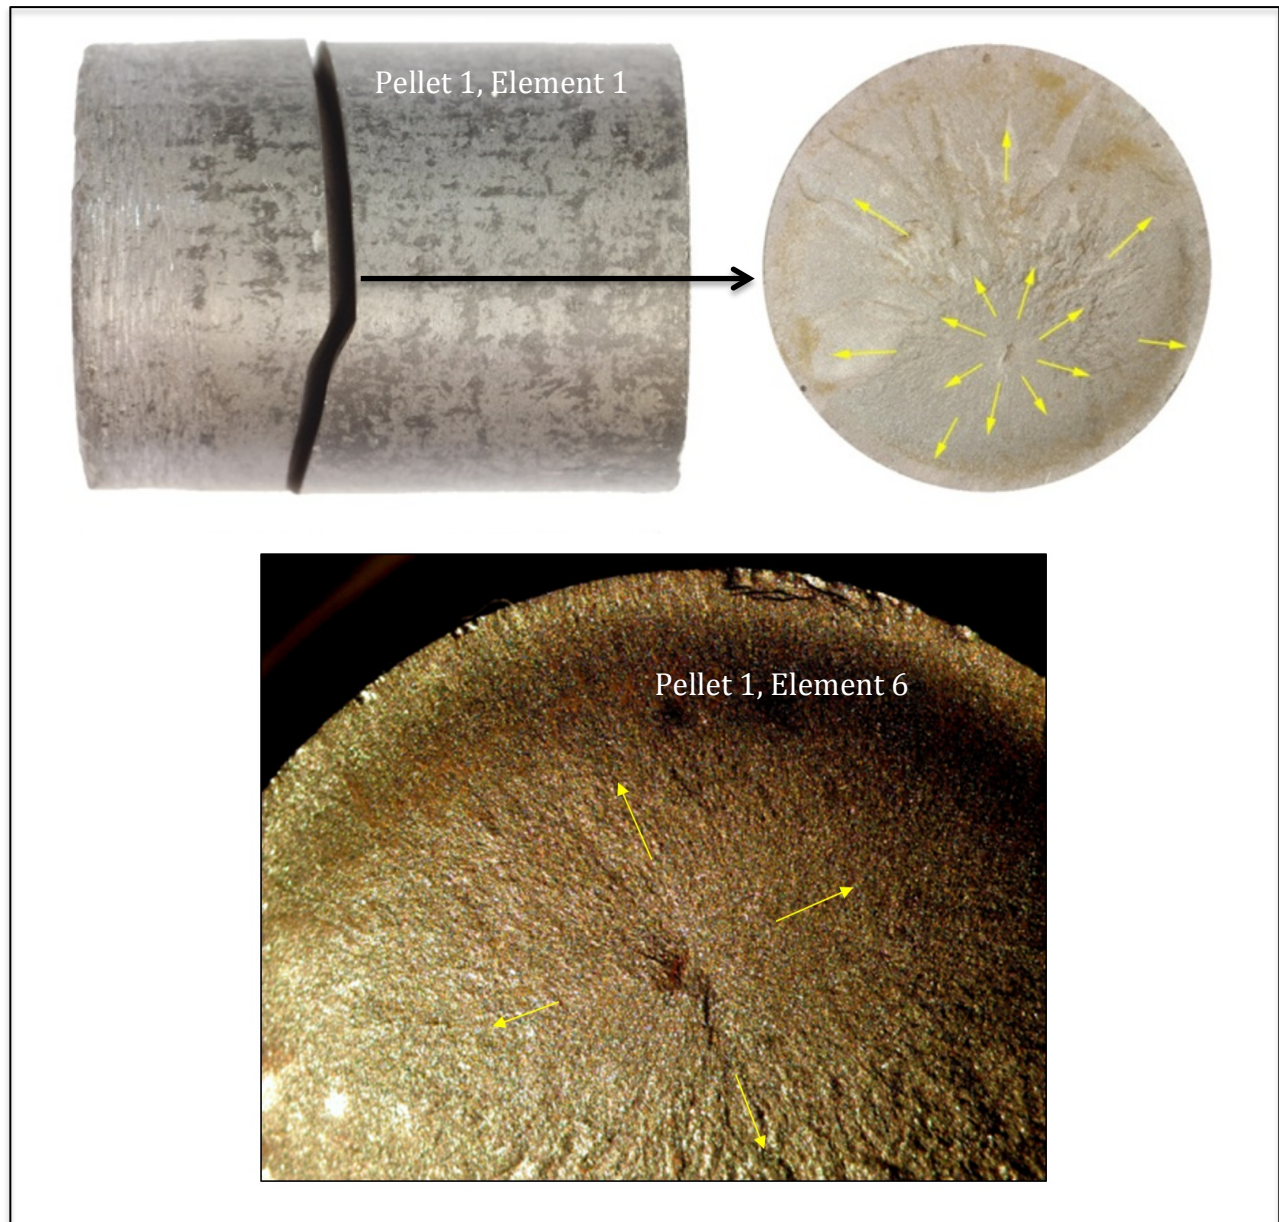
Figure 5 displays images of Pellet 1, Element 1 and Pellet 1, Element 6 from bundle C, which was manufactured in 2002. The fracture surfaces of these two pellets were quite different from those observed in bundles A and B manufactured in 2013 and 2012, respectively. First, the Bundle C fracture surfaces were oriented transverse to the major axis of the pellet (i.e., normal to the orientation of the axial cracks). Secondly, these fractures initiated at internal locations and propagated radially outward towards the cylinder surfaces.

**Figure 5 Crack origin area and propagation directions of two pellets from Bundle C.**

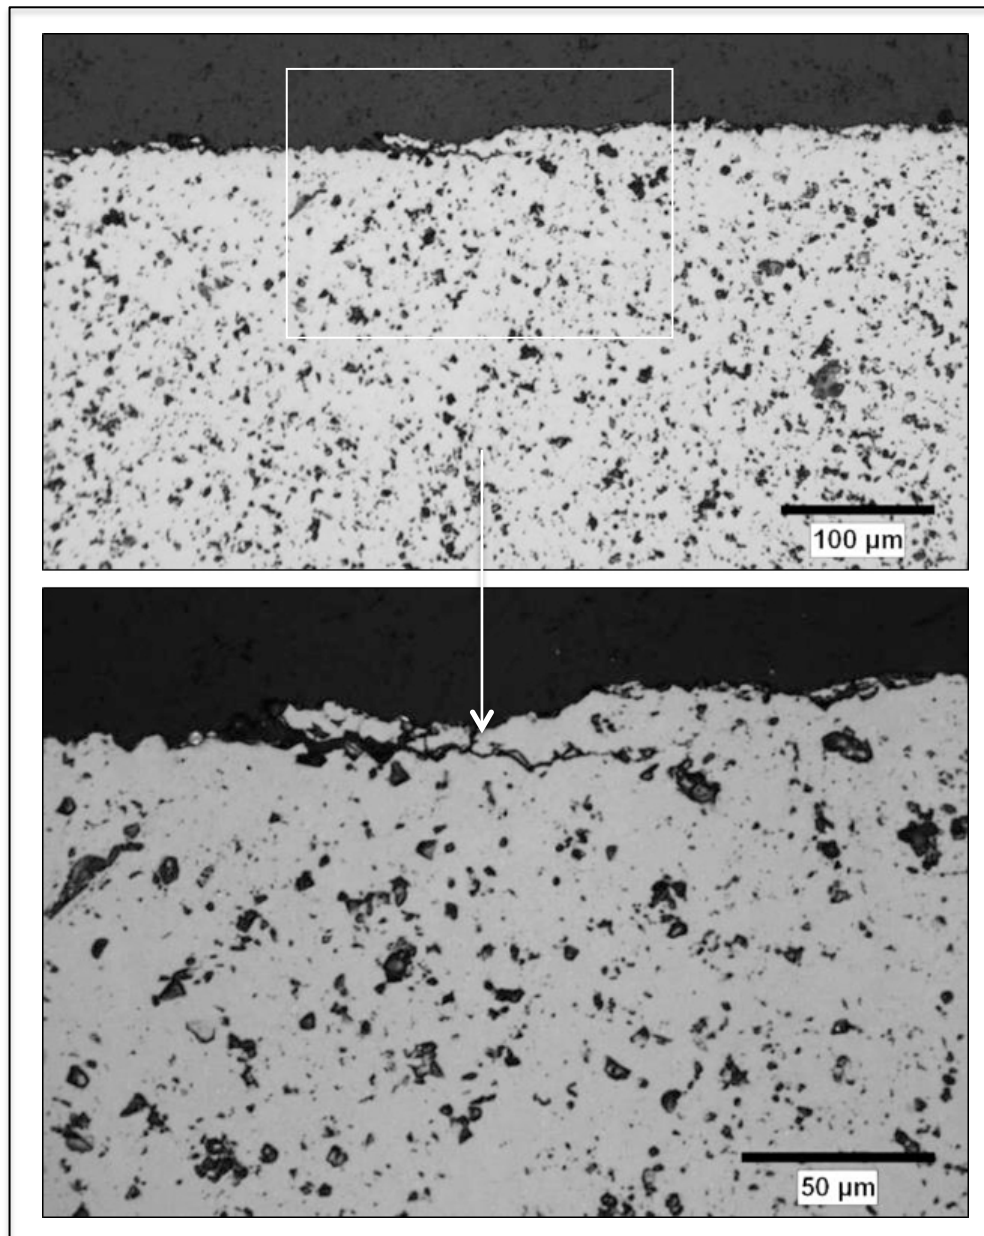
**Figure 7 Polished cross-section through the crack origin area of Pellet 1, Element 1 from Bundle C.**

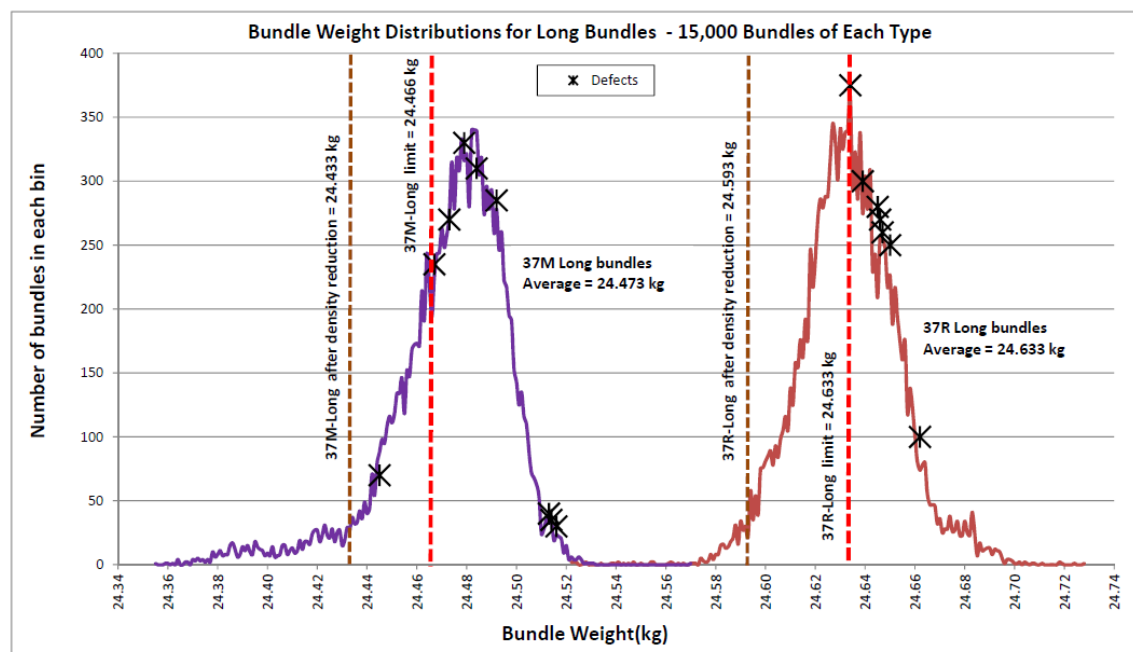
We have also observed that these defected bundles have consistently been among the heavier bundles irradiated at Darlington. This is demonstrated in Figure 8. All of the defected bundles of the 37R Long design were found to reside above the mean of the mass distribution of 15,000 sequentially numbered fuel bundles. This pattern is also observed with the 37M Long bundles, although in this case, two defected bundles are positioned below the mean. This is not unexpected since the 37M design is a recent innovation, with production dates well after the increasing trends in bundle mass and pellet densities were established.

Figure 8 – Weight distributions for 37R and 37M long bundles including defected bundles

OPG adheres to a “zero fuel defect” policy and responded energetically to this fuel defect excursion. The response and recovery plan discussed in our previous paper [1] has been implemented. Figure 8 includes the operational “loading limits” which were discussed in that paper. In addition, OPG and the fuel manufacturer have implemented a number of adjustments to fuel manufacturing parameters to increase fuel pellet to fuel sheath clearances and to reduce the chances of pellet to cladding interactions during pellet loading. These “adjustments” were minor and within the existing approved fuel design envelope, and are; (1) reduction in the target fuel pellet density by  $0.022 \text{ g/cm}^3$ , returning densities to pre 2003 values, (2) reduction in pellet diameters by  $10 \text{ }\mu\text{m}$  to  $20 \text{ }\mu\text{m}$  in an effort to eliminate interference between pellet and fuel sheath during loading of fuel pellets, (3) introduction of controls to limit the applied force during manual loading of fuel pellet stacks into fuel sheaths.
