## Post-Irradiation Examination of Bruce Nuclear Generating Station Elements at Chalk River Laboratories (CNL)

**ABSTRACT** – Bruce Power shipped five fuel elements from five irradiated fuel bundles to Chalk River Laboratories, Canadian Nuclear Laboratories (CNL) in 2013 for routine non-destructive examination (NDE) and destructive examination (DE). Four of the elements were examined to characterize anomalous deposits observed on the fuel cladding.

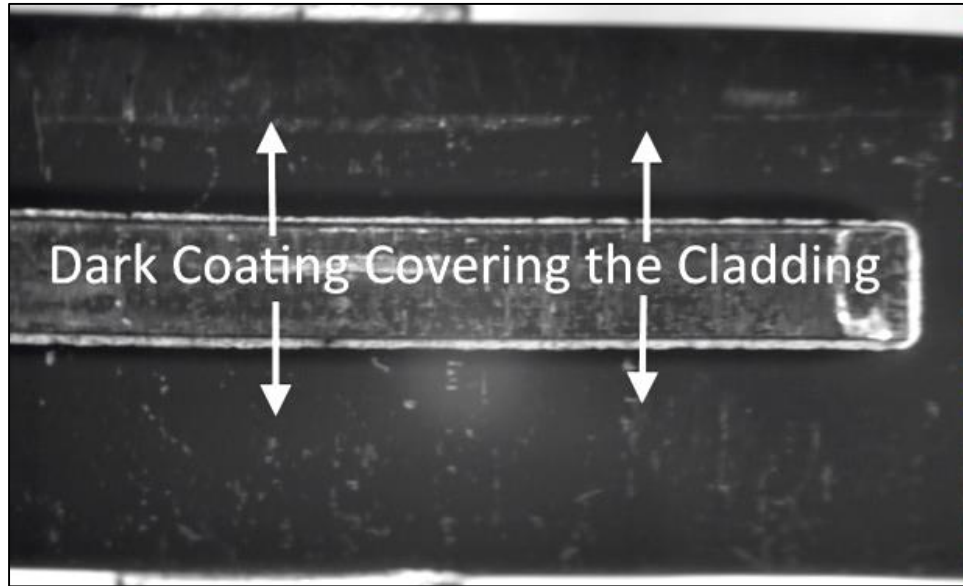
Dark deposits were observed on the two elements discharged from Unit 4 (Figure 1). The cladding was covered in a dark coating, with the exception of the endcap regions (Figure 2). The deposits on the two elements discharged from Unit 1 appeared lighter and more granular (Figure 3).

**Figure 1 - Example of Deposits Observed on Unit 4 Elements**

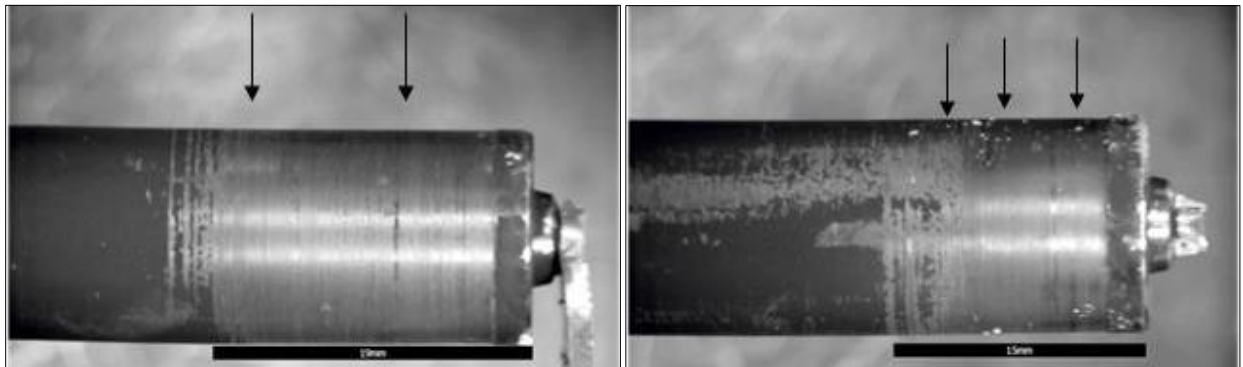
**Figure 2 - The Ends of the Unit 4 Elements Appeared to be Relatively Free of Deposit**

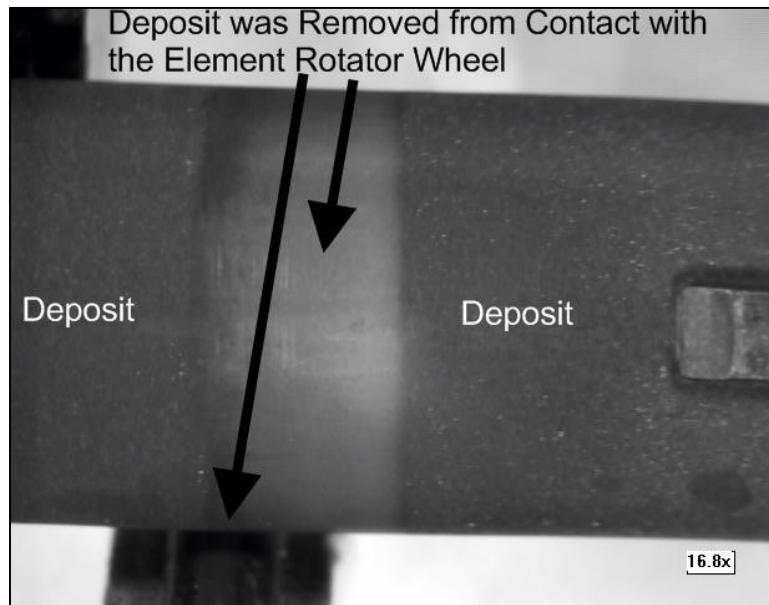
**Figure 3 - Example of Deposit Observed on Unit 1 Elements**

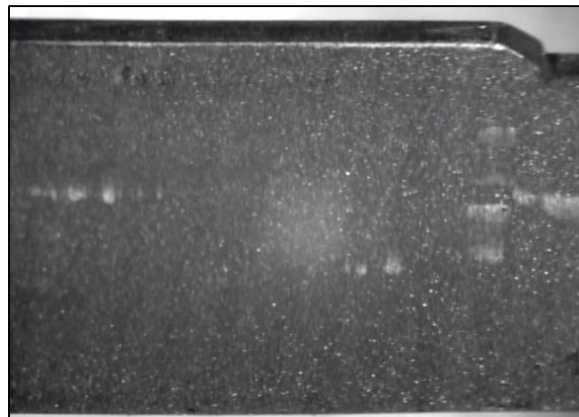
The deposits on the Unit 4 and Unit 1 elements had several similar features. Deposits were observed on the sides of some of the appendages (Figure 4). Post-discharge handling marks were clearly visible and indicated that simply holding the elements with tooling/hot cell manipulators was sufficient to remove the deposit material. All four elements appeared to be intact. To observe the cladding condition underneath the deposits, it was necessary to destructively examine the elements as described in Section 2.

**Figure 4 - Deposit Observed on the Cladding and Side Wall of the Bearing Pad**

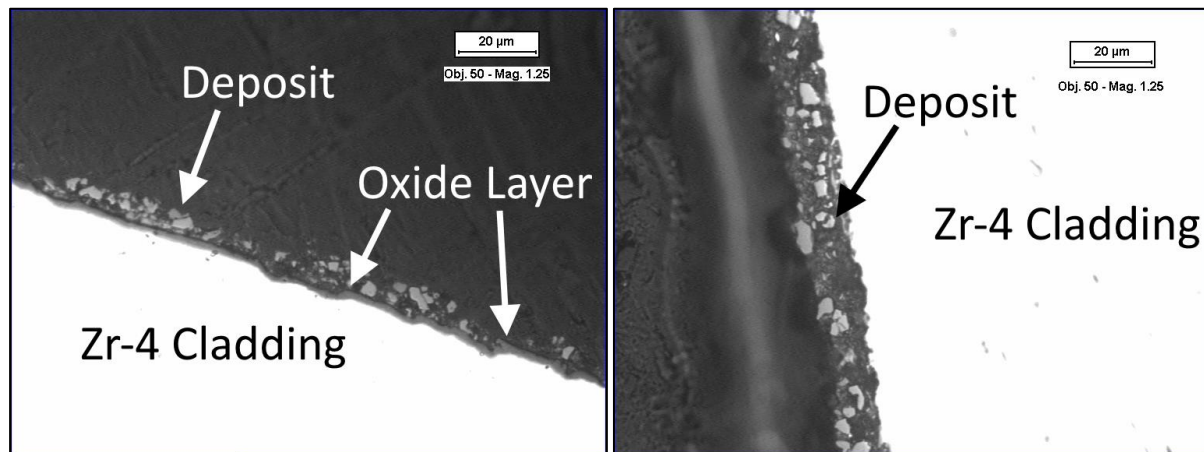
The polished Zr-4 cladding and associated deposits were examined in detail to assess the clad performance beneath the deposits and provide an optical characterization of the deposits. Figure 5 and Figure 6 show examples of the deposits and underlying oxide from the Unit 4 and Unit 1 samples, respectively. All observed deposits appeared to be porous and were present in non-continuous patches. Deposit thickness on Unit 4 samples did not exceed 20  $\mu\text{m}$ . The deposits on one of the Unit 1 samples were noticeably thinner than the Unit 4 samples; the deposit on the other Unit 1 sample was too thin to be resolved ( $<1 \mu\text{m}$ ). The  $\text{ZrO}_2$  layer thickness for fuel operating to  $<450 \text{ MWh/kgU}$  is typically less than 10  $\mu\text{m}$  [5], but can be greater under abnormal conditions and lead to defects in extreme cases [2]. The  $\text{ZrO}_2$  thickness underneath and remote of the deposit patches was less than 10  $\mu\text{m}$ .

**Figure 5 - Microscopic Images of Deposit and Oxide Layers from Unit 4 Elements**

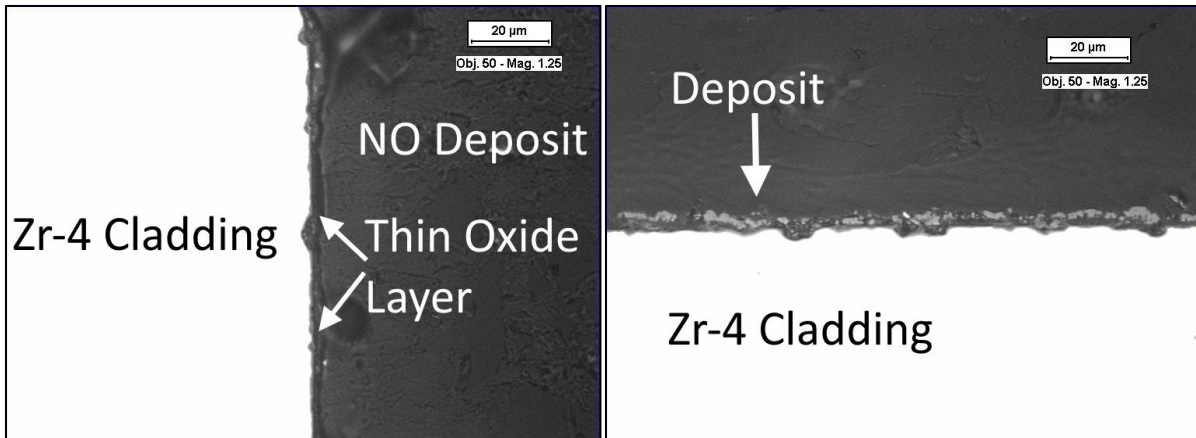
**Figure 6 - Microscopic Images of Deposit and Oxide Layers from Unit 1 Elements**

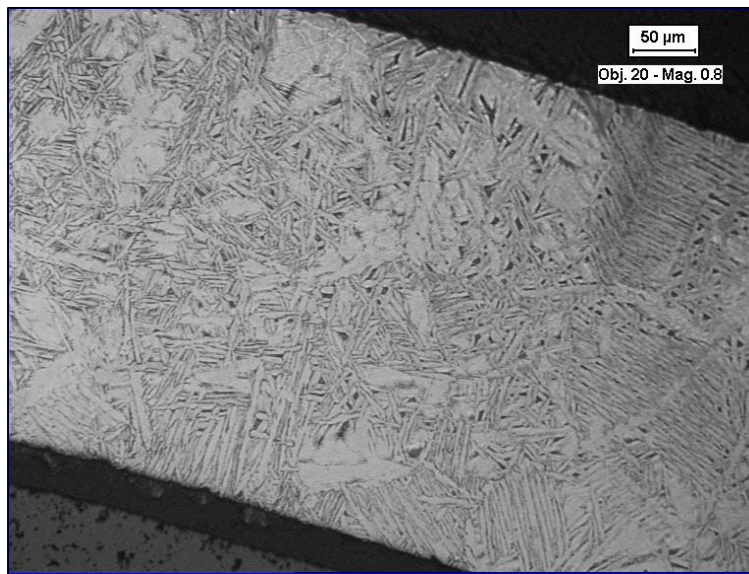
The microstructure in proximity to the appendages was heat-affected Widmanstätten (Figure 7) and the microstructure remote of the appendages was as-received cold-worked alpha, as expected. A stronger etch was used to reveal hydride/deuteride platelets (Figure 8). The deposits did not appear to result in preferentially oriented hydrides/deuterides or elevated hydriding/deuteriding.

**Figure 7 - Example of Heat-Affected Widmanstätten Microstructure**

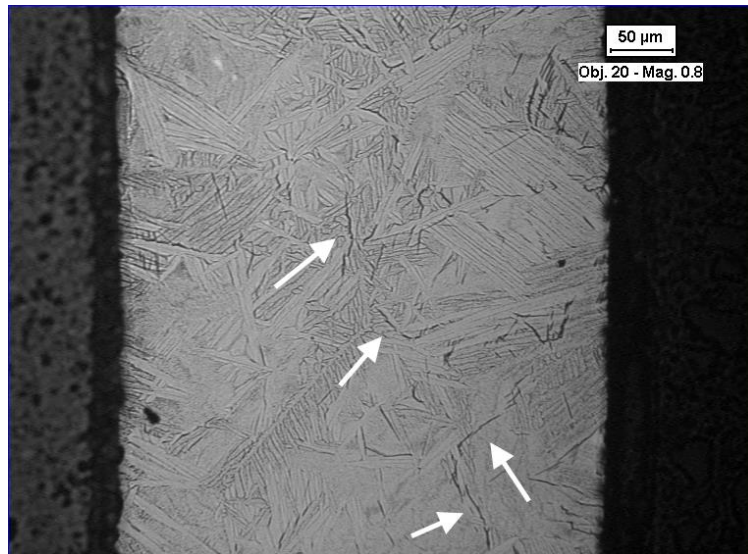
**Figure 8 - Example of Hydride/Deuteride Distribution**

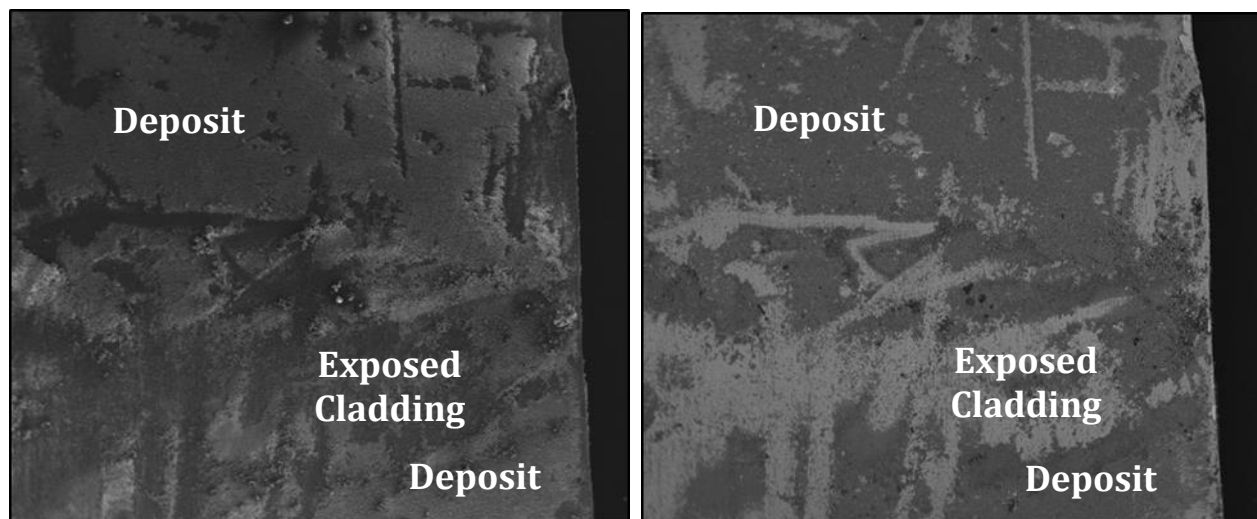
Five rectangular cladding samples with deposits were cleaned to remove residual fuel particles and mounted with the deposit facing towards the detector. Each sample was examined using backscatter and secondary electrons in a shielded scanning electron microscope (SEM; Figure 9 and Figure 10). The secondary electron examinations highlighted the topographical details of the deposits. Figure 11 shows a noticeable difference in the deposit morphology between the Unit 4 and Unit 1 samples, indicating that the deposits from Unit 4 formed under different conditions than the deposits in Unit 1.

**Figure 9 - Unit 4 Secondary (Left) and Backscatter (Right) Electron Images**

Backscatter images are sensitive to atomic number and highlight the different elemental composition of the deposits. Figure 9 and Figure 10 backscatter images revealed darker regions, indicating that the deposits had a lower atomic number. The small black spots observed in the backscatter images were attributed to minor contamination.

The shielded SEM includes an energy dispersive X-ray spectroscopy (EDX) detector, which can provide semi-quantitative elemental composition for most elements. EDX confirmed that the deposit free features in Figure 10 and Figure 9 consisted primarily of exposed zirconium. The deposit regions consisted primarily of iron or iron activation products, confirming that the deposit layer was a form of iron oxide.

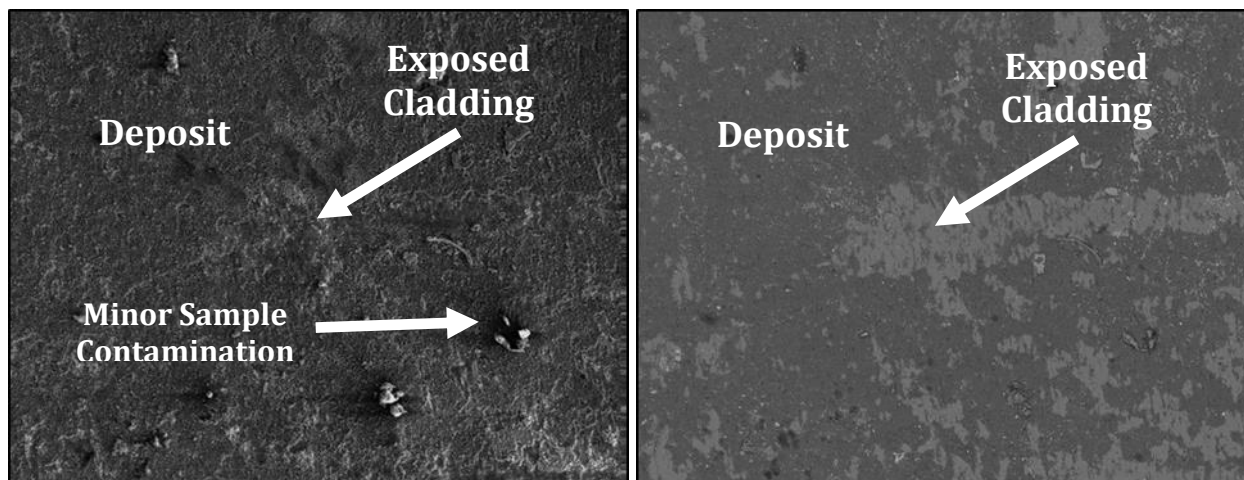
**Figure 10 - Unit 1 Secondary (Left) and Backscatter (Right) Electron Images**

The deposit material appeared to partially coat the samples, with small distinct regions that were free of deposit. Some of the deposit free features appeared to be a result of deposit removal from handling. However, Figure 10 shows examples of deposit-free patches that do not appear to be associated with scraping from handling; these patches were consistent with the sparse deposition observed during metallographic examination of the Unit 1 deposits.

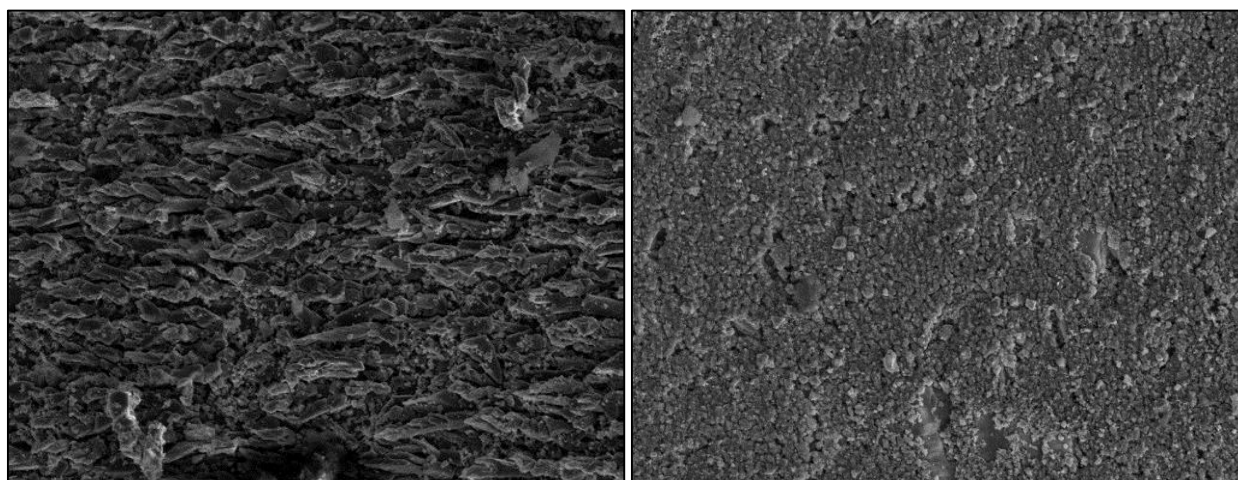
**Figure 11 - Different Deposit Morphology Observed on Unit 4 (Left) and Unit 1 (Right) Samples (Secondary Electron)**
