# MECHANICAL BEHAVIOUR OF HIGH BURNUP PHWR CLADS

Priti Kotak Shah, J. S. Dubey\*, Ashwini Kumar, R. S. Shriwastaw,  
B. N. Rath, Prerna Mishra, V. D. Alur, Sunil Kumar  
Post Irradiation Examination Division  
Bhabha Atomic Research Centre, Trombay, Mumbai 400085  
\*Presenting Author : jsdubey@barc.gov.in

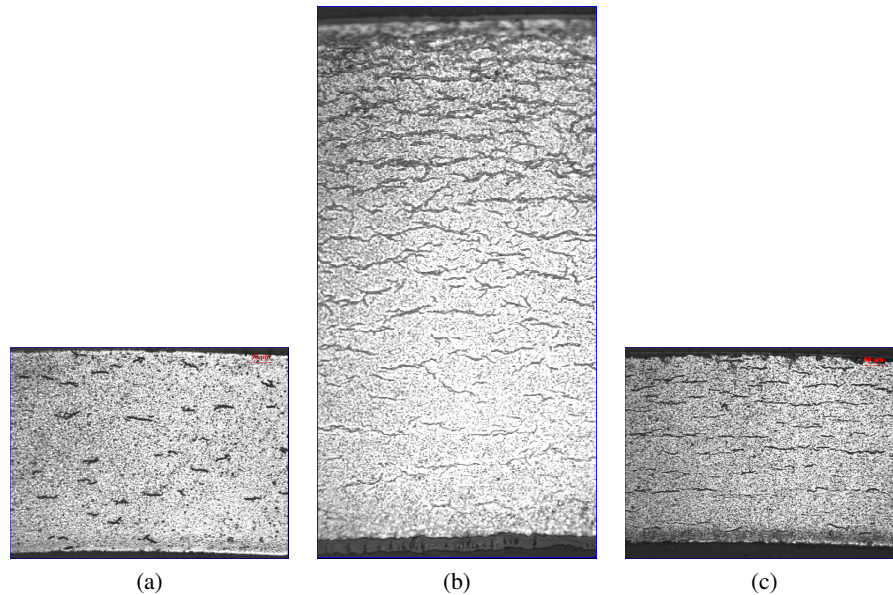
Figure 3: The hydride distribution across the clad thickness (bottom is tube inner diameter) for (a) as fabricated unirradiated tube, (b) low burnup defective fuel pin specimen, (c) high burnup clad tube.

The optical metallographs showing the transverse cross section of the fuel clad and the distribution of hydride are given in Fig. 3. As fabricated clad specimen had around 18 wt. ppm of hydrogen (Table 1) and the hydrogen content in the clad was found to increase with the burnup to a level of 45 ppm for a burnup level of up to around 22,000 MWd/TU. The hydride platelets in clad tubes were found to be oriented predominantly in the circumferential direction of the tube. The as fabricated clad material, Fig. 3(a), had small volume fraction of short hydride platelets distributed uniformly across the tube thickness. The hydride volume fraction increased in the high burnup clad, Fig. 3(c). However, the specimens from the region around the hole in the failed fuel pin had much higher hydrogen level (335 wt. ppm), as indicated by the high hydride density in optical metallograph Fig. 3(b). The defective fuel pin had higher density of hydride platelets at the outer circumference of the tube (coolant side), which decreased toward the clad inner side (fuel side). This is expected behaviour as hydrogen is known to move from higher temperature region towards lower temperature region which is the clad periphery in this case.

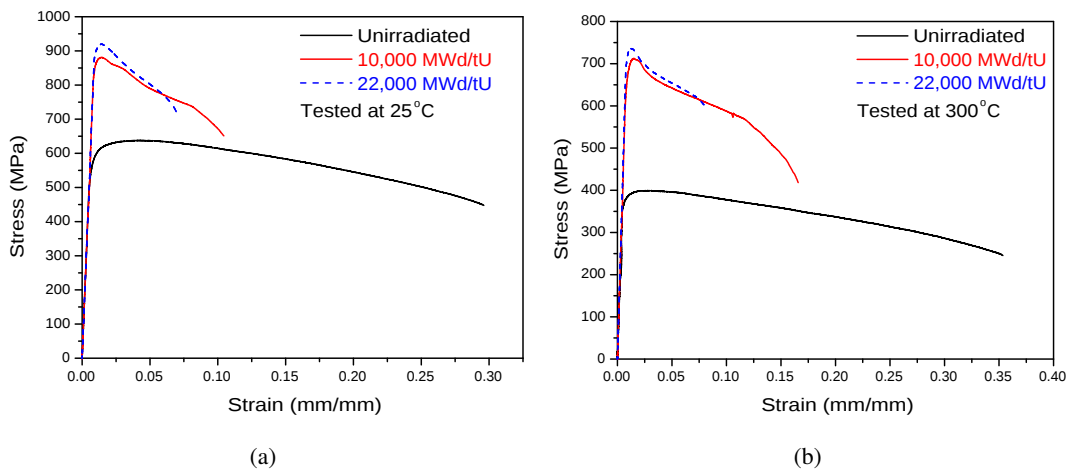
Figure 4: Circumferential tensile deformation behaviour of low and high burnup fuel pin clads, at ambient temperature (300 K) and at 583 K.

Material hardening and loss of clad ductility due to high energy neutron irradiation is evident from ambient temperature tensile stress-strain plot given in Fig. 4(a). The drop in ductility at ambient temperature is more in the non-uniform part of the strain, though uniform elongation also decreased (Table 1). At ambient temperature, the circumferential ductility in low and high burnup fuel clads drop to nearly 25 % of that in as fabricated clad tube.

Tests near reactor operating temperature ( $\approx 583\text{K}$ ) of the clad tubes show an increase in the ductility levels for the low as well high burnup fuel clad tubes. The higher flow stress due to irradiation hardening is evident from the Fig. 4(b) at this temperature. At reactor operating temperature all the clads showed some level of ductility and gross deformation before failure. The defective fuel clad specimens having high hydride platelet densities were also able to undergo gross deformation at these temperature. The brittle to ductile transition in the ductility values for the hydrided zirconium alloy with temperature has been observed in many other studies [4,5].

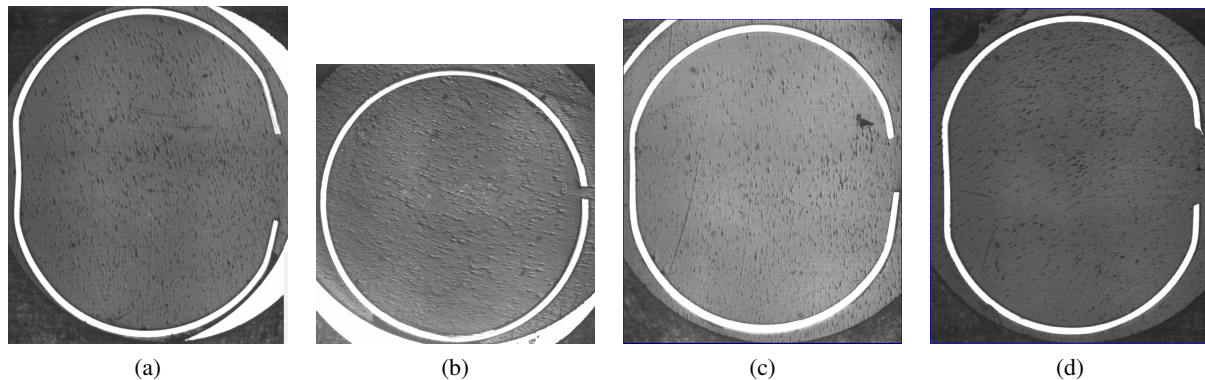
The amount of gross deformation, during RTT at ambient temperature, for different clad tubes can be seen from the shape of the tested ring specimens given in Fig. 5. The close up of the fractured edges of two specimens are shown in Fig. 6. As can be seen in Fig. 5(b) the gross deformation in the gage

Figure 5: The ring cross section after tests at ambient temperature for (a) unirradiated, (b) low burnup defective fuel pin, (c) high burnup pin and (d) average burnup fuel pin.

portion of the defective fuel clad specimen is severely limited at ambient temperature and the ring specimen remains nearly circular even after failure. The fracture edge of defective fuel clad (Fig. 6(a)) shows negligible deformation at ambient temperature and has a radial-axial fracture plane that is nearly perpendicular to the loading axis. In contrast, as fabricated clad tubes and clad tubes having low and average burnup showed higher elongation at ambient temperature. The observed deformation and ductility level in the high burnup clad at ambient temperature is that of intermediate level, around 25% of that of as fabricated clad material.

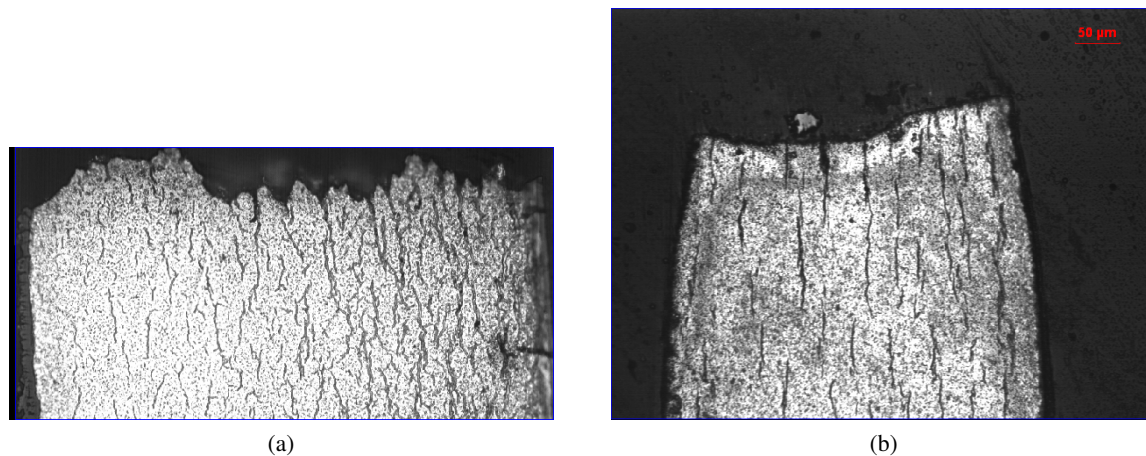
Figure 6: The fractured edge of the ambient temperature tested specimens, showing the full thickness, of (a) defective low burnup fuel clad and (b) for high burnup fuel pin.

It is clear from the RTT results that volume fraction of hydride platelets, their size and distribution play an important role in fracture of the clad tube at ambient temperature. The close up view of the fracture edges, of ambient temperature tested specimens, is shown in Fig. 6. In case of the defective fuel clad, Fig. 6(a), the high hydride platelet density leads to numerous crack formation during loading which get linked up in a zig-zag manner with small amount of slip but maintaining a nearly flat fracture plane perpendicular to loading axis. The high burnup fuel clad, Fig. 6(b), with lower volume fraction of hydride is able to undergo some deformation along the thickness.

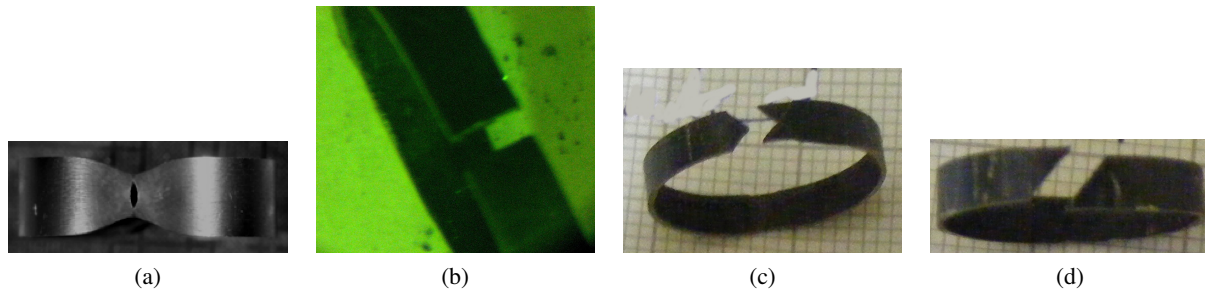
- flat cleavage type rupture, on radial-axial plane, with little deformation along the thickness and axial direction of the specimen, as seen in the defective fuel clad in Fig. 6(b), a material having high density of hydride platelets combined with irradiation damage.
- shear band failure at 45 degree to the tensile loading axis, with some amount of width contraction and limited thickness deformation, as seen in Fig. 7(c) and (d), for low and high burnup fuel clad that had smaller volume fraction of hydride in matrix. The measured ductility is higher when the shear band starts from the center of the specimen, Fig. 7(c), rather from the edge, Fig. 7(d).

Figure 7: The photographs of the ambient temperature tested ring specimens for (a) as-fabricated clad, (b) defective low burnup fuel clad, (c) high burnup pin type-I, and (d) high burnup clad type-II.

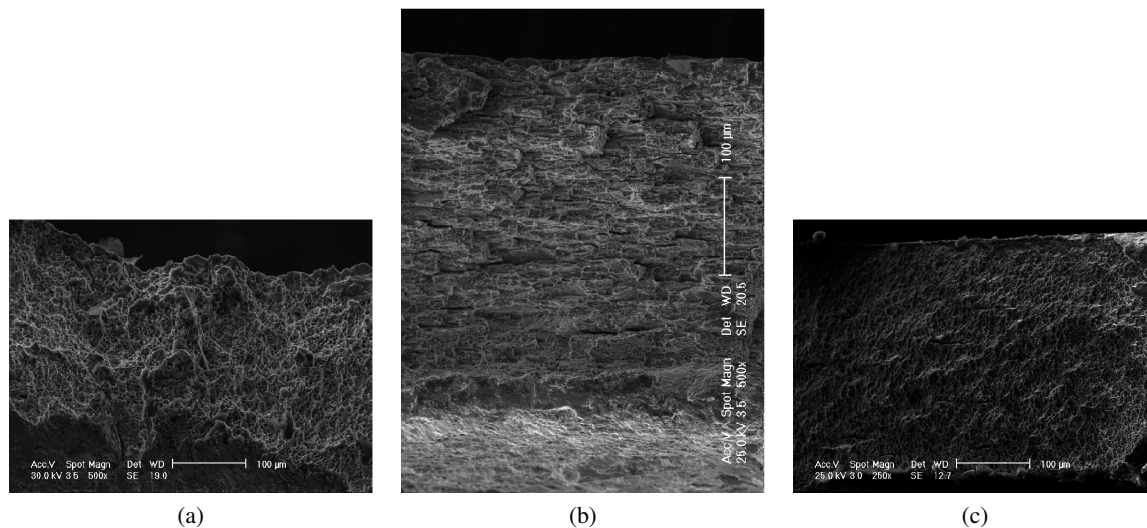
The fractographs of the ambient temperature tested ring tension specimens are shown in Fig. 8. As fabricated, unirradiated clad tubes show fully ductile rupture with prominent neck formation and thickness contraction. The flat fracture plane of failed fuel pin shows closely spaced deep hydride cracks joined together with shallow deformed layer. The fracture plane of high burnup fuel clad showed less amount of hydride cracking and more fibrous appearance, though much flatter than the as fabricated clad material. Fracture in the irradiated clads is by the ductile rupture of the ligament between the cracked hydride platelets.

Figure 8: The SEM fractographs showing radial-axial plane for (a) as fabricated clad material, (b) failed low burnup fuel pin and (c) high burnup fuel clad.

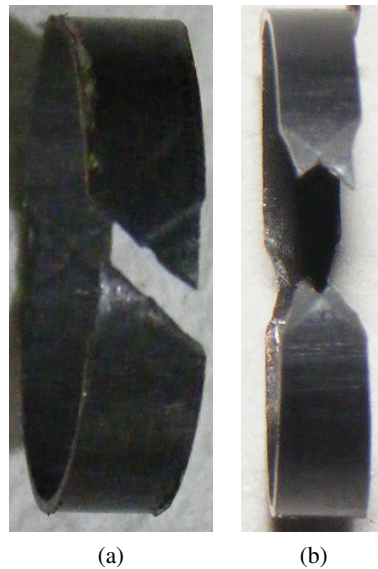
and neck formation before fracture is clearly seen in high burnup clad at 583K, in Fig. 9(b). At this temperature, the fracture becomes more fibrous, with less hydride related crack formation, near the fracture plane. This has also been observed in earlier studies on unirradiated hydrided specimen conducted by author [6]. However, the fracture plane is at 45 degrees to the tensile axis showing shear localization.

Figure 9: The photographs of the ring specimens of high burnup fuel clads tested at 583K showing (a) type I and (b) type II of failure.
