## **REMEDIATION OF HISTORIC DUMP #2 AT CHALK RIVER LABORATORIES**

**K. Stephenson<sup>1</sup>, H. Rummens<sup>1</sup>, and R. Yandt<sup>2</sup>**

<sup>1</sup> Canadian Nuclear Laboratories, Chalk River, Ontario, Canada

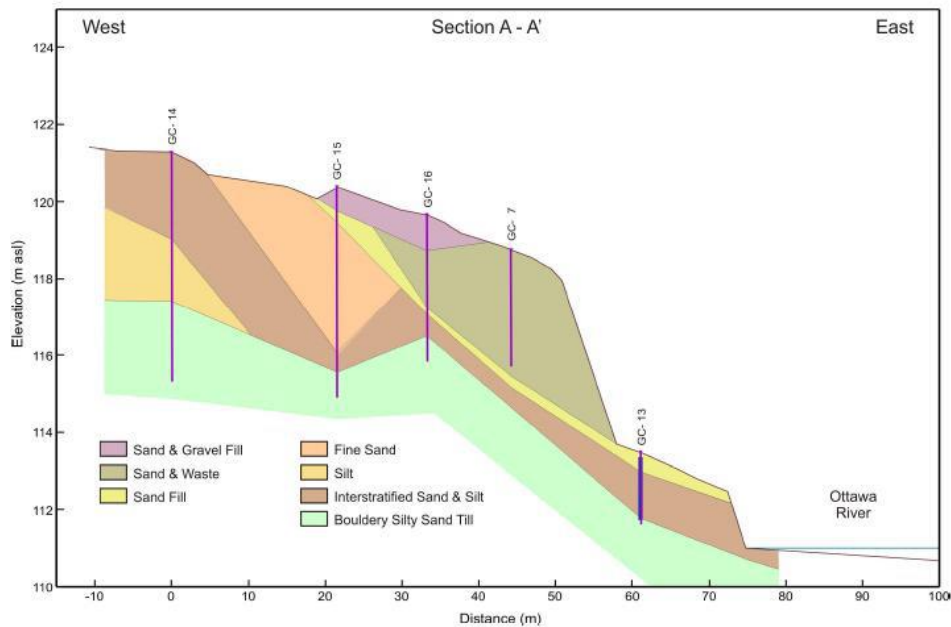
Figure 3: Cross Section of Dump #2 showing the waste thickness, borehole locations, and elevations

Radiological analyses revealed all soil samples to have total beta concentrations  $\leq 1$  Bq/g. Metal contaminants were more of a concern; over half of the samples submitted for metal analysis by X-ray fluorescence (XRF) had concentrations above the CCME industrial soil quality guidelines for the protection of environmental and human health [4]. Metals with sample results over the CCME guideline include: Se, Cd, Sn, Sb, Cr, Co, Ni, Cu, Zn, and Pb. Maximum concentrations measured in a sample taken from the waste for Pb, Cu, and Zn were approximately 125, 115 and 24 times higher than the CCME guidelines, respectively. In general, the highest concentrations of metals in borehole samples were from borehole GC-16 (Figure 3).

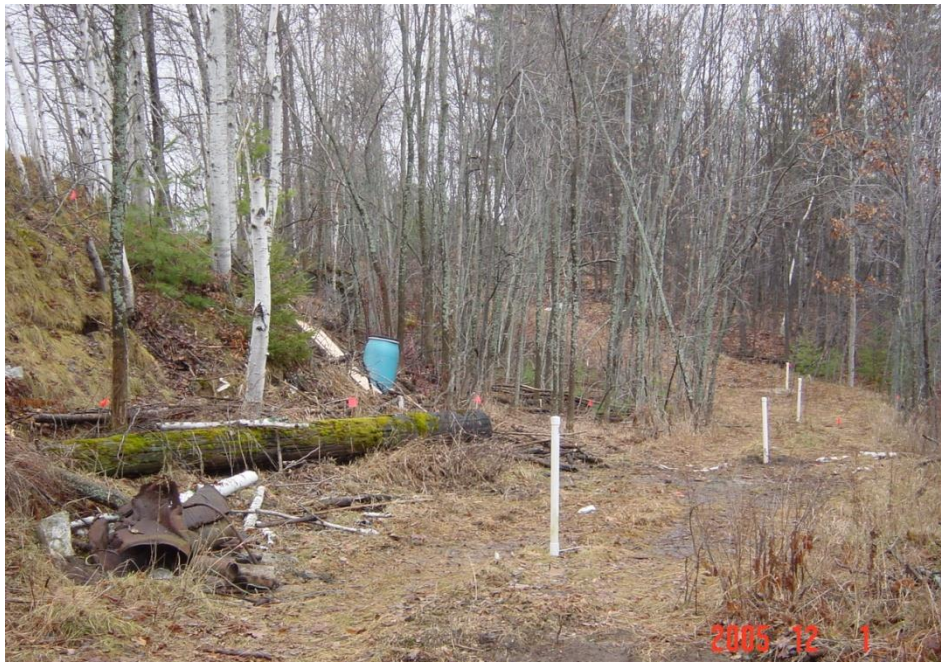
The east and south faces of the site consists of a steep bank sloping towards the River to a flattened access road along the toe of the bank (Figure 3 to Figure 5). A series of monitoring wells have been installed along the centre line of the access trail (Figure 4). Although the steep faces of the dump have grown over with trees and brush, they exhibit obvious signs of erosion from seasonal flooding.

Figure 4: East side of Dump #2 as it appeared in 2005 December

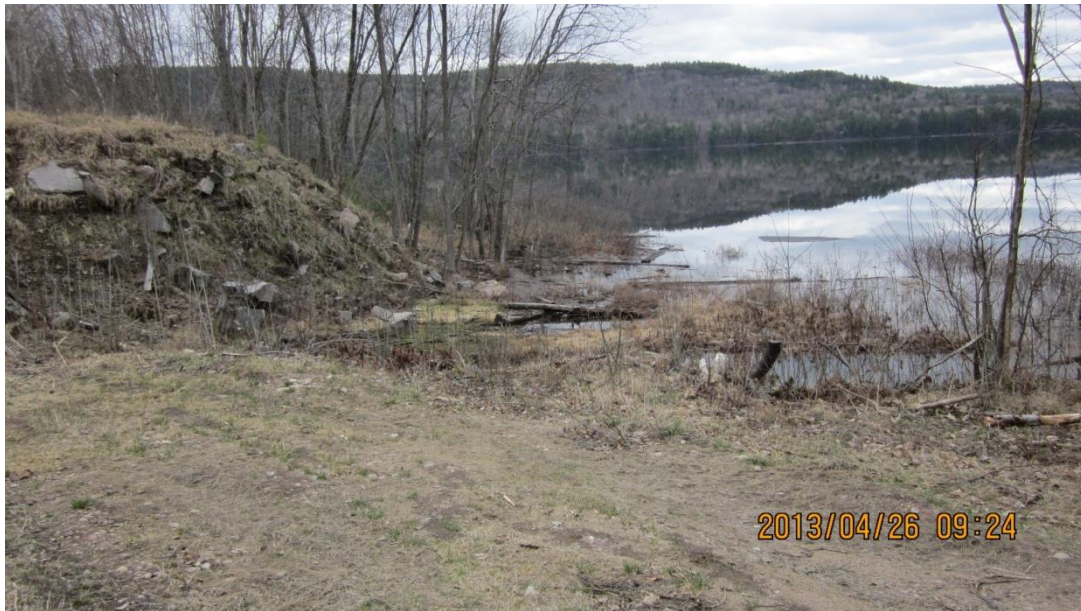
Figure 5: South side of Dump #2 as it appeared in 2013 April

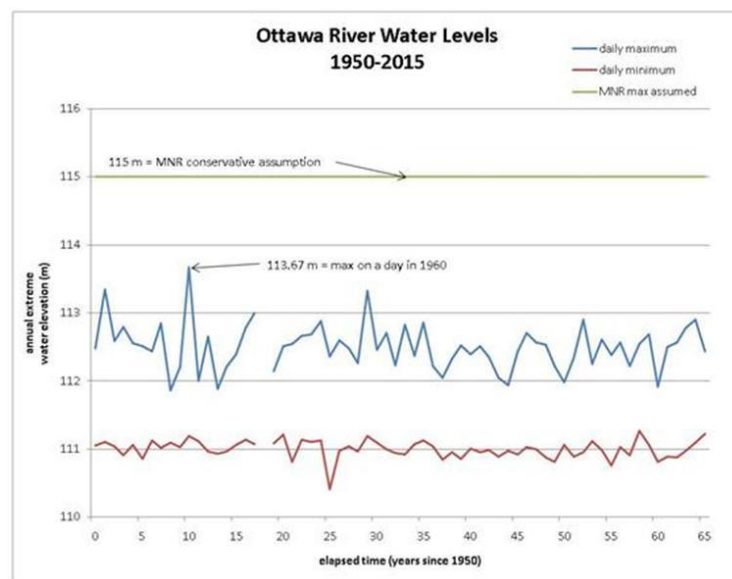
Figure 6 shows the water levels of the Ottawa River since construction of an upstream hydroelectric dam in 1950. In the past 65 years, the average annual mean level was 111.5 m above sea level (asl); the maximum recorded on one day level was 113.7 m asl in 1960, which would have reached the toe of the landfill slope. The calculated conservative estimate of the 100-year flood elevation for this reach of the Ottawa River is 115 m, or about one third of the way up the slope.

Figure 6: Ottawa River water levels at CRL over time

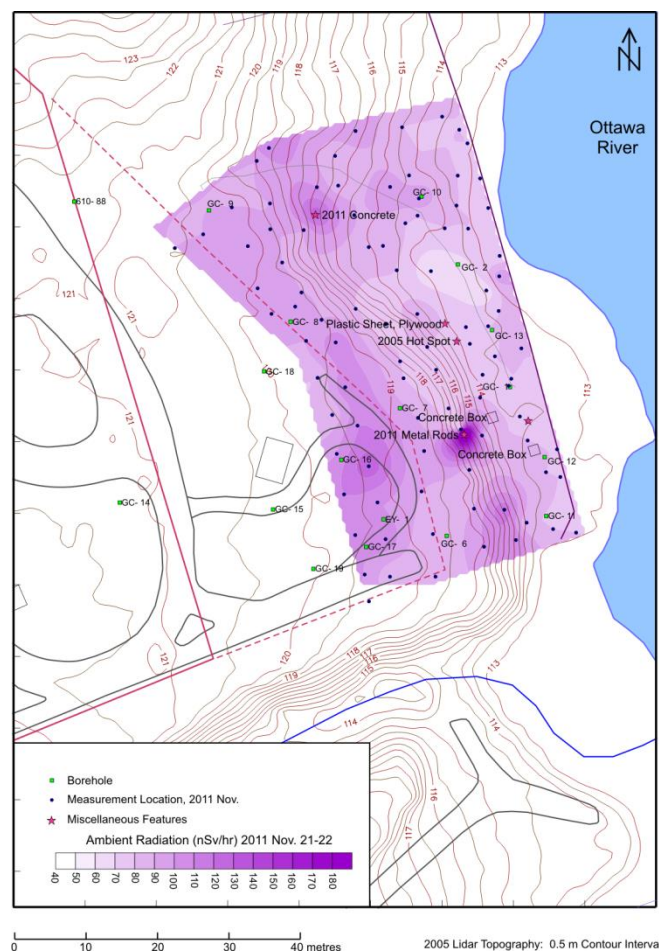
Figure 7: Ambient radiation point measurement locations and contours collected in 2011 November

These surveys showed that there is little in the way of elevated radiation fields in the area. Ambient radiation fields in portions of the CRL site that are unaffected by CRL activities range from 0.05 to 0.12  $\mu\text{Sv/hr}$  (5 to 12  $\mu\text{rem/hr}$ ). A large portion of the ambient radiations fields recorded during the survey of Dump #2 fell toward the low end of this range with the highest recorded reading in 2011 falling slightly above the background at 0.28  $\mu\text{Sv/hr}$  (28  $\mu\text{rem/hr}$ ). The average was 0.089  $\mu\text{Sv/h}$  (8.9  $\mu\text{rem/hr}$ ).

Two ‘hot spots’ were identified; one called ‘2005 hot spot’ was remediated through removal of contaminated soil and a metal pipe at the surface. Contaminated soil and metal at this hot spot exhibited a count rate of 50,000 cpm beta gamma. Laboratory analysis of samples from this location confirmed contamination as high as 840 Bq/g gross alpha and 860 Bq/g gross beta, and up to 500 Bq/g U-238 from refined natural Uranium. This was a factor of 500 higher than the Canadian Nuclear Safety Commission (CNSC) unconditional clearance level for U-238 of 1 Bq/g [1]. The second ‘hot spot’ exhibited a count rate of 30,000 cpm beta gamma over the plastic sheet covering the area, with 3,000 cpm beta gamma being measured within one square meter surrounding the ‘hot spot’. This area will be remediated during the field season of 2016.

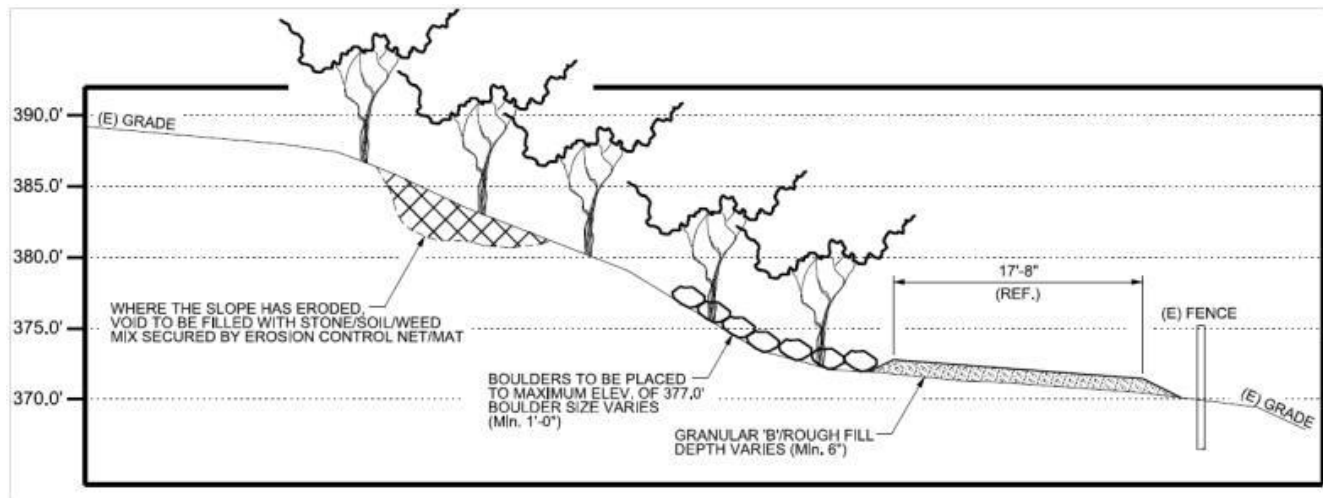
Figure 8: Planned placement of materials on slope

Some stakeholders felt that the initial Remedial Action Plan did not match the level of risk that was discussed in the Remedial Options Evaluation. The removal of trees and the placement of riprap and gabion wall were felt to be excessive. A revised Remedial Action Plan completed in 2015 November is less invasive. The new Plan includes leaving trees in place along the slope, repairing and stabilizing eroded ruts, relying on vegetation to anchor the slope instead of covering the slope with riprap, and using natural rock instead of gabions as an unobtrusive flood barrier over the bottom third of the slope.

Figure 8 depicts the revised interim remedial strategy. This more natural approach will minimize disturbance and capitalize on the existing vegetation.
