## **CRACKING OF 304L STAINLESS STEEL OBSERVED WITHIN CANDU NUCLEAR POWER PLANTS UNDER CYCLIC MOIST ENVIRONMENTS**

**R. G. Allen, G. I. Ogundele, A. C. Lloyd, D. K. Jain, and A. K. Järvine**  
Kinectrics Inc., Ontario, Canada

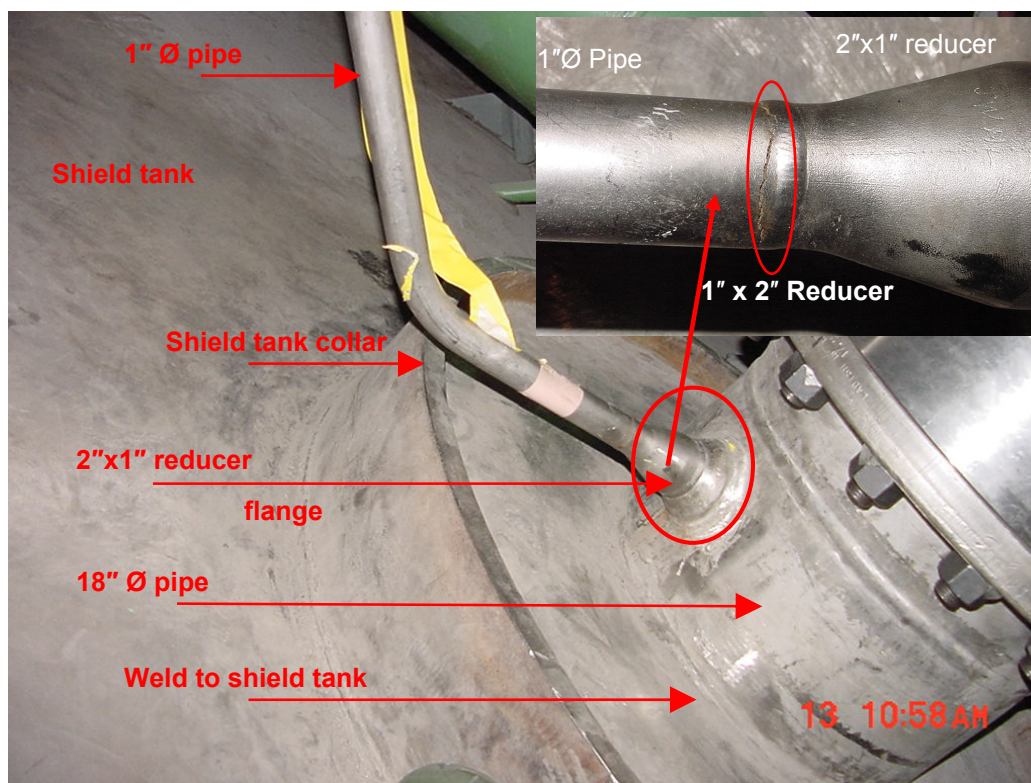
In January 2005, a significant increase in helium make-up supply flow rate was detected within the bulk helium supply system of a CANDU Nuclear Generating Station (NGS). A leak was suspected and traced to the MCG system in one of the units. Four months later, during a scheduled outage, personnel conducted a leak search on the system. Cracking was observed in the one-inch diameter (1"Ø) balance lines between two SS 304L 18-inch diameter (18"Ø) calandria relief ducts Y3 and Y4 in Figures 1 - 2.

Figure 2: Photograph of the 1"Ø pipe and 18" relief duct.

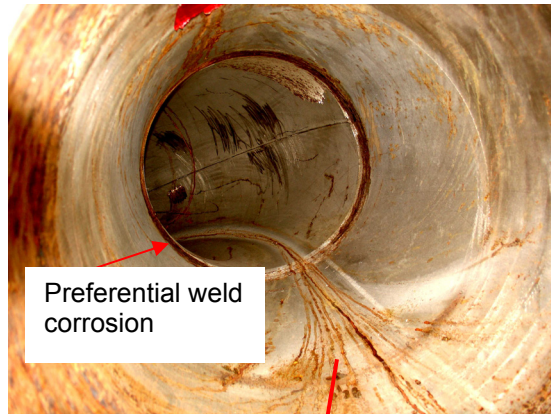
In addition, the inside of one of the 18"Ø relief ducts was inspected and found to be discoloured and contained axial cracks as identified in the field using liquid penetrant inspection (LPI). The inspection revealed that the surfaces of the 18"Ø, schedule 40, 304L stainless steel duct were covered with brownish corrosion products with evidence of a condensation trail through the pipe and evidence of preferential weld corrosion (Figure 3). An array of axial cracks, oriented in the inside diameter of the 18"Ø relief duct directly below the attachment field weld between the shield tank and the outer diameter of the 18"Ø relief duct were visible. The appearance of the inside surface of the duct suggested that a contaminated and/or carbon steel grinding tool may have been used to grind the welds and other areas of the pipe surface during manufacture or installation. The use of carbon steel grinding tools can lead to a large quantity of Fe contamination in these areas, which is well known to cause significant corrosion of austenitic stainless steels.

(a) Inside surface of 18-inch duct, looking down the duct

Figure 3: Photographs illustrating the typical corrosion pattern on the inside surface of the 18"Ø relief duct piping below the flange in the affected unit.

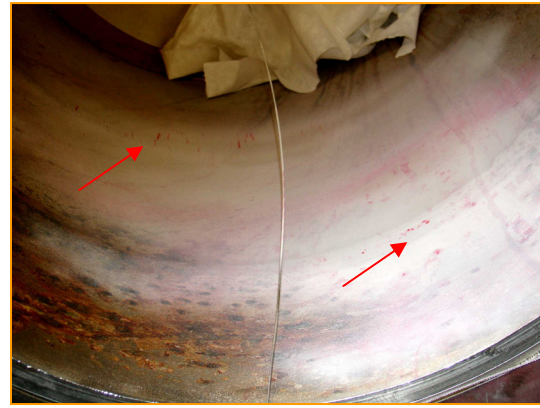
Since it was impractical to remove the section of the 18"Ø duct containing the cracks, an extensive metallurgical examination (similar to those conducted on the 1"Ø pipe) could not be performed. Field UT examination suggested that the depth of the crack in the duct was 20 % through-wall. Field liquid penetrant inspection (LPI) revealed the presence of axial cracks on the inside surface of the 18"Ø pipe. Information regarding the material and nature of the cracking observed in the 18"Ø pipe was obtained from replicas of the axial cracks, analysis of the corrosion deposits, hardness measurements, and microsampling. A section of the replica image is shown in Figure 5. The data from replication indicated that the cracking observed in the 18"Ø pipe had propagated in a transgranular manner, similar to the cracks on the 1"Ø pipe. The nature of the cracking suggests that these cracks likely initiated and propagated by the same mechanism as that for the 1"Ø pipe. Multiple, axially oriented cracks were evident in the areas sampled. Some of these cracks are stepwise in nature, while some had coalesced to form longer cracks.

(b) Liquid penetrant inspection (LPI) found axial crack-like indications

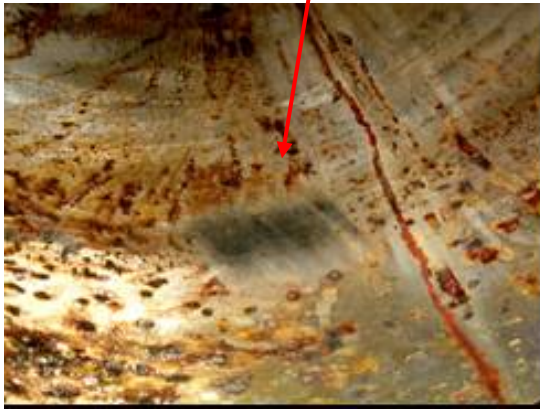
(c) Area scraped for deposit examination

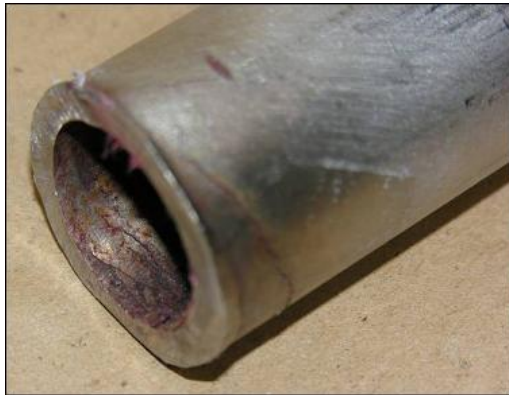
The cracked 2" x 1" reducer and a section of the 1"Ø pipe were removed for examination; extensive circumferential through-wall cracks were observed on the 1"Ø pipe (Figure 4) and the cracking in the 1"Ø pipe was through-wall where the pipe was welded to the reducer. The major crack was located on the 1"Ø pipe just downstream of the weld to the reducer. The pipe was cut open axially to reveal the ID surface where the corrosion indications extended well beyond the weld into the bend and straight sections of the pipe. Brownish-coloured corrosion deposits

(a) 1" Ø pipe showing the cracking

Figure 4: Cracking observed in the 1" Ø pipe (through the cracked region of the 1"Ø pipe just downstream of the weld to the 2"X1" reducer). The cracking appears transgranular and ID-initiated.

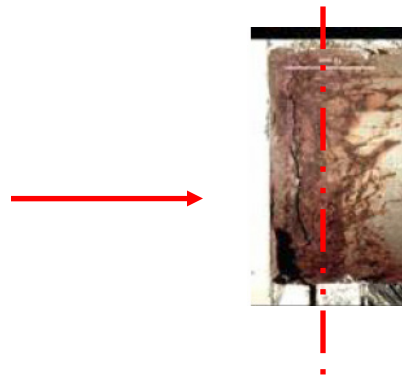
(b) Cut for mount, polishing direction shown

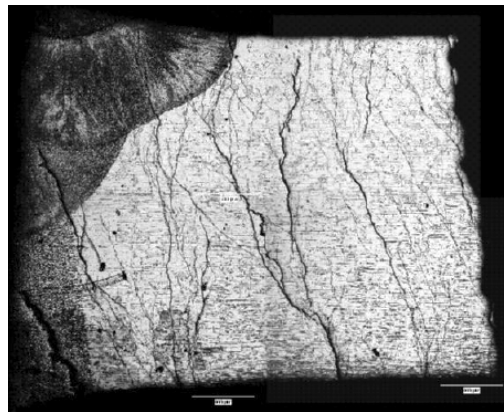
appeared throughout the ID surface of the pipe, which corresponded to dark brown cracks and small localized spots along the sectioned crack. In the 1"Ø pipe, the cracking concentrated in the bends, suggesting that residual stresses from bending contributed to the SCC. As evident in the cross-section (Figure 4), the cracking initiated from the inside surface of the pipe and propagated (with some branching) in a transgranular manner, leading to through-wall failure of the pipe and the resulting increase in the helium consumption observed in the station.

(c) Mounted and etched cross section

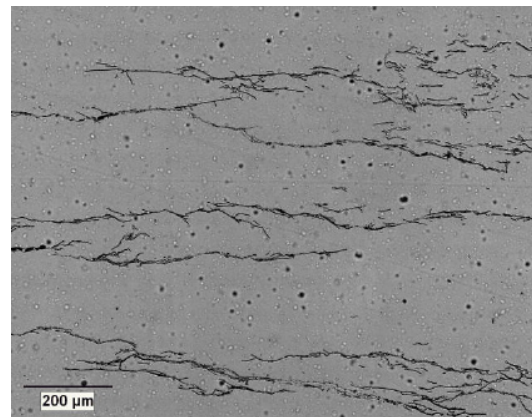
(b) Part of the axial crack

Figure 5: Replica images of the axial cracks on the inside surface of the 18"  $\varnothing$  relief duct piping; these images were taken on the ID of the 18" duct directly below attachment weld to shield tank wall on the OD of the duct (as shown in Figure 1).

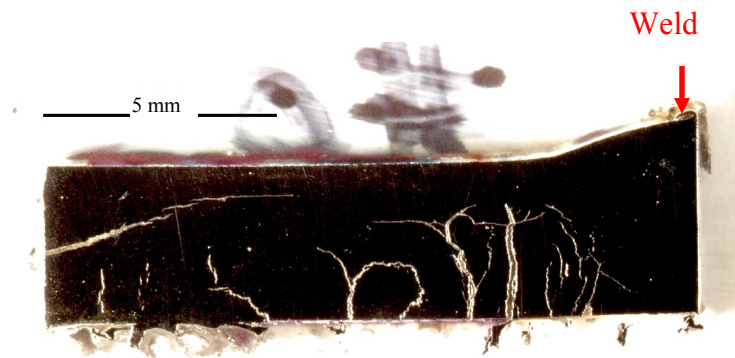
Orientation imaging microscopy (OIM) was used to characterize the residual plastic strain distribution present within cracked areas and around the cracked weld between the 1" x 2" reducer to 1"Ø pipe. An area where severe ID-initiated cracking was found (Figure 6a,b) was sectioned axially, clearly displaying the multiple cracks. A significantly high level of residual strain was observed in the crack tip area, indicating that the crack could continue propagating. Elevated residual strain was also observed along the inside surface of the crack (Figure 6c) indicating that the crack had propagated through a highly strained area so that the internal stress was released. This can be compared to a sample of un-cracked material, in which the residual plastic strain of the material is uniformly distributed and is at low levels (Figure 6d). These results correlate with the elevated hardness measurements obtained, as discussed above.

a) Optical image of the sectioned crack

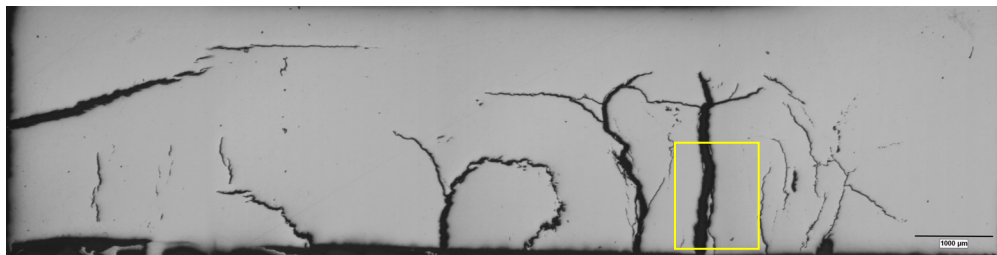
b) Metallographic sample of the sectioned crack

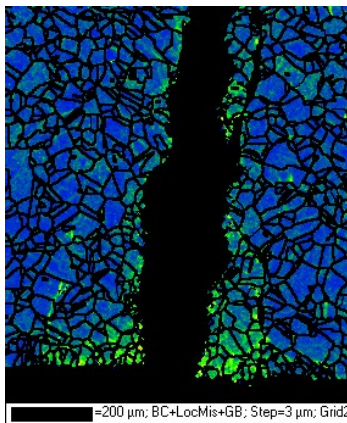
c) Strain map of location indicated in  
(b)

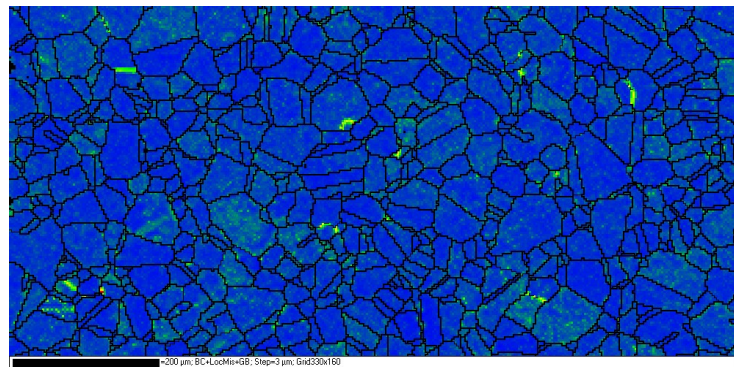
d) Strain map of un-cracked location

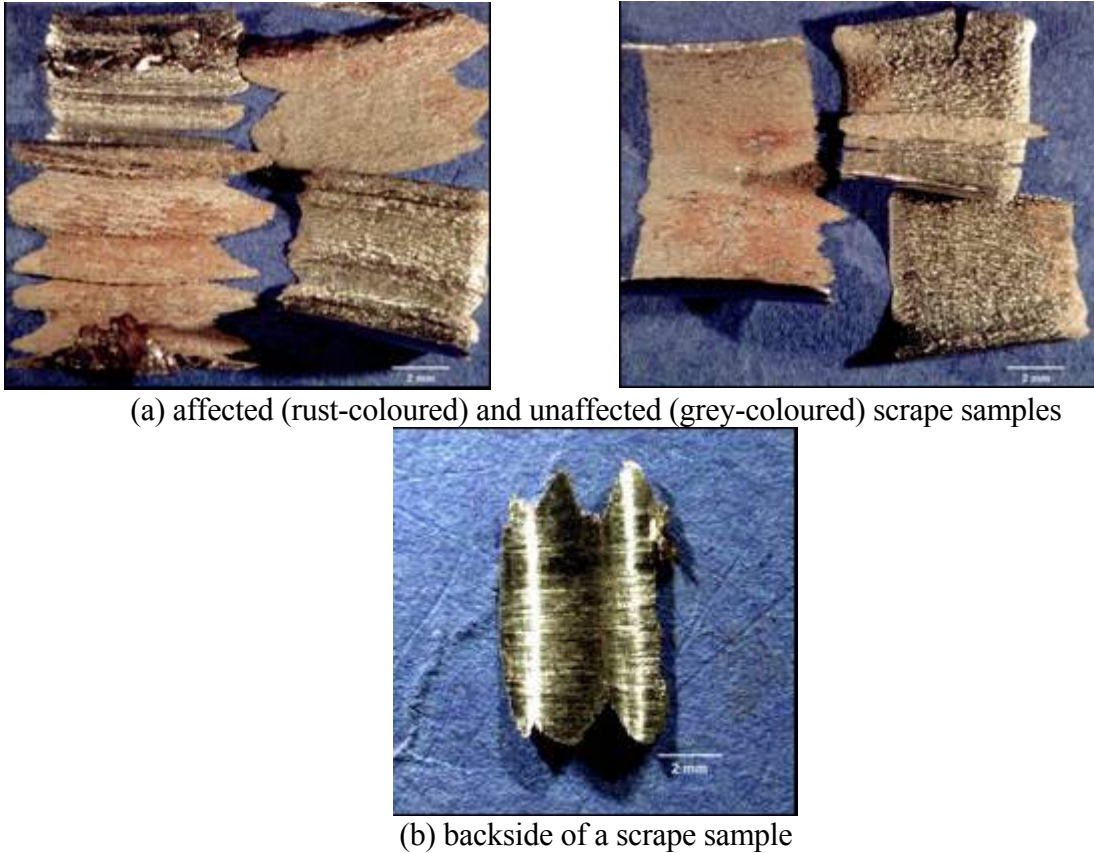
The composition of the oxide deposit on the 18"Ø duct was assessed by taking micro samples approximately 0.008" thick from the inside pipe surface in both unaffected (e.g., grey-coloured surface) and affected (e.g., rust-coloured surface) regions of the pipe. Typical examples of the scrape samples are provided in Figure 7. The smooth, shiny backside surface indicates that the scrape samples were deep enough to penetrate through to the bulk pipe material.

Figure 7: Micro-sampling (scrape) samples from the 18"Ø duct.

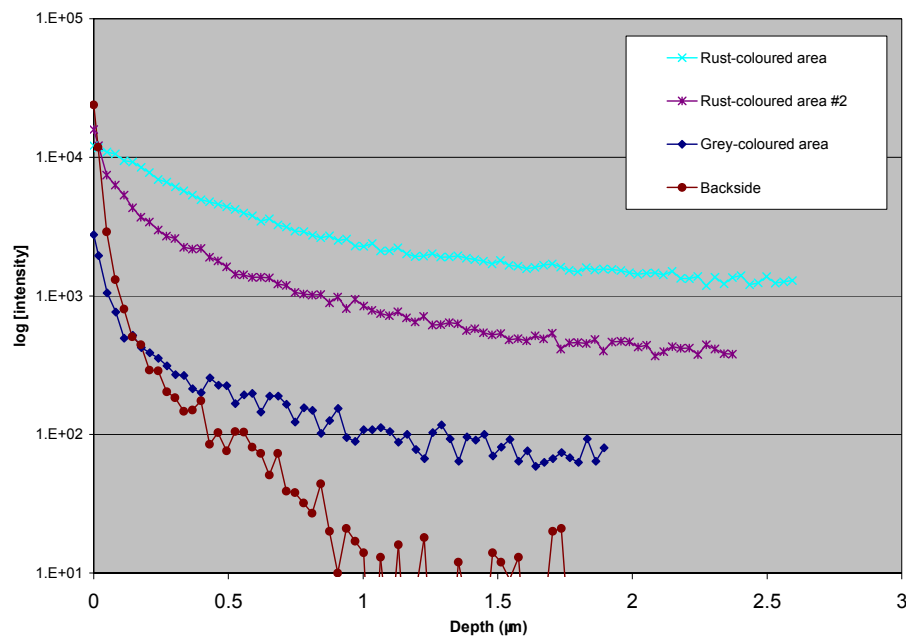
In the SIMS depth profiles obtained for the 18"Ø duct for Cl (Figure 8) the rust coloured areas show the most intense Cl profiles and therefore contain the highest concentration of Cl compared to both the grey-coloured areas and the backside of the scrapes (e.g., base metal). The Cl detected on the backside of the scrape samples was likely introduced during sampling and handling. Chloride is found in higher concentrations and extends deeper into the oxide near the regions that exhibited discolouration or where there is evidence of corrosion product accumulation on the surface. This suggests that Cl is concentrated in localized regions on the 18"Ø pipe. The depth profiles in rust coloured regions display a smooth decrease with time (e.g., oxide depth) in the Cl profiles through the sample approaching the oxide/metal interface. This suggests that Cl in the affected areas was incorporated into the indigenous oxide and thus had built up since the plant went into operation.

Figure 8: Chlorine SIMS depth profiles for scrape samples from the 18"Ø duct.
