## **Pickering Unit 7 Calandria Tube leak operational impacts**

**James Price (james.price@opg.com), Rob Powell**  
Ontario Power Generation, Pickering Nuclear, Pickering, Ontario

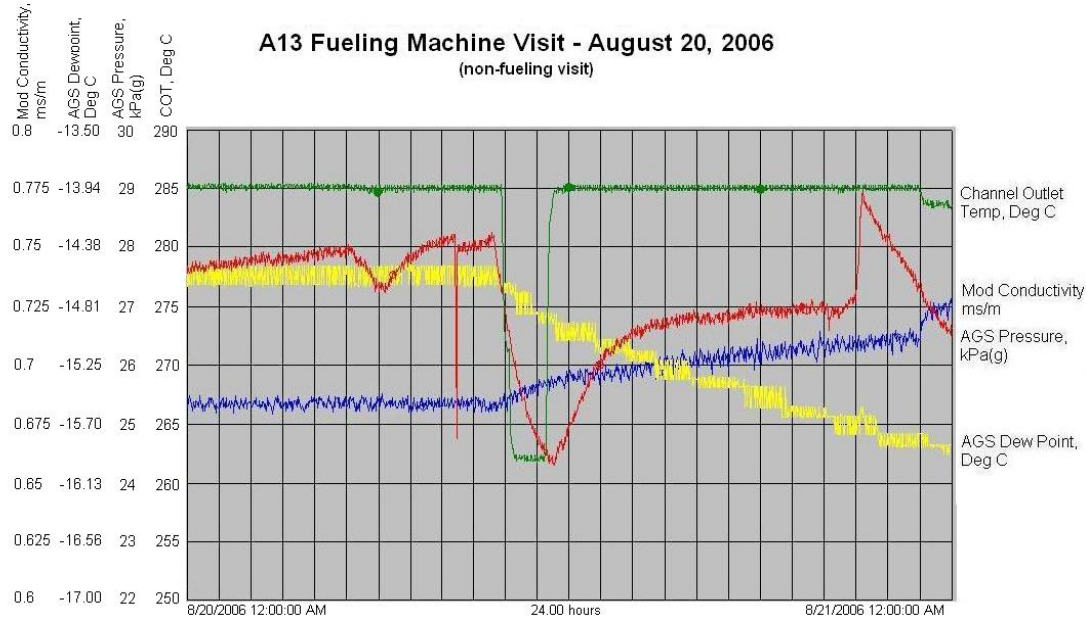
A leak of CO<sub>2</sub> into the Moderator System was originally detected in September, 2005. The leak was detected through falling annulus gas dew point and increasing moderator conductivity. Leak source was verified as CO<sub>2</sub> by total inorganic carbon analysis of the moderator. Within a few weeks it was determined that the source of the CO<sub>2</sub> ingress into the Moderator System was from the AGS, however, it was not known immediately which channel was leaking CO<sub>2</sub> into the moderator or the specific flaw/defect that could be present. Over the course of several months, due to both planned and serendipitous activities, the specific leak location was narrowed to the point where fuel channel A13 was positively identified as the leaker (Figure 1). Final proof was obtained during the outage in 2009 when a “dry ice” plug was formed in the “pigtails” on either side of A13 and the leak location was confirmed by the change in pressure drop rate.

Figure 1 Process changes resulting from a fuelling machine visit to channel A13

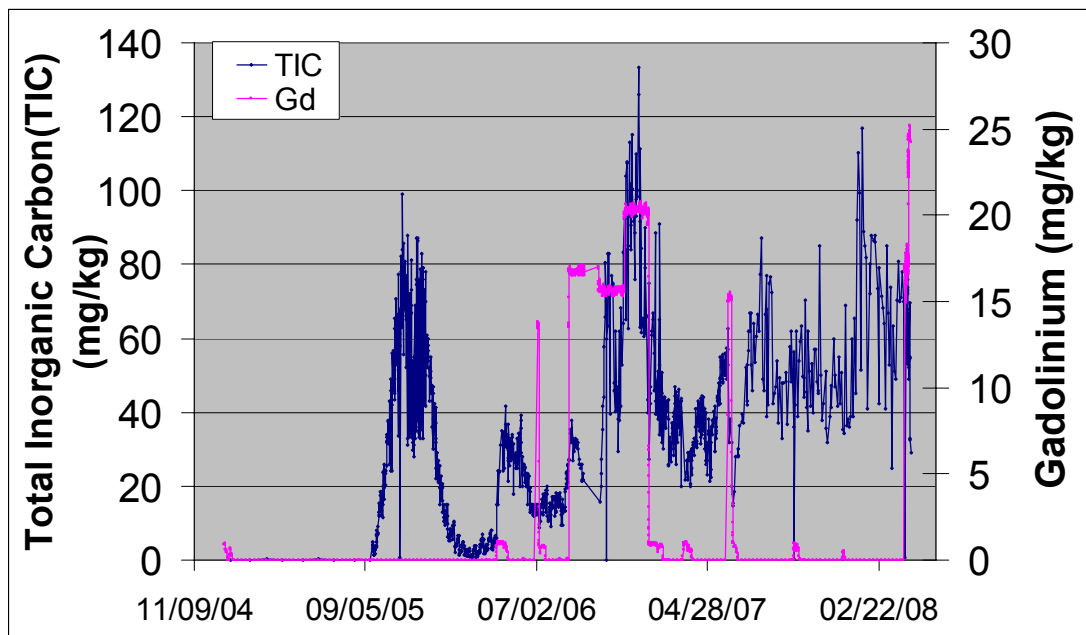
Prior to April 2008 there had been three outages on unit 7 where gadolinium was used to establish the over-poison guaranteed shutdown state. No evidence of unusual behaviour was seen during these outages. The CO<sub>2</sub> leak rate was tracked and was seen to vary over time (Figure 2). The AGS pressure drop rate was also tracked and showed a similar pattern.

Figure 2 Moderator Gadolinium and Total Inorganic Carbon over life of the leak

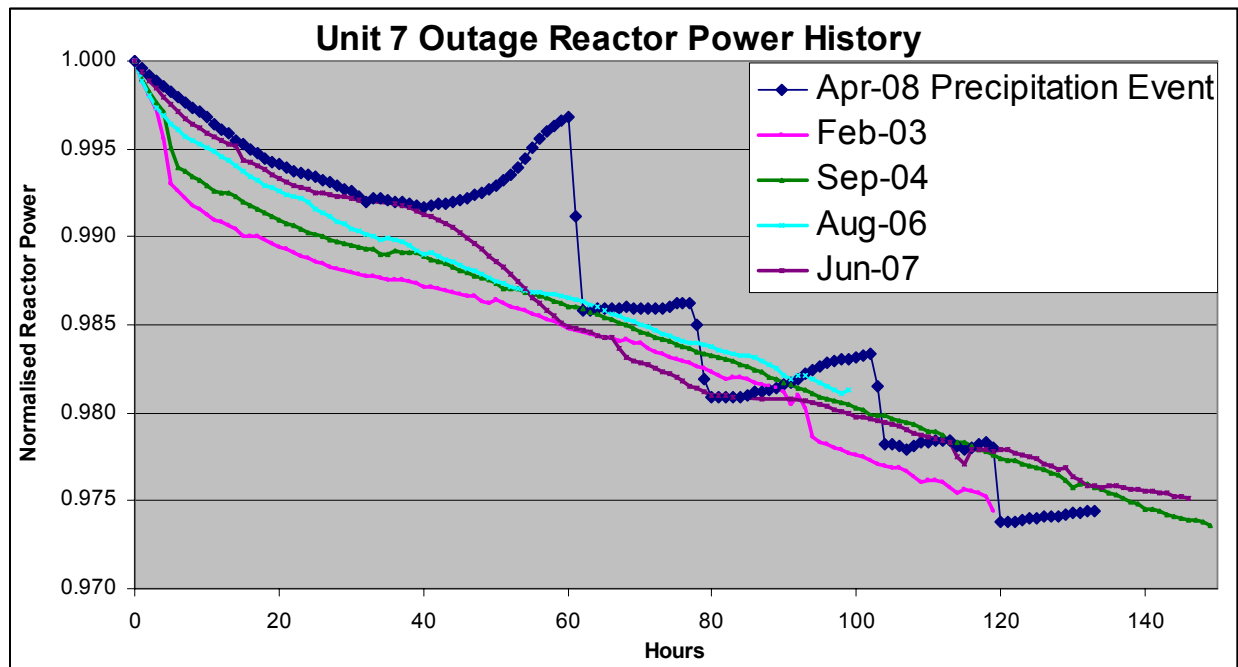
On #1 shift April 06, 2008, Unit 7 was shut down due to a human performance event during the Unit 8 Planned Outage which caused a turbine-generator trip on Unit 7. On #2 shift April 06, 2008, the transition to the Over Poisoned Guaranteed Shutdown State (OPGSS, also known as RSG1) commenced. Delayed due to an apparent flow blockage in the LZCS, between CV2 and zone #14, the RSG was declared in effect on #2 shift April 08, 2008. On April 09, 2008, the Unit 7 moderator gadolinium concentrations began to decrease at a rate of  $\sim 2$  ppm/day following  $\sim 30$  hours of stability (Figure 3). The decrease in gadolinium concentration was accompanied by a corresponding increase in sub-critical reactor power. As a result, periodic additions of gadolinium had to be made to maintain the gadolinium concentration above the 14 ppm administrative limit (N.B. the license limit is 12 ppm). Due to the instability in poison concentration while in RSG1, Operations determined that an alternate GSS that did not rely on gadolinium was required. As a result, the drain of the Moderator System commenced #2 shift on April 15, 2008 and the Drained GSS (RSG3) was declared in effect on #2 shift April 20, 2008.

Figure 3 Unit 7 Post Shutdown Reactor Power History

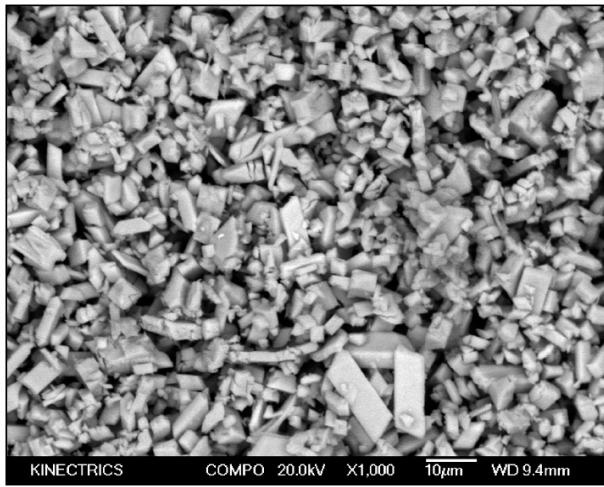
The Root Cause Investigation that was conducted determined that the cause of the decreasing poison concentration was the result of gadolinium precipitation (Figure 4). The gadolinium precipitation was the direct result of the high  $\text{CO}_2$  source term (dissolved  $\text{CO}_2$ ) that was present. In the presence of appropriate levels of radiation the  $\text{CO}_2$  was converted into oxalate which forms an insoluble precipitate with gadolinium. Prior to the drain of the system, the equivalent of  $\sim 11.9$  ppm (or 3 kilograms) of Gd went missing from solution. As this gadolinium was not dissolved in the moderator water, it was assumed at the time that it had either deposited on the internal surfaces of the system or had settled in low flow areas. Normally, Unit 7 would be expected to go critical with 0.95 ppm of dissolved gadolinium present in the moderator

Figure 4 Gadolinium oxalate deposit removed from valve internal

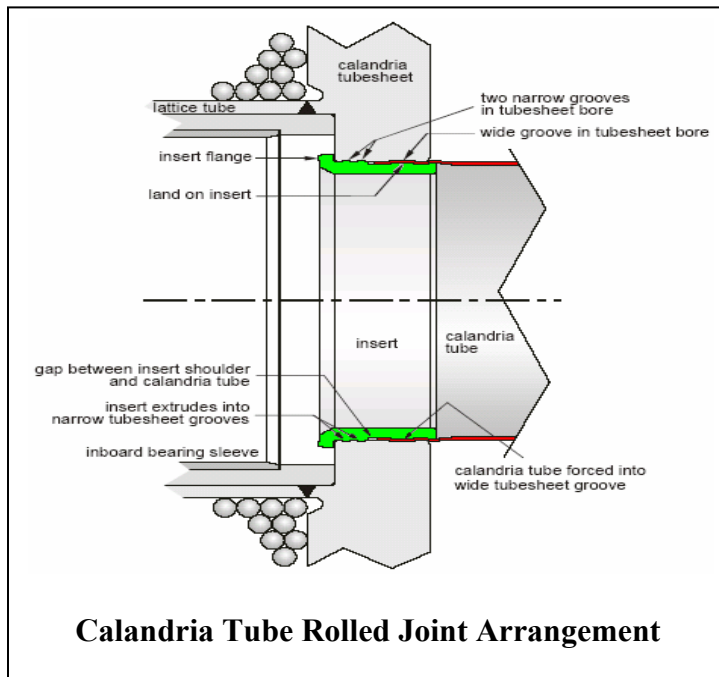
The repair of the leak would require the removal and replacement of both the pressure and calandria tubes. While pressure tube replacement is not common the station had executed this work previously. Calandria tube replacement had not been completed and required a great deal more development work for equipment and procedures. Additionally the nature of the calandria tube flaw was not known. The flaw could exist at the joints between the tube and tubesheet or in the body of the tube (Figure 5).

Figure 5 Cross section of calandria tube rolled joint

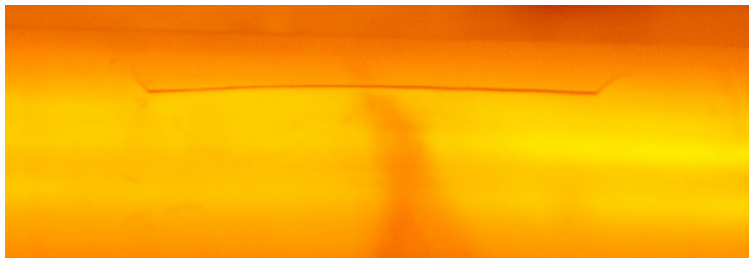
Following removal of the pressure tube on reactor testing revealed that the leak was not likely in the rolled joint area of the calandria tube. Inspection of the body of the tube following removal showed the presence of a 7 cm through wall flaw on the bottom of the calandria tube (Figure 6).

Figure 6 Photograph of flaw in the removed A13 calandria tube

As soon as it was determined that the Gd precipitation was the result of the elevated  $\text{CO}_2$  levels into the Moderator System, the decision was made to repair the calandria tube leak. This would involve, as a minimum, the replacement of both the Pressure Tube and Calandria Tube in the leaking fuel channel. As it was not known what the specific flaw/defect was, developing the specific repair strategy was problematic. A multi discipline team was formed to address the various facets of the repair/recovery strategy.

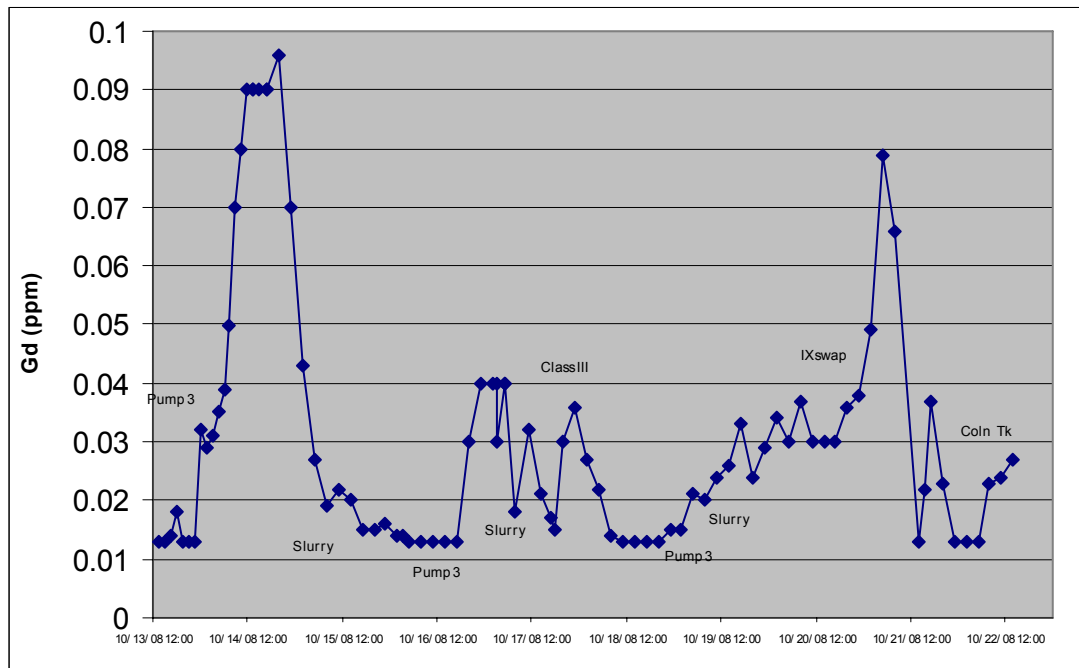
After all the gadolinium had been removed, a series of equipment configuration changes were executed. The intent of these alignment changes was to ensure a minimum potential for having mobile gadolinium in the system. Following the completion of the tests the station was confident that there would be no major changes in gadolinium concentration due to system configuration changes (Figure 7).

Figure 7 Release of gadolinium following equipment configuration changes
