Future Plans for Performance Analysis and Maintenance/Inspection Optimization of Shutoff Rods Based on the Case Study of Bruce Power Unit-3 Shutoff Rod 5 Inspection

E. Nasimi^{1,2}, H. A. Gabbar²

¹Bruce Power LLP

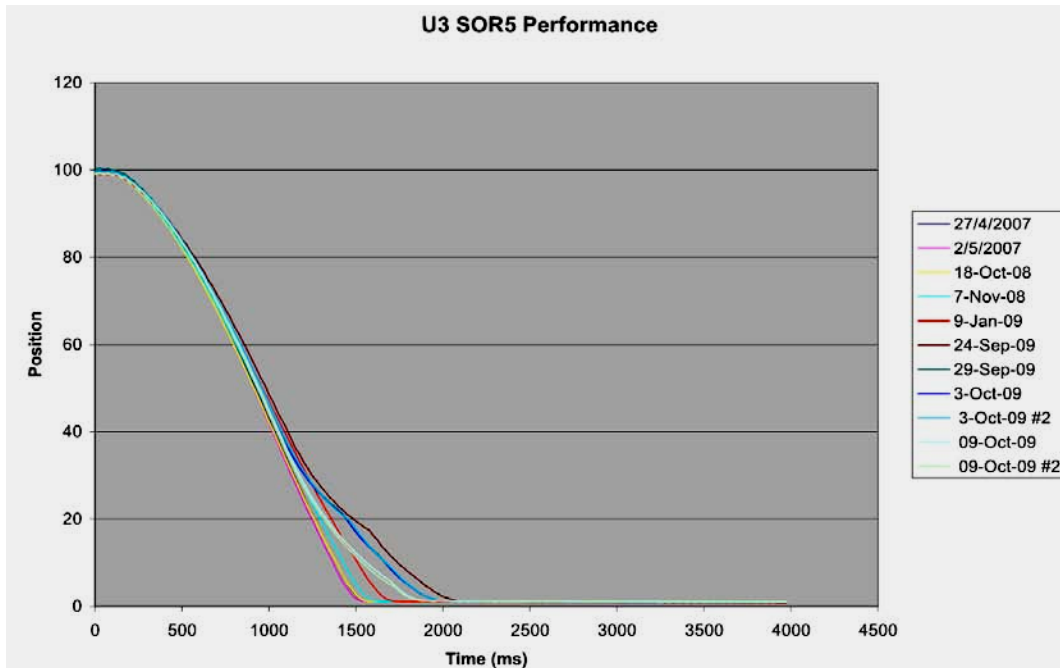
Full rod drop SST 1.19 performed on 07 November 2008 indicated that SOR-5 performance deviates significantly from the rest of the rods. Degradation continued, as shown in SOR drop tests up to 24 September 09. This performance trending is shown in Figure 1 below. As shown, the rod performance in 2007 test was acceptable and within the expected range. With the time progression, the SOR-5 rod drop timing and profile has changes significantly, until the test conducted on 24 September 2009 resulted in the test failure and produces an unusual profile with a clearly defined "hump" at about 80% in-core.

During the Fall 2009 outage, the as-found full rod drop test showed SOR-5 dropping normally up until about the 60-70% in-core, where SOR-5 was slowing down, as if the rod's travel was being impeded by some blockage. The test was repeated 3 more times with similar results.

Figure 1: Unit-3 Shutoff Rod 5 (SOR-5) performance historical trend. Plot is comprised used full rod drop test (SST1.19) data for the period between 27 April 2007 and 09 October 2009.

Following a discovery of the SOR-5 failure, an initial troubleshooting was conducted in order to determine the possible cause of failure. First, SOR-5 Logic unit was replaced as the slow rod performance was originally attributed to an incorrect position indication or calibration problem. The subsequent drop test was performed to determine whether this eliminated the fault, but showed small improvement in time to reach the third timing gate.

Next, SOR-5 Potentiometer was replaced and the full rod drop test repeated, with no improvement in performance.

Next, SOR-5 mechanism was replaced with a new mechanism and tested twice on 09 October 2009. The two full rod drop tests passed, though SOR5 passed with a small margin.

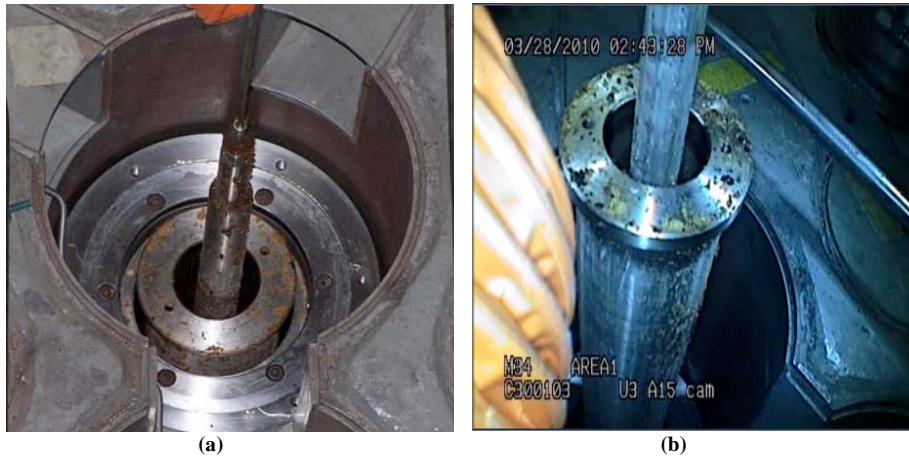
This project started with removal of the grating on the deck. Next, SOR-5 mechanism was lifted off in order to gain access to the rod. This allowed performing a visual inspection of the top of the rod assembly, which revealed a considerable amount of foreign material, believed to be irradiated oil residue, present all over the rod (i.e., oil

flakes, globs). This is shown in Figure 2 (a) below, where the top of the SOR-5 assembly is shown.

Figure 2: (a) The top of SOR-5 assembly is shown, where a clear sign of foreign material contamination can be seen on the top of the rod element and the guide tube exterior; (b) Top of SOR-5 rod, where solid debris are visibly present.

Next, the rod absorber element, consisting of outer layers of stainless steel with an inner layer of cadmium forming a hollow tube was craned out of the guide tube and positioned in suspension inside the reactivity management flask. The top of the rod is shown in Figure 2 (b) where the presence of solid foreign material is also clearly visible. As the rod was being lifted, the rod condition was recorded and initial visual inspection was performed. As shown in Figure 3 (a) below, there was significantly less debris present on the middle portion of the rod.

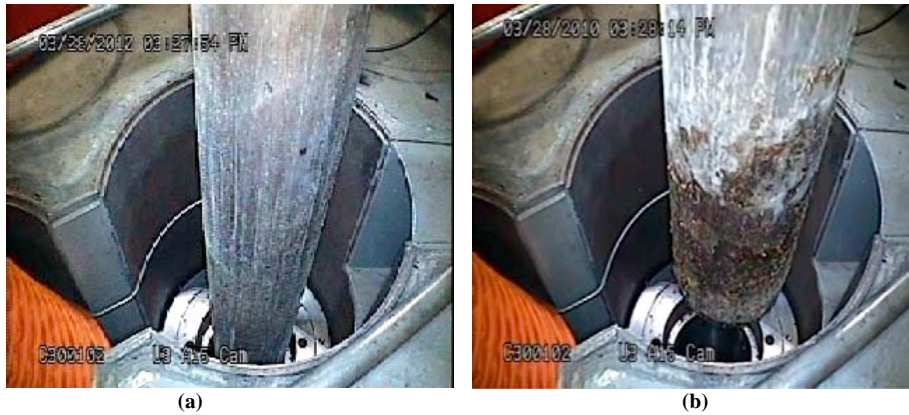
Figure 3: (a) Middle section of SOR-5 - normal wear and tear is present; (b) Lower portion of SOR-5 - a significant amount of foreign material buildup is present.

When the rod was completely lifted out, it was noted that the last 3-4 inches of the rod appeared to be completely covered by a rust colored residue as shown in Figure 3 (b). Furthermore, once the rod was placed into the flask, the inspection revealed that the ID (inside diameter) of the rod was contaminated with the rust-colored material as well.

One of the proposed alternatives for future work is to use a dry ice blasting method for SOR-5 rod absorber element clean-up. The main advantage of dry ice blasting is that it is very gentle, almost like snow, and leaves no cleaning residue. Therefore, for this alternative it is possible to develop a work package where the rod absorber element is lifted up into a plastic tent connected to the active exhaust ventilation system. Any tritiated vapors will be ventilated and off-gassed while the solid residue will be collected inside the plastic tent. The ice blasting will be conducted inside the tent and will leave no residue or corrode the rod element surface. Once the rod is dried up, it could be lowered down into the guide tube into its normal position. The work progress can be monitored real-time using several cameras positioned inside the tent and all steps can be recorded for future analysis.

Alternatively, a mechanical tool can be designed for the rod cleanup. The tool will be created using a typical bottle cleaning brush concept and connected via a flexible long

handle to a small-size, e.g. $\frac{1}{2}$ HP motor, which speed/rotations can be controlled by a variable frequency inverter (VFI). The brush will rotate around and inside the guide tube and scrape the solid build-up of oil off the exterior and internal surfaces. This process, again, will take place inside a plastic tent with the active exhaust ventilation and will be remotely monitored over a video link. The brush speed/rotation/angle can be adjusted so that an optimal contact is made with the rod surface.

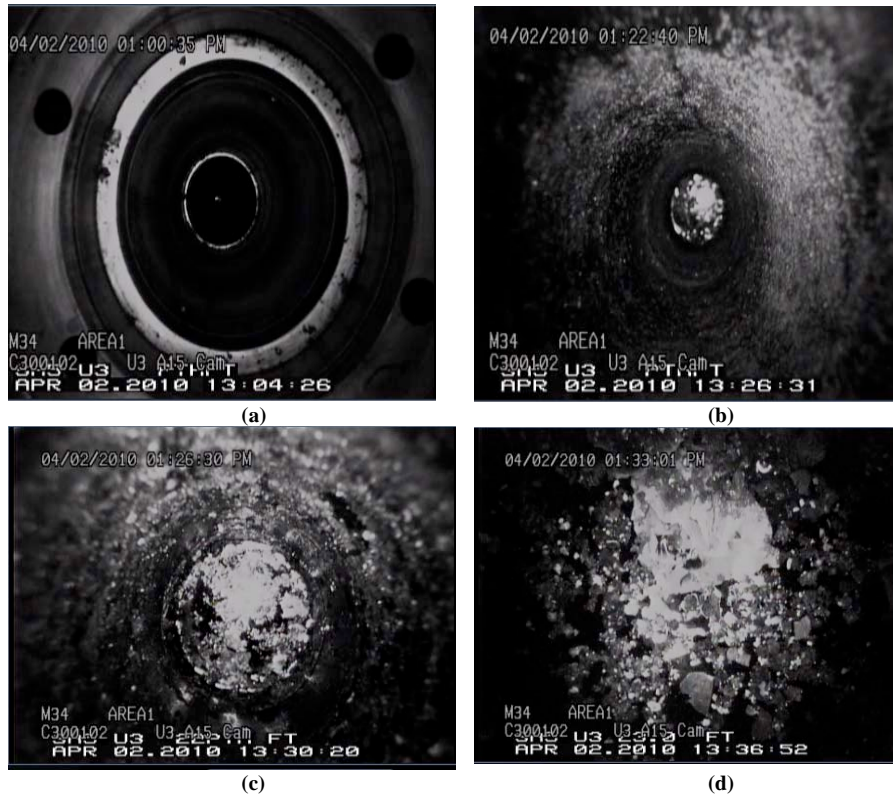
Next, SOR-5 guide tube inspection was conducted. A downward looking camera was inserted into the guide tube up to the moderator level as shown in Figure 4 (a). The camera died in a few seconds once it past the first set of guide tube holes. It appears that the radiation coming through the holes was greater than the 2 million REM limit of the camera. The first video shows that the guide tube is clean until about 3-5 feet from the moderator level (as shown in Figure 4 (b)). At that location, a similar excessive build-up of crud that was seen at the last 4-6 inches of the SA5 rod's bottom. In addition, there was a layer of oil crud floating on top of the mod D2O, covering almost 50% surface area, consisting of small flakes, and 2-3 big chunks as shown in Figure 4 (c) and 4 (d).

Figure 4: (a) Downward looking camera was inserted into the SOR-5 guide tube up to the moderator level; (b) At approximately 3-5 feet from the moderator level there is an excessive build-up of crud similar to the one that was seen at the last 4-6 inches of the SOR-5 rod's bottom; (c)&(d) A layer of oil crud floating on top of the mod D2O, covering almost 50% surface area, consisting of small flakes, and 2-3 big chunks.

Once the camera passed through the moderator level, the image quality suffered, due to the water and crud until at the guide tube perforations (holes) level the camera burnt out in a few seconds. It appeared that the radiation coming through the holes was greater than the 2 million REM limit of the camera. A second camera, typically used for reactor maintenance at Bruce Power, was obtained. This camera had lower image quality, but was shielded in a metal cylinder and was expected to last longer so that a second inspection could be conducted in order to obtain further data and have a means of verification.

Currently no methodology exists for the in-situ guide tube clean-up. It is important to remember that most of the surface buildup is present on the internals of the guide tube just above the moderator level. Thus, foreign material control is absolutely paramount as this task has to be performed on a working unit in OPGSS. No additives or chemical residue can be introduced into the moderator as well as no particulate or foreign substance can be left inside the guide tube itself.

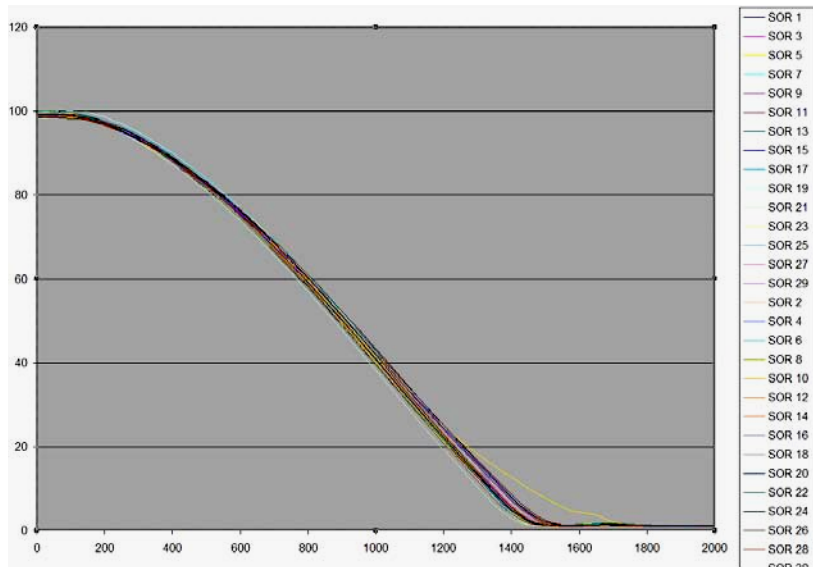
Once the guide tube inspection was complete, the rod assembly was replaced and post maintenance testing was conducted by the means of a full rod drop test (SST1.19). As shown below, the SOR-5 (light yellow) was still showing an unusual drop profile and tracking slower than the rest of the group.

Figure 5: A full rod drop test performed on 04 April 2010 for post-maintenance testing and verification following the SOR-5 rod and guide tube inspection. SOR-5 is still showing an unusual drop profile and tracking significantly slower than the rest of the group.

Nuclear safety analysis was conducted to assess the safety impact of the slow Shutoff Rod 5 (SOR-5) and concluded that the slow rod performance has no impact outside the large break LOCA (Loss of Coolant Accident) [3] mainly based on the fact that the rod does meet the first two timing gates.

Based on the analysis of SOR-5 performance from November 2008 to October 2009, the rate of slowing of SOR-5 at the third gate decreased with time; therefore based on the short period of time that Unit-3 is required to run until its next planned outage the performance was deemed to be unlikely to deteriorate significantly. It is expected that SOR-5 may marginally fail its drop test in the next outage, but it is very unlikely that its performance will decrease significantly.

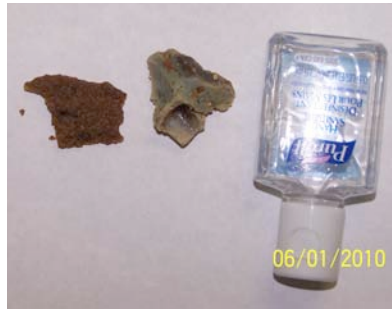
Figure 6: Two pieces of solid material floating on the open surface of the moderator were retrieved for material analysis. As shown, there is a variation in color, thickness and texture of the samples.

As can be noted from Figure 6, the two samples vary in color and texture as well as in thickness and brittleness of the material. The lighter-coloured sample on the right is significantly thicker and has a texture of a gum-like material, very much like a gummy-bear type of a jellied substance. The darker-coloured material on the left is much thinner and significantly more brittle.

A portion of the samples was pyrolyzed at about 750C. The pyrolysate was examined as a thin film condensate on a KBr (Potassium Bromide) disk by Fourier transform infrared spectroscopy (FTIR: Thermo Nicolet Nexus 470 SN 2620 instrument). The resulting spectrum was examined for major spectral features and also compared with commercial spectral libraries. Based on this examination the material was identified as a hydrocarbon, similar to many lubricating oils with some oxidation being evident.

Another portion was ground with KBr in a mortar and pestle to examine the structure of the polymerized form. An FTIR Identification by Fourier Transform Infrared spectrum was obtained and examined as above. The spectrum indicated that the oxidized portion was inherent to the sample and not an artifact caused by pyrolysis. Comparison with commercial materials indicated a similarity to hydrocarbon resins with aliphatic linear, branched and cyclic structures. There was also indication of some free water trapped in the material [2].

The material analysis of the samples identified this foreign rusty-coloured substance as hydrocarbon resins with aliphatic linear, branched and cyclic structures, similar to many lubricating oils, although an exact match to a commercial product brand or type could not be made. These observations were consistent with the known history whereby some oil was inadvertently released into the Unit-3 moderator. The main finding of the inspection was the confirmation for the presence of foreign material on the surfaces of the guide tube and external and internal surfaces of the rod absorber, which had not been previously witnessed or analysed.
