## **BALANCING RISK: SITE REMEDIATION OUTSIDE THE ENVIRONMENTAL ASSESSMENT**

**T.L. Yankovich**, A. Klyashtorin, Z. Guo, J. Muldoon, S. Lysohirka, E. Petelina, E. Gergely  
Saskatchewan Research Council  
Saskatoon, Saskatchewan, Canada

### **ABSTRACT**

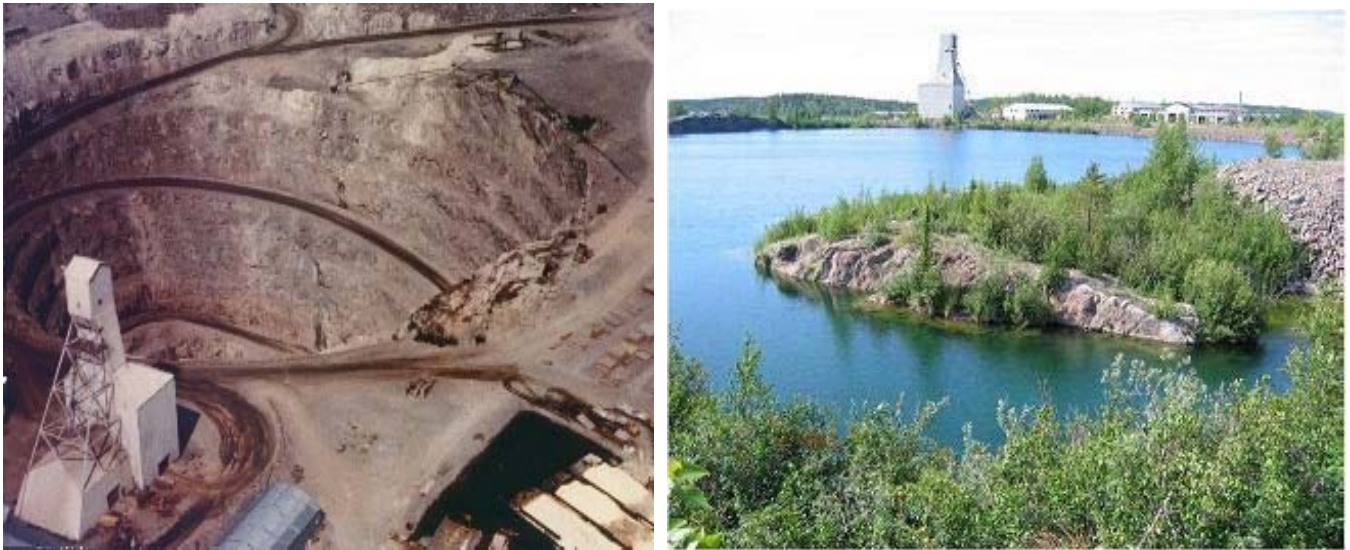
**Figure 3. Gunnar pit and headframe shaft. Left panel: 1963; Right panel: 2009**

Initially, mining was conducted on the Gunnar Site in an open pit, and later, continued through use of underground workings (Figure 3). The pit was flooded following the cessation of mining activity through blasting and excavation of a channel through the bedrock land bridge that separated the pit from the Lake Athabasca. The flooded pit is currently a stagnant water body with a depth of over 100 m, a volume of approximately 3 million m<sup>3</sup> and is some 300 m wide. The pit is connected to the underground mine workings through a stope. Once the pit was flooded, the blasted channel was backfilled with waste rock, although this barrier is highly permeable and does not impede water flow from the pit to the lake. As a result, seasonally, during times of peak water levels, water from the pit can enter Lake Athabasca.

Options that have been considered for remediation of the pit include leaving the pit "as is", conducting water treatment over time to address uranium and Ra-226 concentrations in pit water, and dewatering the pit, so that it can serve as a site for the waste rock and demolition debris. Regardless of the option, clean water from upstream will be diverted to minimize water flow into the pit.

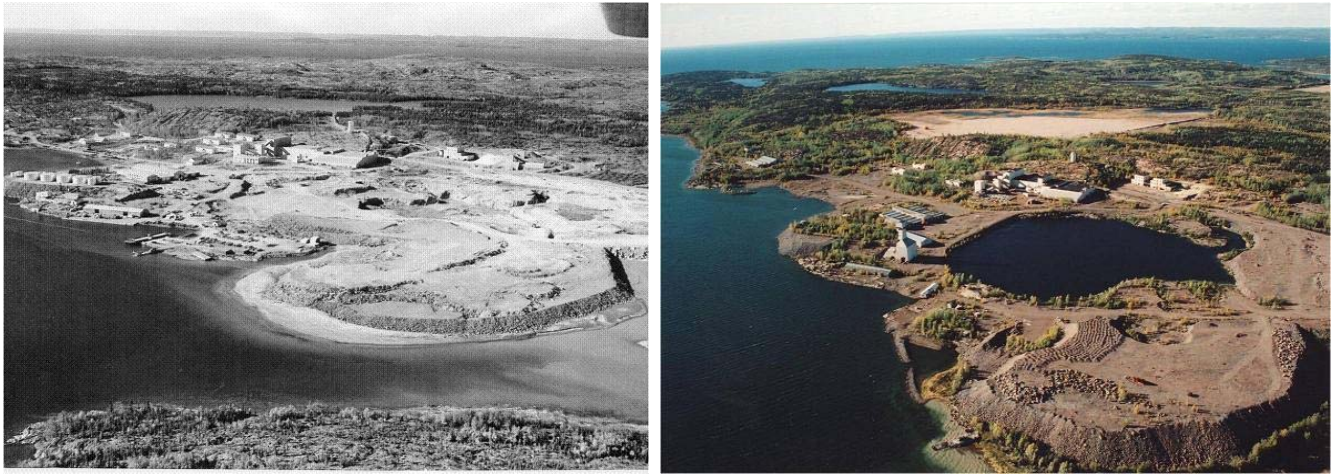
Uranium ore originating from the open pit and sub-surface mines at Gunnar was generated from a total of over 8.5 million tons of rock that had been mined and processed. This resulted in some 2.2 to 2.7 million m<sup>3</sup> of waste rock and over 5 million tons of unconfined tailings that were directed to nearby valleys, depressions, and lakes, covering a total of over 70 ha of land (Figure 4).

**Figure 4. Gunnar Mine Site. Left panel: Gunnar Site in progress during 1955 (with no headframe yet); Right panel: Abandoned Gunnar Site in 2009**

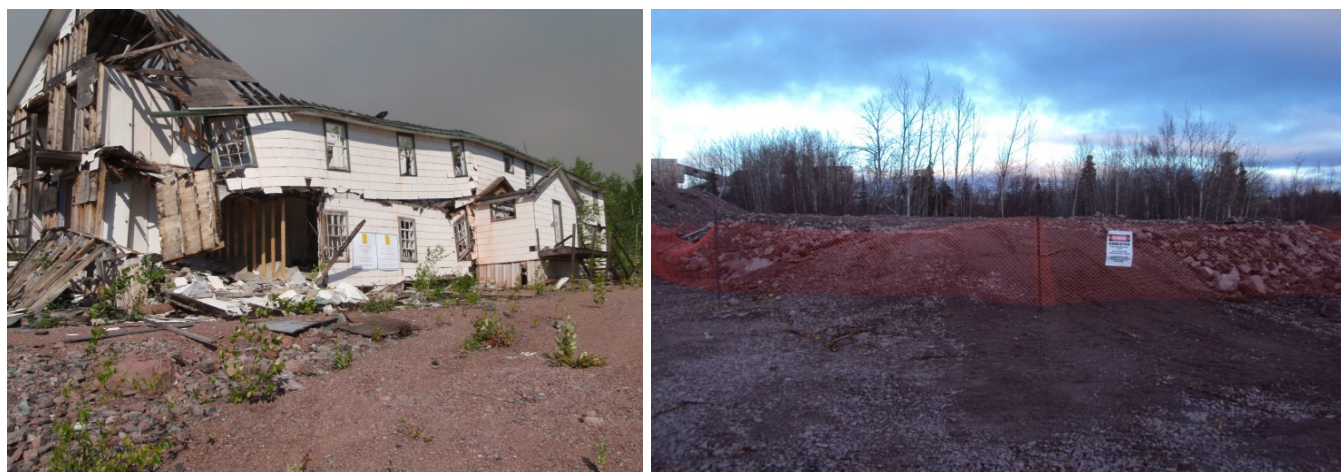
**Figure 5. Before (left panel) and after (right panel) photos of the wooden structures following remediation efforts in 2010 at the Gunnar Mine Site.**

Buildings and structures on the Gunnar site that have been taken down in compliance with the CNSC Order included the headframe, collar house and bin house, which supported the underground workings, uranium mill and associated industrial complex, acid plants, storage area with residual elemental sulfur, maintenance warehouse, acid tanks, water tanks, and other industrial, office, and residential buildings (Figures 5-7). The headframe and mill were contaminated by radioactive materials, with a gamma dose rate at some localities in the buildings reaching up to 10  $\mu\text{Sv/h}$  [8-9]. Many of the buildings and structures contained various types of asbestos, including its friable and non-friable forms, and measures had to be taken to protect workers from the associated inhalation risks. SRC directly hired an asbestos expert to provide oversight during the work due to the relatively high asbestos-related risks on the job. Protection of workers from inhalation risks associated with friable asbestos also provided protection from inhalation of radioactive particulates. In addition, recent surveys found the presence of relatively small quantities of hazardous materials and substances (hazmats), including PCBs, elemental sulfur, carbon tetrachloride ( $\text{CCl}_4$ ) and others [8]. These are to be transported off-site for disposal in an approved disposal facility.

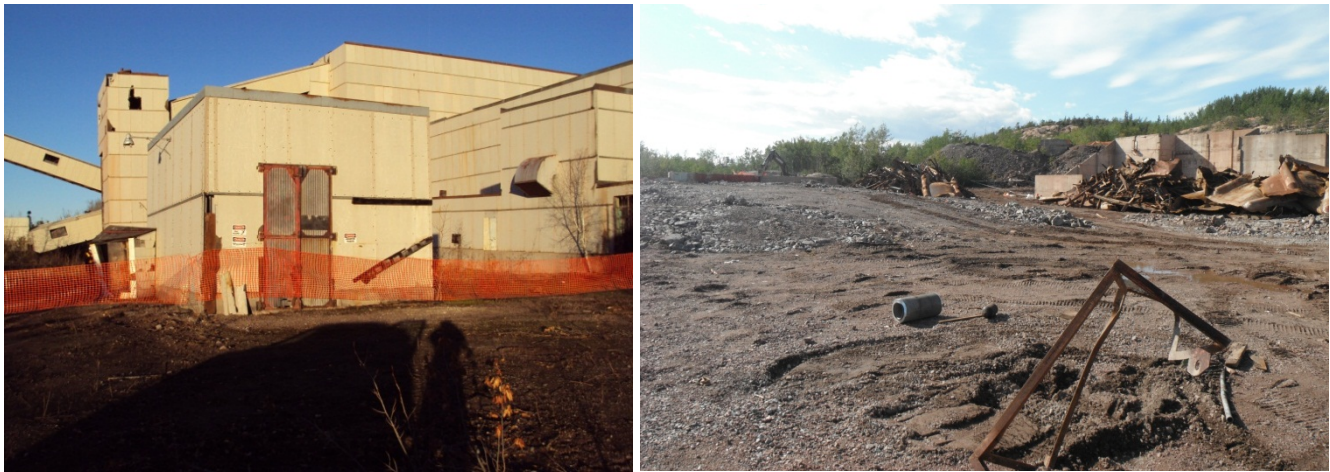
**Figure 6. Before (left panel) and after (right panel) photos of the demolition of the Gunnar Mill Complex following remediation efforts in 2011 at the Gunnar Mine Site.**

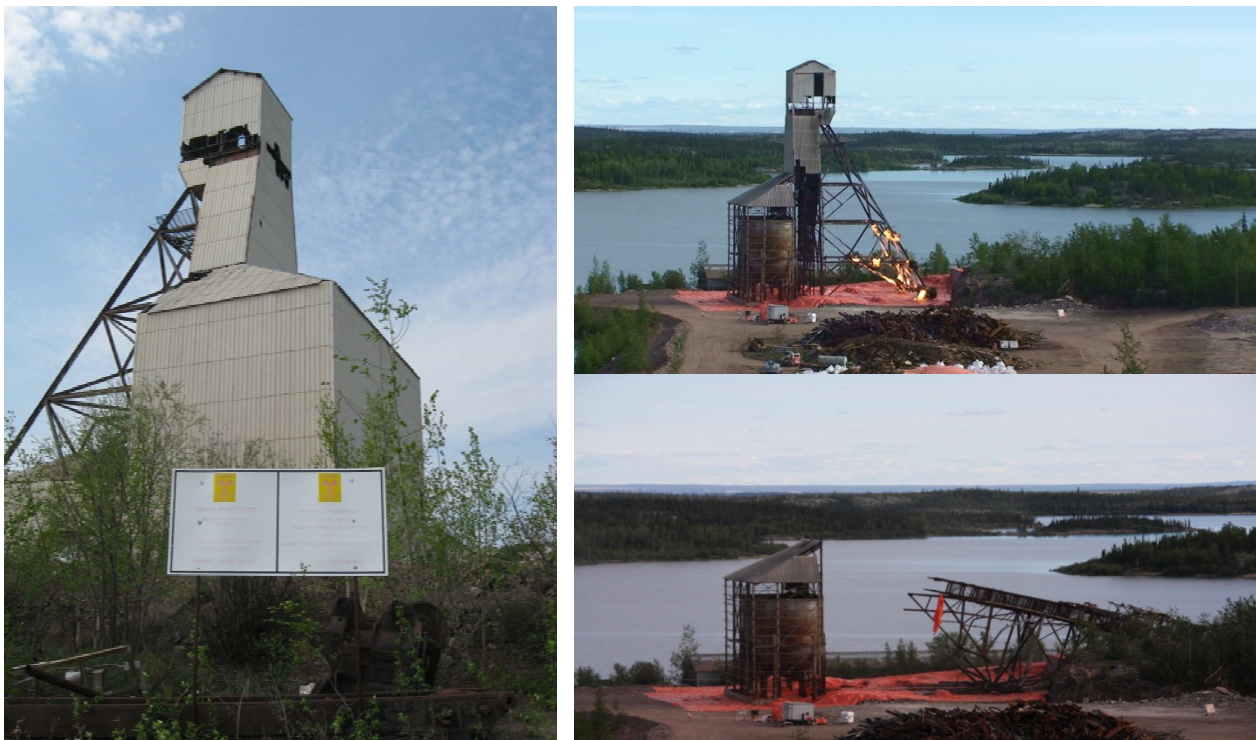
**Figure 7. Before (left panel) and after (right panels) photos of the demolition of the Gunnar Headframe following remediation efforts in 2011 at the Gunnar Mine Site.**

Prior to initiation of abatement and demolition of the buildings and structures on the Gunnar Mine Site, a structural safety assessment was conducted to identify associated risks and hazards that required consideration during work planning [10]. In addition, it was necessary to develop detailed safe work plans, including: An Occupational Health and Safety (OH&S) plan [7]; a hazardous substances and materials inventory [8]; a demolition plan [9]; and a waste management plan [11], which are available on the Project CLEANS web-site. Establishment of barriers [12-13], removal of overhead and other hazards [14], securing of the hazmats [15] and securing of the site itself were also carried out to ensure public safety under the Order.

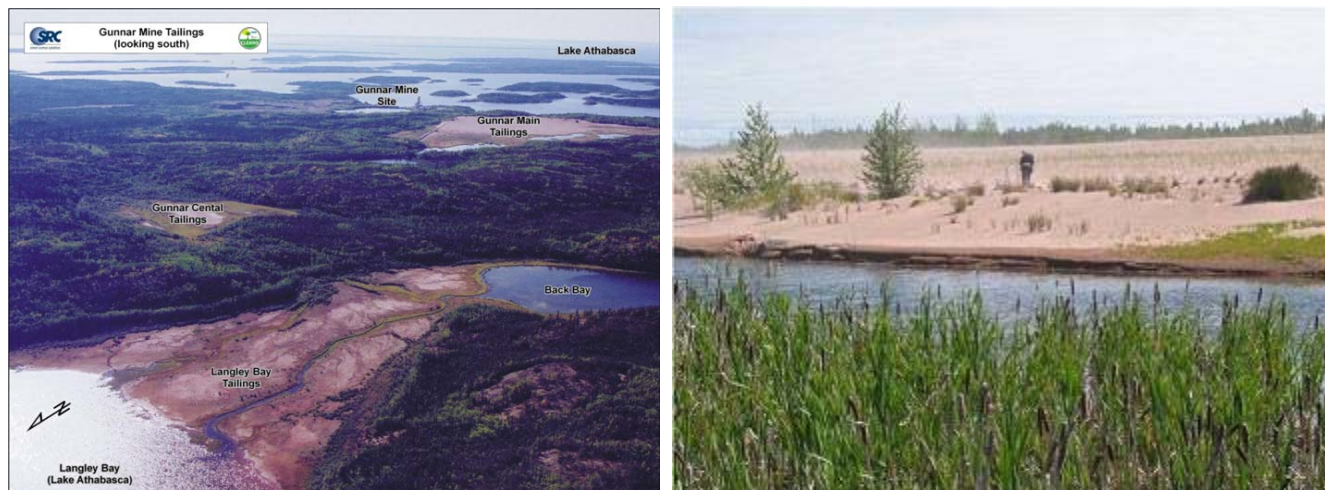
During past operations of the Gunnar Site, the mill tailings were discharged from the Mill as a pulp into a small lake located approximately 500 m to the north of the Mill. This area is currently referred to as the Gunnar Main tailings. The basin eventually filled with tailings solids and a small, rocky outcrop was blasted to allow the tailings to flow from the Gunnar Main area to a small depression referred to as the Gunnar Central Tailings. Once this relatively small basin was filled, the tailings continued to flow downhill, eventually entering Langley Bay of Lake Athabasca (Figure 8, left panel).

In total, over 4.4 million tons of tailings ( $3.3 \text{ million m}^3$ ) were released to the environment and left unconfined (Figure 8, right panel). The tailings contain residual uranium with progenies (Table 3) and have a gamma dose rate that varies from 5 to 15  $\mu\text{Sv/h}$  (1 m above the surface). Contaminants that are present in the tailings are being geochemically transported from the Gunnar Main tailings to Langley Bay in Athabasca Lake, approximately 3 km north of the Gunnar Mine Site.

**Figure 8. Overview of Gunnar unconfined tailings areas (left panel) and photo of wind blow at the surface of the Gunnar Main tailings (right panel) in 2008.**

Work is underway to develop site-specific revegetation technologies that can ultimately be applied in the establishment of engineered covers on the Gunnar Site. In addition, detailed work is being planned to develop engineered designs for the covers.
