# **Behaviour of Aged and New Flux Detectors in Darlington Reactors**

**Constantin Banica, Matthew Foster**

Darlington Nuclear, Ontario Power Generation, Canada

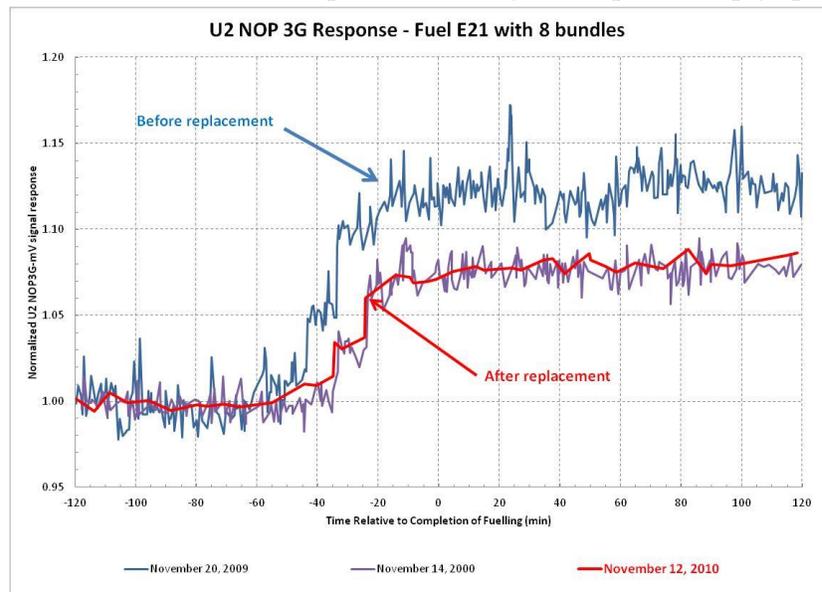
Specific NOP detectors had been noted to have an increased response to fuelling of channels in their immediate vicinity. The exaggerated response to localized flux increases exhibited by some detectors resulted in a number of SDS channel trips. The SDS2 (Platinum-clad Inconel) detector G03 was replaced in both Units 1 (2011) and 2 (2010). The decision for replacement was initially based on the increasing trend in prompt fractions (PF) estimated from rundown tests: in one case the PF even increased above 100%. Note that, in this case, “replacement” means that a new detector was inserted in a spare well, while the old detector was kept in its original well after disconnection from the loop.

Figure 1 presents one Unit 2 example: responses of NOP detector 3G to three regular (8 bundle push) fuelling operations of the adjacent fuel channel E21, at comparable discharge burnups. The top graph represents the response of the aged detector (2009, few months before replacement), while the lower graphs present the response of the new detector (smooth, red graph, 2010) and mid-age detector (2000). It is clear that the response of a new detector to fuelling is not just smaller, but its signal contains much less “noise” than an aged detector.

**Figure 1 - Response of Detector 3G to Fuelling of Adjacent Channel E21**

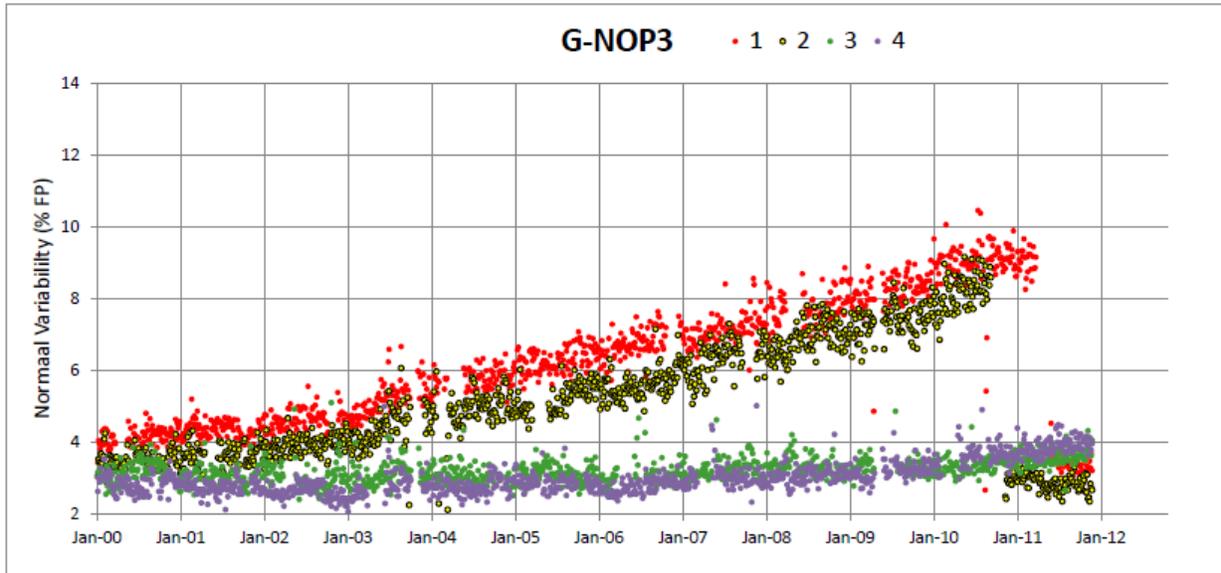
The increased “noise” (variability) is presented in Figure 2 below; please refer to sections 4 and 5 for more details on calculation. For both Units 1 and 2, there was a significant decrease in detector signal variability after replacement (2010 – 2011). The 3G detectors were not replaced in Units 3 and 4 because their behaviour and their estimated prompt fractions are normal, a difference currently attributed to the different detector batches.

**Figure 2 - Noise of Detector 3G in all Darlington Units**

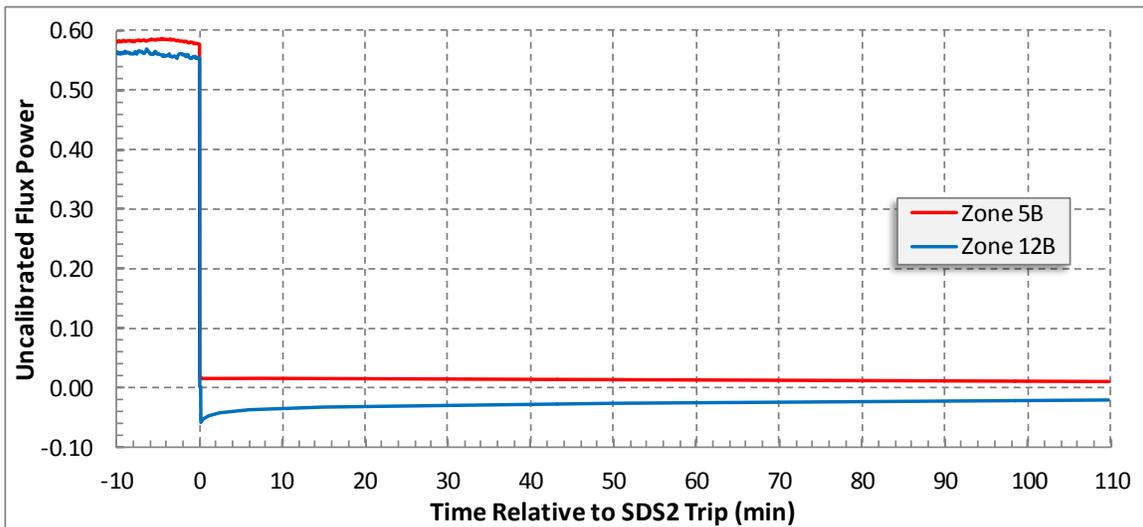
Some Inconel (vertical) detectors are also overly responsive to changes in neutron flux and their overpromptness is growing worse in time. Although this aging mechanism is in the safe direction, the exaggerated promptness of these detectors has caused regulating problems during power reductions (multiple RRS detectors irrational low) and a number of SDS1 channel trips. Figure 3 presents the dynamic response of two different Unit 3 RRS (Inconel) detectors to a SDS2 trip from 59%FP. Both zone 5 and 12 detectors belong to RRS channel “B” and are located in the bottom of the core.

**Figure 3 – Response of Inconel Detectors with Different Prompt fractions to Reactor Shutdown From 59%FP**

The 5B detector (red) was slightly underprompt (estimated PF of 98%)<sup>1</sup>, while the 12B detector was “too overprompt” (estimated PF of 108%) at the time of the trip. The 5B signal remained positive, while the 12B signal dropped to about -5% and slowly recovered over the next few hours.

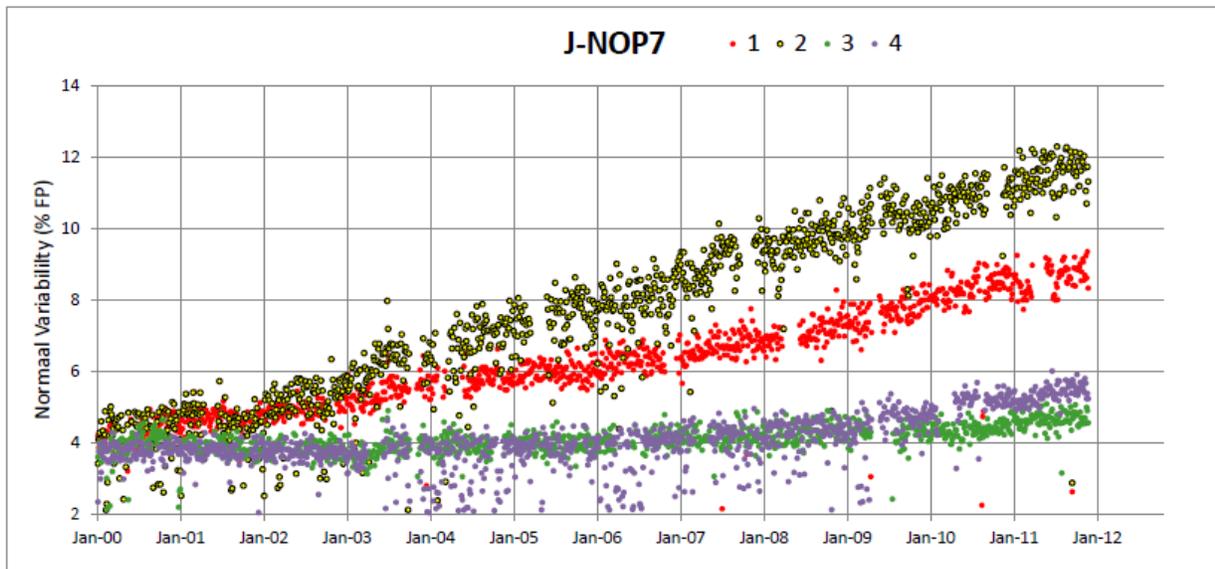
In addition to changes in prompt fraction, both vertical Inconel and horizontal Pt-clad Inconel detectors have exhibited increasing signal variability (“noise”) over time. To quantify noise, the range of a specific detector signal was calculated every two hours for one full day, and the median value was selected to eliminate other effects (such as testing, maintenance, fuelling, and moderator temperature fluctuations). This procedure was repeated every 3 ½ days for 12 years. These data are shown in Figure 2 above for detector 3G (horizontal Pt-clad Inconel) in all four units. Similar observations have been made for other detectors. Figure 4 below shows the noise trend for detector 7J (horizontal, Pt-clad Inconel).

**Figure 4 – Noise of detector 7J (Pt-clad Inconel) for all Darlington Units**

This detector exhibits similar behaviour to detector 3G, albeit with more severe signal variability. Once again Units 1 and 2 detectors 7J display significantly increasing noise compared to Units 3 and 4, although Units 3 and 4 noise begins to trend upward after approximately 2008. Increasing noise is not

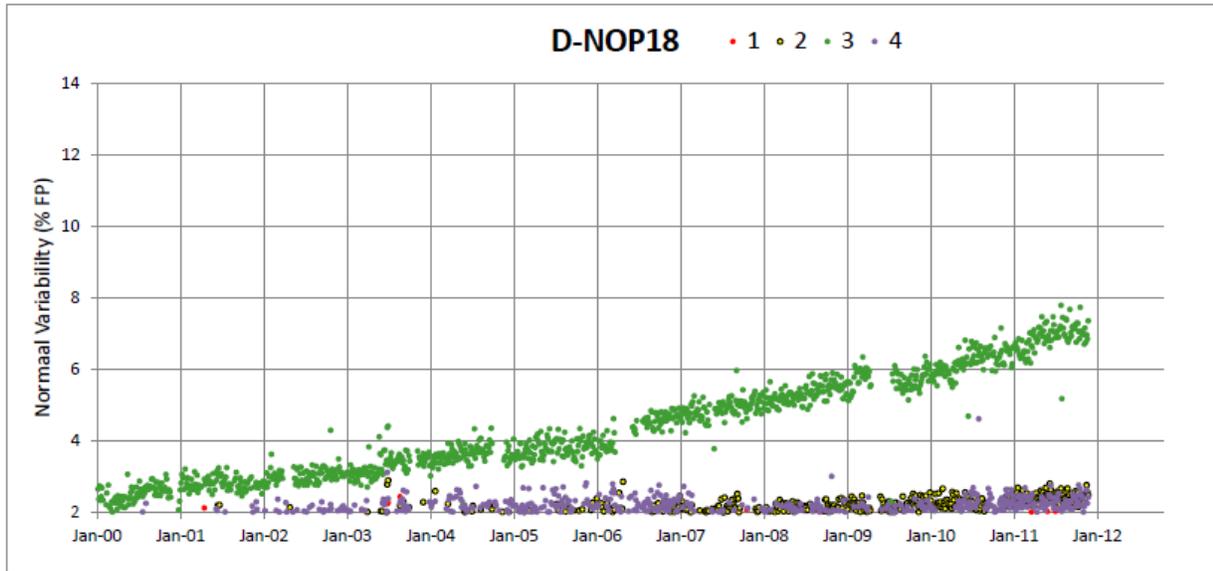
limited to Pt-clad Inconel detectors, as shown by Figure 5. In this case, detector 18D (vertical Inconel) signal variability is seen to increase, but the effect is mostly limited to the Unit 3 detector.

**Figure 5 – Noise of detector 18D in all Darlington Units**

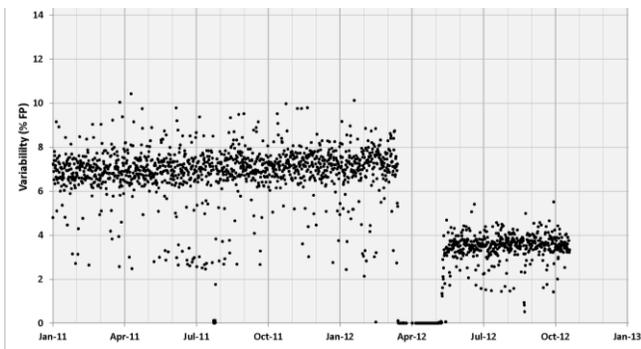
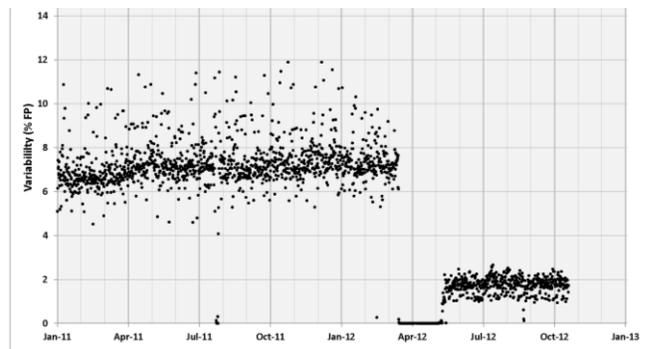
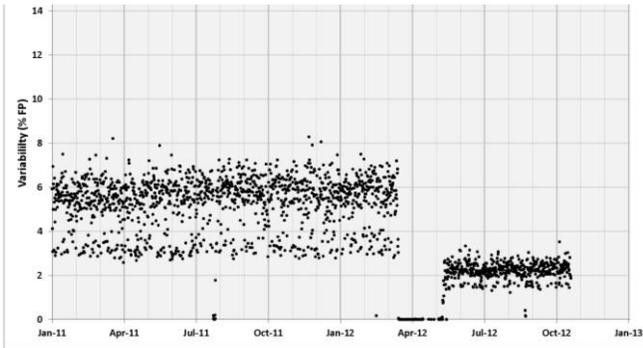
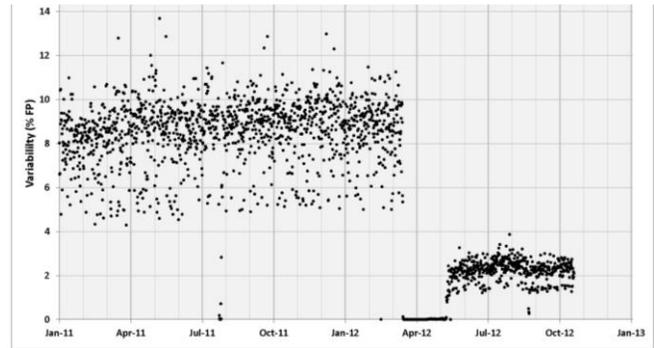
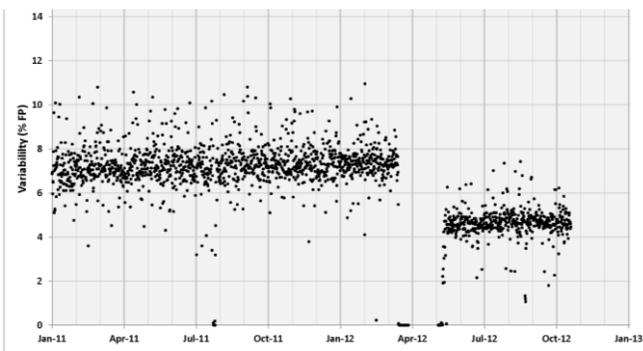
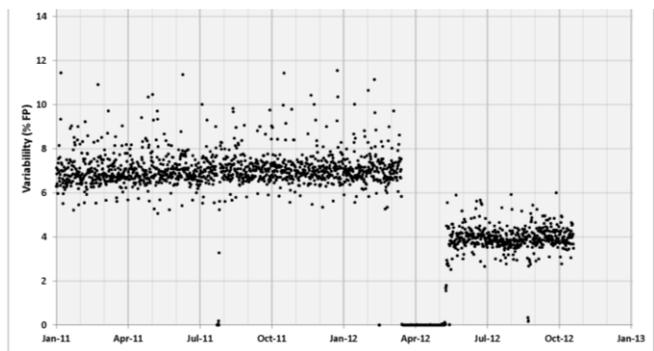
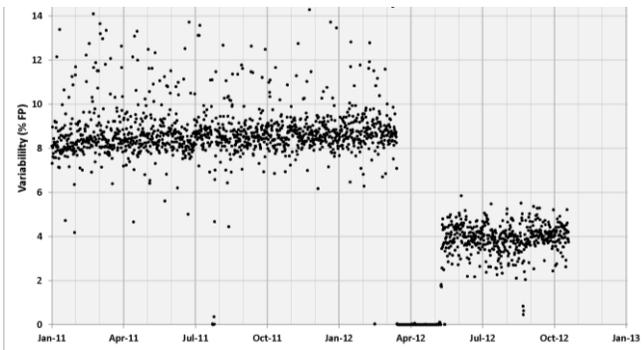
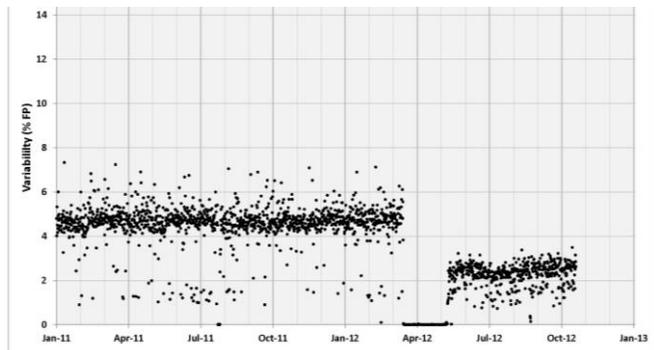
Recently completed detector replacements in Unit 3 further illustrate the reduction in signal variability of new compared to aged detectors. Figures 6(a) through (h) show examples of detector noise measured in the same manner as described above, covering a period of time prior to and following replacement. After replacement, both vertical Inconel, and horizontal Pt-clad Inconel detectors exhibit significant reduction in signal variability. One potential explanation for this is that the detectors lose sensitivity as they age. This is discussed further in the following section.

**Figure 6(a) – Unit 3 detector 11D (Inconel)**

**Figure 6(b) – Unit 3 detector 18D (Inconel)**

**Figure 6(c) – Unit 3 detector 10E (Inconel)**

**Figure 6(d) – Unit 3 detector 15E (Inconel)**

**Figure 6(e) – Unit 3 detector 10F (Inconel)**

**Figure 6(f) – Unit 3 detector 1H (Pt-clad Inconel)**

**Figure 6(g) – Unit 3 detector 4H (Pt-clad Inconel)**

**Figure 6(h) – Unit 3 detector 12H (Pt-clad Inconel)**

For both safety reasons (some low prompt fractions) and production reasons (trips or margin to trip alarms caused by exaggerated promptness), Darlington started in 2012 a program to replace 2-3 detectors in each SDS channel during each planned outage. Preference was given to detectors exhibiting significant aging effects: low currents, unexplained high variability (noise), low or very high prompt fractions. The partial replacement program was successful in reducing the number of margin to trip alarms and the risk of channel trips due to excessive detector response.
