Innovative Pipe Thickness Verification for Feedwater Flow at Darlington Nuclear Power Generating Station

Inspection and Maintenance Services, Ontario Power Generation, Ontario, Canada

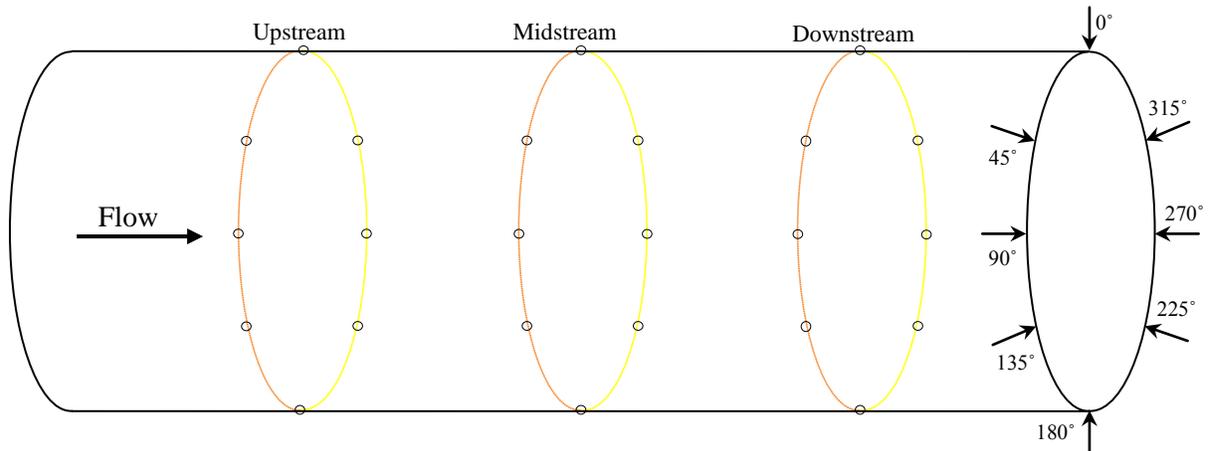
Figure 1 Pipe thickness measurement points prior to transducer installation

installation in 2001 [1], as shown in Figure 1. This method involves: removing the transducer, performing the thickness measurement, and then re-installing the transducer. In the WER ATL 14-0448 event report, the UFM vendor employed the direct measurement method. This method poses two issues: safety and cost.

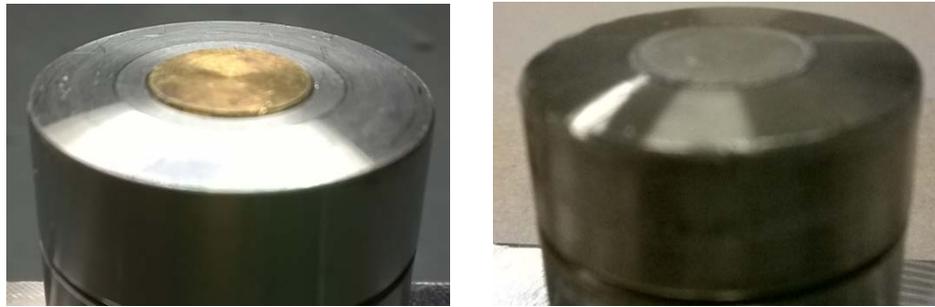
Figure 2 Probe contact comparison new (left) verse used (right)

- UFM transducers need to be removed and re-installed. This process takes four persons 1.5 days (per pipe) to complete: 0.5 day to remove and 1 day to install and tune the transducer. This labour cost is \$1850.
- During installation, the probes contact is deformed to take the shape of the pipe for proper contact (see contact deformation in Figure 2). The contacts can only be used once; as such, probe contacts need to be reconditioned by the vendor upon re-installation. The cost for probe reconditioning is about \$1000 per probe, and each transducer has four probes. The probe reconditioning cost is about \$4000.
- Threads and fasteners on UFM transducer frame are damaged during removal process (see Figure 3) due to thermal cycling. They need to be replaced, or reconditioned prior to re-installation (this cost about \$3000).

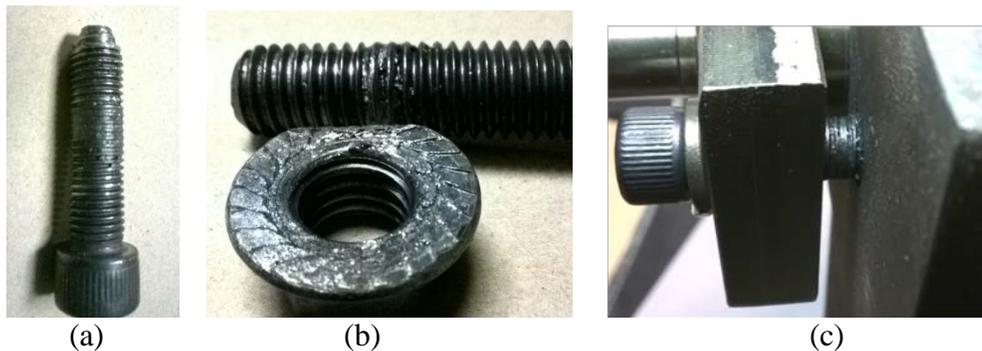
Figure 3 Thread damage due to thermal cycling of UFM transducers

- (a) Sample of a small bolt used to secure probe to transducer frame
- (b) Sample of large bolt used to secure transducer frame to pipe
- (c) Example of a small bolt seized in the frame

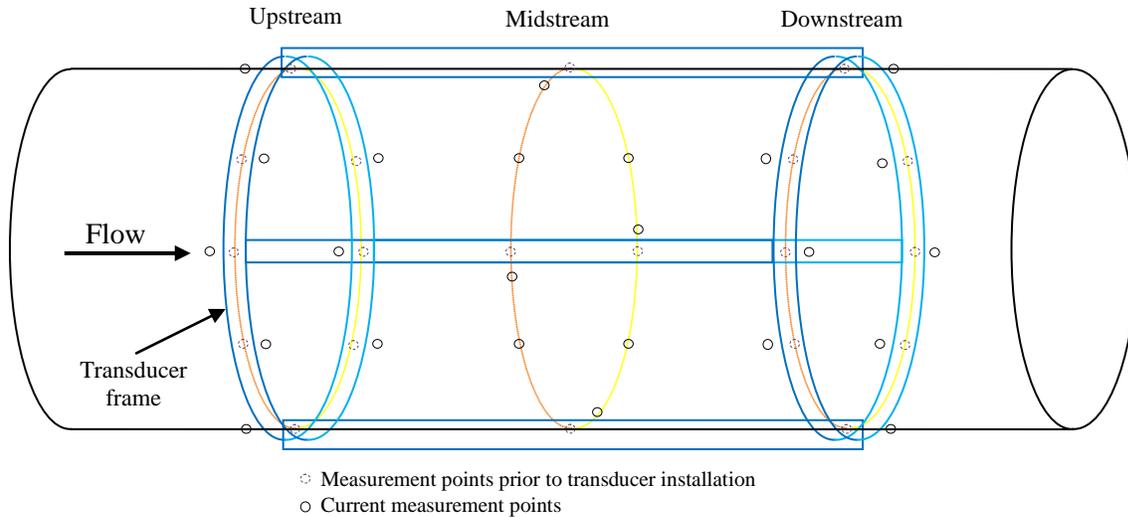
Figure 4 Pipe thickness measurement points with transducer installed

The indirect measurement involves measuring the pipe thickness around the transducer, as shown in Figure 4, where measurement points are not the same as the original measurement performed in 2001 [1]. However, the thickness of seamless pipe is non-uniform due to their manufacturing process [2]. This method of measurement improves safety and reduces cost issues associated with direct measurement method. The concern is whether the indirect thickness measurement can provide the same results as the direct measurement. To address this concern, the new thickness measurement points are measured twice by two different teams, where each team performs independent measurements. This is to ensure that each measurement remains bias free. The difference between the new data sets of measurement is used to gauge the difference and compare against the original thickness measurement that was performed in 2001 [1]. The thickness measurement is performed to address the concerns raised by the OPEX WER ATL 14-0448.

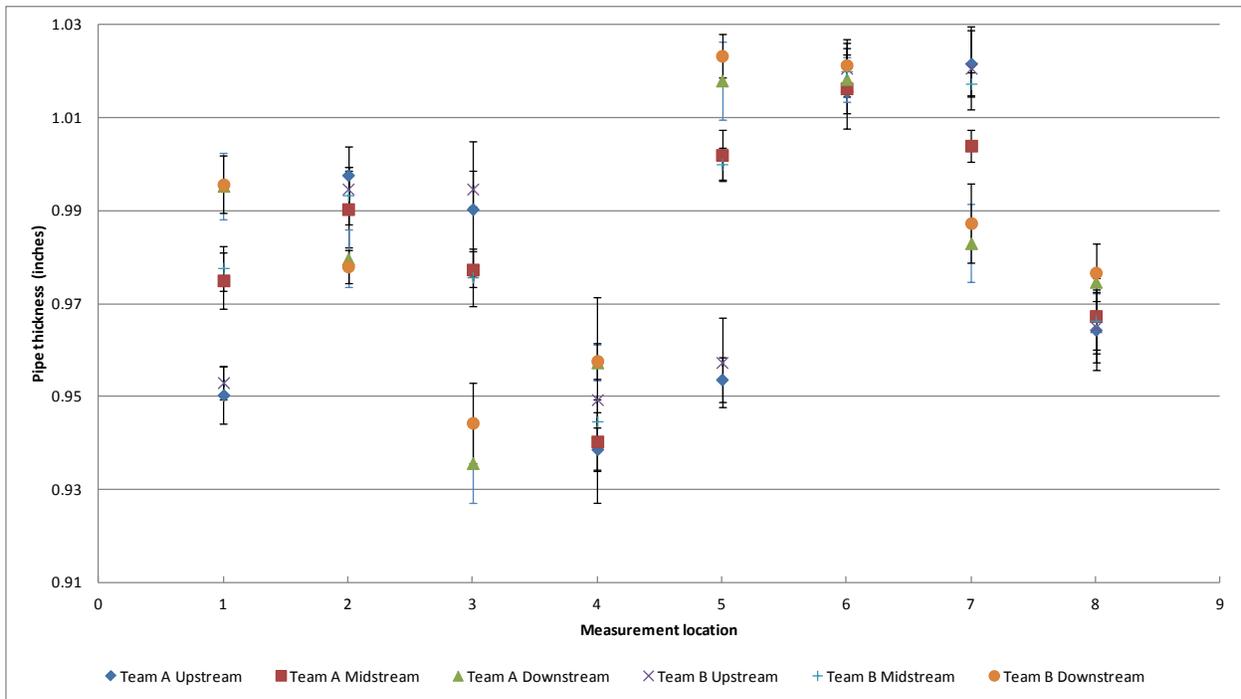
Figure 5 Point by point thickness measurement for Boiler 2

In this section, the point by point comparison of data collected by PPS personnel is analysed. As there are large amount of data to compare, only the data from Boiler 2 and Boiler 3 are presented in this section. Figure 5 displays the point by point thickness measurement of Boiler 2, and Figure 6 displays the point by point thickness measurement of Boiler 3. The error bars on these figures indicate the measurement uncertainties (also known as confidence interval) of the points.

Both Figure 5 and Figure 6 show that the measured thickness varies in range which is greater than the measurement uncertainties. This fact confirms the assumption that the thickness of a seamless pipe is non-uniform. However, when the measurement data from the same point is compared between two teams, most results are within the uncertainty, but some points do not agree and are outside of the uncertainty. This is because there are only three measurements per point for the estimated uncertainty. With only three points, the statistical relation is weak, and can be easily over whelmed by potential human performance issues. Regardless of these points' misalignment, the overall average of the measured thickness agrees within the overall measurement uncertainty (section 4.1).

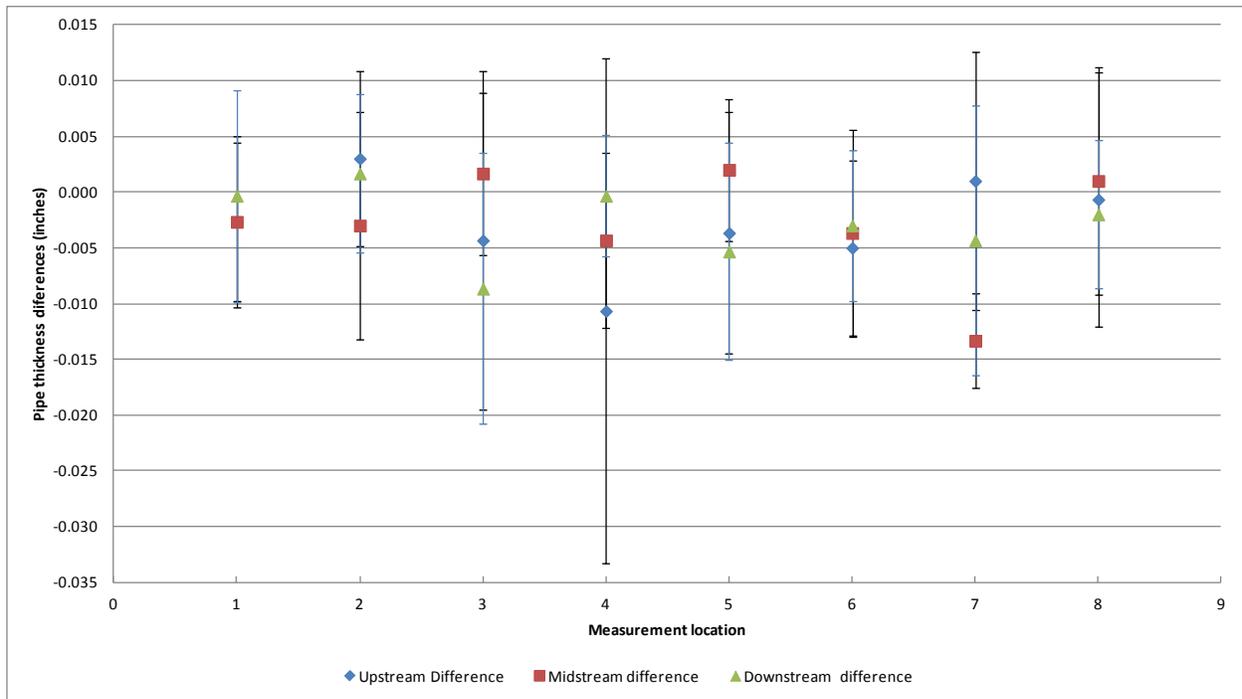
Figure 7 Difference in thickness measurement between teams A and B for Boiler 2

The details for Figure 5 and Figure 6 are hard to see due to the number of plots on the graphs. For simplicity, the differences between the measurements are plotted in Figure 7 and Figure 8. The error bars in these plots are the combined uncertainties of the two measurements. These plots show that most of the points' error bars cross the zero of the Y-axis; while, a few of them do not. The measurements agree within combined uncertainty, if error bar of a point crosses zero of the Y-axis; otherwise, they do not agree. This analysis mirrors the analysis of Figure 5 and Figure 6. This result indicates that the overall average value of the pipe thickness does not depend on the measurement locations. As long as enough data points are collected, they cover the section of the pipe where the transducer is installed.

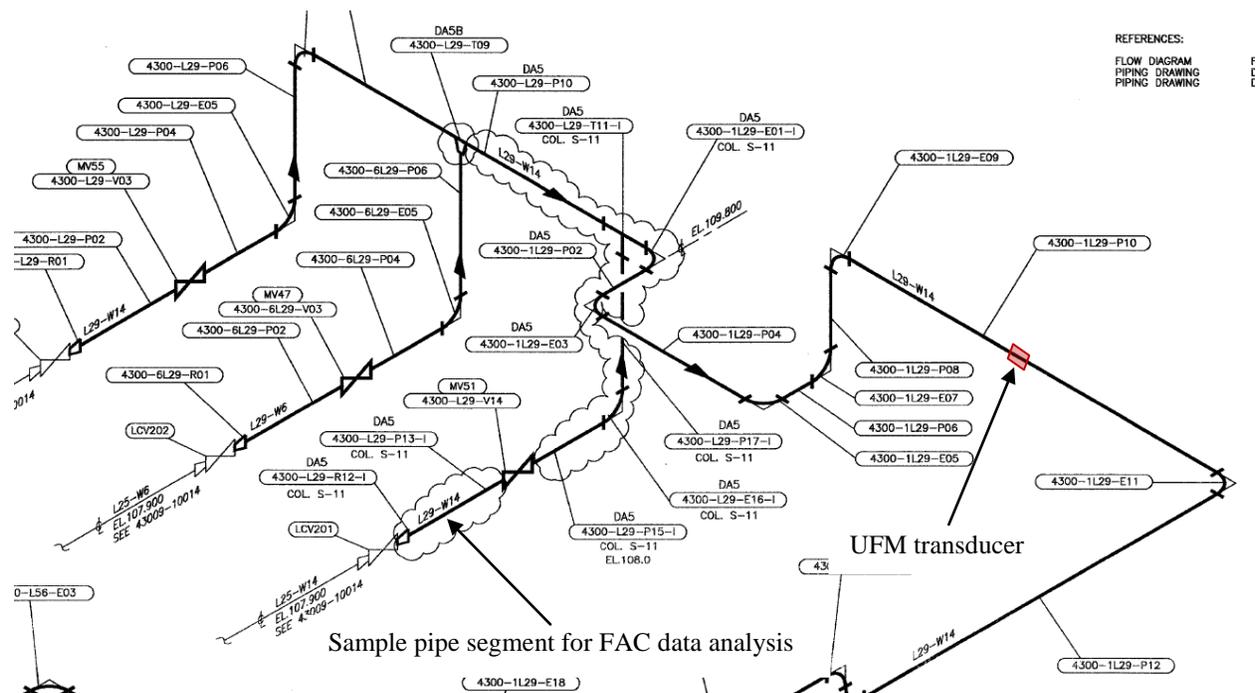
Figure 9 Piping layout of sample FAC data

OPG has procedures to monitor thinning of many pipes [3], [4] to ensure piping integrity. Particularly, many feedwater pipe sections near the boiler LCVs, upstream of the UFM transducer location, are monitored by this process (Figure 9 shows an example of Boiler 2 piping). If the FAC monitoring data show that the pipe upstream of the UFM transducer location is not thinning, then it can be deduced that the pipe under the UFM transducer is not thinning.

The pipe segment downstream of boiler LCV201 with CHECWORKS™ identification 4-4300-L29-P13-1 (Figure 9) is chosen for sample analysis for two reasons: one, this pipe is upstream of the UFM transducer location, and two, it is situated at the exit of an LCV. As such, the turbulent condition in this pipe is more violent compared to the location under the UFM transducer. FAC is related to turbulent condition in the pipe [6], [7].
