# DARLINGTON NGS FUEL DAMAGE INVESTIGATION AN OVERVIEW

# W.B. STEWART Senior Design Engineer - Nuclear/Civil Darlington Engineering & Construction Services

### Ontario Hydro

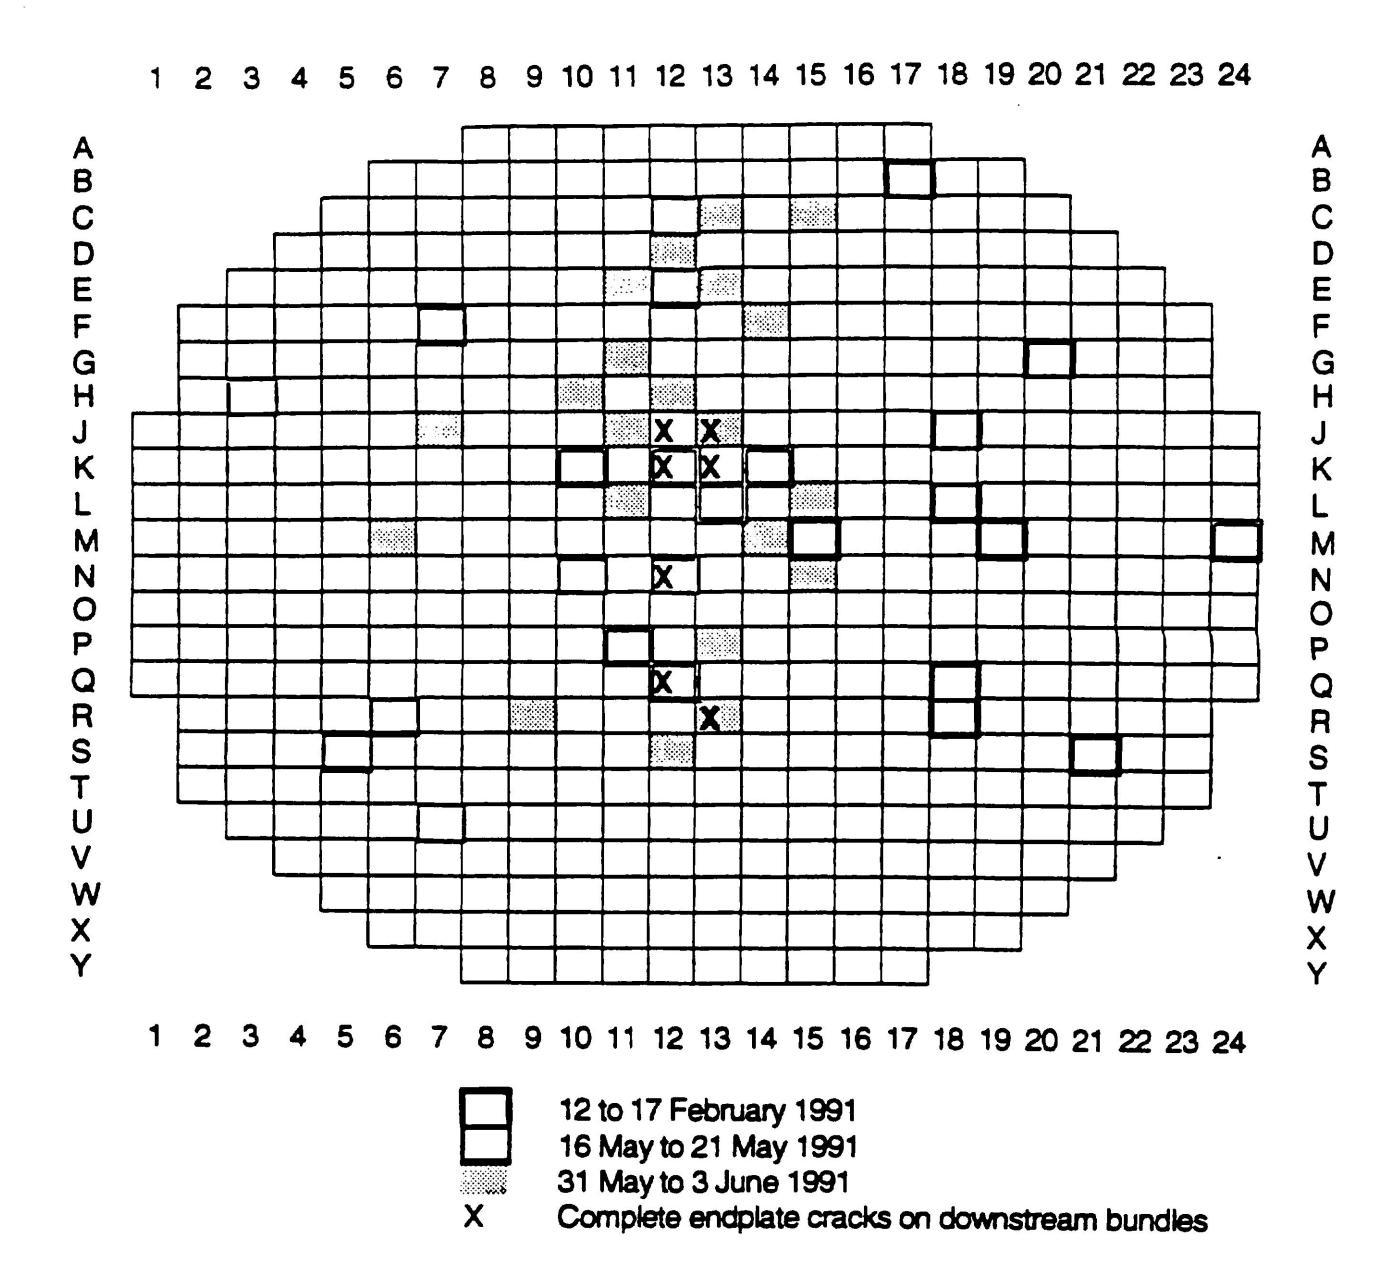
FIGURE 1 UNIT 2 CHANNELS INSPECTED BY CIGAR VIDEO EQUIPMENT

Subsequent to the shutdown of Unit 2, in-reactor inspections of the downstream end plates of selected bundles in position 1 and 13 were performed with CIGAR (Channel Inspection Gauging and Recording) video camera inspection equipment. Inspections were done on three separate occasions in 1991; February 12-17, May 16-21 and May 31-The channels inspected are shown in Figure 1. The first June 3. inspections revealed cracks in D2K12/1 (Darlington Unit 2 Channel <u>K12</u> bundle <u>1</u>) and D2Q12/1 downstream end plates. The second inspecton period concentrated on channels away from the centre columns 12 and 13 of the reactor face, except for channels C12 and The inspected endplates showed no visible indications of E12. cracks but channels R06, F07, and H03 were flagged for abnormal marks on the end plates. During the third inspection three channels, J13, H12 and R13, presented indications of cracks and two channels, L11 and E11, were flagged as indicating possible cracks. Subsequent inspection in the Irradiated Fuel Bay on the downstream end plates of the H12 and R13 position 1 bundles, confirmed the presence of a crack in R13 and that H12 was not cracked.

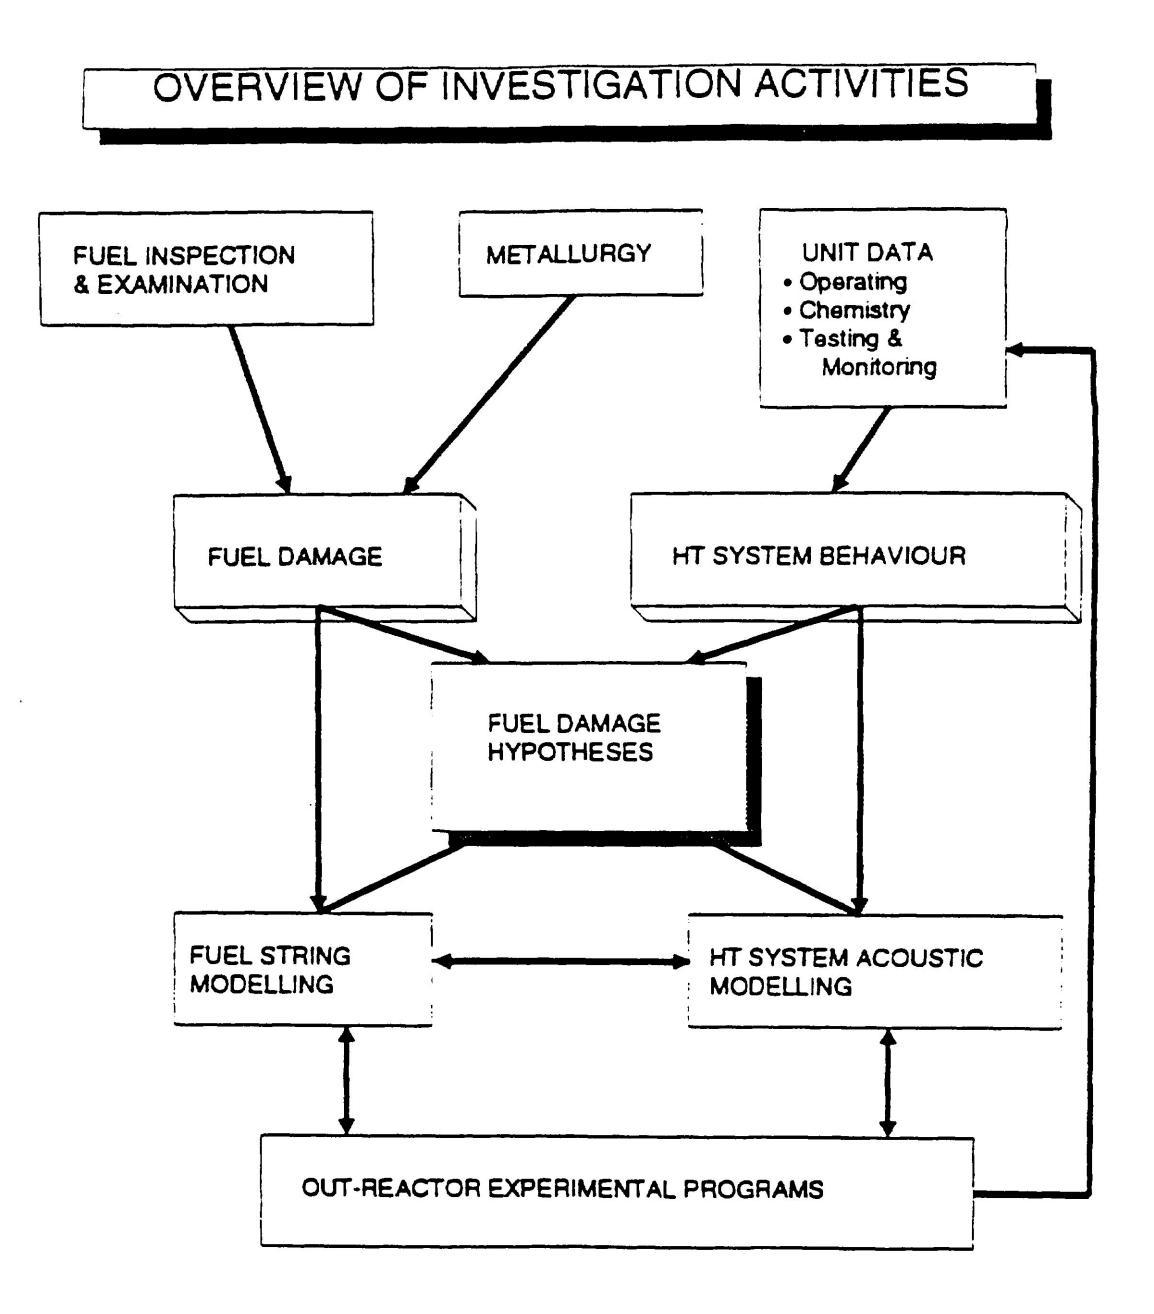
# FIGURE 3

Characterization of damaged fuel in Unit 2 has recently been completed. Endplate cracks have been identified on fuel from 8 channels (J12, J13, K12, K13, M13, N12, Q12 and R13). Severe bundle 13 bearing pad wear, due to interaction bearing pad with the spacer sleeve, has been observed on fuel from 7 channels (J13, J14, K07, K12, K13, M12, V20).

The initial activities of the investigation team were concentrated on evaluating potential scenarios whereby the observed break-up of the N12 bundle in position 1 could have occurred, assessing the potential implications of bundle break-up occurring in-reactor, establishing a fuel inspection plan and reviewing operating history. The work was focused in large measure on identifying the causes of fuel damage observed in Unit 2 as shown in Figure 3.
